**Icicle Creek Fish Passage Evaluation for  
The Leavenworth National Fish Hatchery**

**Final Clean Water Act Section 401 Certification Order No. 7192  
for the Leavenworth National Fish Hatchery  
Icicle Creek, Chelan County, Washington**

**September 10, 2013**

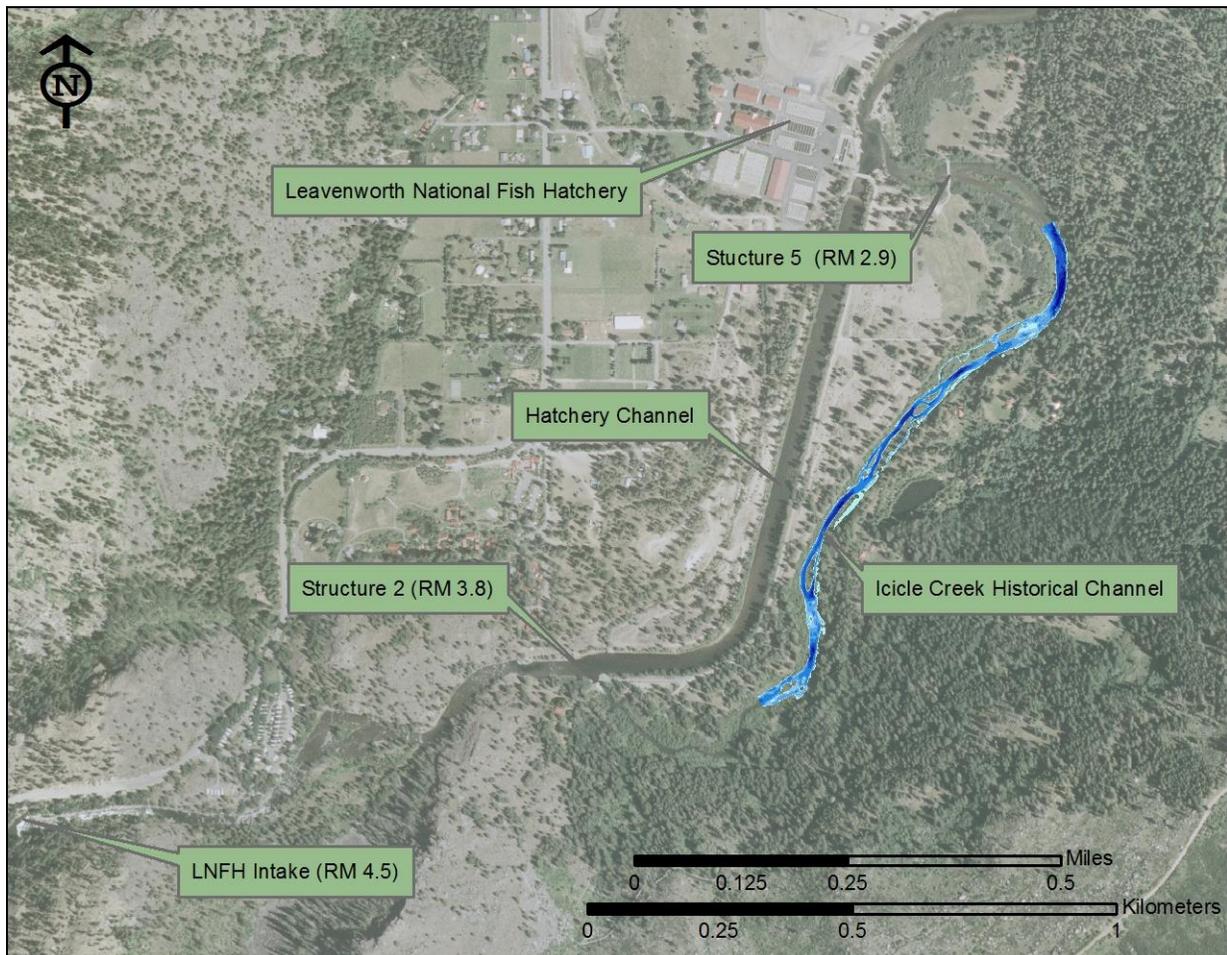
Figure 1. Study site overview depicting the location of LNFH, Icicle Creek, and Structures 2, 5, and the hatchery intake.

Following are detailed descriptions of the three sites included in this passage evaluation. The LNFH water intake structure is located approximately one river mile upstream from the hatchery itself, and from the location where the hatchery channel and historical channel diverge (Figure 1). S2 is located at the point of divergence of the two channels, and at the upstream end of the historical channel. S5 is located near the downstream end of the historical channel, approximately one river mile from S2.

LNFH shares a point of diversion with Cascade Orchard Irrigation Company (Cascade) on Icicle Creek at RM 4.5 (Figure 1). LNFH maintains and operates the intake diversion dam and its associated intake structures. Cascade has a 1905 water right for 12.4 cfs during the irrigation season (approximately May 1 through October 1) and LNFH holds a 1942 water right to divert 42 cfs all year long.

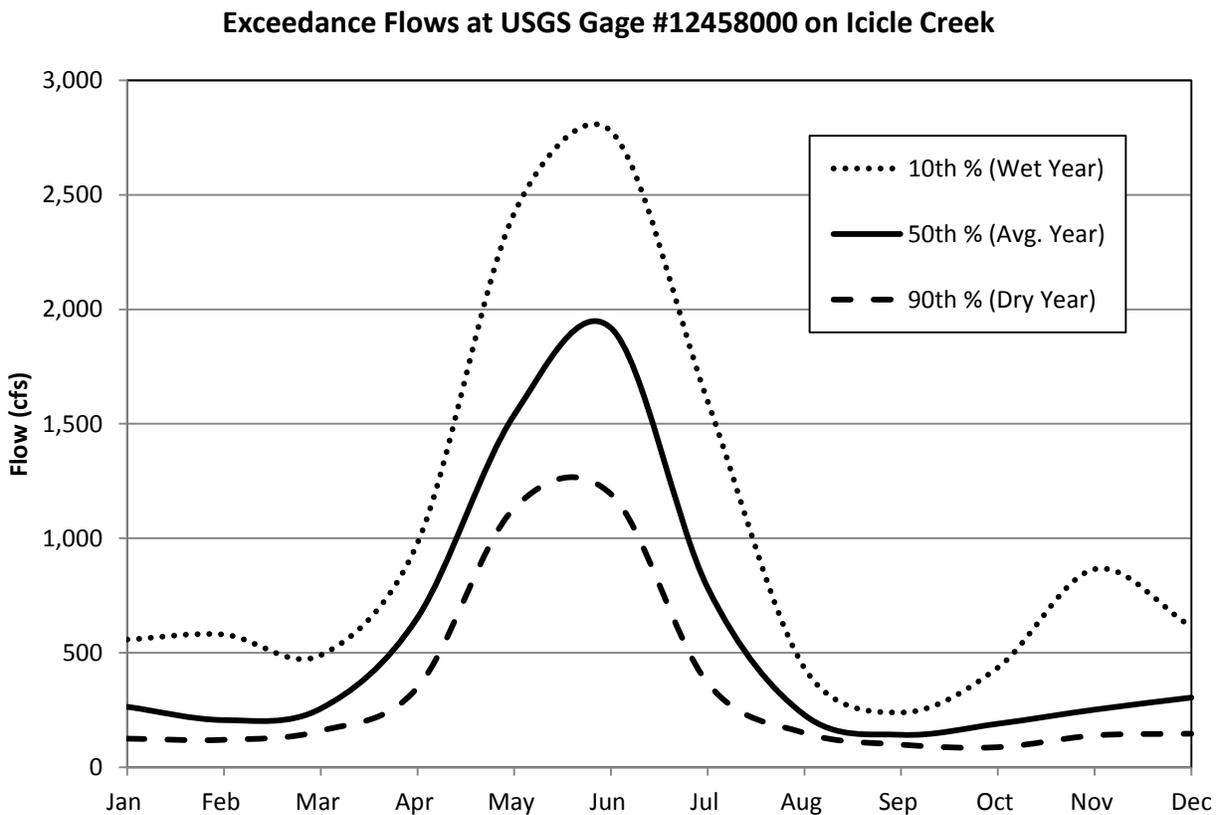
**Figure 2.** Exceedance flows as measured at USGS Gage #1245800 on Icicle Creek near Leavenworth, WA for an average, wet, and dry year for the period of record (1936 – 2012). Mean annual flow is 624 cfs.

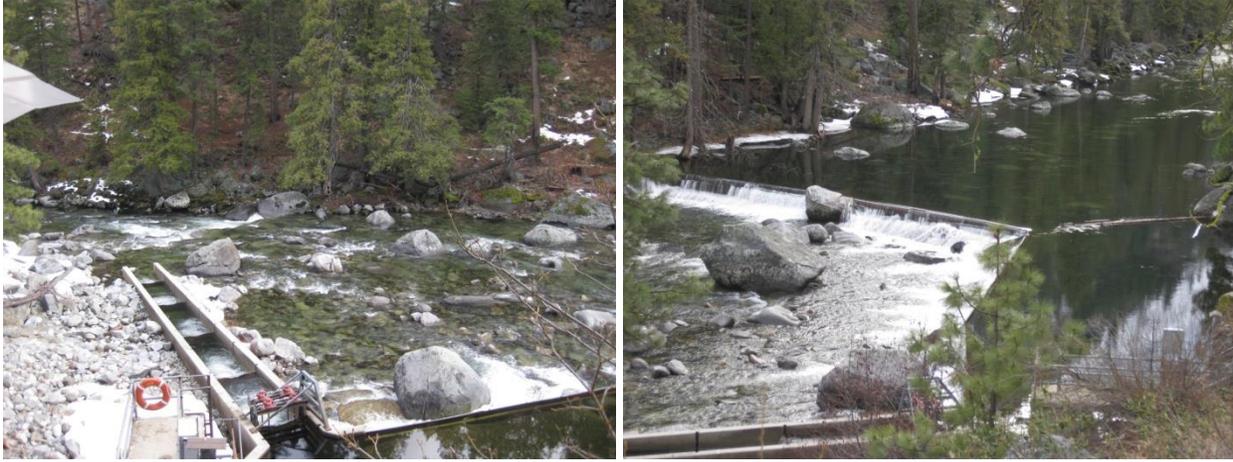
**Figure 3. LNFH intake structure located on Icicle Creek at RM 4.5. Left image is looking downstream at the fish ladder and the right image is of the low head dam with the ladder visible in the lower left. The location of the water conveyance channel is not depicted in the figure but it is located to the right and just downstream of the ladder when looking upstream.**

LNFH's intake facilities are comprised of several components. Primary to the water intake system is a low rubble masonry diversion dam with a concrete spillway crest across Icicle Creek. The dam impounds and raises water surface elevations several feet allowing a portion of the streamflow to be diverted both into a pool and weir fish ladder with water control structure and through a trash rack (six inch bar spacing) and into a concrete water conveyance channel (Figure 3). Water which enters the conveyance channel is transported down gradient into a 33-inch-diameter buried pipeline. Approximately 1,260 feet down gradient from the beginning of the pipe system is a bifurcation that allows water to flow into Cascade's delivery system. A maximum of 42 cfs of river water that does not enter Cascade's water delivery system is transported through a 31-inch-diameter buried pipeline approximately 5,200 feet to a sand settling basin at the hatchery, through fish screens, and then to the rearing units. When rearing units are cleaned, effluent is discharged through the pollution abatement pond.

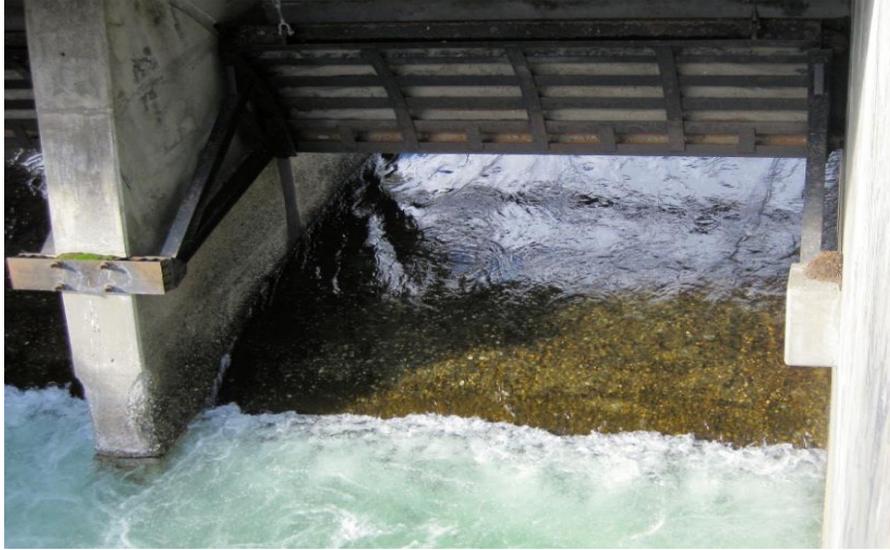
**Figure 4. LNFH Structure 2 located on Icicle Creek at RM 3.8. Image is looking upstream at one of two spill bays with the spill gate open.**

S2 is a concrete water control structure with two steel radial gates located at RM 3.8 in Icicle Creek (Figure 4). It was designed to control flow into the historical channel, and a hatchery channel was built to bypass excess Icicle Creek streamflow. The hatchery channel parallels the historical channel until both channels reconnect downstream from S5 at RM 2.8. In recent times, the gates at S2 have been fully opened most of the year. The few exceptions are discussed below.

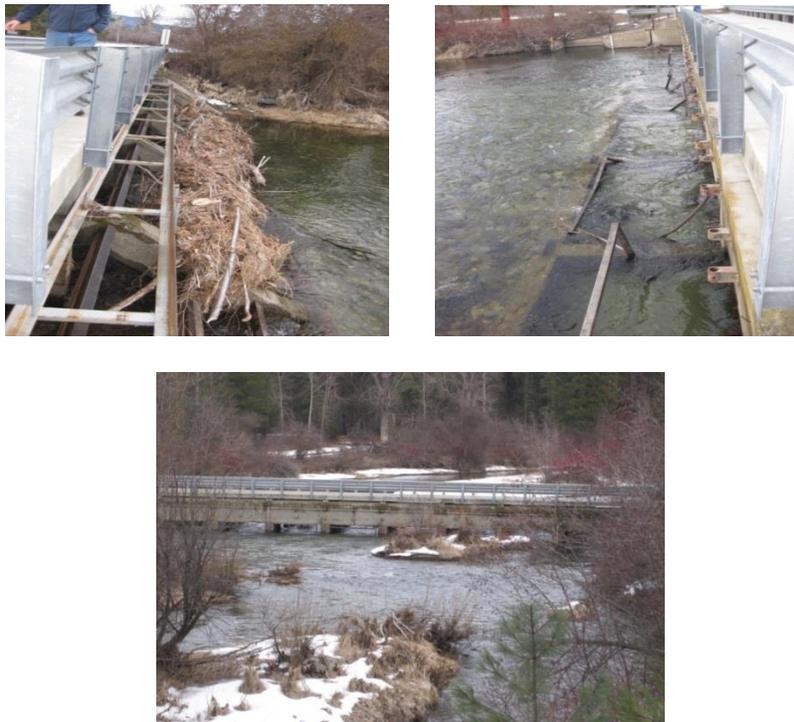
**Figure 5. LNFH Structure 5 located on Icicle Creek at RM 2.9. Top left image shows the upstream side of Structure 5 with debris accumulation, top right image shows downstream side of Structure 5 with staff gage on far concrete wall, and bottom image is looking upstream at Structure 5.**

S5 is located near the downstream end of the historical channel at RM 2.9 and functions as a specialized bridge with a foundation to support racks or pickets, dam boards, and/or fish traps (Figure 5). The hatchery channel reconnects with the historical channel approximately 0.1 RM downstream from S5. Currently, racks or pickets, dam boards, and/or fish traps are removed from S5 most of the year except as discussed below. This management strategy can impact the Service's ability to meet some of the operational needs of the hatchery such as broodstock collection.

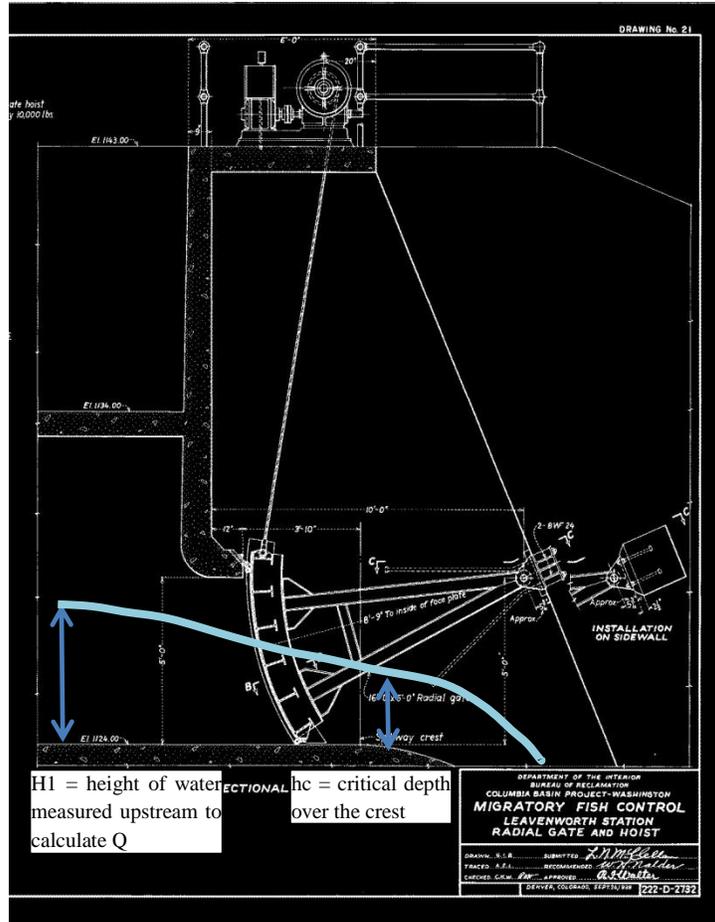
Figure 6. Relative locations of  $H$  and  $h_c$  on the weir at S2. (Drawing courtesy of Mary Lindenberg, FWS)

Since there are two gate openings, Equation 4 was multiplied by two to determine total discharge. Height of the water surface,  $H$ , was measured upstream from the weir for the calculation of discharge in Equation 4. Figure 6 shows the location of  $H$  relative to the radial gate opening. Critical depth, or depth on the weir itself was the condition required for the passage evaluation. In this case, since the radial gates are in contact with the water surface over the weir,  $B$  from Equation 4 above set the critical depth on the weir.

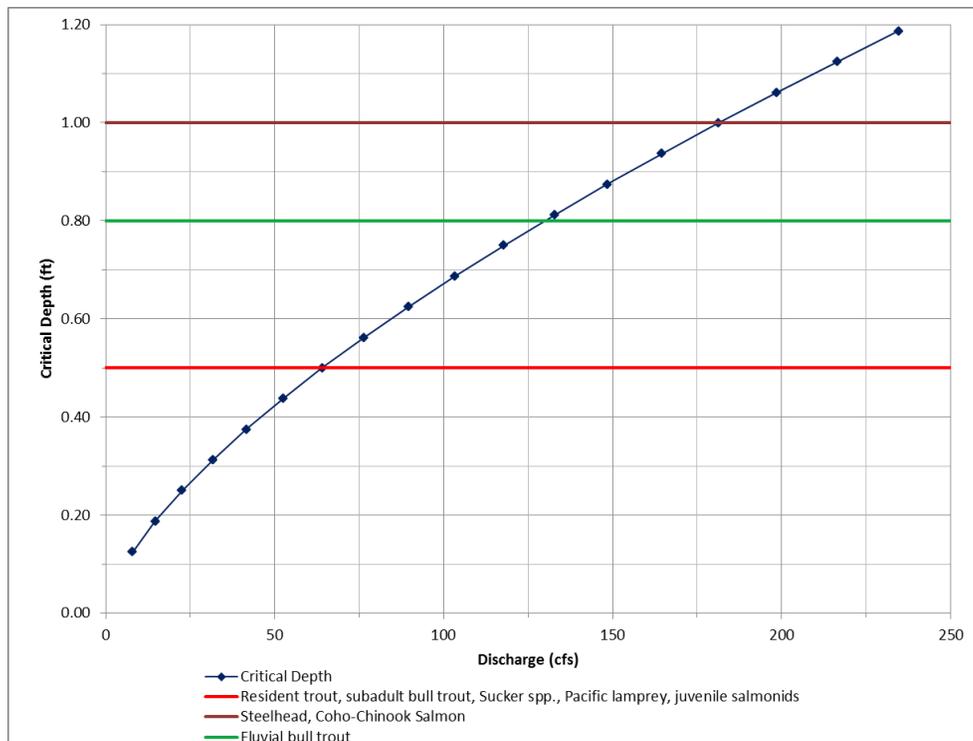
**Figure 7. Relationship between discharge (cfs) and critical depth (ft) over the weir at Structure 2 with the radial gates open. Also shown are the depth passage criteria from Table 2.**

Critical depths on the weir at S2 over a range of streamflows with the radial gates open are shown in Figure 7. A minimum discharge of approximately 64 cfs is required for upstream passage of resident trout (including mountain whitefish), subadult bull trout, sucker spp., Pacific lamprey, and juvenile salmonids, a minimum discharge of approximately 132 cfs is required for upstream passage of fluvial bull trout, and a minimum discharge of approximately 181 cfs is required for upstream passage of salmon and steelhead. The downstream passage criteria for juvenile salmonids (0.33 ft) occurs at a discharge of approximately 37 cfs.

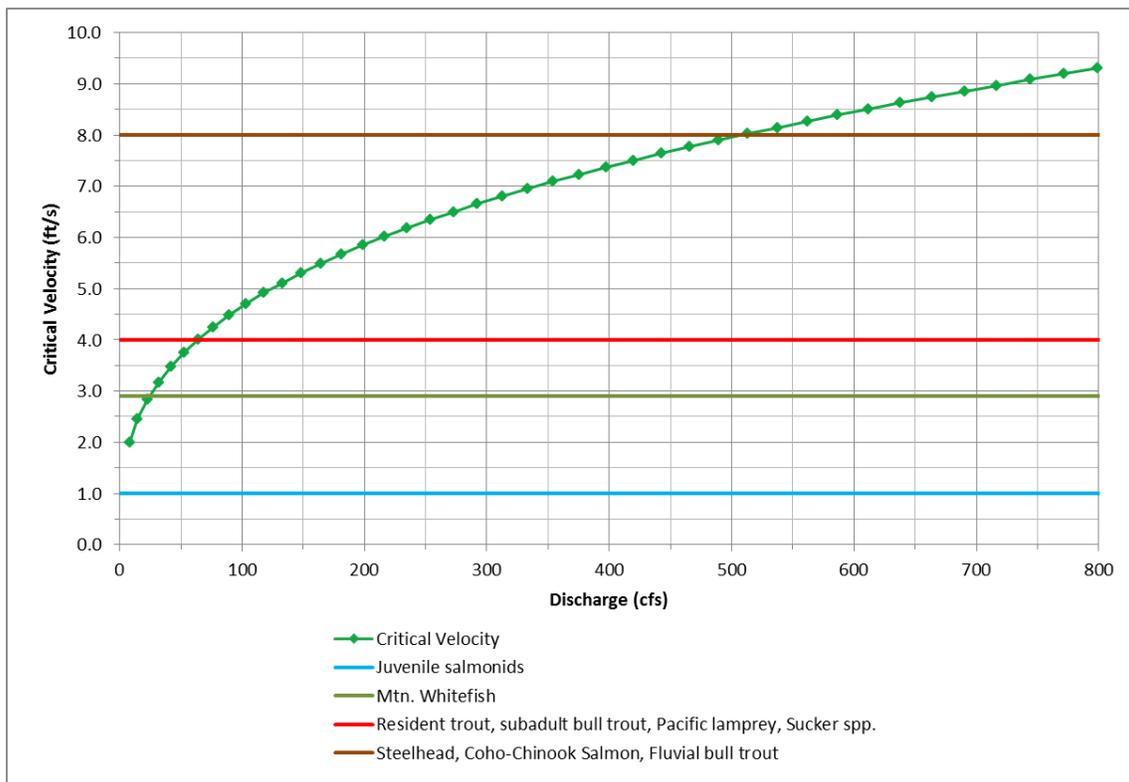
**Figure 8. Relationship between discharge (cfs) and critical velocity (ft/s) over the weir at Structure 2 with the radial gates open. Also shown are the velocity passage criteria from Table 3.**

Critical velocities on the weir at S2 over a range of streamflows with the radial gates open are shown in Figure 8. The lowest discharge modeled produced a critical velocity of 2.01 ft/s at a discharge of 8 cfs. Thus, upstream passage of juvenile salmonids over S2 does not appear to be possible. Mountain whitefish swimming capabilities are less robust than the other resident salmonids. The maximum velocity criteria used for mountain whitefish occurs at a discharge of approximately 23 cfs. The maximum velocity criteria of 4 ft/s used for resident trout, subadult bull trout, sucker *spp.*, and Pacific lamprey occurs at a discharge of approximately 64 cfs, and the maximum velocity criteria of 8 ft/s used for salmon, steelhead, and fluvial bull trout occurs at a discharge of approximately 512 cfs.

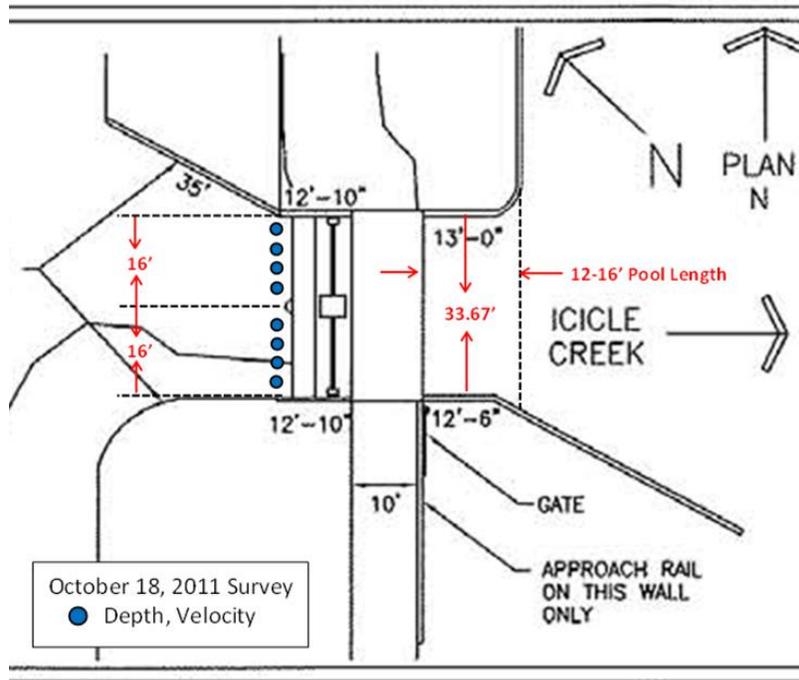
Figure 9. Plan view of S2 showing dimensions of the structure, the two 16-foot radial gate bays, the exit pool, and the location of depth and velocity measurements collected on October 18, 2011.

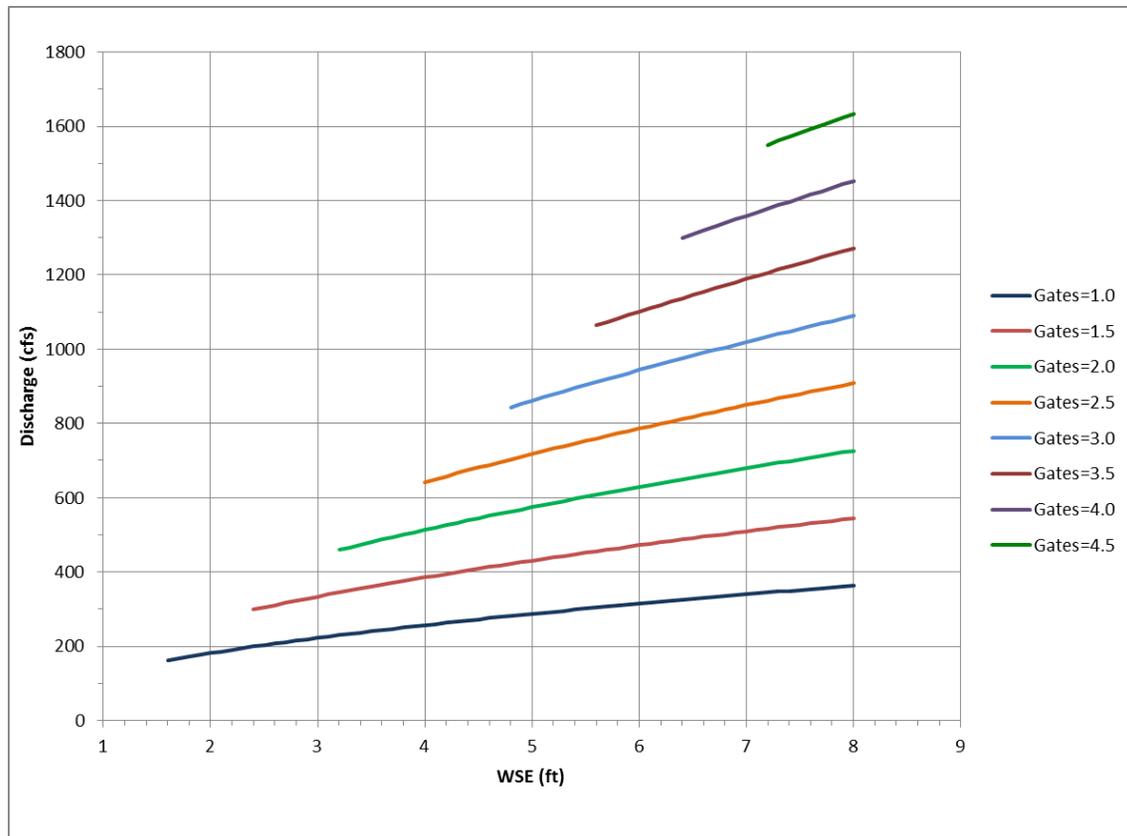
**Figure 10. Relationship between water surface elevation (WSE) upstream from Structure 2 and discharge (cfs) through the two 16-ft radial gate bays at gate openings from 1.0 feet to 4.5 feet.**

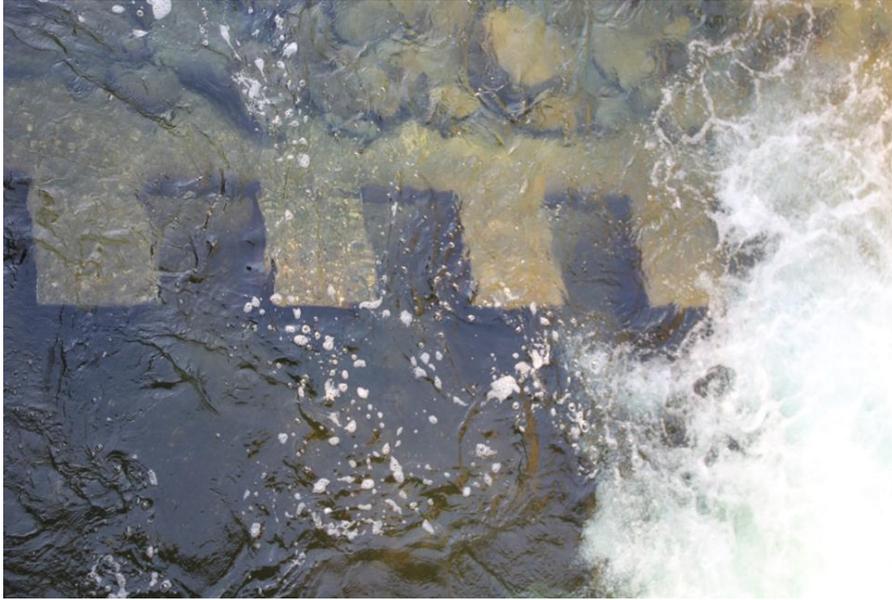
**Figure 11. Dentates at the downstream end of the pool below the weir at S2.**

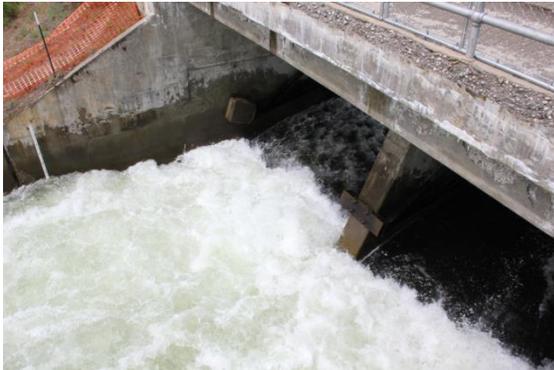
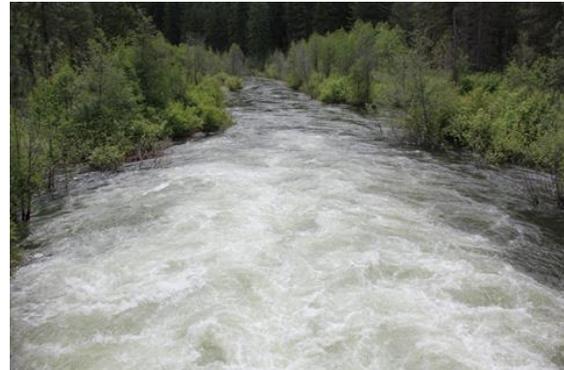
**Figure 12. Downstream pool at S2 at approximately 1500 cfs on June 5, 2012.**

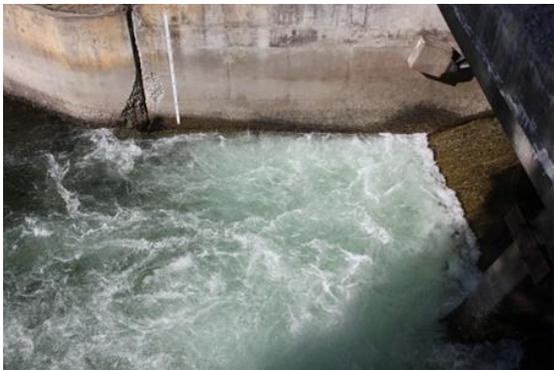
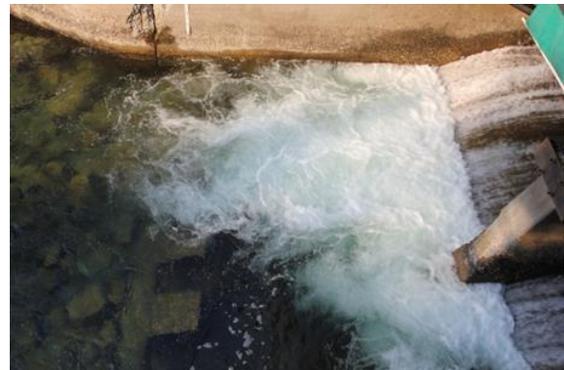
**Figure 13. Downstream pool at S2 at approximately 220 cfs on August 14, 2012.**

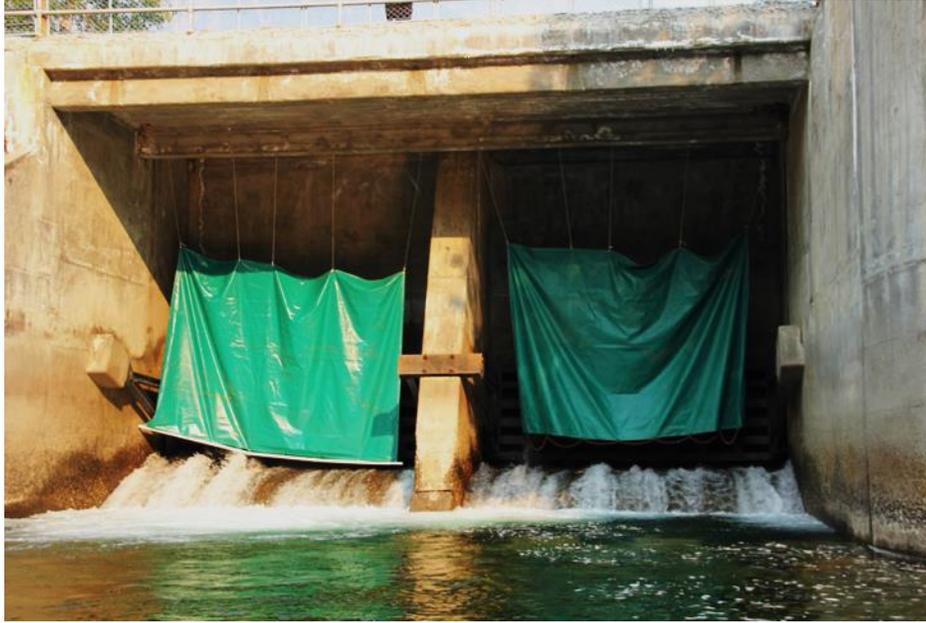
**Figure 14.** Tarps deployed to protect jumping fish from impact injury on the steel radial gates or the concrete weir.

Fish have been observed attempting to jump from this pool onto the weir to pass S2. The jumping behavior could be a response to either shallow depths on the weir, high velocities on the weir, or the turbulence in the pool below. One issue associated with this method of passage is physical injury from impacts with the steel radial gates or concrete structure. Hatchery personnel have deployed tarps in the past (Figure 14) to prevent injury to jumping fish.

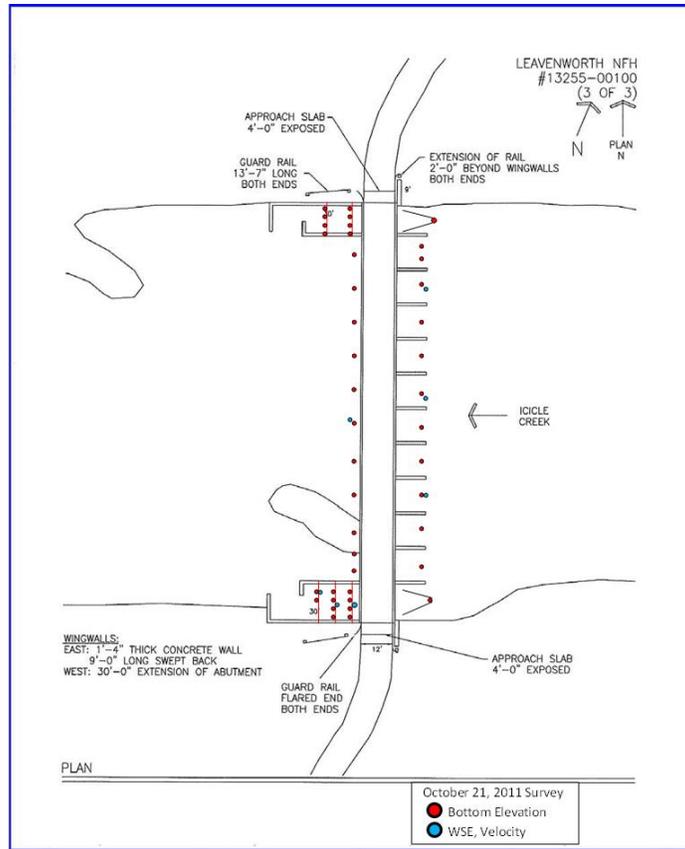
Figure 15. Plan view of Structure 5 showing locations of survey points on the upstream and downstream footings and the fish trap/fish passage structures on each river bank. Also shown are the locations of water surface elevation (WSE) points and velocity measurements

Surveyed elevations, depths, and velocities were measured on the upstream and downstream sill foundations of S5 as shown in Figure 15. Data were collected at streamflows of 42.6, 149, and 238 cfs. Rating curves were developed for each sill, and the WSE was determined for a range of flows including the flows required to provide depths to meet the passage criteria. The rating curve for the upstream sill is shown in Figure 16, and the rating curve for the downstream sill is shown in Figure 17. Since the flow range modeled was relatively narrow, both rating curves had linear relationships.

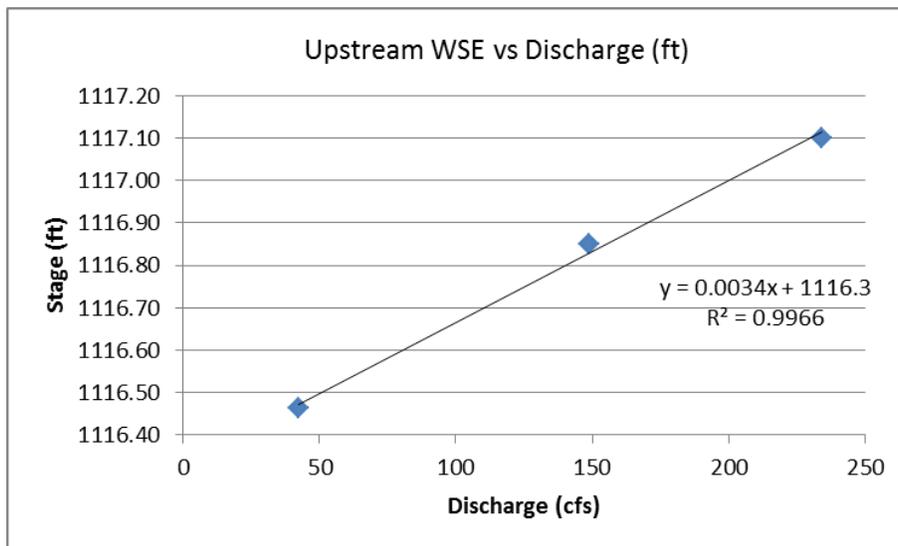
Figure 16. Rating curve for the upstream foundation sill at S5.

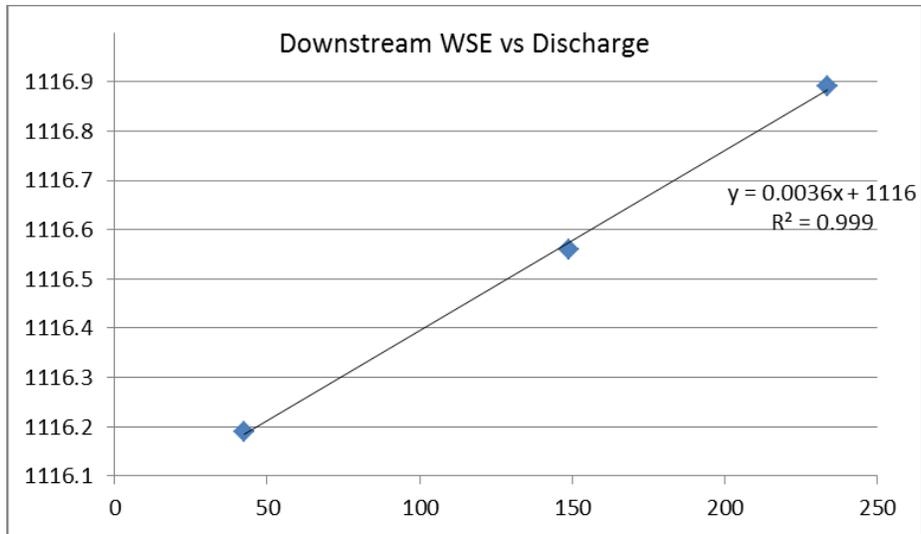
**Figure 17. Rating curve for the downstream foundation sill at S5.**

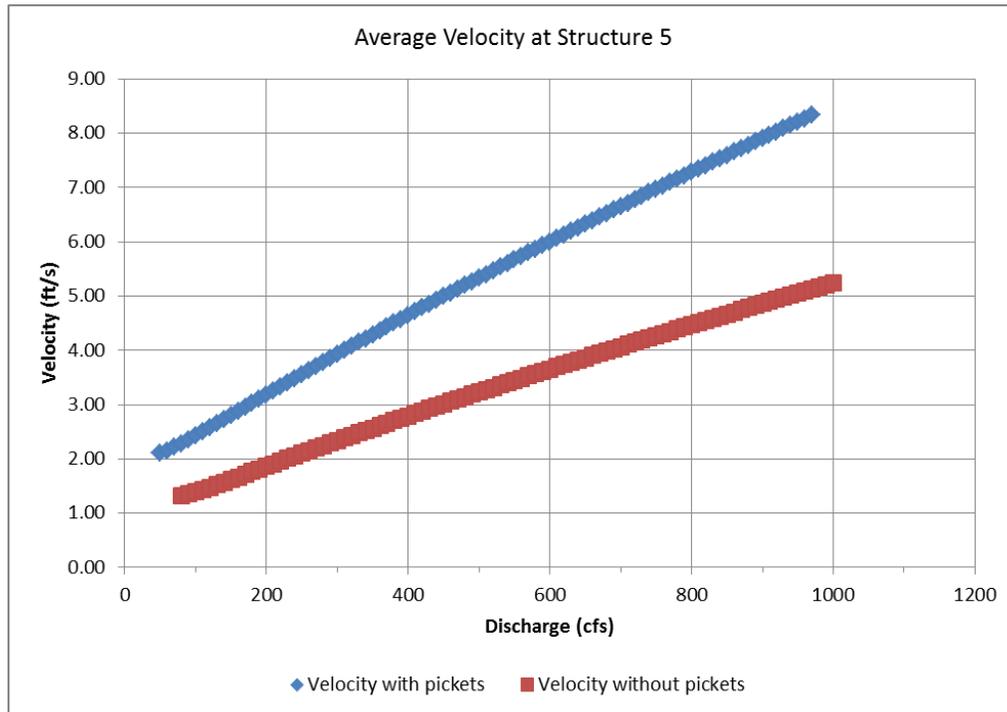
Figure 18. Average velocity at S5 with and without pickets installed.

estimate velocities with the pickets installed. The graph in Figure 18 shows the estimated velocities for both conditions.

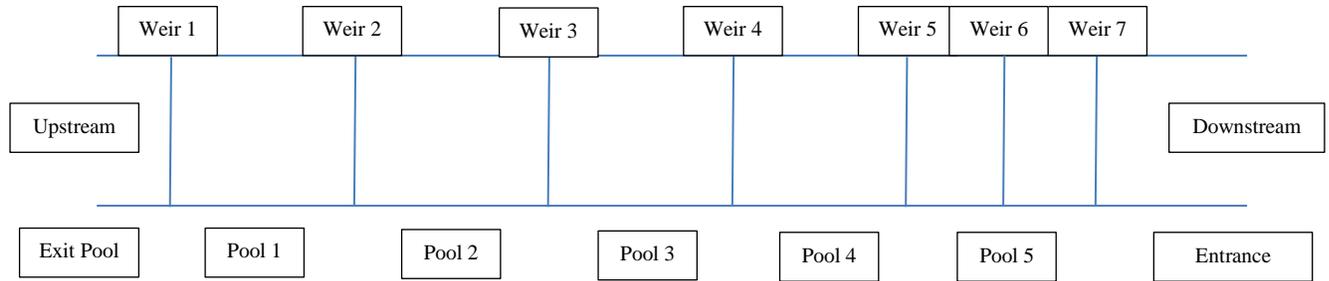
**Figure 19. Diagram of the fishway at the LNFH intake.**

The purpose of the fishway at the LNFH diversion dam is to allow upstream passage around the approximately six foot tall, low head diversion dam that supplies water to the hatchery and Cascade Orchards Irrigation Company. Among the factors that were assessed are the fishway entrance location, attraction flows, transportation channels/pools, weirs between the pools to control hydraulic drop, and an exit at the top. Specific data collected included depths, widths, velocities, hydraulic drop between the fishway pools, weir crest depth and velocity, and sediment deposition within fishway pools. The diagram in Figure 19 shows the weir and pool structure of the fishway that corresponds to fishway conditions shown in Table 9 and Table 10. Figure 20 shows the dimensions of the notched weir crest.

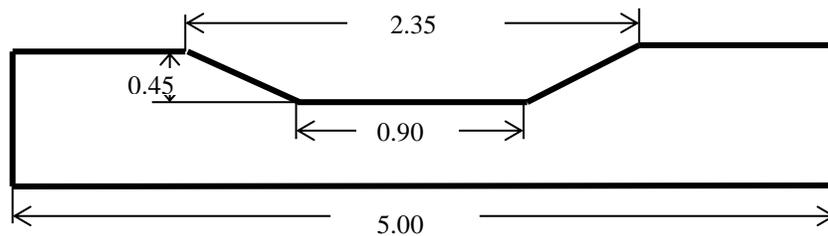
**Figure 20. Weir top dimensions for the LNFH fishway weirs.**

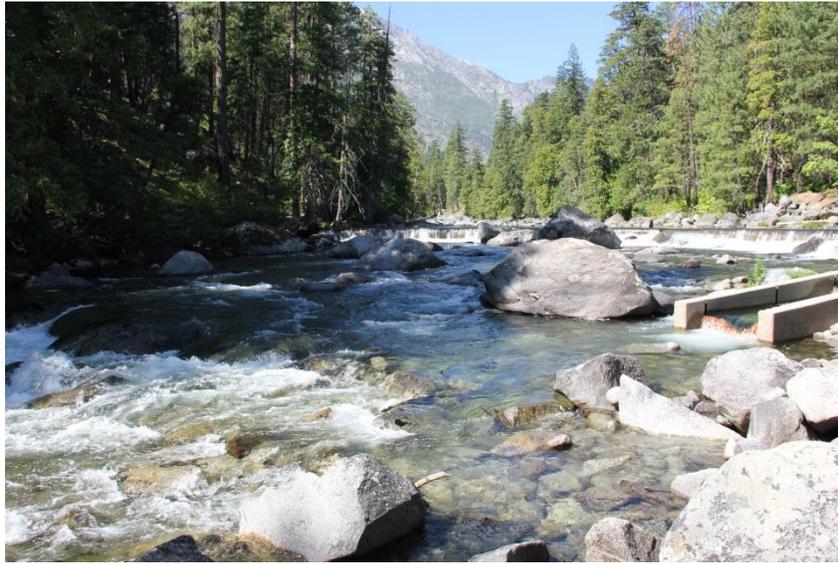
**Figure 21. Location of the fishway entrance with conditions shown in August 2012.**

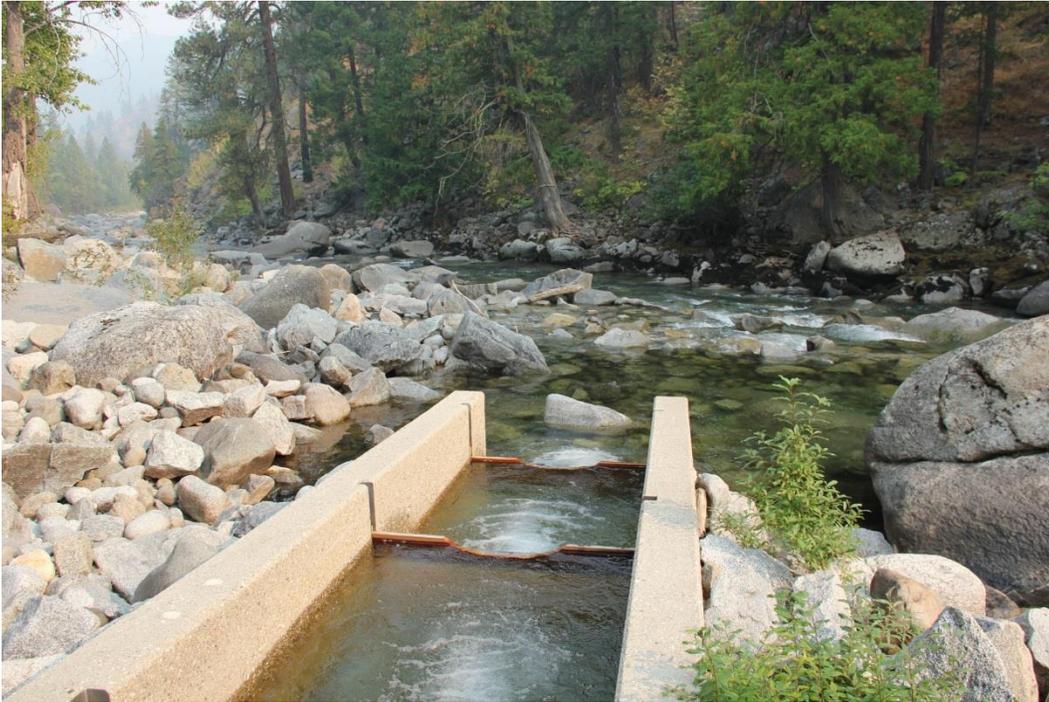
**Figure 22. Location of the fishway entrance with conditions shown in September 2012.**

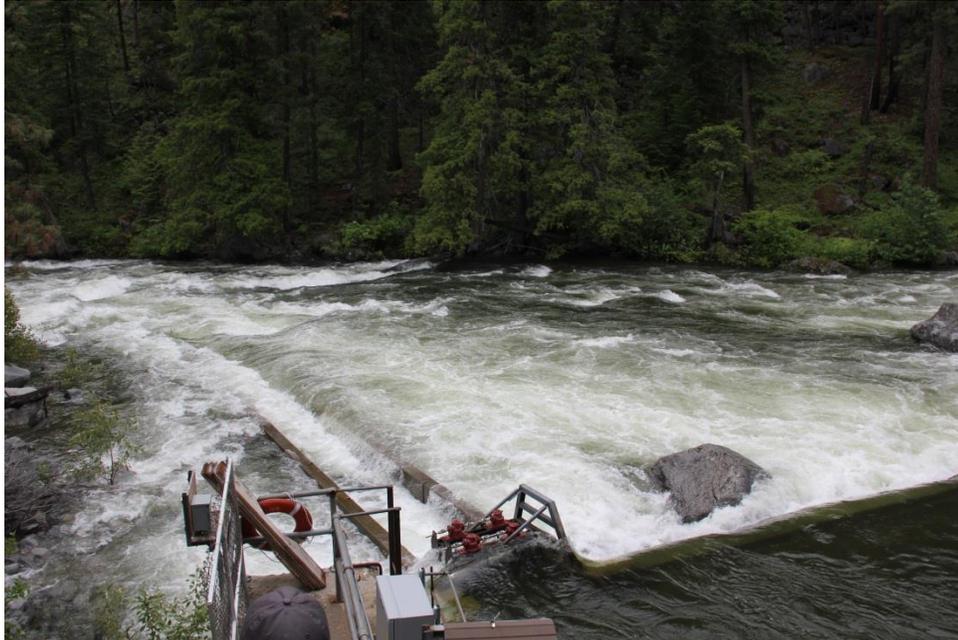
Figure 23. Figure 20.7. LNFH diversion, fish ladder, and streamflow conditions on June 5, 2012 at a streamflow of 2,663 cfs.

At the highest flow we observed (2,663 cfs) in June 2012, the entire fishway and water control structure at the top of the fishway were washed out (Figure 23). The fishway weirs had been removed to allow sediment to wash downstream. Thus, fish passage was not the objective at this flow level. The water surface elevation differential between the forebay and tailrace was estimated to be approximately 2.5 feet at this flow, likely allowing passage directly over the dam. The primary flow path for upstream migrants appeared to be on the opposite side of the river from the fishway (Figure 24).

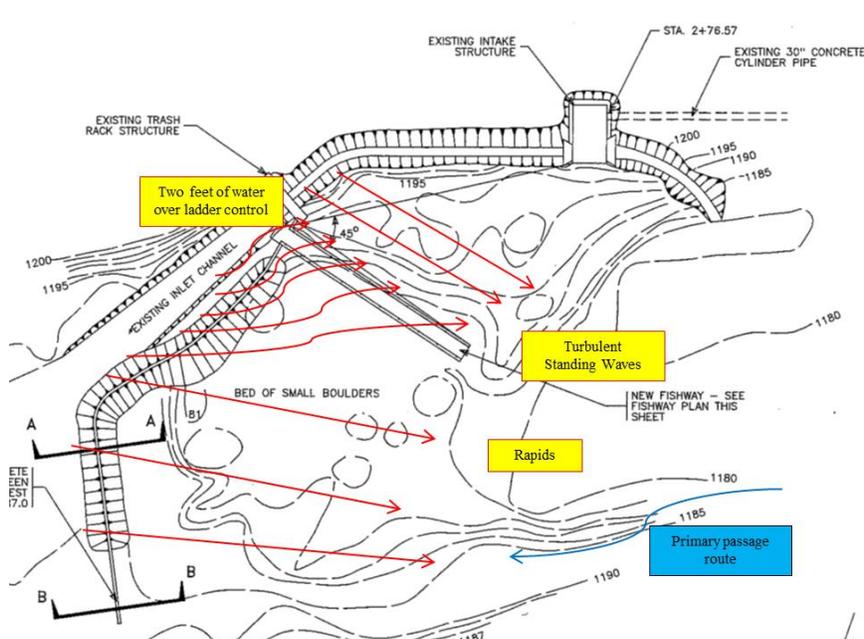
Figure 24. LNFH diversion, fish ladder, and streamflow conditions on June 5, 2012 at a streamflow of 2,663 cfs. Red arrows indicate the direction of flow over the dam, through the tailrace, and over the fish ladder (washed out). The blue arrow indicates the most likely route for upstream migrants.

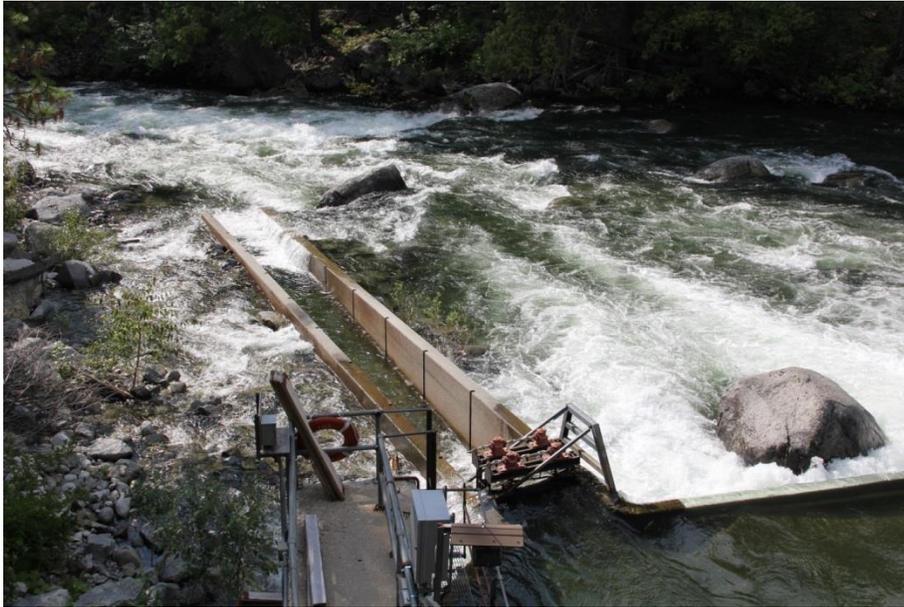
Figure 25. LNFH diversion, fish ladder, and streamflow conditions on July 20, 2012 at a streamflow of 1,271 cfs.

fishway were washed out (Figure 25). Thus, fish passage was not the objective at this flow level. The water surface elevation differential between the forebay and tailrace was estimated to be approximately 3.5 feet at this flow, continuing to allow passage directly over the dam. Two primary flow paths were evident for upstream migrants at this flow (Figure 26), both on the opposite side of the river, and in a thalweg roughly mid-channel.

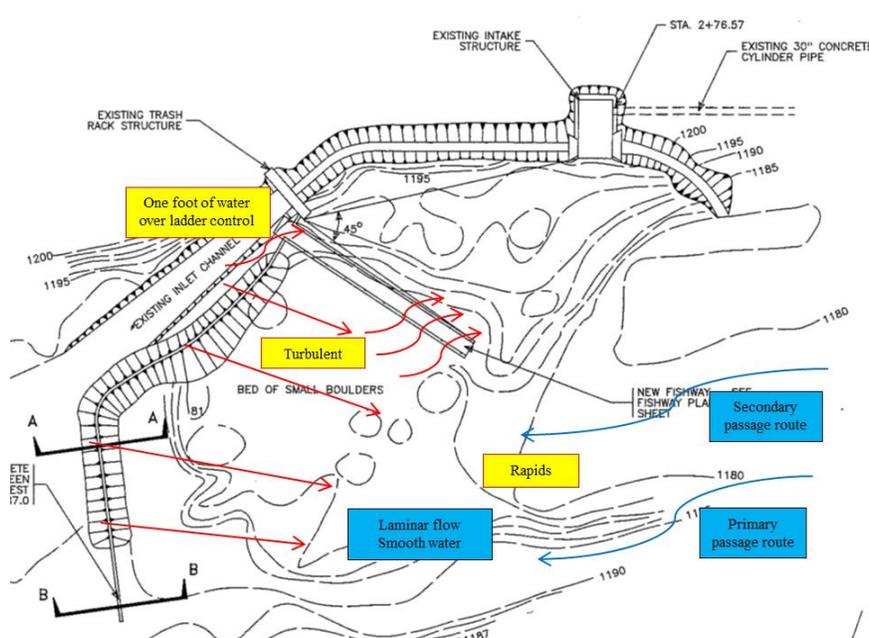
Figure 26. LNFH diversion, fish ladder, and streamflow conditions on July 20, 2012 at a streamflow of 1,271 cfs. Red arrows indicate the direction of flow over the dam, through the tailrace, and over the fish ladder (washed out-lower end). Blue arrows indicate the most likely routes for upstream migrants.

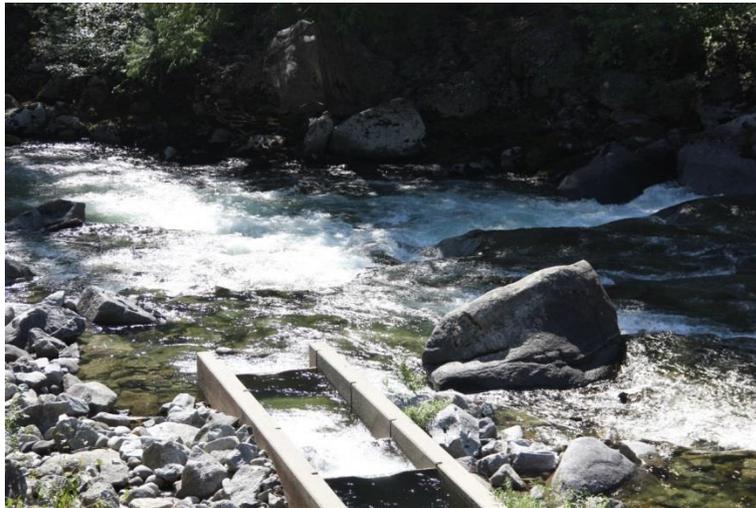
Figure 27. LNFH diversion, fish ladder, and streamflow conditions on August 14, 2012 at a streamflow of 324 cfs.

The next lower flow we observed was 324 cfs in August 2012. At this flow, the fishway weirs were in place, and the fishway and water control structure at the top of the fishway were not affected by flow over the dam. The location of the fishway entrance relative to the main river flow can be seen in Figure 27. Also apparent is a hydraulic control downstream from the entrance to the fishway that blocks a direct flow path to the entrance. The water surface elevation differential between the forebay and tailrace was estimated to be approximately 4.5 feet at this flow, and fish that do not use the fishway would have to jump the dam to move upstream. The same two primary flow paths were evident for upstream migrants at this flow (Figure 28), both on the opposite side of the river, and in the thalweg roughly mid-channel.

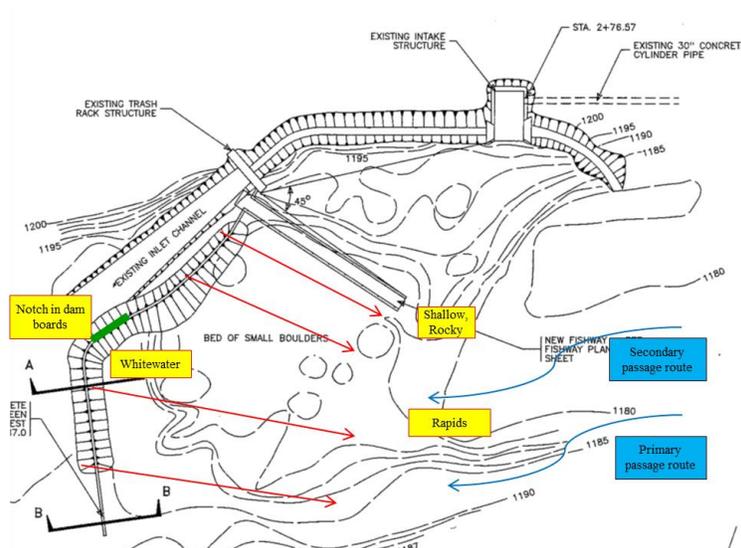
Figure 28. LNFH diversion, fish ladder, and streamflow conditions on August 14, 2012 at a streamflow of 324 cfs. The green bar is the location of the notch in the dam boards and spillway. Red arrows indicate the direction of flow over the dam and through the tailrace. Blue arrows indicate the most likely routes for upstream migrants.

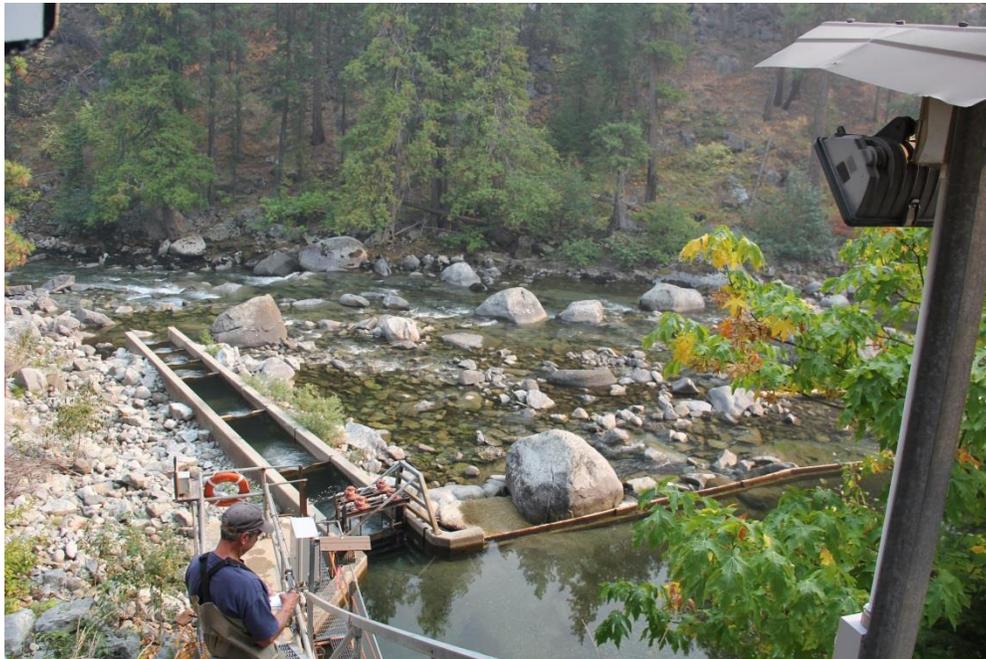
**Figure 29. LNFH diversion, fish ladder, and streamflow conditions on September 18, 2012 at a streamflow of 121 cfs.**

The lowest flow we observed was 121 cfs in September 2012. The location of the fishway entrance relative to the main river flow can be seen in Figure 29. It is apparent from this photo that the fishway is perched on a shelf on the near side of the river, and the same two main flow paths are evident. The water surface elevation differential between the forebay and tailrace was estimated to be approximately 5.5 feet at this flow, and fish that do not use the fishway would have to jump the dam to move upstream. The same two primary flow paths were evident for upstream migrants at this flow (Figure 30), one on the opposite side of the river, and a second in the thalweg roughly mid-channel. Also shown in Figure 24 is the depth of potential jump pools. Hotchkiss and Frei (2007) cited a criteria that the State of Oregon uses for jump pool depth as “1.5 times jump height, or a minimum of 0.6 m (2 ft) depth (Robison et al. 1999). All of these pools met the two feet minimum depth criteria, but none met the 1.5 times jump height (7.65 feet) criteria.

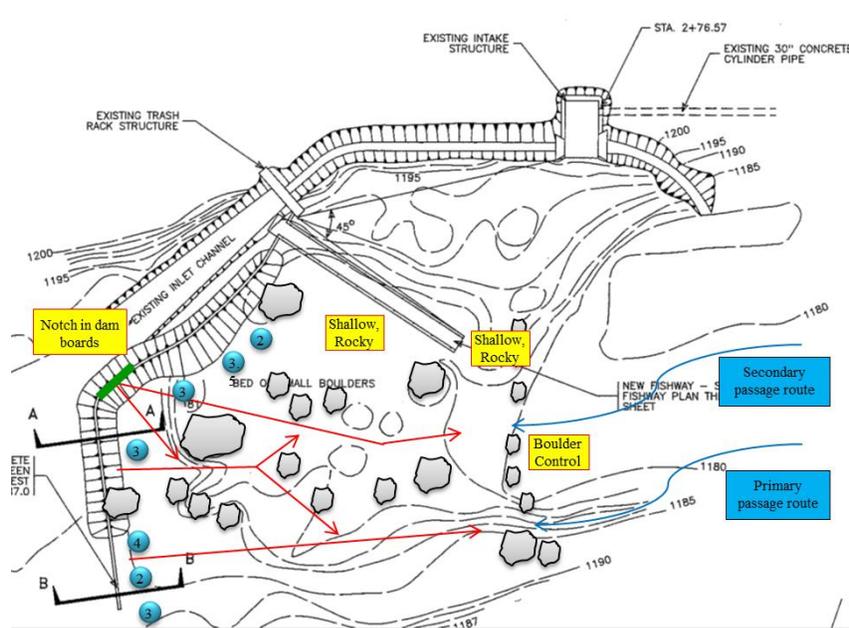
**Figure 30. LNFH diversion, fish ladder, and streamflow conditions on September 18, 2012 at a streamflow of 121 cfs. The green bar is the location of the notch in the dam boards and spillway. Red arrows indicate the direction of flow over the dam and through the tailrace. Blue arrows indicate the most likely routes for upstream migrants. Primary boulders are shown in gray. Numbers within the blue circles indicate depth of jump pools fish could use to breach the dam.**

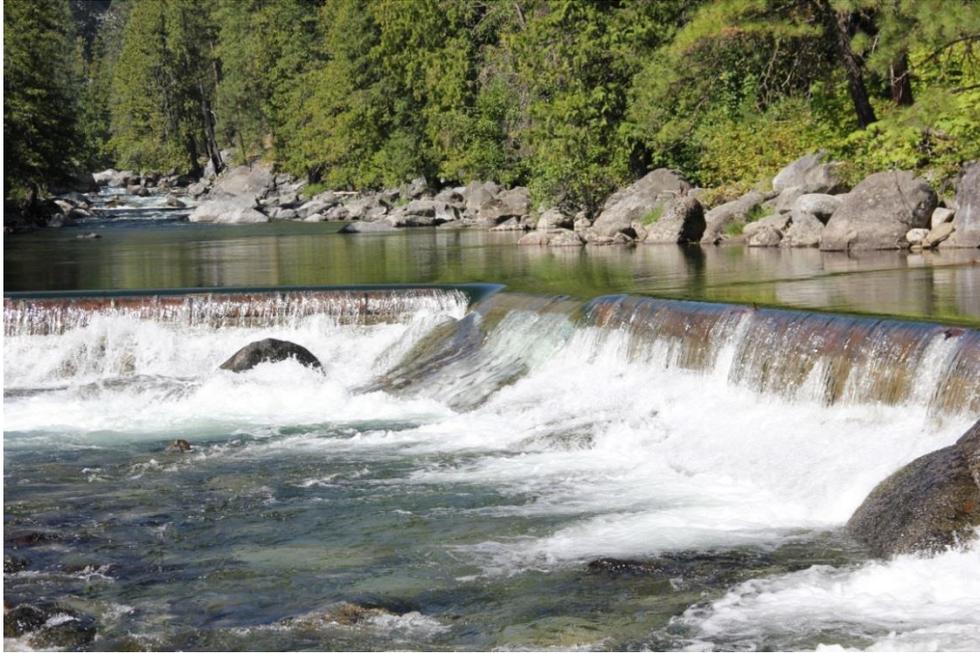
**Figure 31. Spill over the LNFH diversion dam in August 2012 at a streamflow of 324 cfs. The notch in the dam flashboards is visible in the center of the photo.**
