**Icicle Creek Fish Passage Evaluation for  
The Leavenworth National Fish Hatchery**

**Final Clean Water Act Section 401 Certification Order No. 7192  
for the Leavenworth National Fish Hatchery  
Icicle Creek, Chelan County, Washington**

**September 10, 2013**

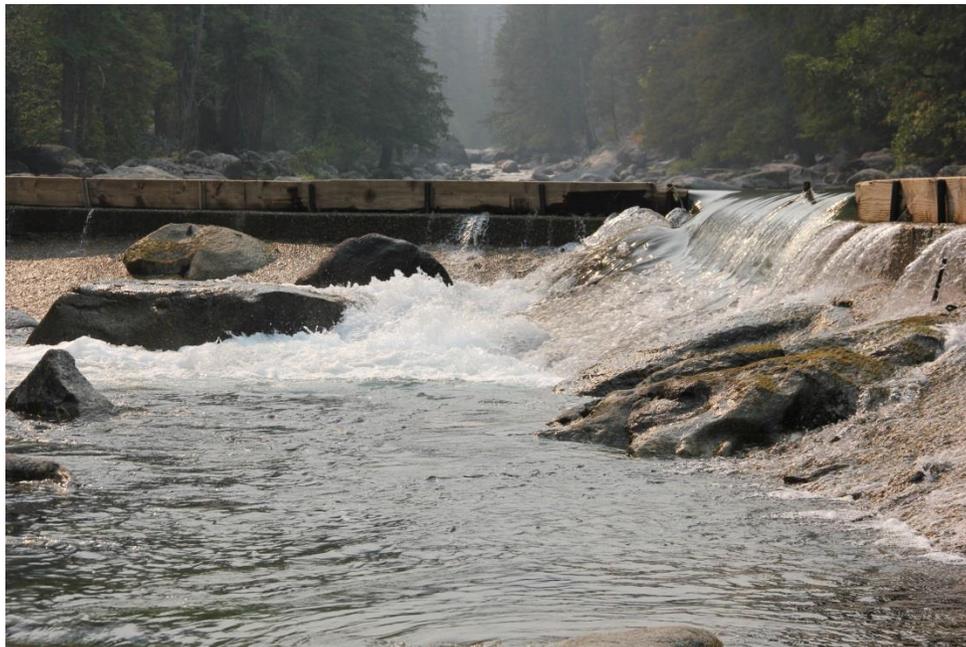
**Figure 32. Spill over the LNFH diversion dam in September 2012 at a streamflow of 121 cfs. The notch in the dam flashboards is visible near the right side of the photo.**

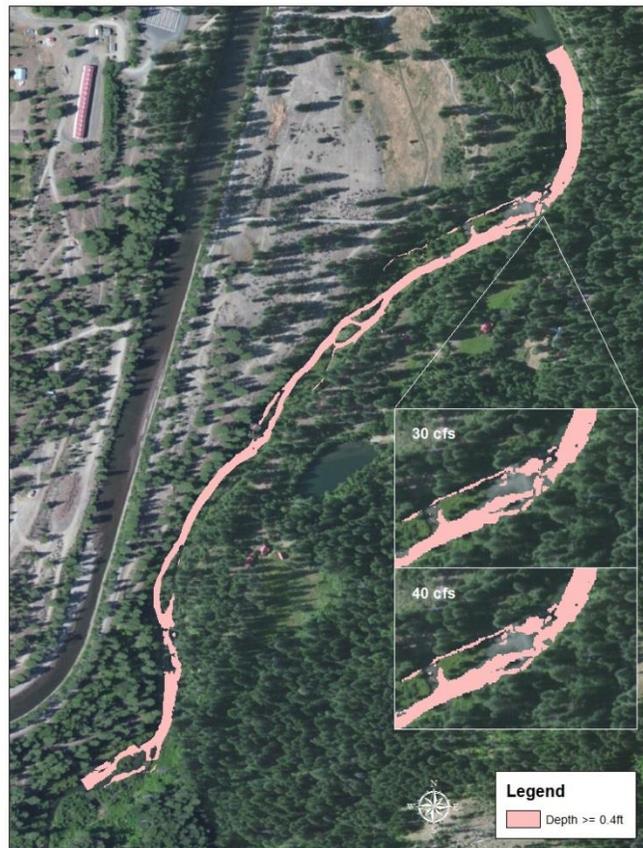
Figure 33. Fish passage in the historical channel based on the 0.4 foot depth criteria.

The lowest minimum depth passage condition we assessed was 0.4 feet. Figure 33 shows the Icicle Creek historical channel with one location near the downstream end of the study reach that did not meet the criteria. The insets show that the passage was not continuous through the reach at 30 cfs, and at 40 cfs, the break in passage was eliminated. The downstream passage criteria in Table 2 for juvenile salmonids is 0.33 feet, and these results show that passage is continuous for downstream migrants at 40 cfs.

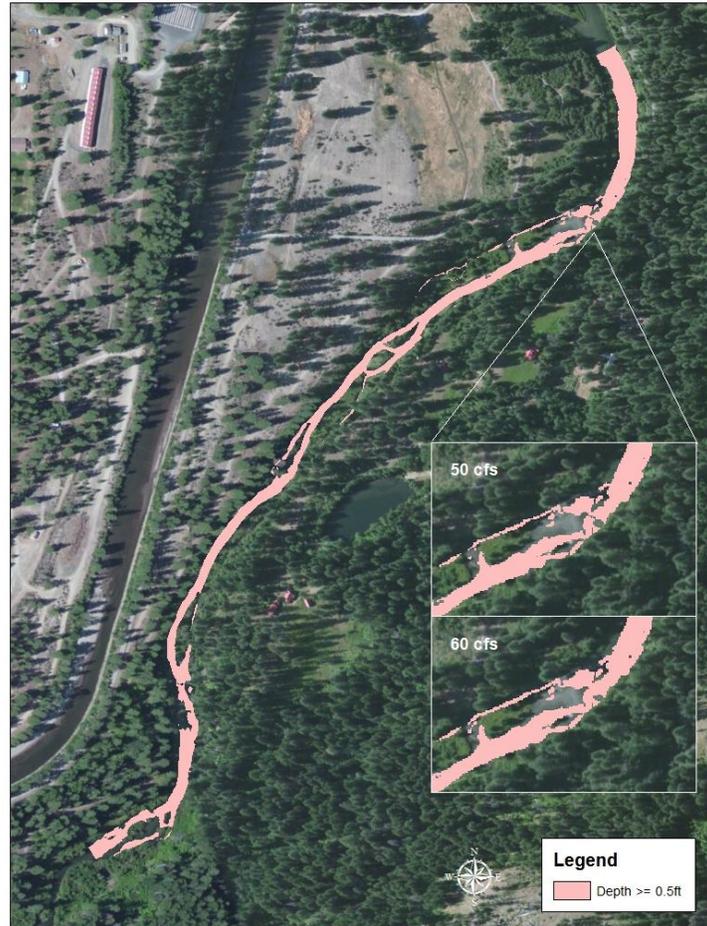
**Figure 34. Fish passage in the historical channel based on the 0.5 foot depth criteria.**

For a minimum passage depth of 0.5 feet, the same downstream location in the Icicle Creek historical channel did not meet the criteria at 50 cfs (Figure 34). The insets show that the break in passage was eliminated at 60 cfs. These results suggest that 60 cfs is required for continuous passage through the historical channel for rainbow trout, Westslope cutthroat trout, mountain whitefish, subadult bull trout, suckers, and Pacific lamprey.

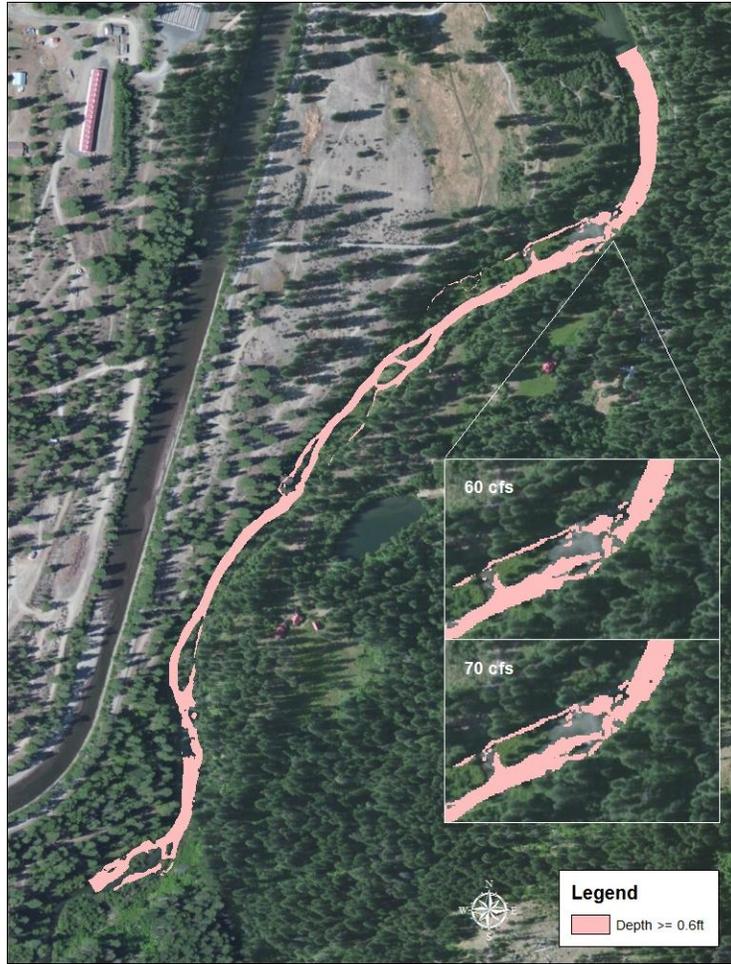
**Figure 35. Fish passage in the historical channel based on the 0.6 foot depth criteria.**

For a minimum passage depth of 0.6 feet, the same downstream location in the Icicle Creek historical channel did not meet the criteria at 60 cfs (Figure 35). The insets show that the break in passage was eliminated at 70 cfs. Although 0.6 feet was not used as a target for this assessment, Figure 35 shows that the same location in the historical channel continued to be limiting.

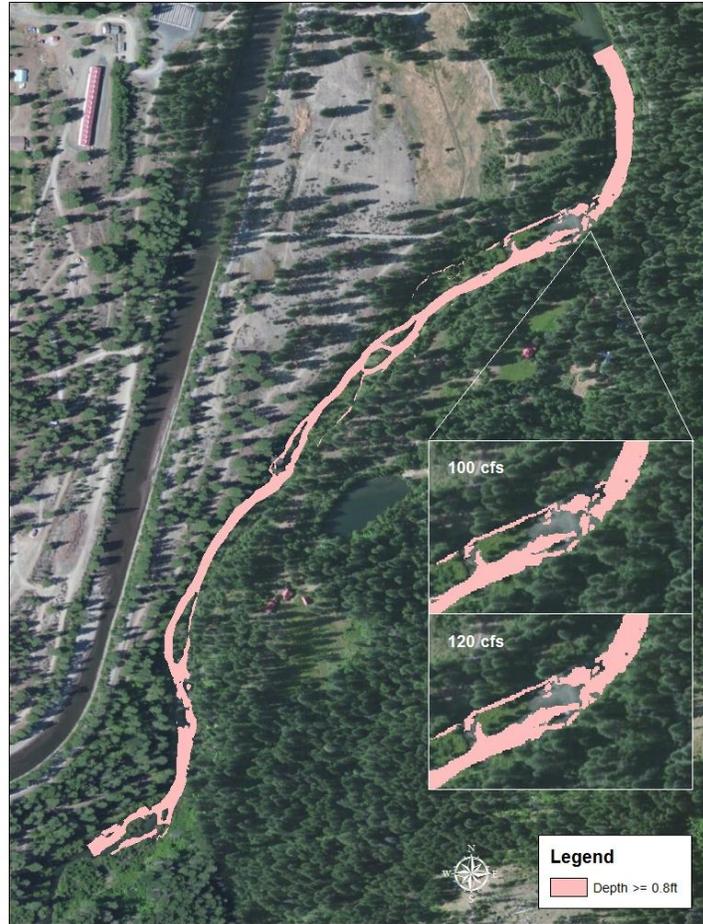
**Figure 36. Fish passage in the historical channel based on the 0.8 foot depth criteria.**

For the minimum passage depth of 0.8 feet, the same downstream location in the Icicle Creek historical channel did not meet the criteria at 100 cfs (Figure 36). The insets show that the break in passage was eliminated at 120 cfs. The upstream passage criteria for fluvial trout (i.e. bull trout) from Table 2 is 0.8 feet and these results suggest that 120 cfs is required for continuous passage through the historical channel.

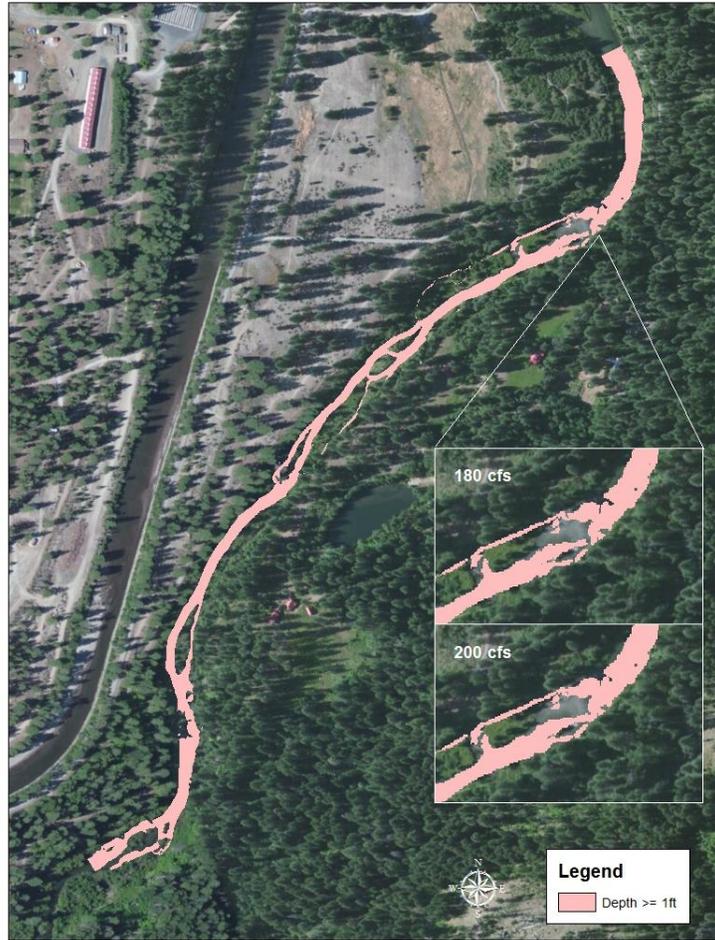
**Figure 37. Fish passage in the historical channel based on the 1.0 foot depth criteria.**

For the minimum passage depth of 1.0 foot, the same downstream location in the historical channel did not meet the criteria at 180 cfs (Figure 37). The insets show that the break in passage was eliminated at 200 cfs. The upstream passage criteria for adult steelhead, coho, and Chinook from Table 2 is 1.0 foot and these results suggest that 200 cfs is required for continuous passage through the historical channel.

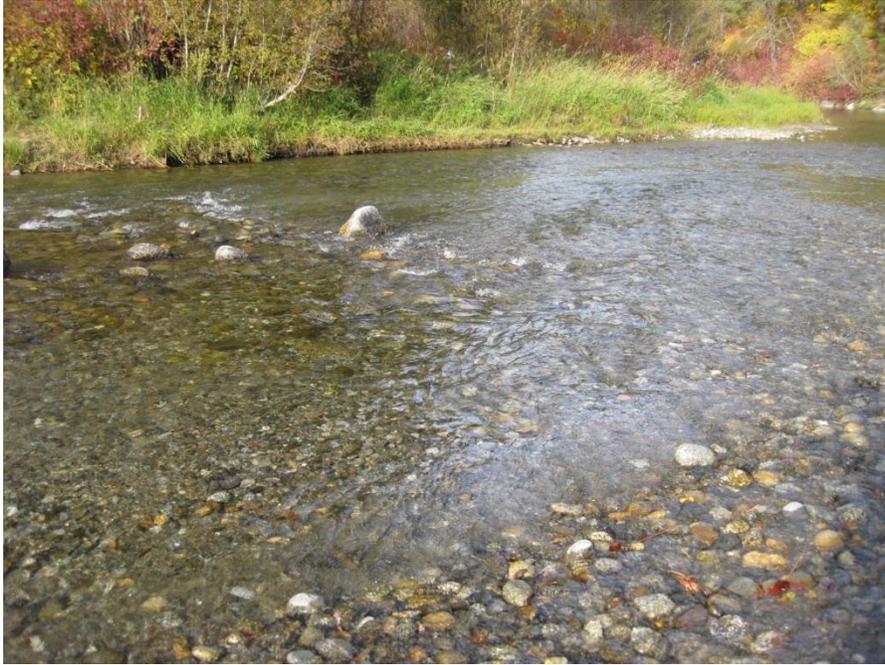
**Figure 38. A riffle in the main channel of the Icicle Creek historical channel that was the limiting passage location for all target species.**
