## **APPENDIX D: Bridge/Structure Bat Assessment Form Guidance**

### **Federal Transportation Agency/State Department of Transportation (DOT) Preliminary Guidelines for Using the Bridge/Structure Bat Assessment Form**

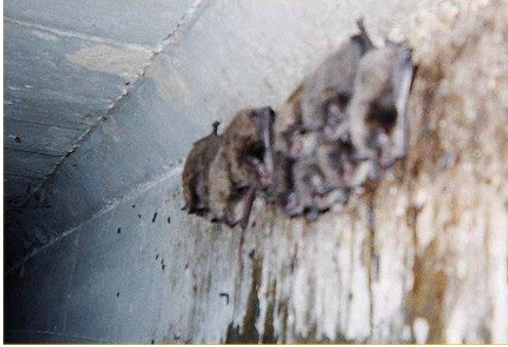
Photo 1: Bats hanging from cracks along support beams

Cracks in the concrete are used by bats as a foothold in roosting (Photo 1). In addition, some bats may be hidden from sight in wider cracks in the concrete and behind deteriorating concrete sections in the ceiling or walls. Look for cracking along support beams and inner walls especially below a fillet (a concrete filling between ceiling and vertical beam). During inspection, sounds may be heard coming from behind such cracks and/or expansion joints.

**Day:** Look for bats flying or roosting (hanging) during the assessment (Photo 1, 2, & 8). A flashlight or headlamp will be needed and binoculars may be necessary when viewing higher areas. If bats are present; record numbers as best as possible and their locations. Note any dead or injured bats. A sketch map would be helpful (use bridge plan sheet as base for sketch).

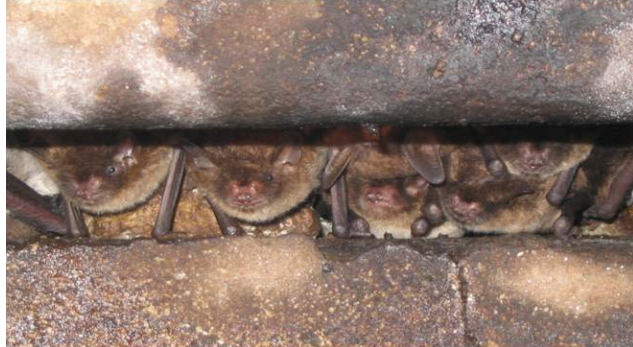
Photo 2: Visible bats within an expansion joint

Expansion joints can provide protected cover for bats (Photos 2 and 5), but do not always provide habitat, depending upon whether they are obstructed by road debris or other blockages. If possible during the assessment, individuals should use a flashlight to look into expansion joints or cracks. Guano may be present under joints if being used by bats (Photos 7 and 8).

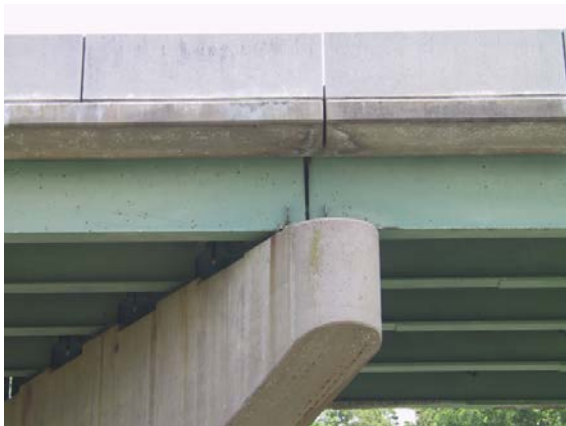
Photo 3: Example of open concrete joint used by bats

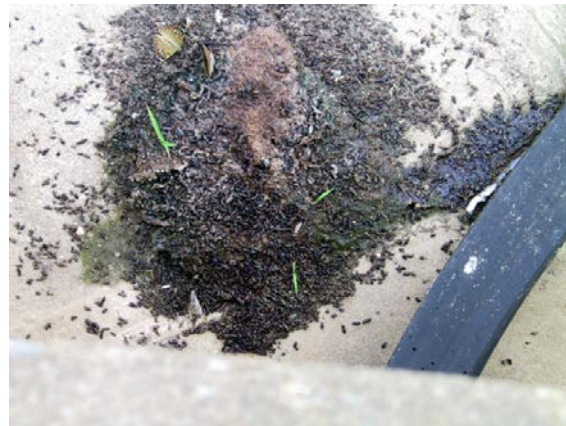
Photo 4: Guano deposits visible from bridge deck, on top of pier

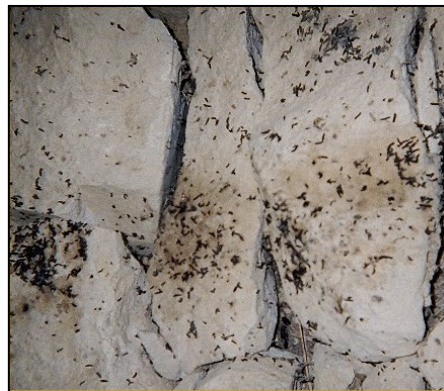
Photo 6: Bat Guano on Riprap

Bat droppings are small (mouse-like in appearance but less regular) brown or black pellets (Photos 6 - 8). Older droppings may be gray in color. These droppings will accumulate on the ground, floor of a covered bridge or on structural components below where bats roost. Droppings may also adhere to support beams and walls below roosts.

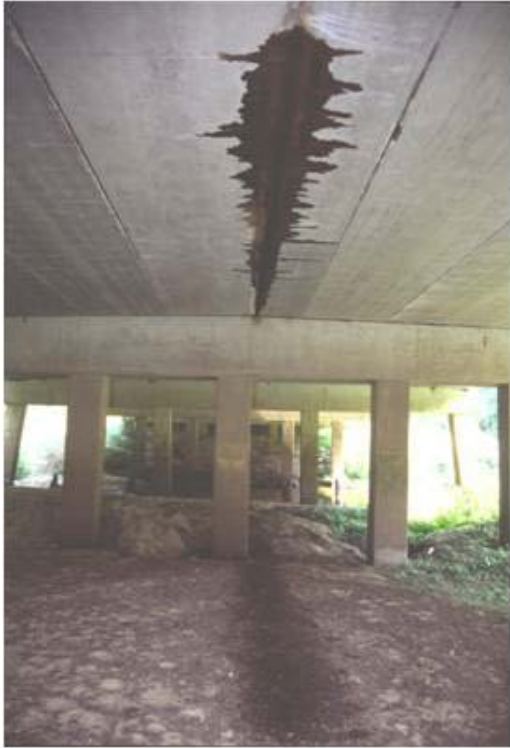
Photo 7: Staining along longitudinal joint.  
Guano deposits on the ground.

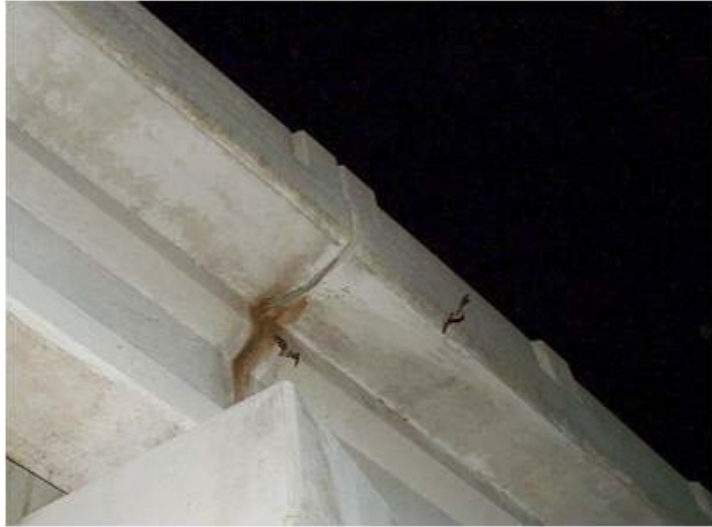
Photo 8: Staining on underside of expansion joint from bat use.

Stains may appear wet and are usually found in dark places. Look for four to six inch wide dark stains located on concrete support beams and walls immediately below the ceiling of the bridge, and beneath joints (Photos 8 - 11).

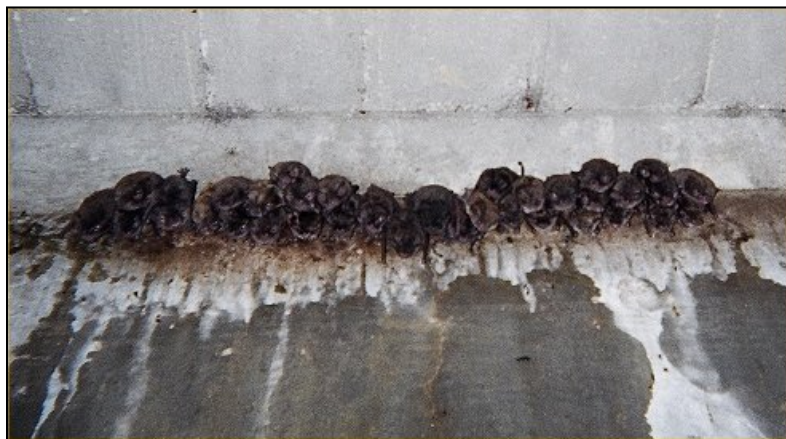
Photo 11: Bats roosting & associated staining

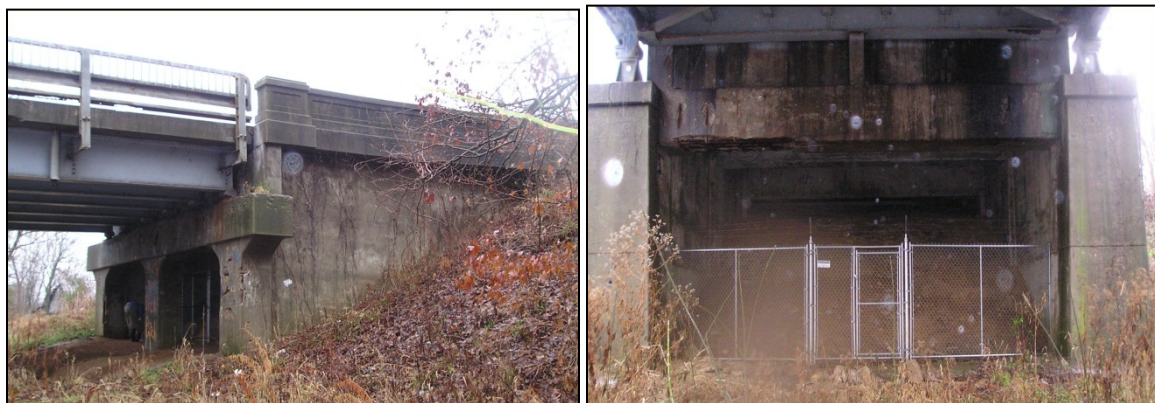
Photo 12 and 13: Bridge design mimicking “cave-like” atmosphere

While assessing bridges or structures, look for dark environments that mimic cave-like conditions such as under the deck in the case of a bridge (Photos 12 and 13) or an attic in the case of a structure. This may involve crawling under low areas so a hard hat is recommended. Such places (e.g., a concrete bunker secreted into a hillside with an open front) provide protection from wind, rain, sleet, hail and predators. Bats do not roost near the ground where predators (cats, raccoons, etc.) can reach them. Roosting is usually at least 4 ft. from the ground.

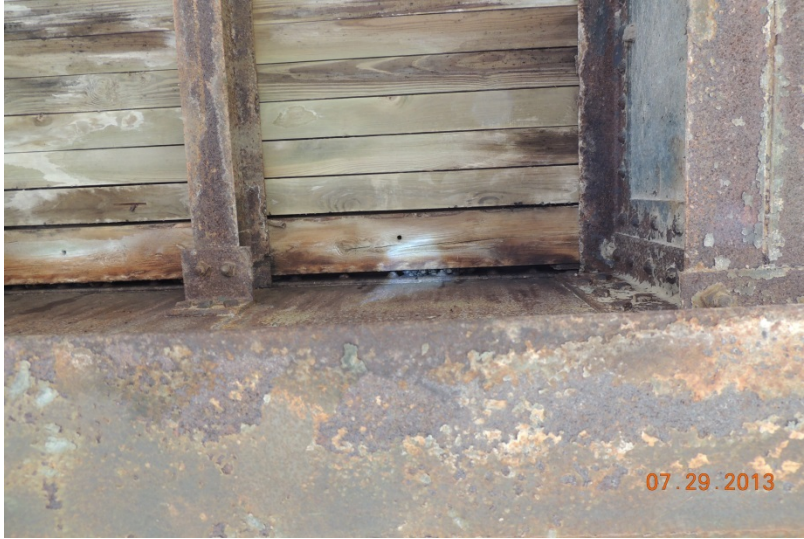
Photo 14: NLEBs roosting under a timber decked bridge
