Ball Creek

in northwest Lake Oswego, north of Kruse Way and east of I-5,
within a developed subdivision

in Lake Oswego, northeast of the Mormon Temple; access to the site is from the west end of Suncreek Drive

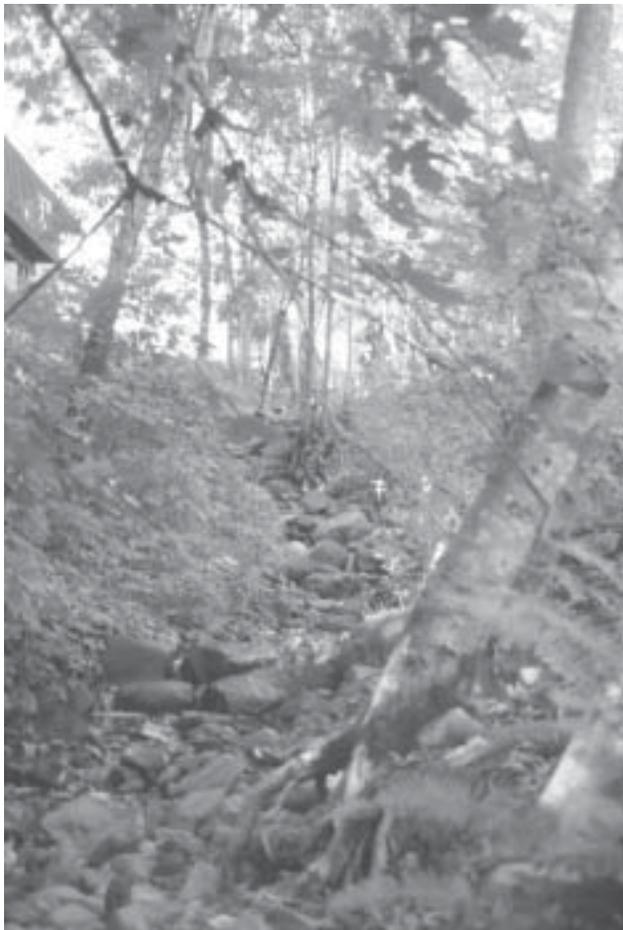
BEFORE

Lack of vegetation for habitat

Ball Creek is in a part of Lake Oswego that was farmed prior to platting and construction of the subdivision in the 1980s. Land use during the time that the property was farmed caused severe erosion and degradation of vegetation along stream bank. The creek was relocated during construction of the subdivision due to poor stream health, and banks were stabilized and revegetated. Irrigation was not installed during the first year.

The goal of the project, was to improve the fish and wildlife habitat and water quality of Ball Creek, this was accomplished by removing blackberries and tall non-native grass species and revegetating the area with native riparian trees and shrubs.

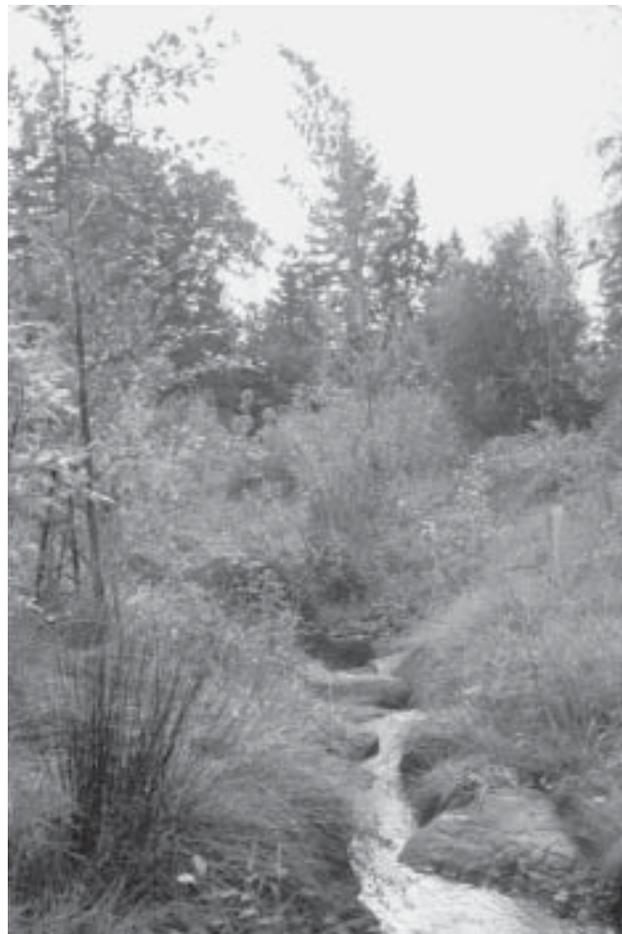
AFTER

Plantings doing well after the first year

Stream health and fish and wildlife habitat quality greatly increased by planting native tree and shrub species along the bank. The shade and increased diversity of vegetation provided wildlife food and habitat and also assisted in controlling bank erosion.

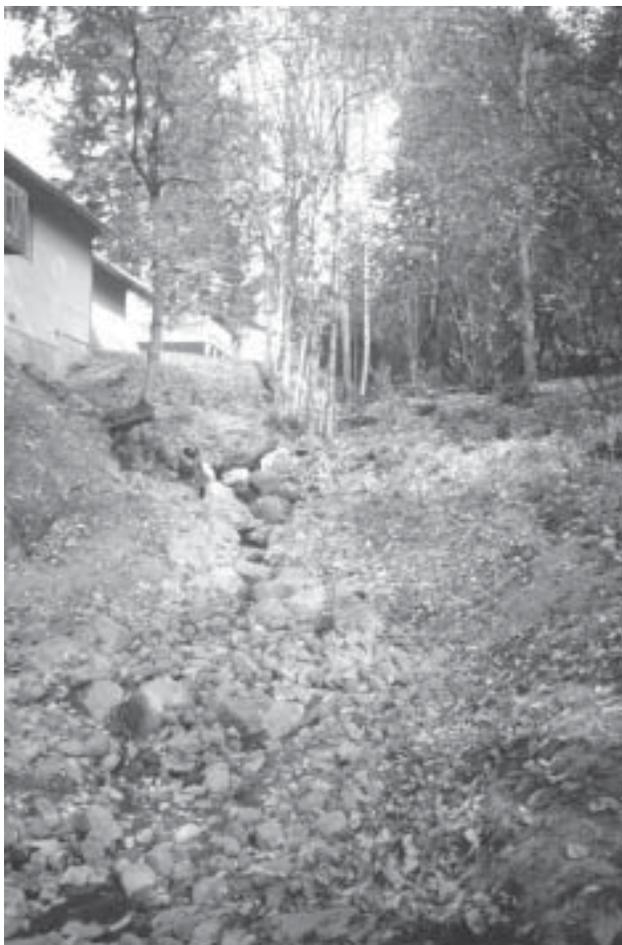
AFTER

Enhancement by planting native species

Disturbed areas had been invaded with Himalayan blackberry. Wildlife habitat was improved by removing blackberries and planting and maintaining indigenous species along the corridor. These species included serviceberry, alder, willow, native hawthorne, red elderberry, fern, vine maple, hazelnut and Pacific dogwood. Vegetation was planted to restore the structural and native habitat diversity of the stream corridor. Large woody debris and fallen logs were retained for habitat. Trash, discarded wood products and old fencing was removed.

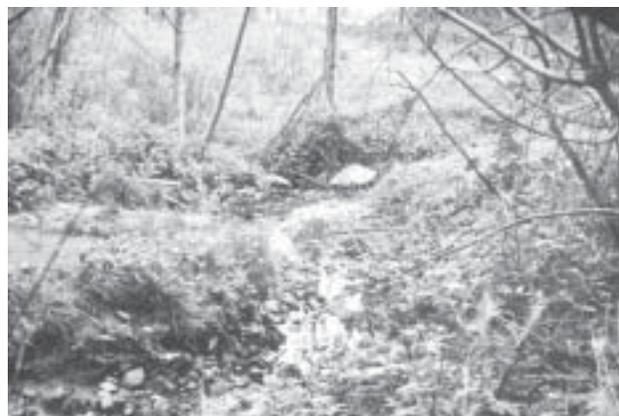
BEFORE

Heavy development adjacent to the stream during the past several years had degraded the riparian corridor. Half of the stream had been channelized by a concrete liner. The liner and a culvert were removed to restore the natural stream channel. Erosion control was accomplished

Invasive Himalayan blackberry is the dominant vegetation

through stabilization using rock check dams and bioengineering techniques. Check dams were constructed using boulders in areas where erosion had occurred due to steep stream gradients and stream flow velocity. Natural stream bed gravels were installed.
