FINAL REPORT ◦ JANUARY 2015

Fish Passage in Lower Antelope Creek

PREPARED FOR
U.S. Fish and Wildlife Service
National Fish Passage Program
Red Bluff, California

PREPARED BY
Stillwater Sciences
850 G Street, Suite K
Arcata, CA 95521

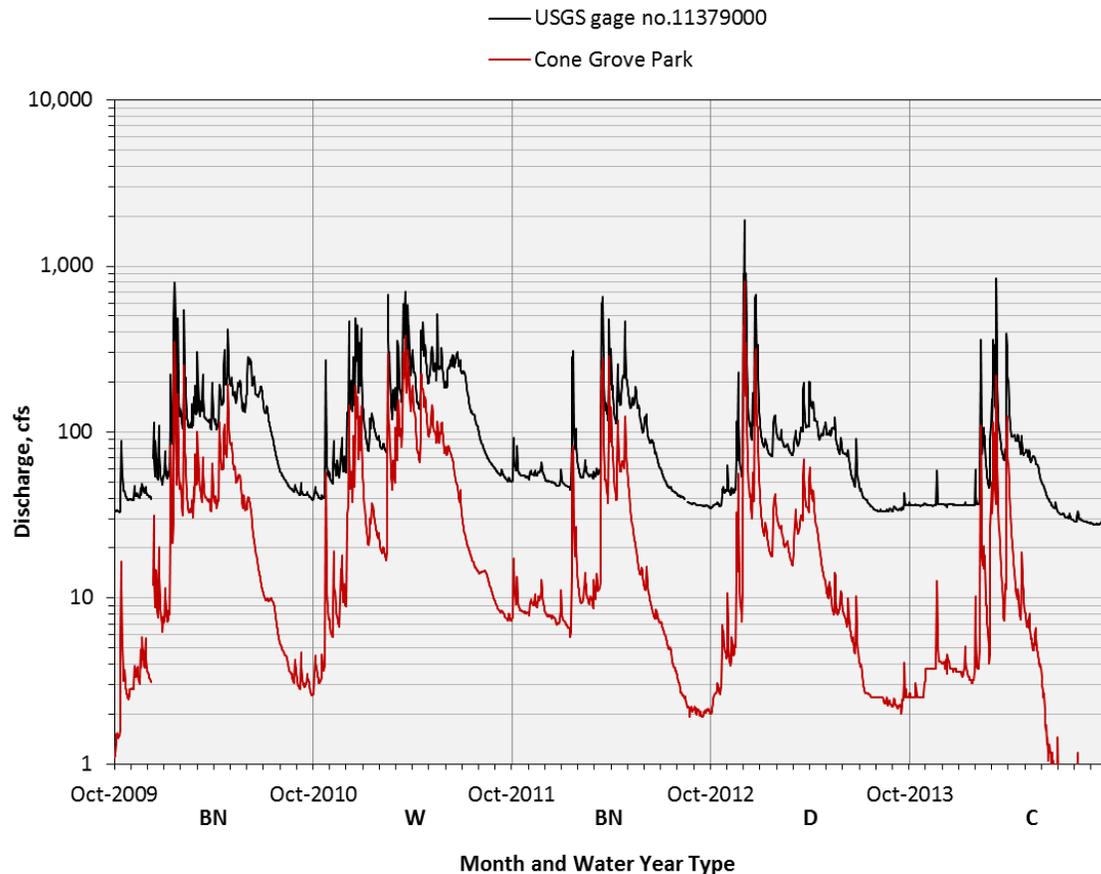
Figure 2-6. Synthetic hydrographs for Antelope Creek during Water Years 2010-2014 at USGS gage no. 1137900 and at Cone Grove Park (Water Year type: W=wet, BN=Below Normal, D=Dry, C=Critical).

Average daily discharges were also estimated in Antelope Creek at Cone Grove Park during Water Years 2010–2014 using a flow regression equation developed by the USFWS (USFWS 2009). Comparison of flow estimates at USGS gage no. 11379000 and Cone Grove Park illustrates the critical spring and summer period when flows in lower Antelope Creek are most affected by water diversion at the Edwards Diversion Dam (Figure 2-6).

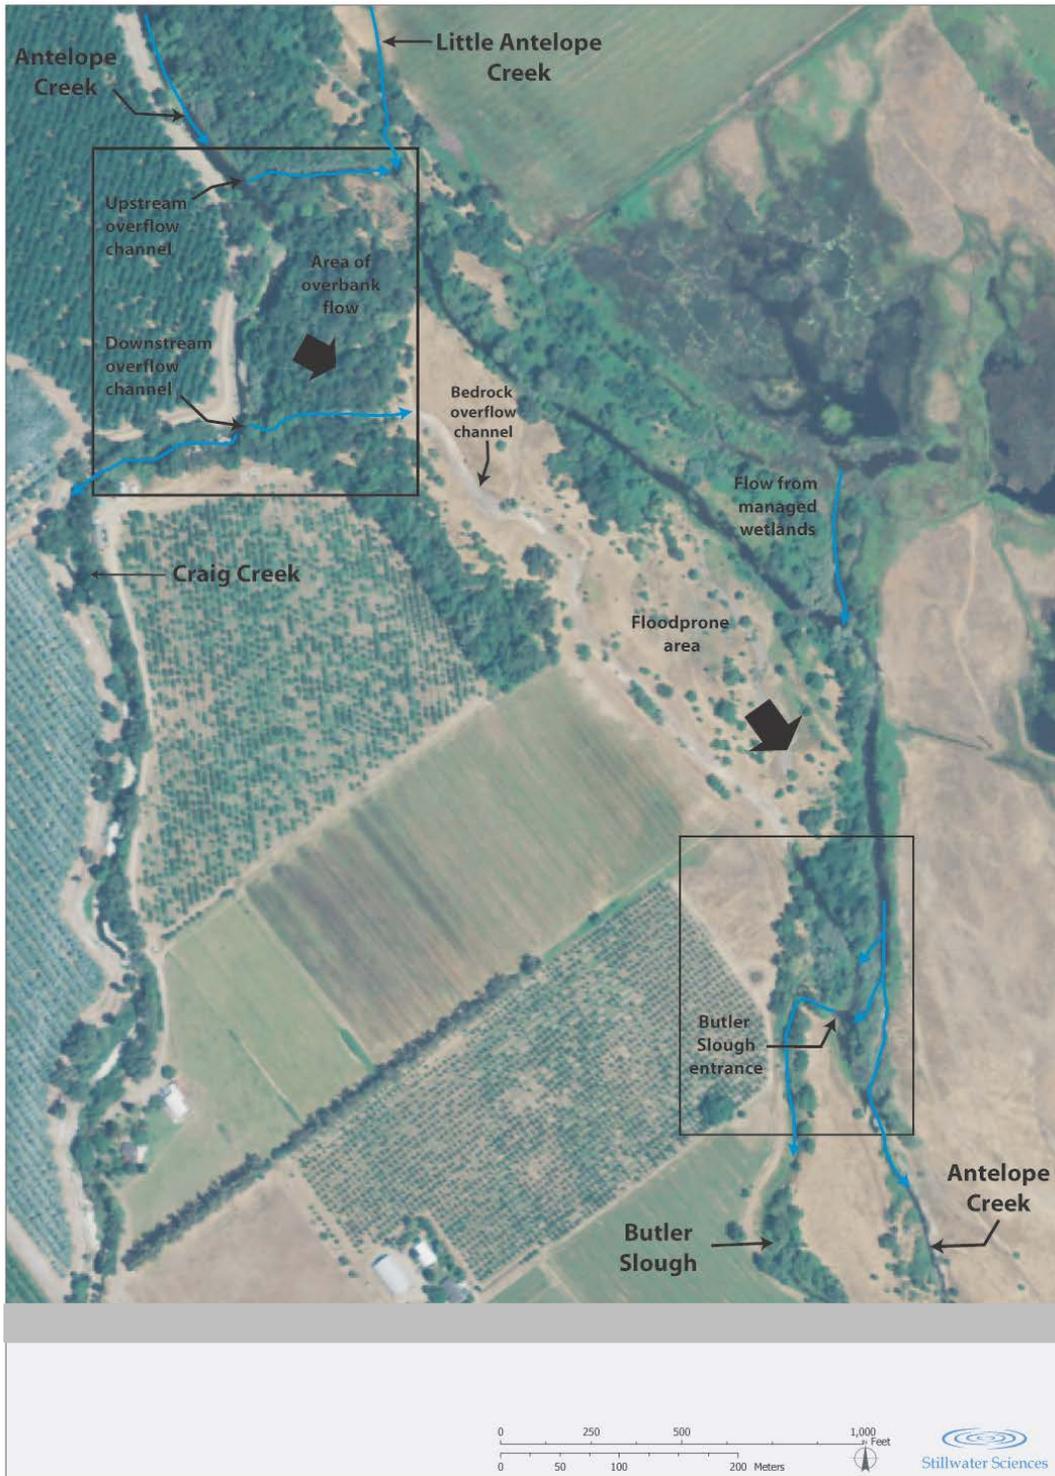
Figure 2-8. Distributary junctions and intervening floodprone area.

the distributary junction have the potential to significantly change flow splits between the mainstem and distributary channels, as well as create low flow migration barriers.

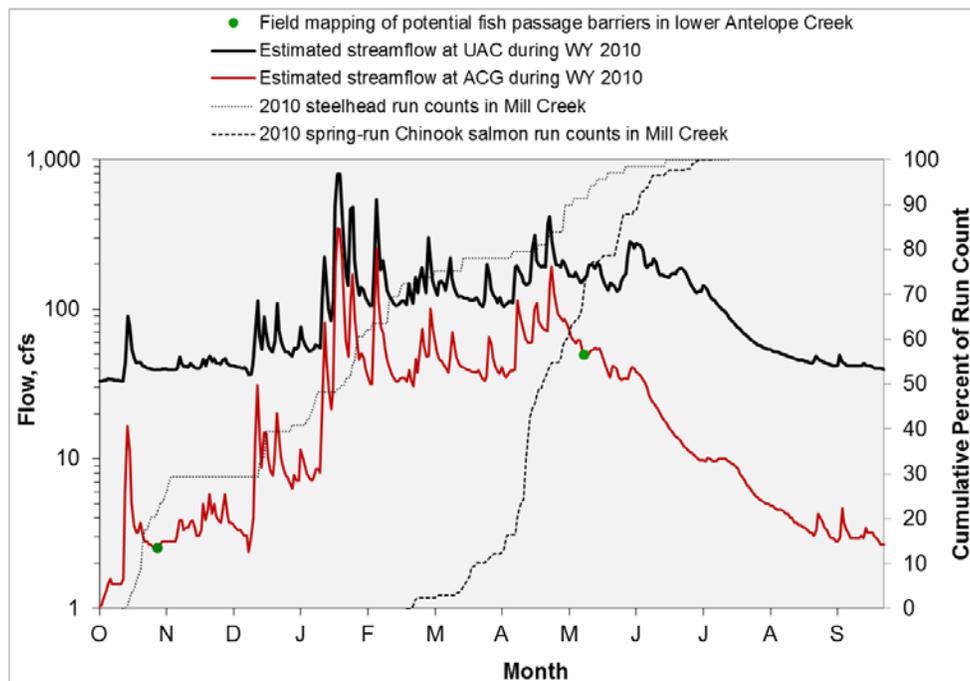
Figure 3-1. Estimated streamflow and field survey dates during WY2010. Spring-run Chinook salmon and steelhead run counts in Mill Creek during WY2010 illustrate probable run timing in Antelope Creek.

Field surveys were conducted in lower Antelope Creek during fall 2009 (28 October 28–1 November) and spring 2010 (13–14 May) (Figure 3-1). The fall 2009 survey documented channel reach morphology and condition, spawning and rearing habitat conditions, and potential barriers to migration when water diversions most affect adult fall-run Chinook salmon immigration and juvenile Steelhead and spring-run Chinook salmon emigration. Potential sites for monitoring streamflow, stream temperature, and water quality were identified during the fall field effort. The spring 2010 survey documented spawning and rearing habitat conditions and potential barriers when water diversions most affect adult spring-run Chinook salmon and steelhead immigration. Water Year 2010 (mean annual runoff =115 cfs) ranks in the 55th percentile for the gaging period of record and was a Below Normal Water Year according to the Sacramento River Index. The spring runoff period was wet, with relatively high baseflow into June. Table 3-1 summarizes estimated streamflows in lower Antelope Creek during the fall 2009 and spring 2010 surveys.

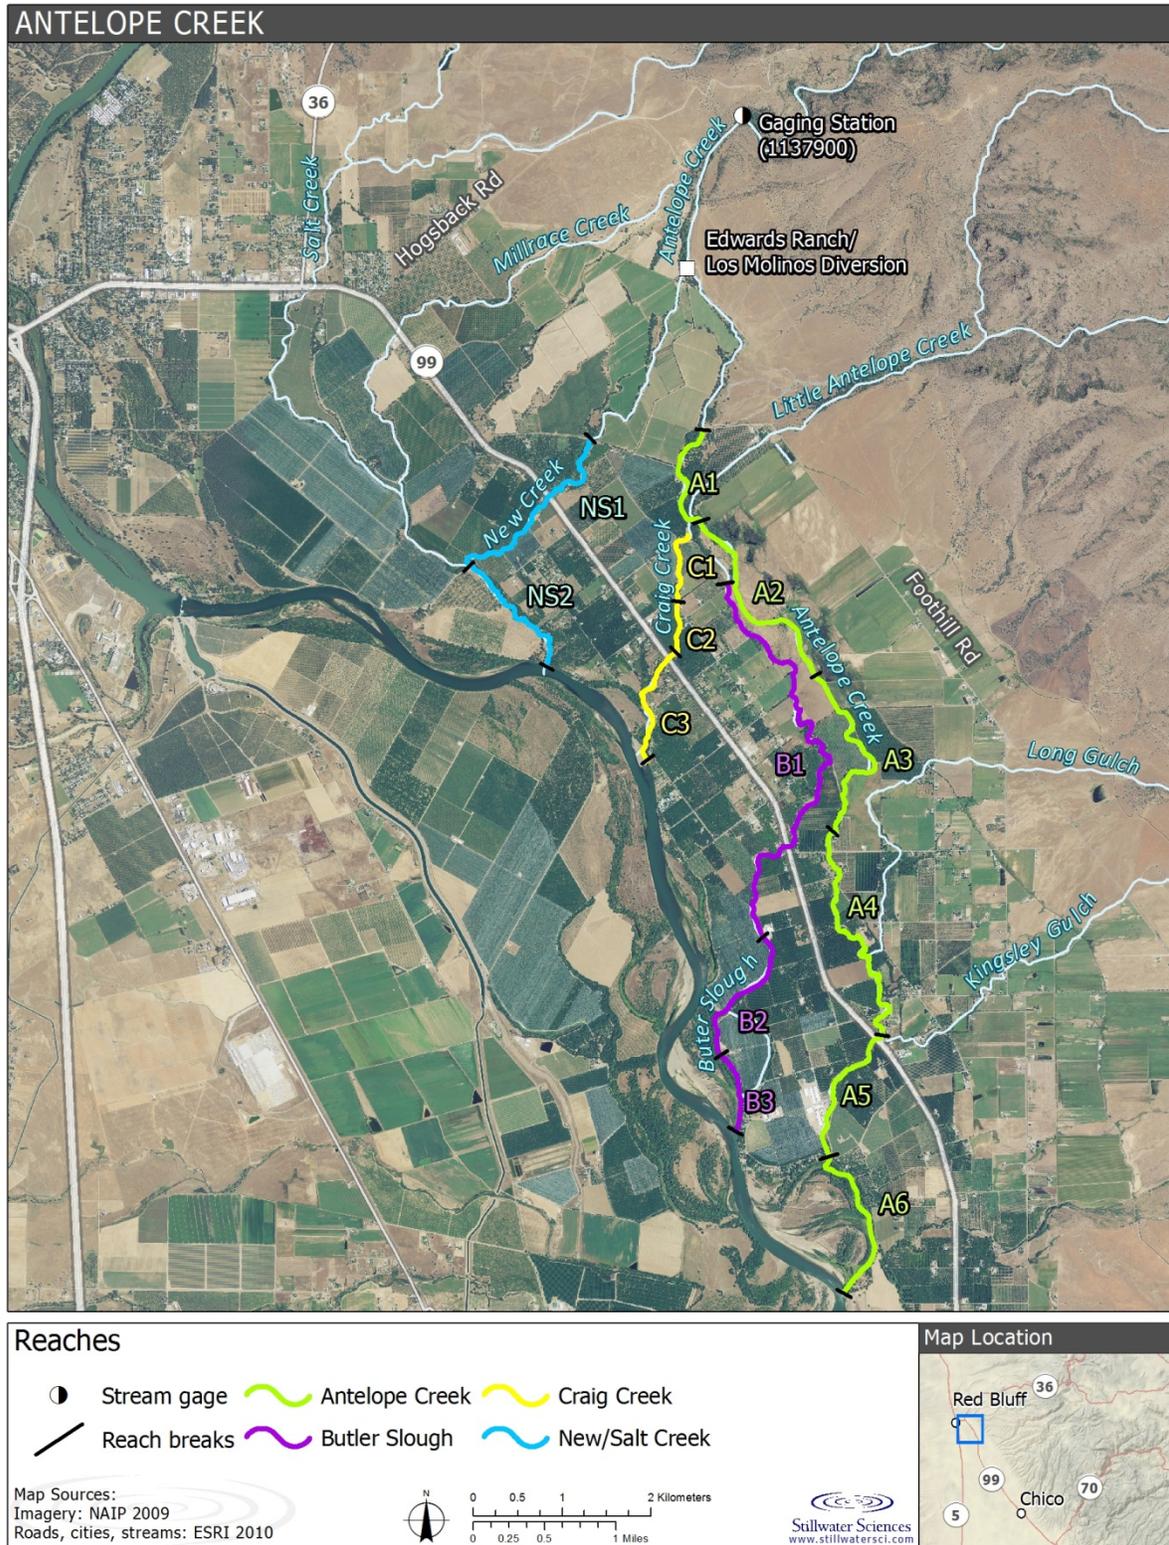
Figure 3-2. Channel reaches delineated in lower Antelope Creek.

To better understand the locations and mechanisms limiting fish passage, channels reaches with similar channel morphology and hydraulic conditions were delineated during fall 2009 based on observations of bedrock and stratigraphic controls, channel geometry, bedforms, and bed surface textures (Figure 3-2). Wetted channel width, bankfull width, and valley bottom width were measured or estimated at typical cross sections in each reach (Table 3-2). Observations of local sediment sources and active sediment storage, anthropogenic influences on the channel (e.g., water diversion, irrigation return flow, levees and bank protection, impoundments, and crossings), and riparian vegetation encroachment in the bankfull channel were also made in each reach. Limited mapping and survey work was conducted at distributary junctions to develop an understanding of local hydraulics and sediment dynamics controlling flow splits.

private property that was not accessible at the time of the survey. Downstream of this point, Antelope Creek was divided into six reaches (Figure 3-2, Table 3-1). Reach-specific channel morphology and condition, spawning and rearing habitat, and potential barriers in Antelope Creek are described below.

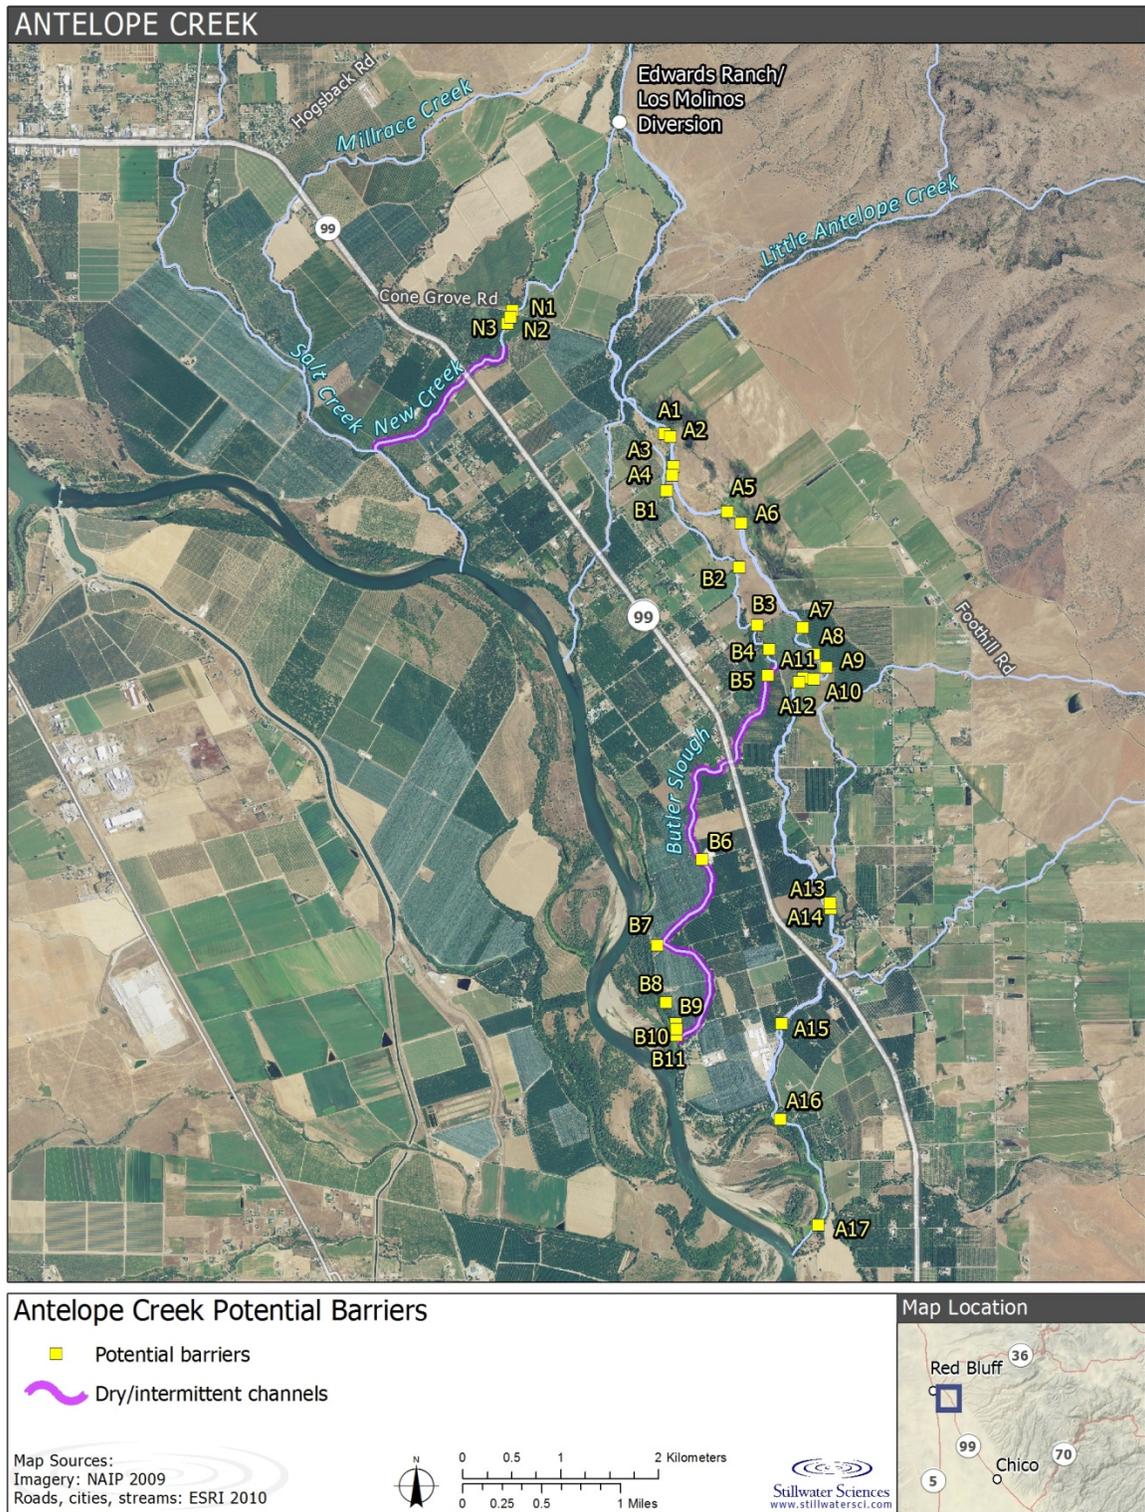
Figure 3-3. Potential fish barriers observed in lower Antelope Creek during fall 2009 and spring 2010.

The location and characteristics of potential fish migration barriers (e.g., dams or diversions, pumps, culverts and other structures with limiting flow velocities and/or jump heights, and reaches with limiting flow depths) were documented during the fall 2009 and spring 2010 field surveys (Figure 3-3). Potential barriers were characterized by type (e.g., anthropogenic versus natural) and their status (e.g., barrier, obstacle, passable) qualitatively assessed based on minimum flow depths for upstream adult passage (0.6 ft) and downstream juvenile passage (0.4 ft) (Table 3-4) (Thompson 1972). Wetted width, mean and maximum depth, and length of channel segments where passage may be limited by low flow depths were also measured (Table 3-5). Features posing a potential vertical barrier to fish were also described, including the height and length of the barrier, horizontal and vertical jump distance, mean and maximum jump pool depth, and depth of the hydraulic control.

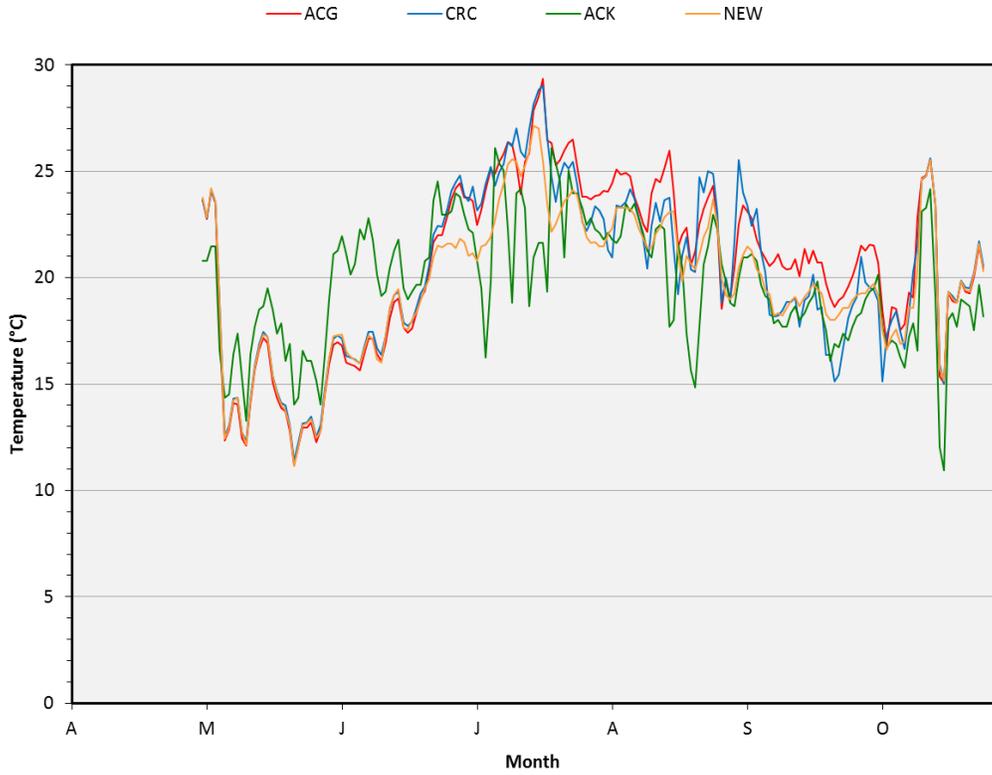
Figure 4-2. Mean daily stream temperatures during May through October, WY2010.

Stream temperatures were measured at seven sites downstream of Edward Diversion Dam (Table 4-1, Figure 4-1) from late April through October 2010. Stream temperatures upstream of Edwards Diversion Dam were not measured during 2010 due to access limitations on private property. Mean daily temperatures at all monitoring sites generally increased steadily from a low of 11–14°C in mid-May to a high exceeding 25°C in mid-July (Figure 4-2, Figure 4-3, Table 4-2). ACK had the highest temperatures early in the monitoring period (e.g., prior to July), but cooled relative to other monitoring sites during July and August, likely due to the influence of relatively cool tailwater supplied by the HiLine Canal and Main Canal carrying water from Mill Creek. Stream temperatures at ACG, CRC, and NEW were very similar until June 23, after which temperatures at these sites began to diverge. ACG was typically warmer than CRC and NEW during much of the remaining monitoring period, likely due to greater solar insolation and influence of relatively warm return flows from flood-irrigated pastures in the reach from Edwards Diversion Dam to Cone Grove Park. By the beginning of October, temperatures at ACG, CRC, and NEW were again very similar and slightly higher than ACK. ACG and CRC maintained similar MWAT each month during the monitoring period (Table 4-2).

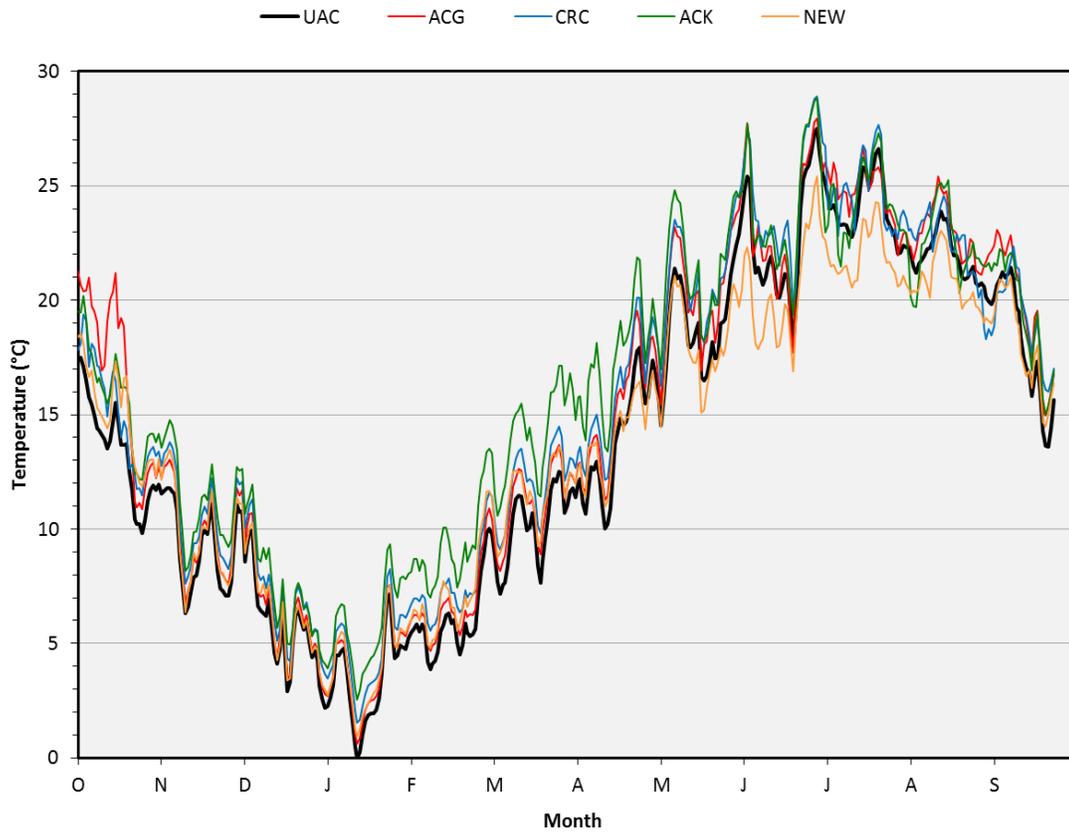
Figure 4-6. Mean daily stream temperatures during WY2013.

occurring June through August (Figure 4-6, Figure 4-7, Table 4-4). Spatial differences in mean daily temperatures were similar to those observed during 2011, with the highest temperatures typically measured at ACK (especially prior to June) and the lowest typically measured at NEW.

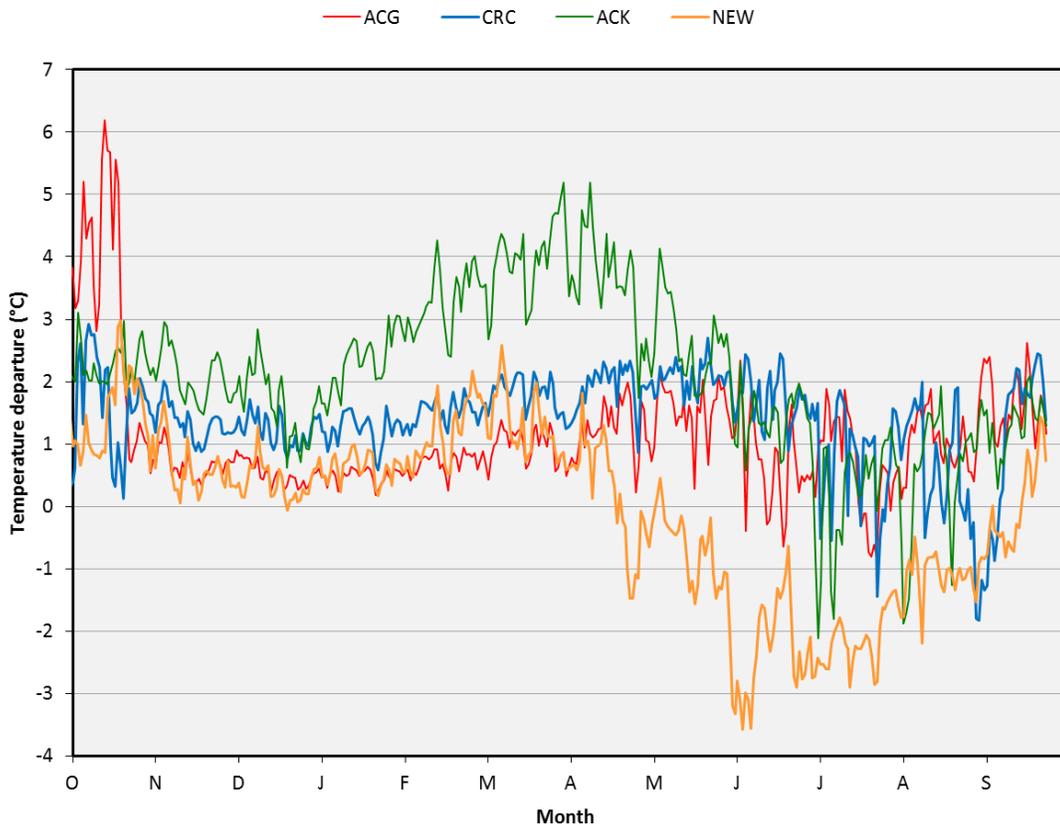
Figure 4-8. Departure in WY2013 mean daily stream temperatures from those measured at UAC.

Mean daily temperatures at sites downstream of Edwards Diversion Dam were about 0.5 to 5°C warmer than UAC from October through April (Figure 4-8). Stream temperatures at mainstem sites downstream of the diversion (ACG and CRC) had a similar and more stable pattern than sites in distributaries (ACK and NEW), each remaining about 0.5 to 2° C warmer than UAC through mid-June. Temperatures at ACK were the warmest, on average 2.8°C warmer than UAC between October 16 and May 22, with maximum departures up to 5.2°C during the first two weeks of April. Warmer temperatures at ACK relative to UAC during this period are likely due to low streamflow and greater solar insolation related to lack of vegetation cover in nearby upstream reaches. Temperatures at ACK significantly cooled relative to UAC and other sites from mid-May through September, likely due to the influence of tailwater returned to the channel after adjacent pastures to the east were flood irrigated with relatively cool water supplied from Mill Creek. Stream temperatures at NEW were variable but typically about 1 to 2°C warmer than UAC during March and early April. Temperatures thereafter at NEW were significantly cooler than UAC and other sites, likely due to relatively more vegetation cover and topographic shading and/or the influence of relatively cool water discharged to New Creek via an irrigation canal located immediately downstream of the monitoring site. The volume, quality, and timing of irrigation water discharged to the channel at this location is unknown. After late May, temperatures at sites downstream of the diversion were generally similar to but more variable than UAC.

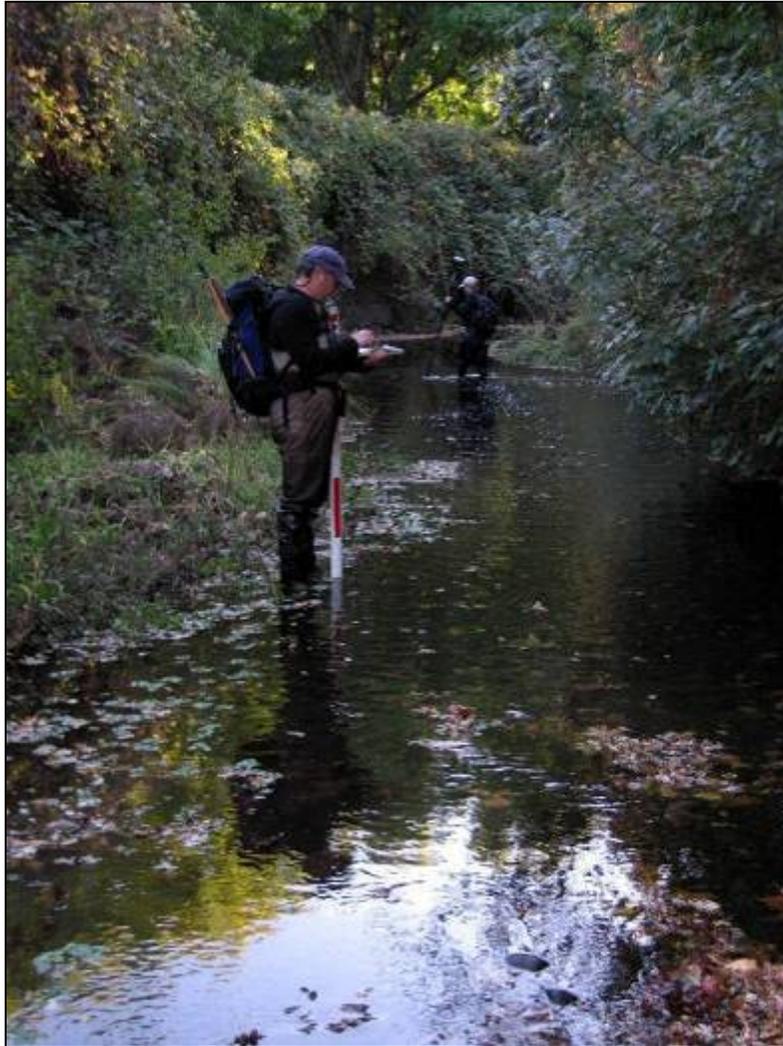
Figure C-5. Antelope Creek in Reach 3. Channel is entrenched within vertical banks of unconsolidated alluvium and soil material.

Reach 3 extends from the southern extent of the managed wetlands (Station 6, 700 m) to Kauffman Avenue (Figure 3-2). Reach 3 becomes increasingly entrenched, with as much as 18 ft of incision occurring by Kauffman Avenue (Appendix C, Figure C-5). The channel is intermittently bedrock controlled, occasionally forming bedrock knickpoints and associated step pools. Steep banks are prone to failure during high flow events, recruiting large quantities of gravel, sand, and silt. Bank erosion has exposed the roots of mature riparian trees growing in or at the top of the bank. Dense herbaceous and woody riparian vegetation typically occupies bar surfaces in the reach.

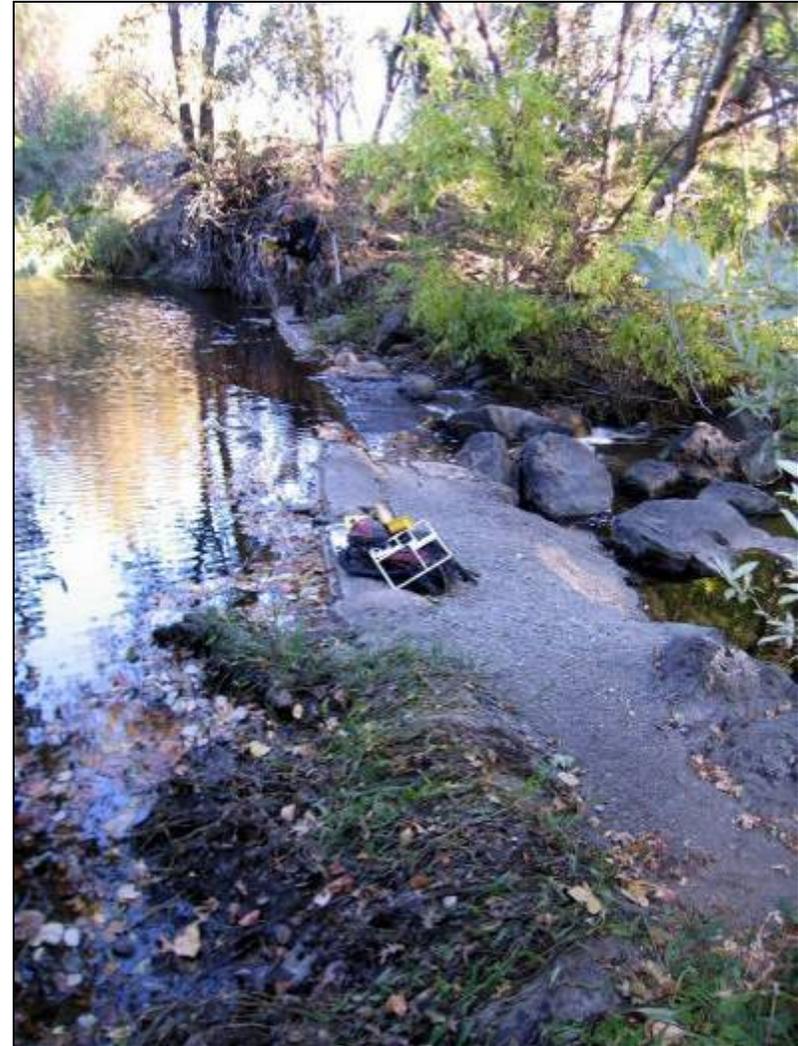
Figure C-6. Antelope Creek in Reach 3. Channel-spanning concrete apron that encases a water pipe.

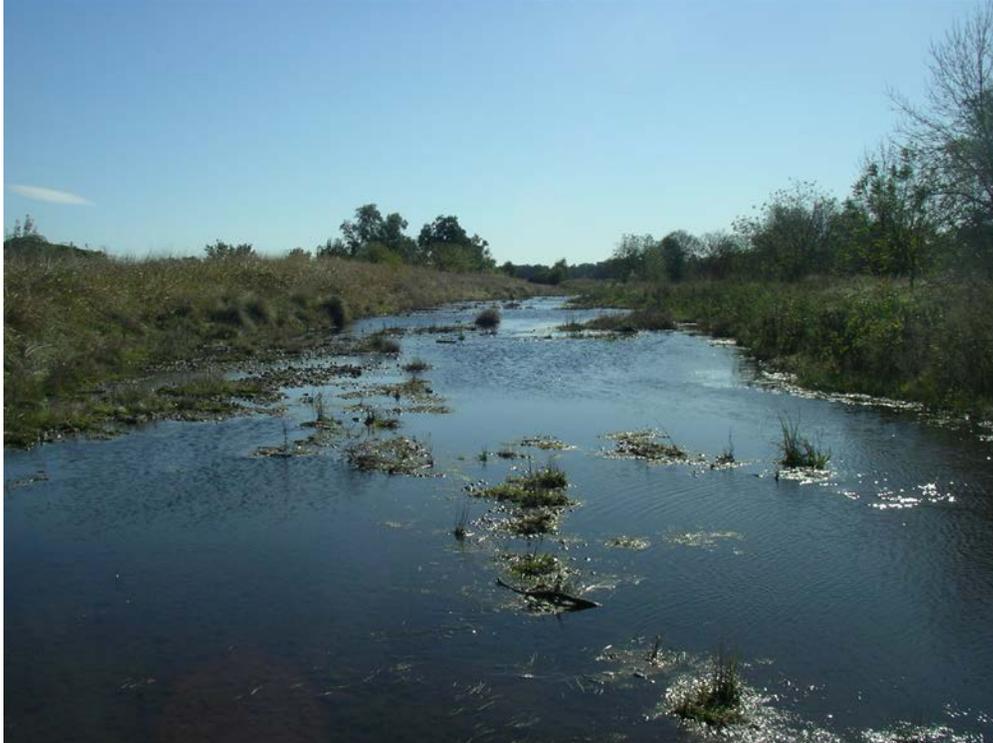
Figure C-14. An example of poor rearing habitat conditions in Reach 2 of Antelope Creek.

No suitable spawning habitat was observed in Reach 2 during the fall 2009 and spring 2010 surveys. Many of the beaver ponds, pools, and deeper runs provided high-quality rearing habitat with moderate to high complexity and substantial terrestrial and aquatic vegetation cover (>30%) (Appendix C, Figure C-13). Conversely, shallow flow over bedrock riffles and runs provided poor rearing habitat with little cover or habitat complexity (Appendix C, Figure C-14). These shallow reaches also had excessively high stream temperatures.

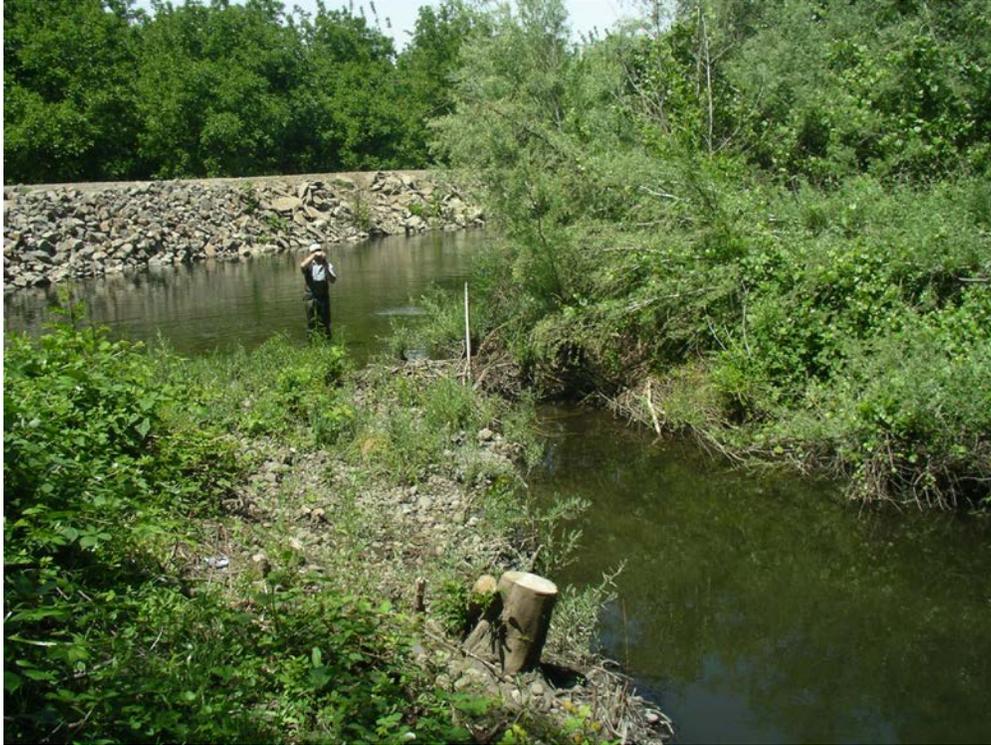
Figure C-15. Potential barrier A1 (spring 2010). A beaver dam located at the head of the upper overflow channel at the Antelope Creek-Craig Creek junction.

No potential barriers to fish passage were observed in Reach 1 during fall 2009. A beaver dam located at the head of the upstream-most high flow channel at the Antelope Creek-Craig Creek distributary junction was considered a barrier to upstream adult and downstream juvenile fish passage during spring 2010 (Appendix C, Figure C-15). The barrier prohibited fish from migrating between Reaches 1 and 2 of Antelope Creek, but did not inhibit migration from Craig Creek into upper Antelope Creek.

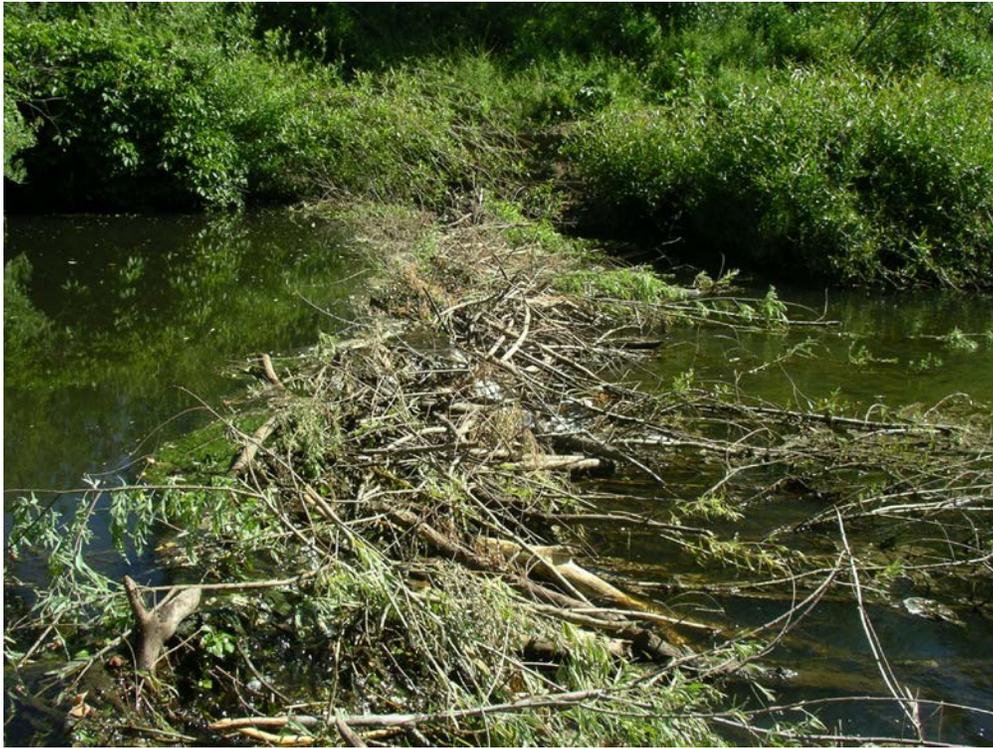
Figure C-31. Potential barrier A16 (spring 2010). Beaver dam in Reach 5 of Antelope Creek.

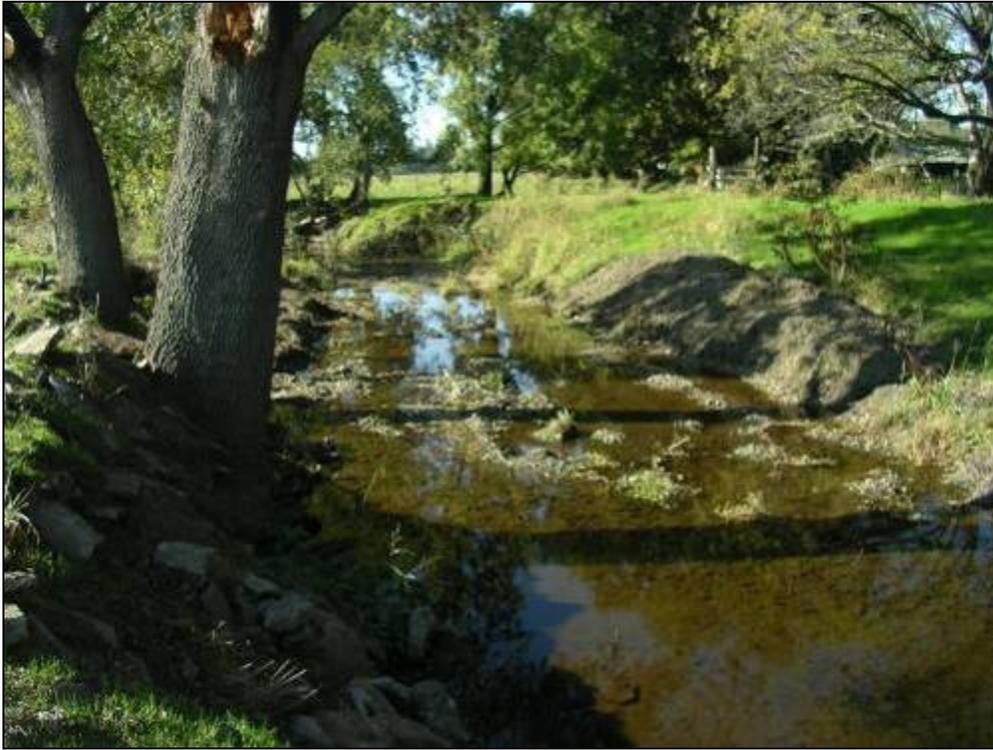
Figure C-49. Potential barrier B4. Excavation of alluvial sediment in Reach 1 of Butler Slough.

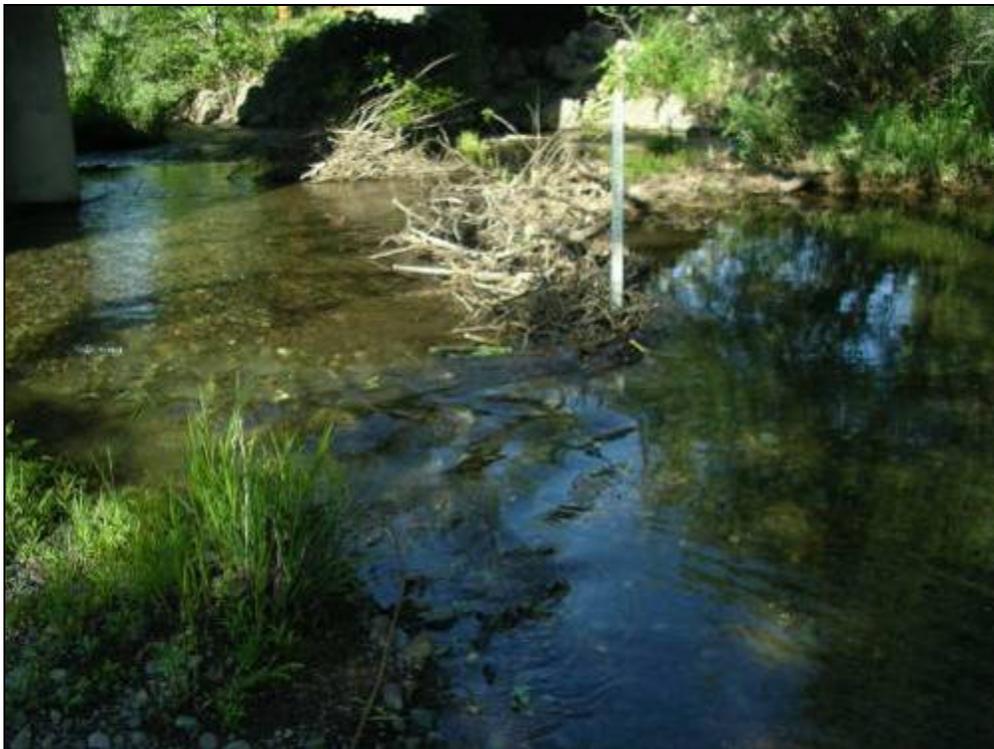
Figure C-63. Potential barrier N1. The partially collapsed beaver dam upstream of Cone Grove Road in Reach 1 of New Creek (Spring 2010 survey).

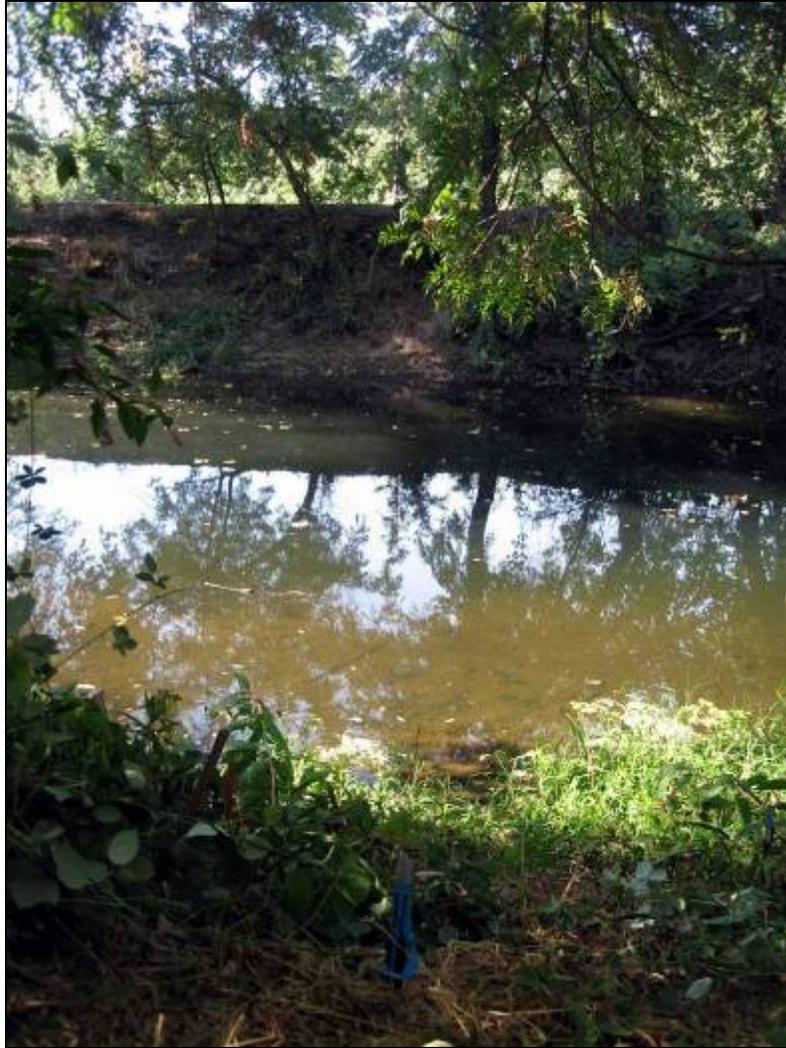
Figure C-68. Monitoring Site 1 (Antelope Creek at Cone Grove Road) on 10 October 2010 showing summer baseflow at a water surface elevation slightly lower than the transducer.

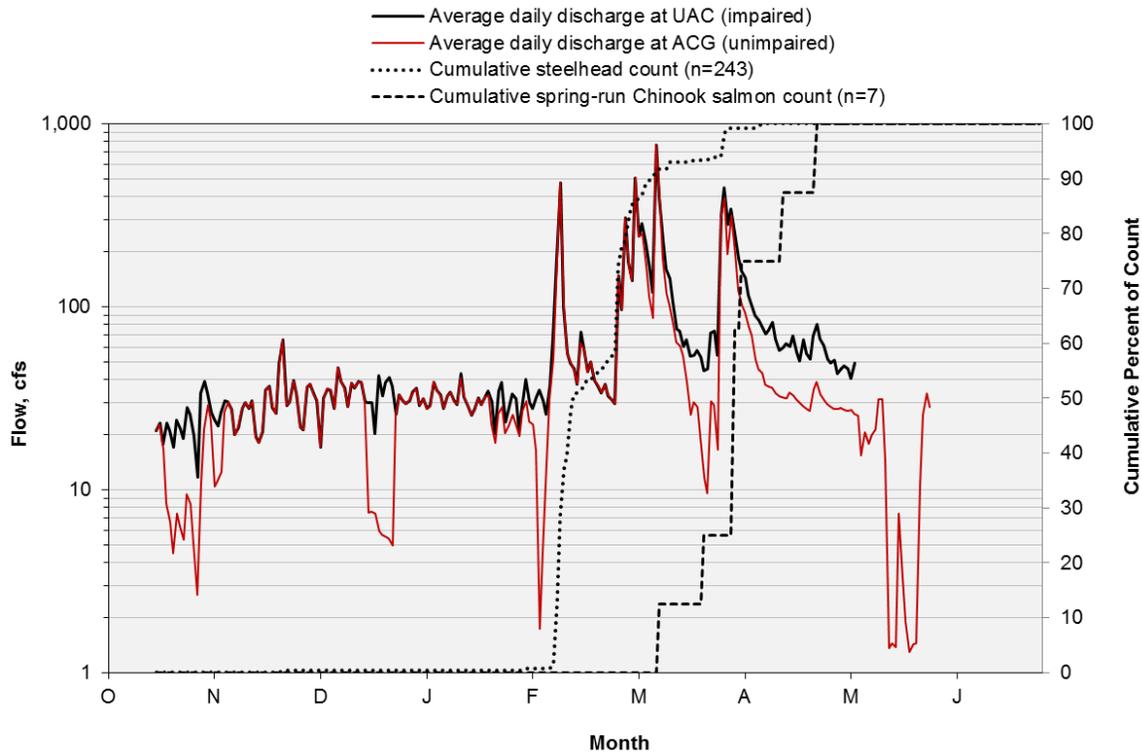
Figure 4-12. Streamflow at UAC (unimpaired) and ACG (impaired) shown with spring-run Chinook salmon and steelhead run counts in Antelope Creek during WY2014.

Video monitoring equipment installed at Edwards Diversion Dam on 15 October 2013 and operated through 30 June 2014 documented seven spring-run Chinook salmon moving past the dam between March 10 and April 26 (Figure 4-11) (preliminary data, M. Johnson, CDFW, pers. comm., 2014). Immigration was triggered by several high flow events that occurred between February 25 and March 7. The first adult spring-run Chinook passed Edwards Diversion Dam on March 11 (416 cfs at ACG), the day after the annual peak flow. The second was counted on March 24 (12 cfs at ACG) when flow was rapidly receding. The remaining five fish migrated past Edwards Diversion Dam between April 2 and April 26 during the receding limb of the last high flow event of the year. These fish moved on flows ranging from 32 to 194 cfs and temperatures ranging from 10 to 17°C at ACG. After April 29, flows remained less than 30 cfs and temperatures remained 18°C or greater at ACG.

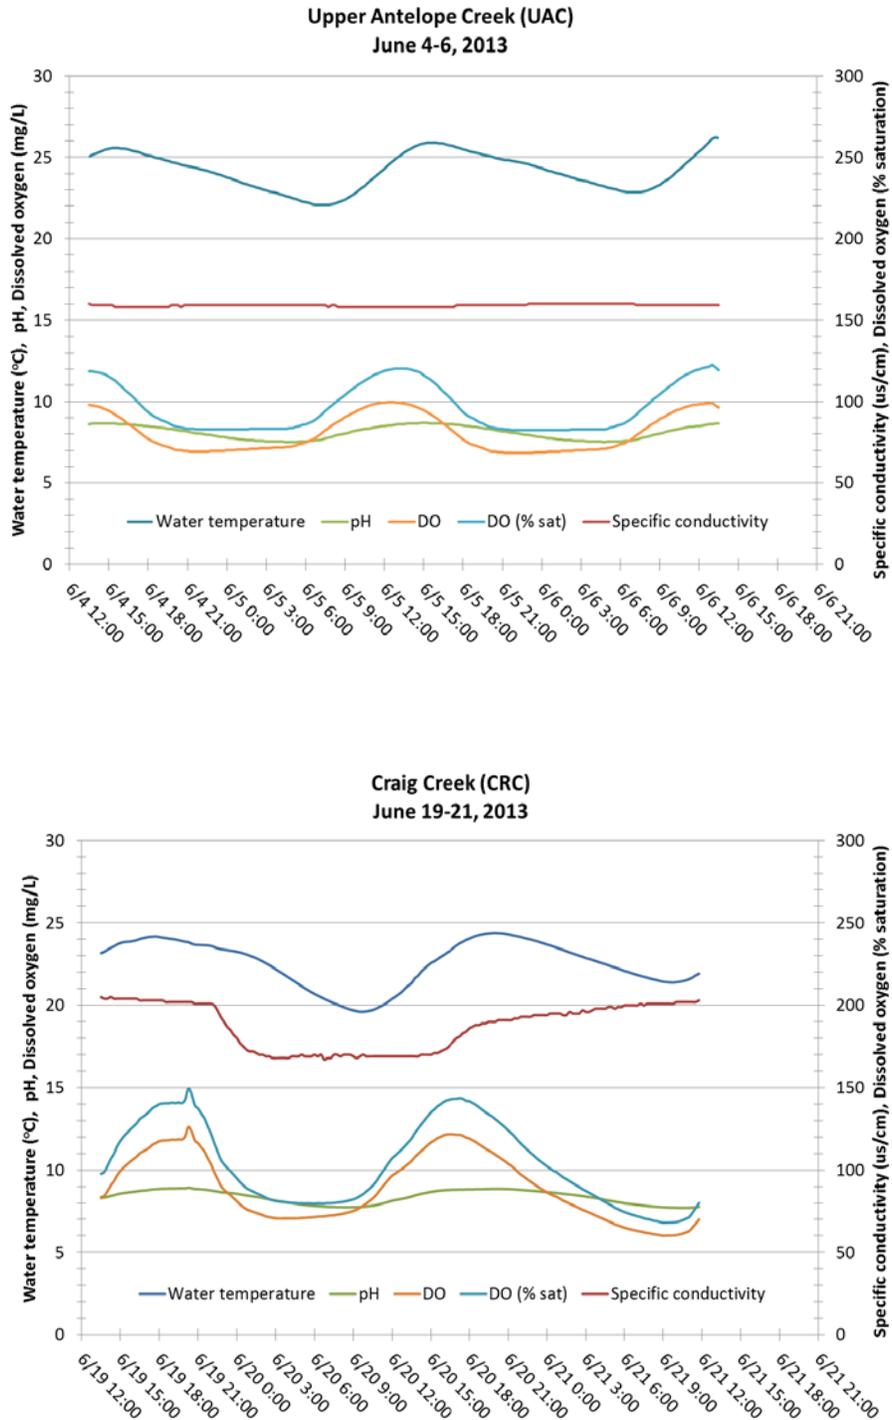
Figure 4-12. Continuous *in situ* water quality monitoring results at UAC and CRC during June 2013.

(Appendix I). Dissolved oxygen concentrations dropped below 7.0 mg/L but remained above 5.0 mg/L at all sites on 18 September 2013. Overall, monitoring results indicate that lower Antelope Creek does not consistently support the COLD designated beneficial use with respect to dissolved oxygen concentrations during spring and late summer/early fall. Low dissolved oxygen concentrations in the evening and early morning hours suggest intense respiration by aquatic organisms, such as attached algae or periphyton. Based on the life history timing of spring-run Chinook salmon and steelhead in lower Antelope Creek, the diurnal decreases in dissolved oxygen during June and September could result in potential effects on migrating adult and juvenile spring-run Chinook salmon and emigrating juvenile steelhead.
