FINAL REPORT ◦ JANUARY 2015

Fish Passage in Lower Antelope Creek

PREPARED FOR
U.S. Fish and Wildlife Service
National Fish Passage Program
Red Bluff, California

PREPARED BY
Stillwater Sciences
850 G Street, Suite K
Arcata, CA 95521

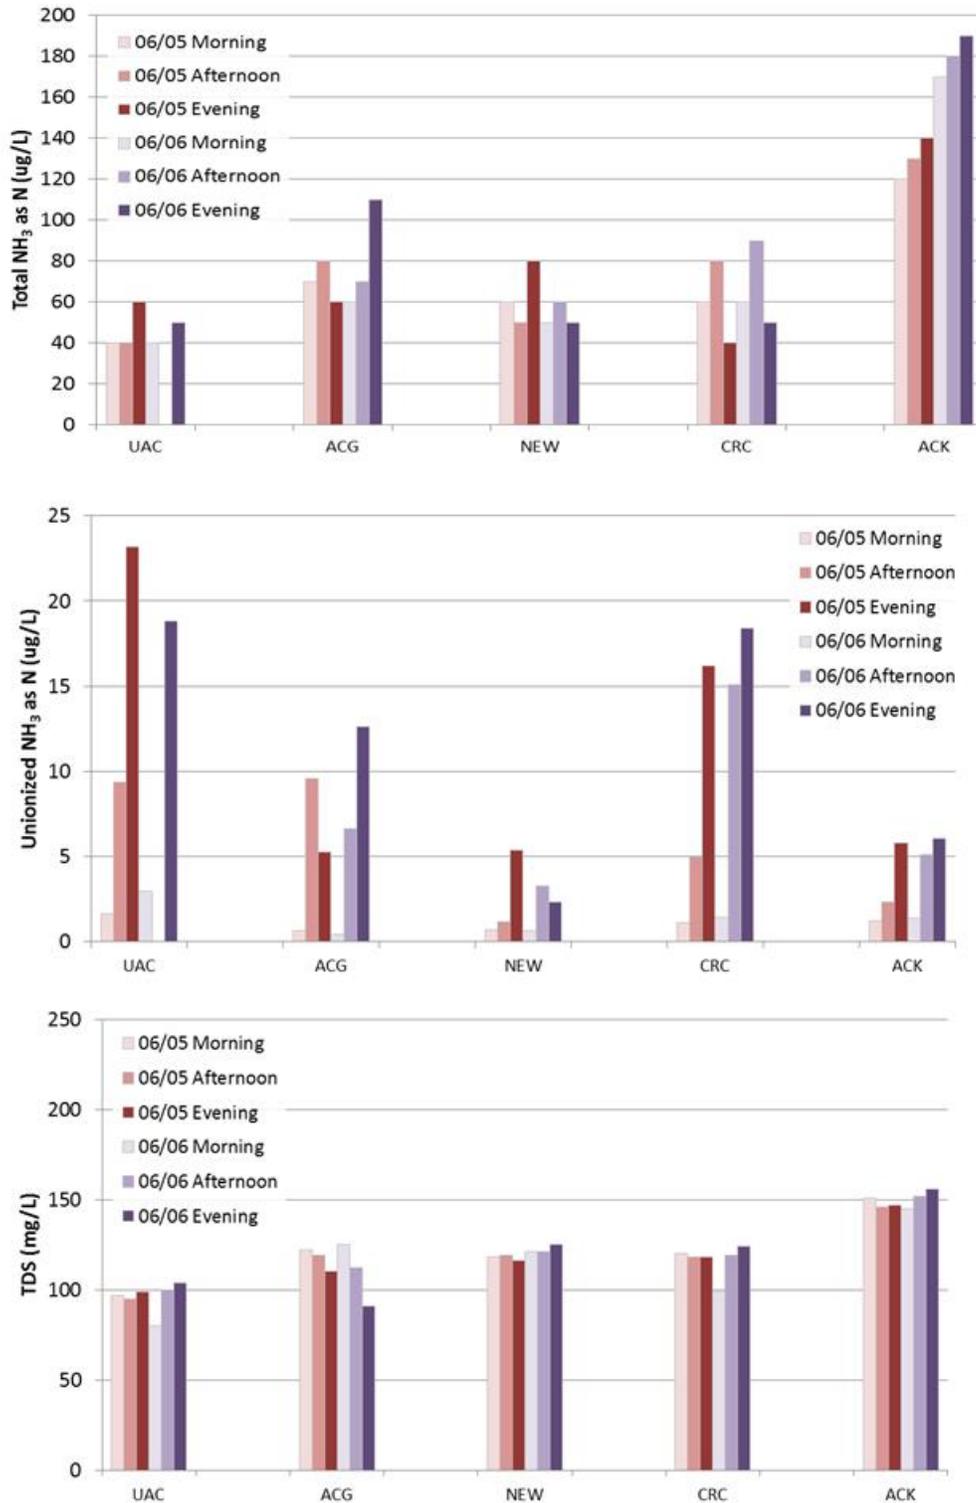
Figure 4-14. Total ammonia (NH₃ as N), unionized ammonia (NH₃ as N), and TDS during morning, afternoon, and evening grab samples at all monitoring sites during June 2013.

Ammonia is a known toxicant to fish. As noted in the previous section, pH affects the equilibrium speciation of ammonium (NH₄⁺) and unionized ammonia (NH₃), with high pH levels causing conversion of NH₄⁺ to the toxic unionized form. In general, ammonia toxicity is temperature and pH dependent; however, recent data indicate that vertebrate sensitivity to unionized ammonia is independent of temperature, while invertebrate sensitivity to ammonia decreases as temperature decreases (USEPA 2013). Acute exposure to unionized ammonia in fish may cause mortality, while prolonged exposure to sub-lethal levels (i.e., chronic exposure) may result in skin and gill hyperplasia, respiratory problems, stress, and conditions which support proliferation of opportunistic bacteria and parasites (USEPA 2013). While the Basin Plan does not include a numeric criterion for ammonia toxicity, the USEPA (2013) recommends a 1-hr average maximum concentration (CMC) and a 3-day rolling average chronic concentration (CCC) for freshwater aquatic biota. For pH 7.0 and stream temperature at 20 °C, the total ammonia nitrogen CMC is 17 mg/L and the CCC is 1.9 mg/L. Appendix H includes temperature and pH-dependent calculations for the CMC and CCC. Based on pH and stream temperatures measured along with the grab samples, total ammonia CMC and CCC values for June and September 2013 are one to three orders of magnitude greater than measured concentrations (Figures 4-16 and 4-17, Appendix H), indicating little to no potential for ammonia toxicity to fish in Antelope Creek.

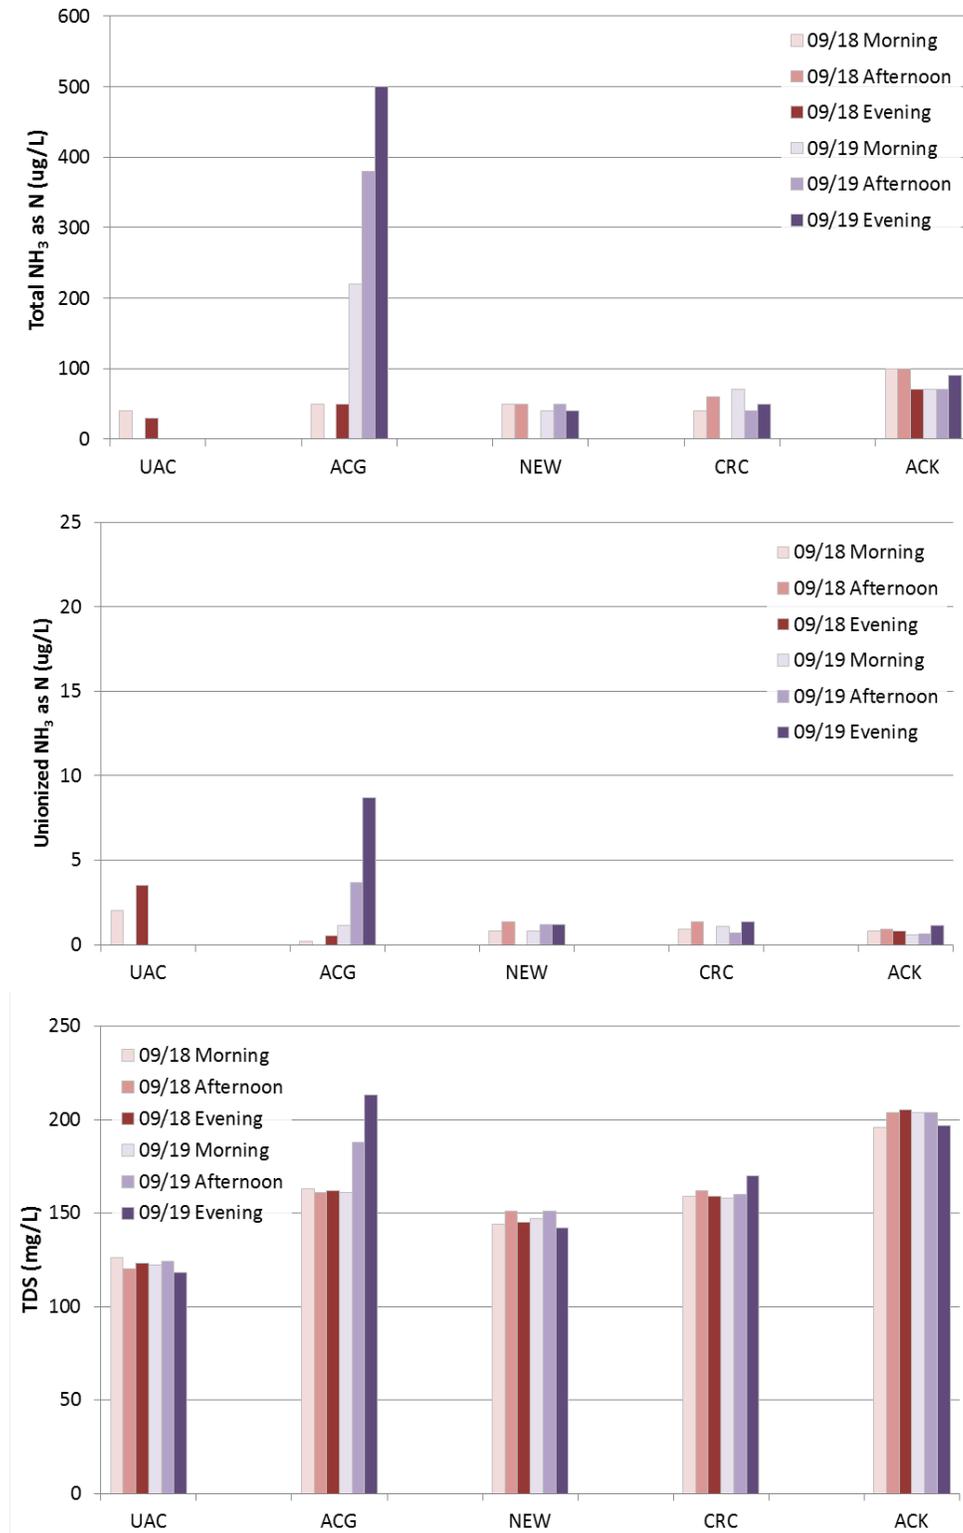
Figure 4-15. Total ammonia (NH₃ as N), unionized ammonia (NH₃ as N), and TDS during morning, afternoon, and evening grab samples at all monitoring sites during September 2013.

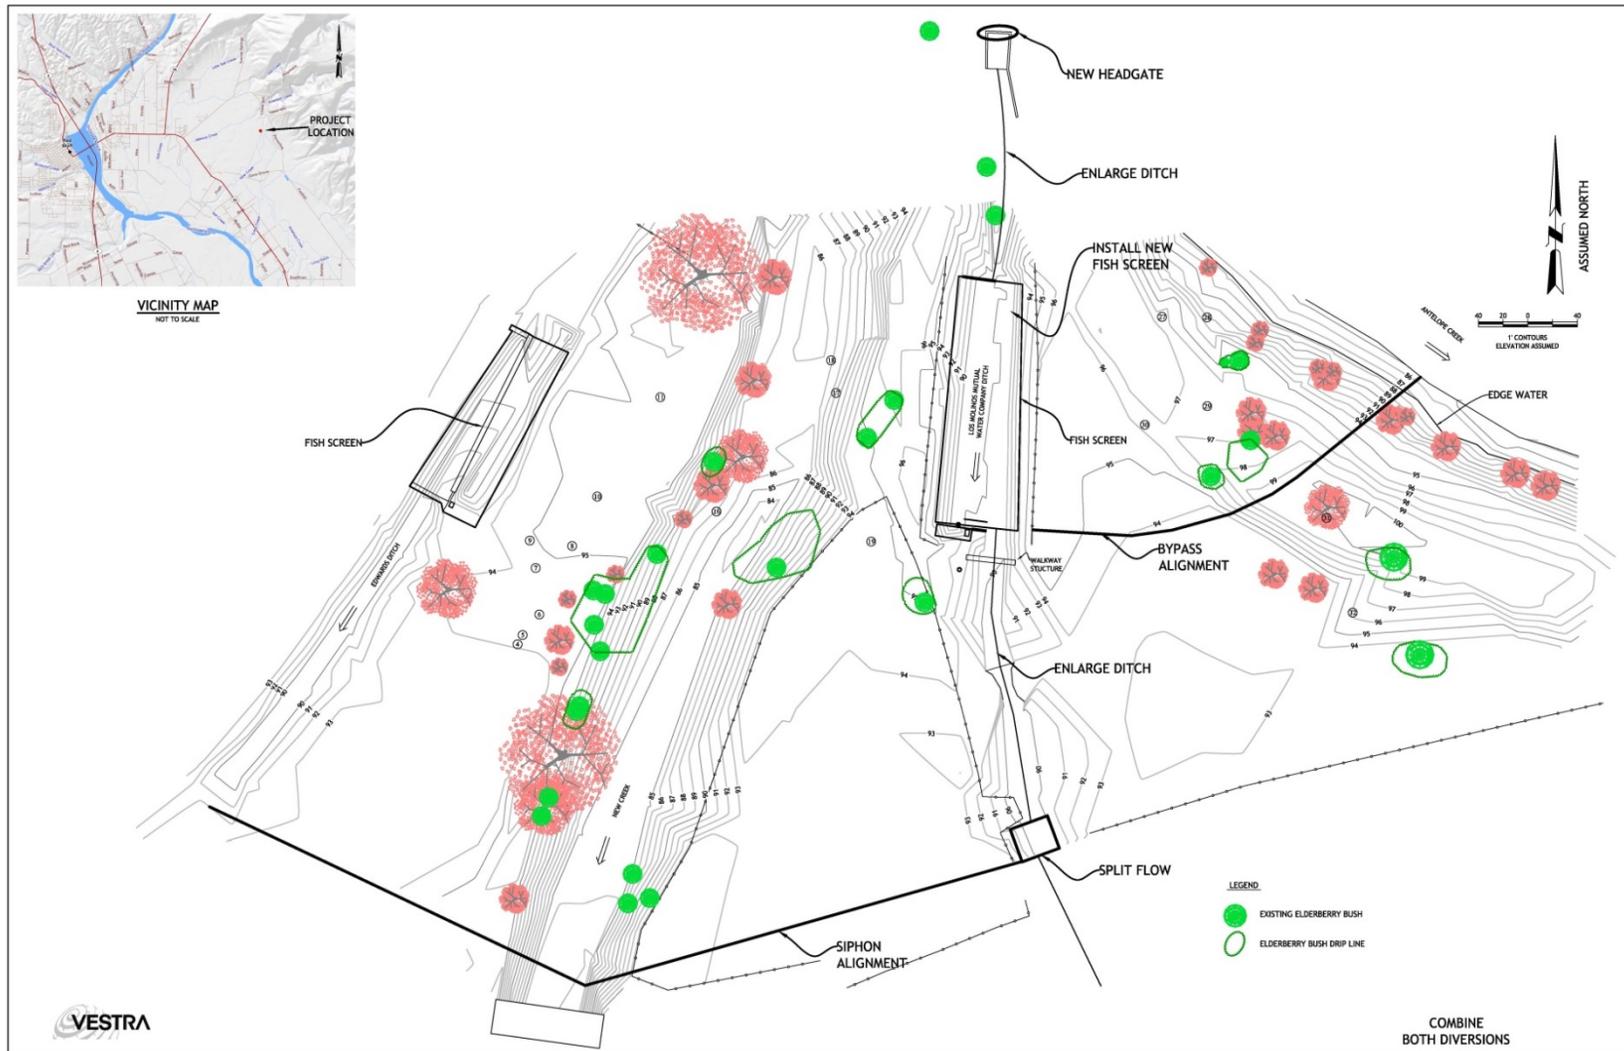
Figure 5-1. Preferred design concept for improving juvenile fish passage at Edwards Diversion Dam.

The TCRCDC in cooperation with the U.S. Fish and Wildlife Service, National Marine Fisheries Service, and California Department of Fish and Wildlife completed a study in 2013 of the diversion dam and related water distribution infrastructure in order to develop a retrofit design that would minimize juvenile entrainment, provide reliable and measurable instream flow releases necessary for fish passage in downstream reaches during critical adult and juvenile migration periods, and allow diverters to utilize most if not all of their respective water allocations outside of these critical migration periods. The preferred design concept, selected from a range of alternatives by CDFW and USWS, would consolidate water diversions into a single canal (i.e., the East Diversion) (Figure 5-1). New screens would be installed in the East Diversion, which would be sized to meet its current 80 cfs diversion capacity. A bypass pipe would be installed at the downstream end of the screens to return fish to Antelope Creek, and a siphon would be installed downstream of the screens to convey the Edwards Ranch share of water under New Creek to the existing West Diversion canal. To maintain the maximum combined diversion allowance of 130 cfs, the existing West Diversion headgate would remain in place but closed until diverters require more than 80 cfs. Use of the West Diversion headgate to obtain additional water would be conditional, and require that New Creek convey sufficient flow to provide unimpeded juvenile fish passage to the Sacramento River. A bypass pipe would be installed at the downstream end of the fish screen in the West Diversion to deliver fish to New Creek.
