Humboldt Bay Water Control Structure Inventory, Assessment, and Mapping

**Humboldt Bay Water Control Structure Inventory,
Assessment, and Mapping Project
Final Report**

October 30, 2007

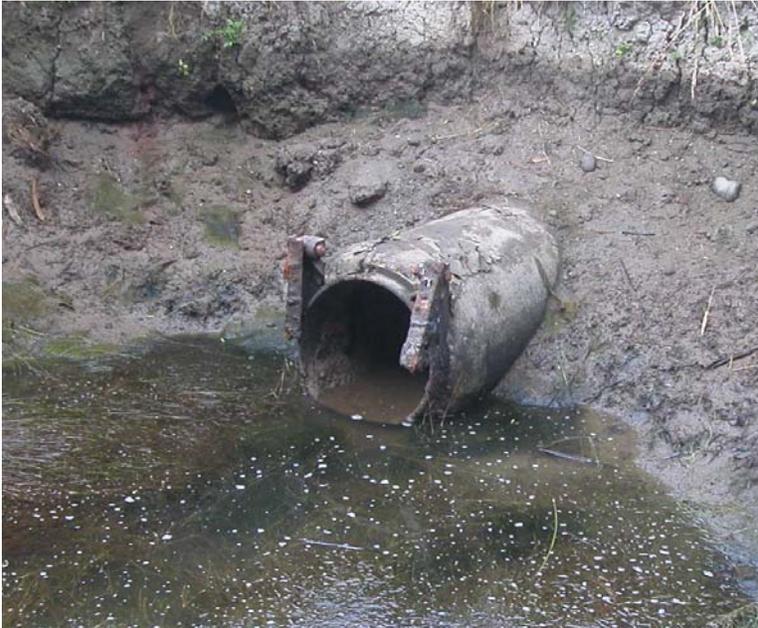
Figure 1. Example of a concrete pipe culvert with failed (missing) tidegate.

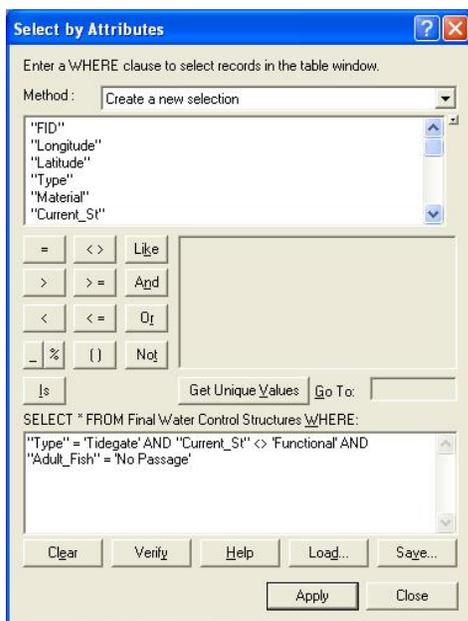
This database can be easily used by agencies and the general public to prioritize replacement or repair of these structures based on the attributes and photographs contained within. In the example query in Figure 2, we selected structures that are “tidegates” with a current status that includes “broken–closed,” and with “no adult fish passage.” The resulting output table only lists those structures that are tidegates with a status of broken-closed and that do not allow passage of adult salmonid fish. It is our hope that the information in this database will be useful and helpful in planning efforts for prioritization of restoration as well as other types of projects in the tidal waters surrounding Humboldt Bay.

Figure 2. Query selection example.

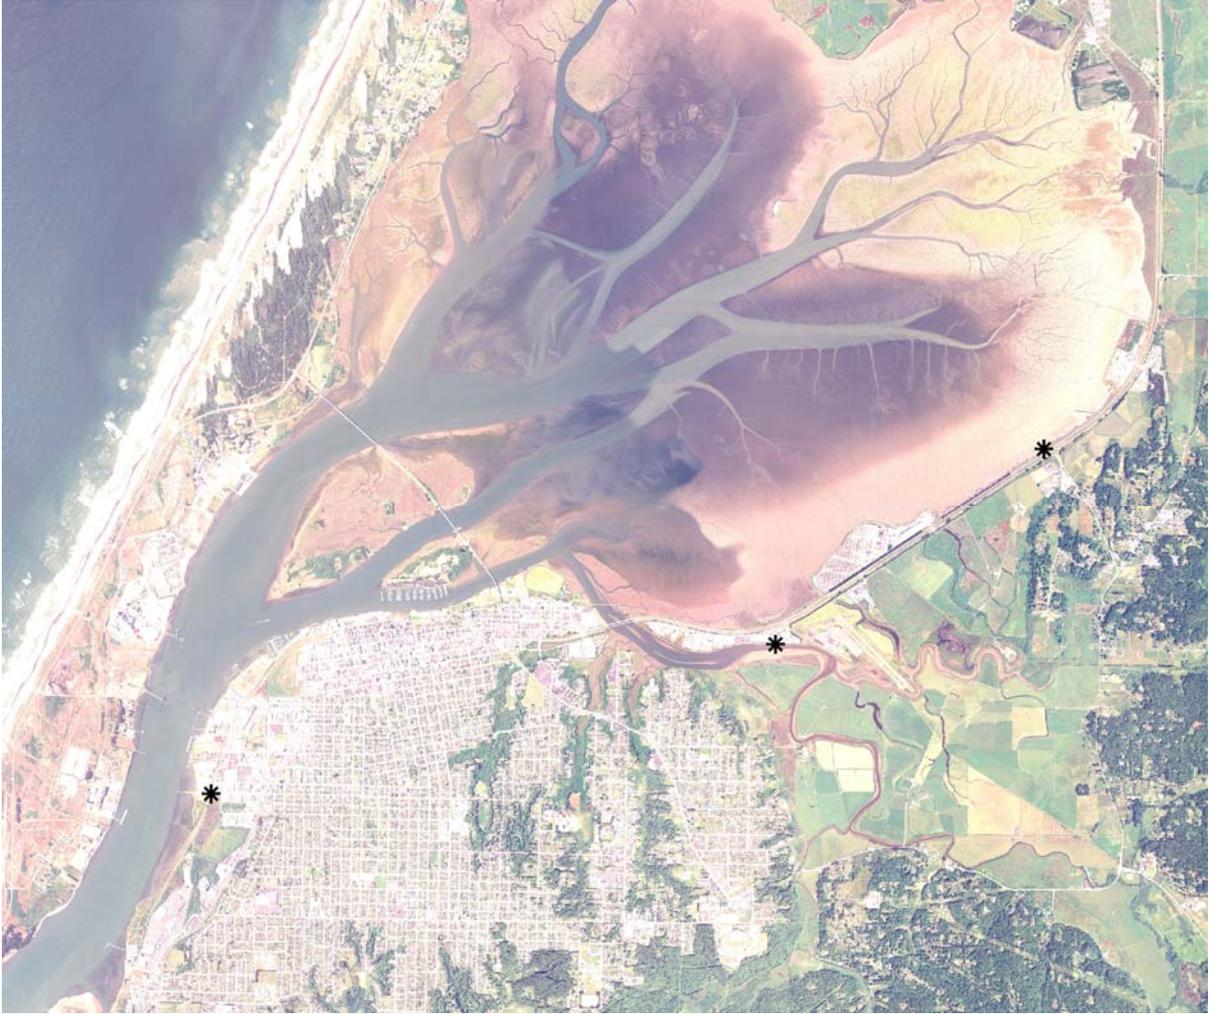
selected records will be shown on a map of Humboldt Bay as highlighted point features (Figure 3).

Figure 3. Map showing results from query in Figure 2.
