HATCHERY MAINTENANCE

Hagerman National Fish Hatchery

Hatchery II Epoxy Coating

January 19, 2011

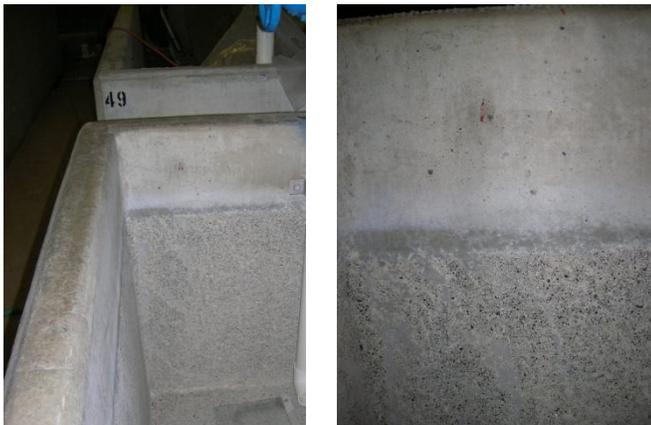
Worn Tanks

The Hatchery II concrete tanks at the Hagerman National Fish Hatchery (Hatchery) were purchased in 1982. Twenty-nine years of fish production has deteriorated the unfinished concrete surfaces and created refuge for diseases and accumulation of fecal material. During 2010, the Hatchery researched several coating options and decided to coat two trial tanks with epoxy coatings.

The first and most important step of the project was preparation of the concrete surface. The tanks were allowed to dry for several months after fish rearing activities. The dried tanks were then ground with an angle grinder and cup brush to remove loose concrete and laitance. Bug holes were chipped to expose cavities in the concrete. After grinding, a 12" x 12" sheet of plastic Visqueen was duct taped to the tank floor. Inspection of this moisture test after 24 hours revealed a dry surface, so the coating process was ready to begin.
