Lake Champlain Aquatic Habitat Connectivity

Fish Passage in the Browns River Watershed

Crane Brook at Irish Settlement Rd, Underhill, Vermont

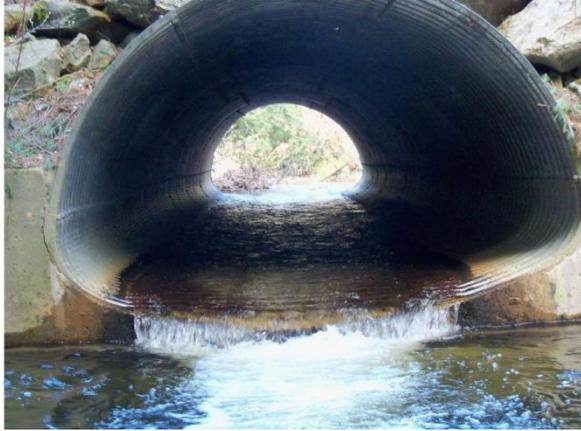
Before

Left: A view of the Crane Brook culvert outlet on Irish Settlement road. This culvert is perched, allowing minimal to no fish or aquatic organism passage. **Right:** New Crane Brook culvert at the Irish Settlement road crossing designed for fish and aquatic organism passage.

Problems / history: Crane Brook has a healthy population of brook trout that have been cut off from the colder headwater reaches and the spawning/rearing areas by a perched culvert on Irish Settlement road. The culvert was in good condition, with no damage, undermining or washouts. The estimated lifespan of the structure is > 30 years. Retrofitting the stream bed to insure fish passage was our partners preferred option. The height barrier was addressed by an instream weir and the velocity barrier with baffles in the culvert itself.
