Upper Connecticut River Aquatic Habitat Connectivity: White River Watershed

Upper and Lower Eaton Dams, First Branch White River, Windsor County, Royalton, VT

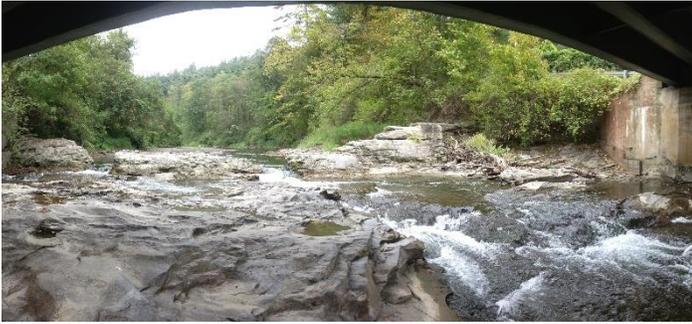
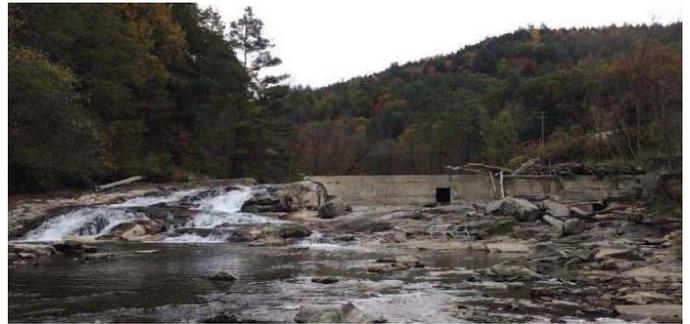
Left: Upper Eaton Dam before removal (WRP). Right: Lower Eaton Dam before removal looking upstream (WRP).

Site description: Located in Royalton, Vermont the Upper & Lower Eaton Dams are the first two dams on the First Branch of the White River; both dams were inactive and are barriers to aquatic organism passage and sediment continuity; and the landowners support a dam removal project.

Problems / history: The dams block natural stream function and aquatic organism passage to 15 miles of upstream habitat. The section of the First Branch was listed as "impaired" for bacteria in 2016 and water quality monitoring indicated that fine sediments deposits behind the dams may be harboring bacteria populations. Removing the dam will restore the natural sediment regime, and will remove the conditions for bacteria to thrive.

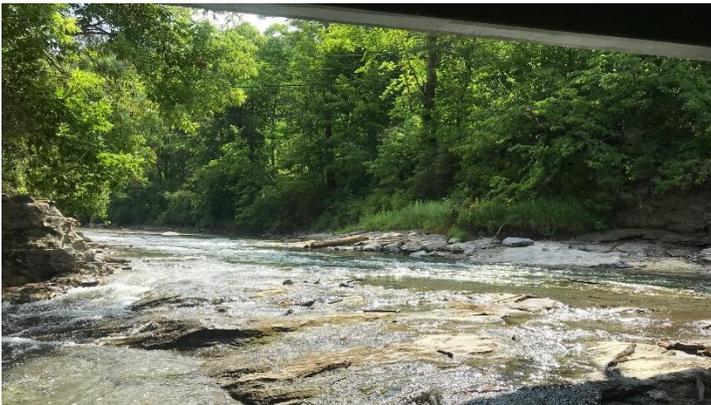
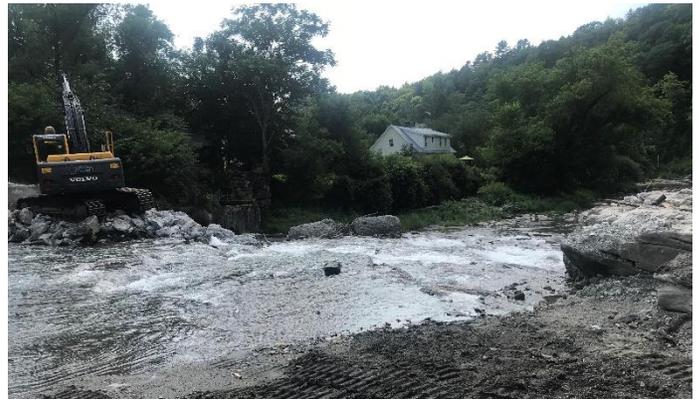
Left: Upper Eaton Dam after removal (USFWS). Right: Lower Eaton Dam, looking downstream, during removal (USFWS).

Objective and Method: The removal of the dams will address an upstream water quality issue, improve flood resiliency, restore sediment transport and restore fish passage to 15 miles of habitat for brook trout, dwarf wedgemussel, sea lamprey, and American eel.
