## 8. Indirect Injuries

### 8.1 Introduction

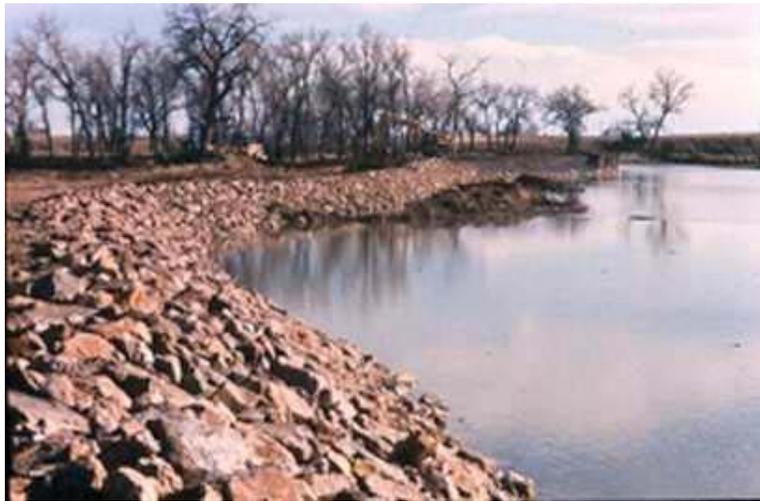
**Figure 8.1. Shoreline stabilized with riprap.**

Stabilizing the banks of the Kalamazoo River in former impoundment areas could be used to reduce bank erosion and the ongoing PCB load from the banks into the river (Blasland, Bouck & Lee, 2000a). However, bank stabilization can also lead to river channelization and prevent natural geomorphologic processes from operating, thereby causing indirect injuries. The engineering method selected for bank stabilization will affect the nature and level of indirect injury resulting from this alternative. Use of a technology such as riprap (Figure 8.1) or sheetpile (Figure 8.2) will essentially eliminate riparian and nearshore aquatic habitat, alter the hydrologic and temperature regimes of the river, and affect sediment transport processes. Additionally, this type of engineered shoreline may have effects on the human use of the river by altering the aesthetic qualities and/or public access. For example, although ease of access to the shoreline may be facilitated by bank stabilization, human use may be impacted because of the absence of natural vegetation and the variety of habitats that provide scenic value to the shoreline. It is also likely that the quality of birdwatching and fishing will be reduced due to a loss of shoreline vegetation and nearshore instream habitat types.

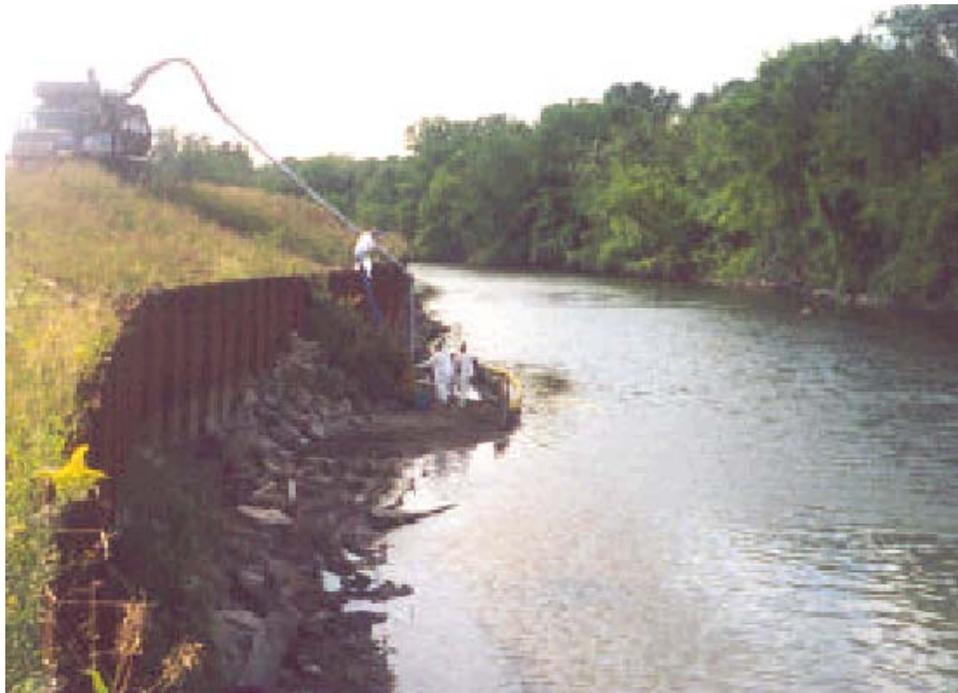
**Figure 8.2. Sheetpile along the Kalamazoo River.**

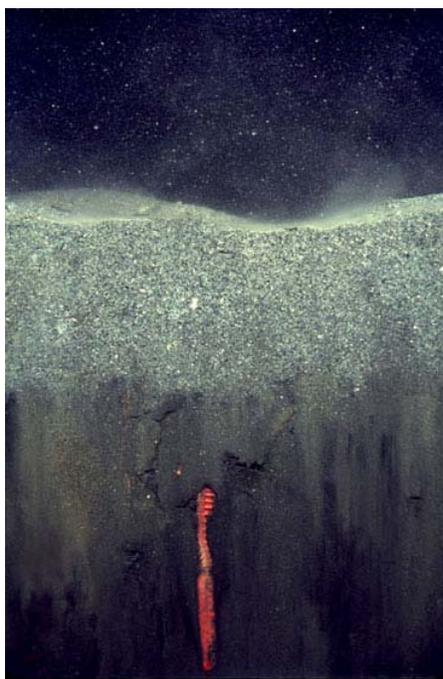
**Figure 8.3. Cross section of sediment cap over contaminated sediment.** An orange worm living in the sediment is visible.

Capping of stream sediments may be used to isolate PCB contaminated sediments from the active river system (Blasland Bouck & Lee, 2001) (Figure 8.3). Engineering technologies can enhance this process by increasing the rate of sediment deposition or effectively sealing the sediments. Particle broadcasting introduces additional fine particles to the system to increase the deposition rate, while an engineered cap involves placing one or more layers of material such as sand, gravel or geotextiles over the sediment.

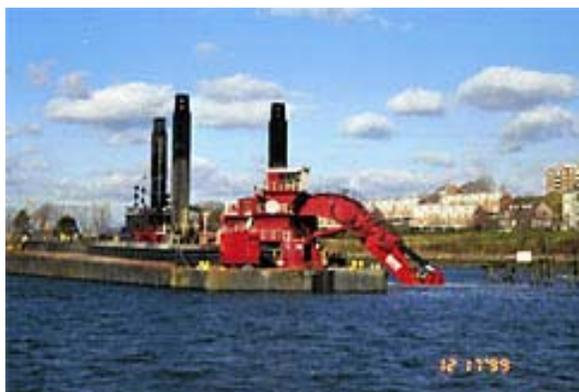
**Figure 8.4. Mechanical dredge removing sediment.**

Removal of PCB contaminated sediment from the site has also been proposed as a remedial alternative (Blasland, Bouck & Lee, 2000a). Excavation could be done with a mechanical dredge (Figure 8.4), which physically scoops the sediment from the bottom; a hydraulic dredge, which pumps the sediment in a slurry (Figure 8.5); or by controlling the flow of the river so that sediments can be excavated “in the dry.” The removal of PCB contaminated sediments from the KRE can be a very effective strategy for reducing the exposure of natural resources to PCBs, and thereby the ongoing direct injuries to resources. Nevertheless, sediment removal can cause indirect resource injuries that the Trustees may consider in future stages of the NRDA, if sediment removal is selected as a remedial option.

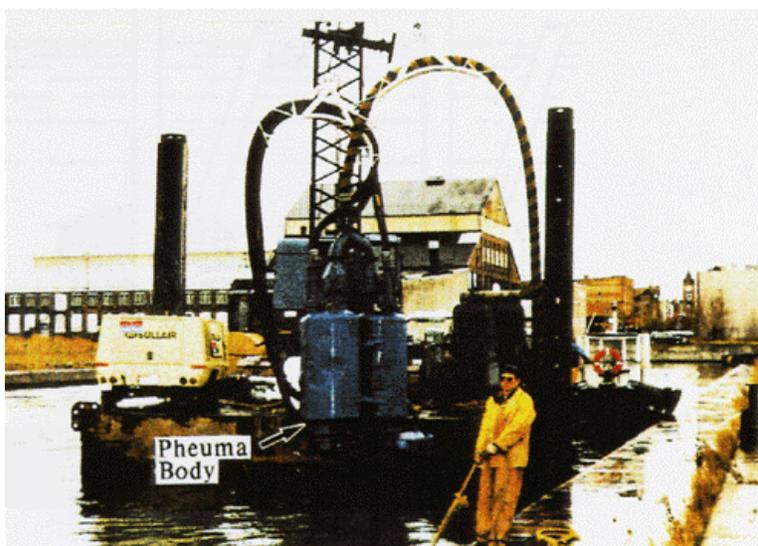
**Figure 8.5. Suction-style hydraulic dredge.**
