FINAL ENVIRONMENTAL ASSESSMENT/ 90 PERCENT PLAN FOR TOBICO MARSH

**SAGINAW RIVER/BAY NRD SETTLEMENT
BAY CITY, MICHIGAN**

**OCTOBER 2004
REF. NO. 18204 (13)**

**Prepared by:
Conestoga-Rovers
& Associates**

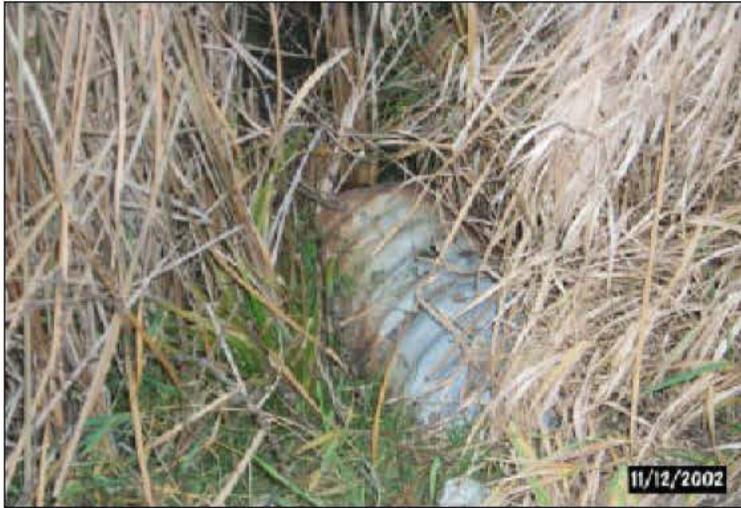
PHOTO NO. 1 - OVERGROWN CULVERT

During field observations it was noted that all three of the culverts were in need of maintenance. Photographs presenting the existing conditions of each of the culvert pipes are presented on Figures 2.17 to 2.19.

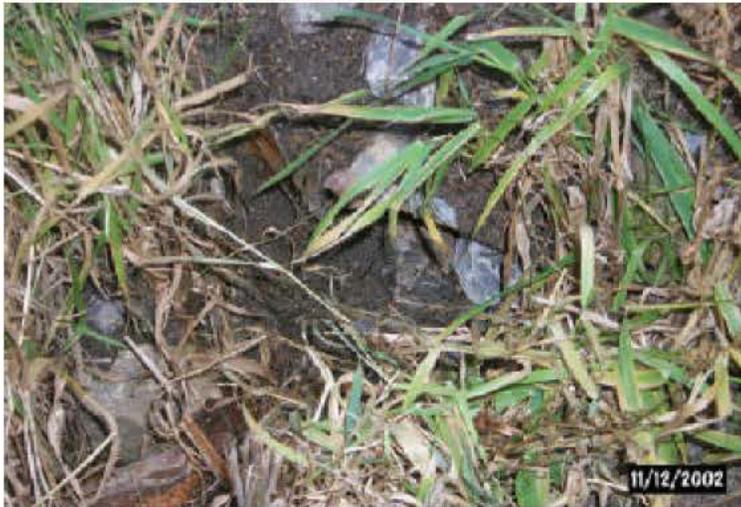
PHOTO NO. 3 - DETERIORATED AND PARTIALLY COLLAPSED CULVERT

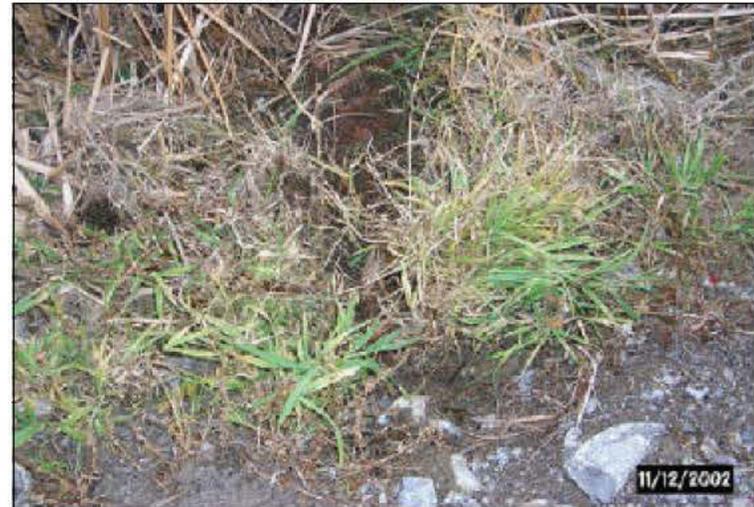
PHOTO NO. 4 - OVERGROWN CULVERT

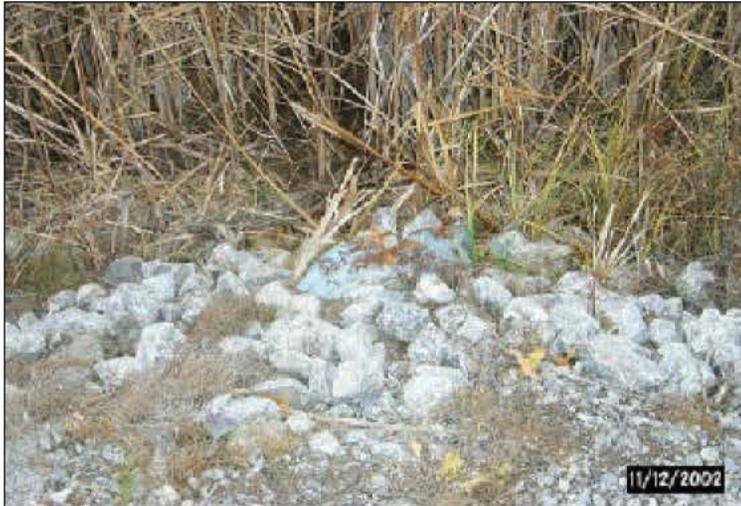
PHOTO NO. 1 - OVERGROWN CULVERT

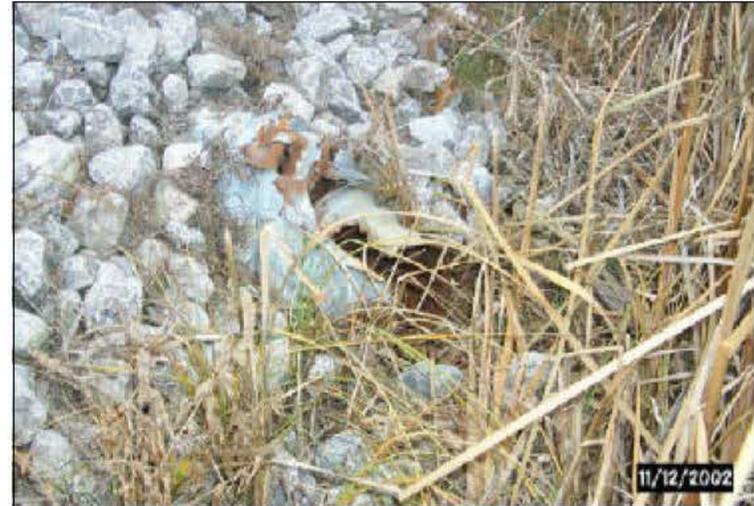
PHOTO NO. 2 - DETERIORATED CULVERT

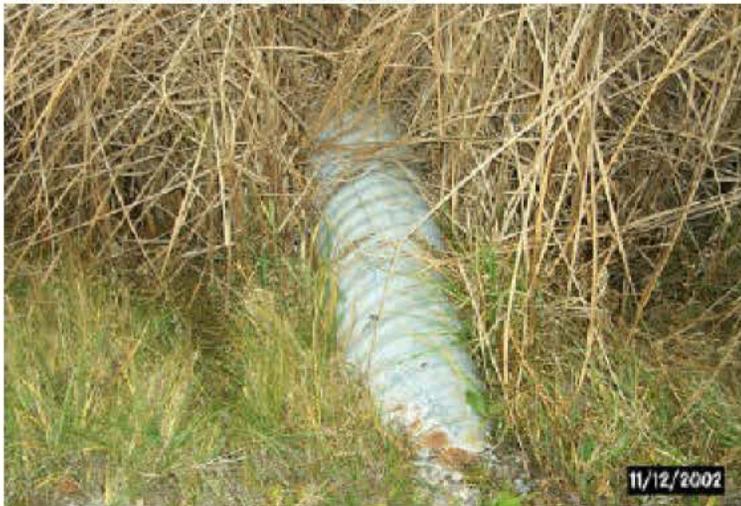
PHOTO NO. 3 - OVERGROWN CULVERT
