DRAFT ENVIRONMENTAL ASSESSMENT

BRIGHAM FACE WILDLIFE MANAGEMENT AREA Evans and Mathias Canyons Debris-Retention Basins Project

Brigham Face Wildlife Management Area Evans and Mathias Canyons Debris Basins Project Perry Flood Control District

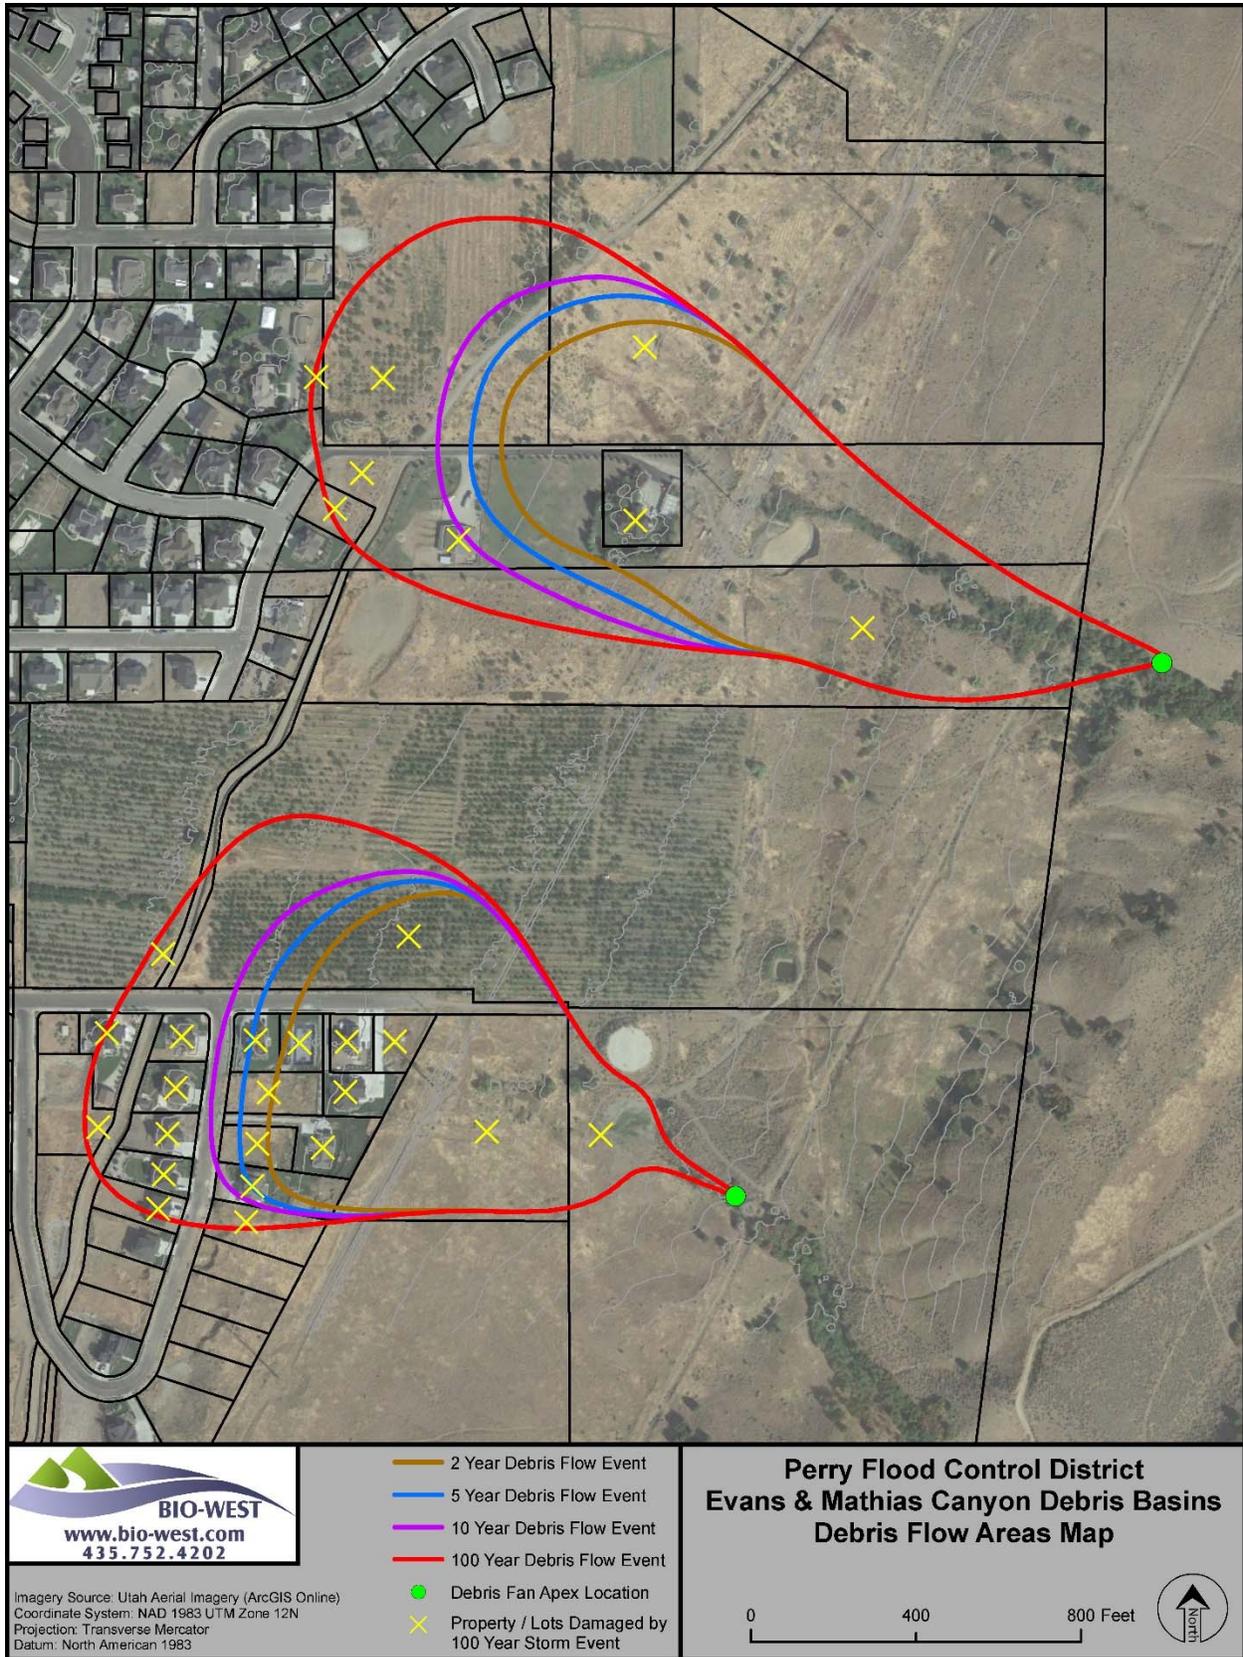
Figure 4. Perry Flood Control District Evans and Mathias Canyons Debris Flow Areas Map.

(Figure 4). Given the topography of the existing drainages above the apex, and the ability of the steep canyon walls to contain debris flows, a greater volume of debris can be contained in the canyons within a smaller footprint compared to debris-retention basins located below the apex.

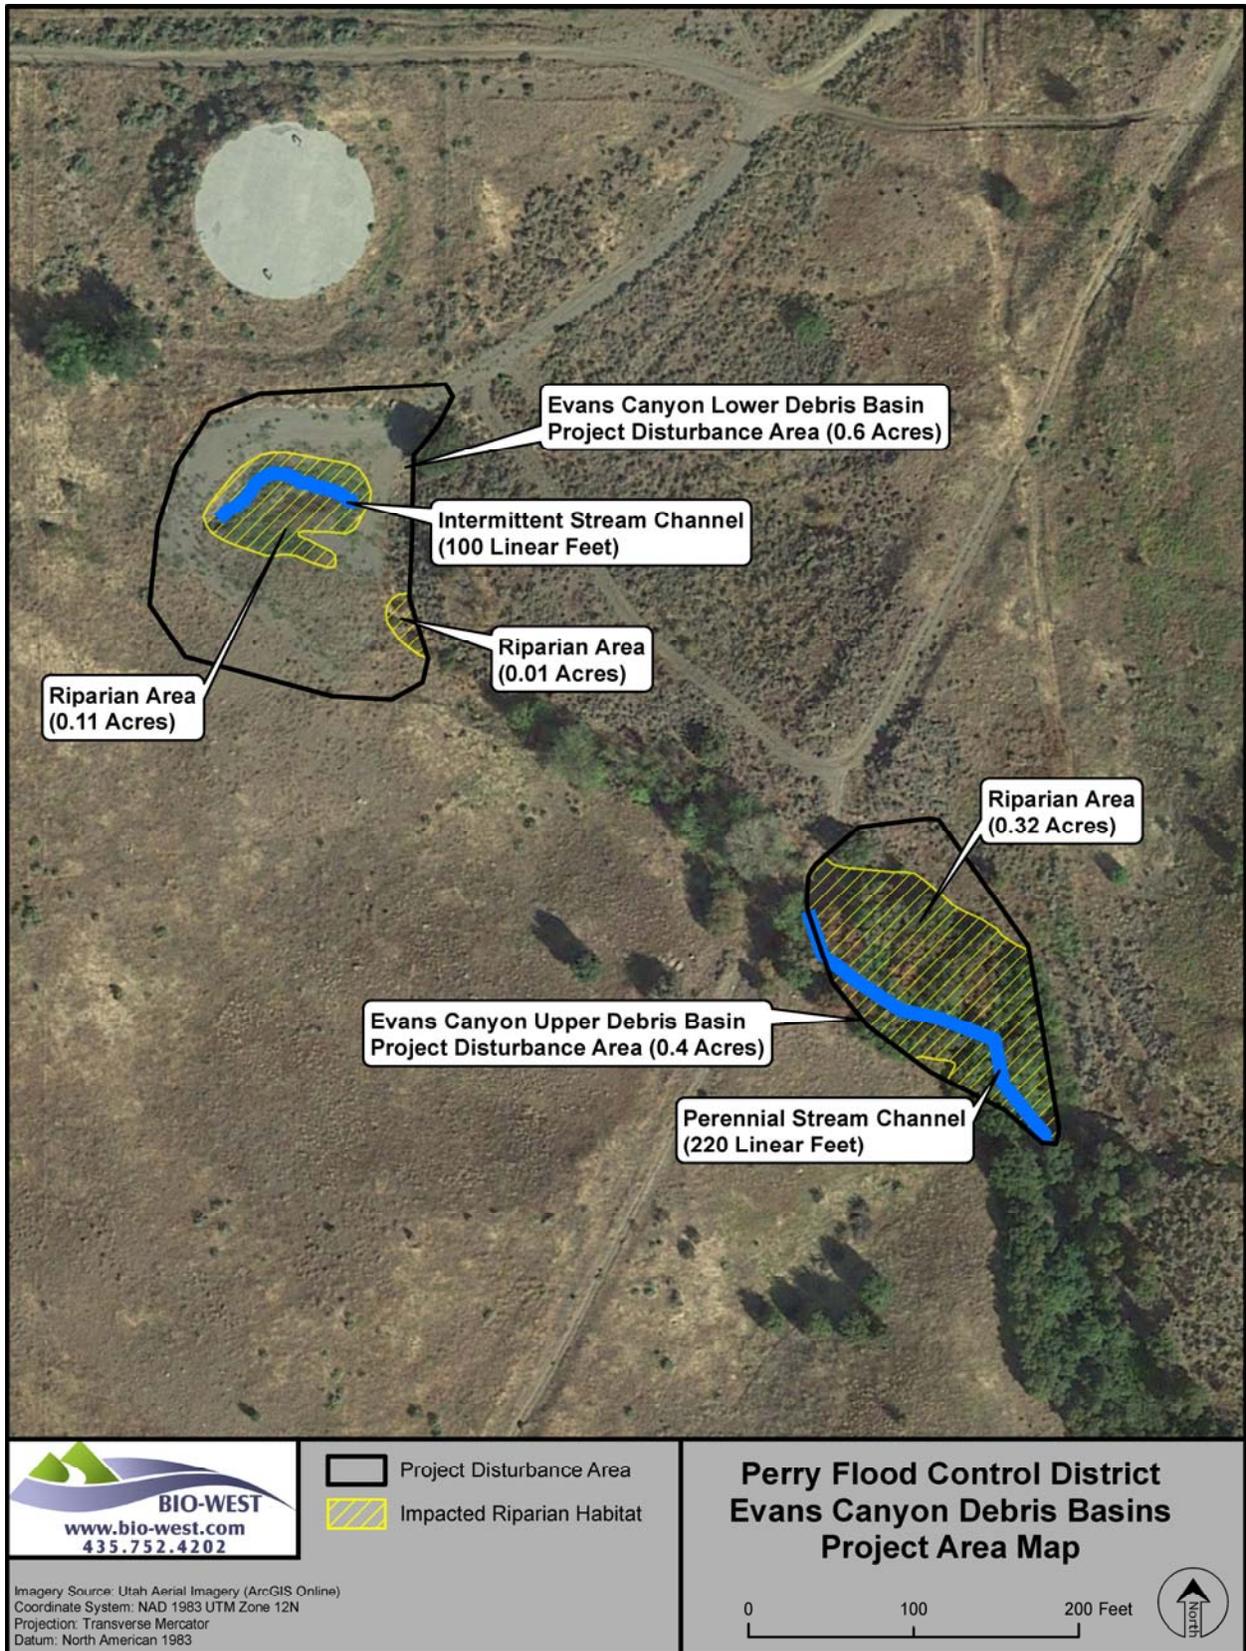
Figure 5. Perry Flood Control District Evans Canyon Debris Basins Project Area Map.

Figure 5 illustrates the proposed debris-retention basins for Evans Canyon—enlargement of an existing basin and the addition of a second basin at the mouth of the canyon. The existing basin receives discharge from Evans Canyon and also receives overflow discharge through a storm drain/irrigation diversion pipe from Mathias Canyon. The outflow from the basin enters a storm drain pipe that flows to the Perry City drainage system. The existing basin is inadequately sized to contain the debris flow potential from Evans Canyon (GeoStrata 2015) and is located slightly below the apex of the alluvial fan. The existing basin would be enlarged by excavating material on the south end of the basin to increase its capacity from 0.60 acre-feet to 1.84 acre-feet. The total project area disturbance for enlargement of the existing debris-retention basin is 0.6 acres.

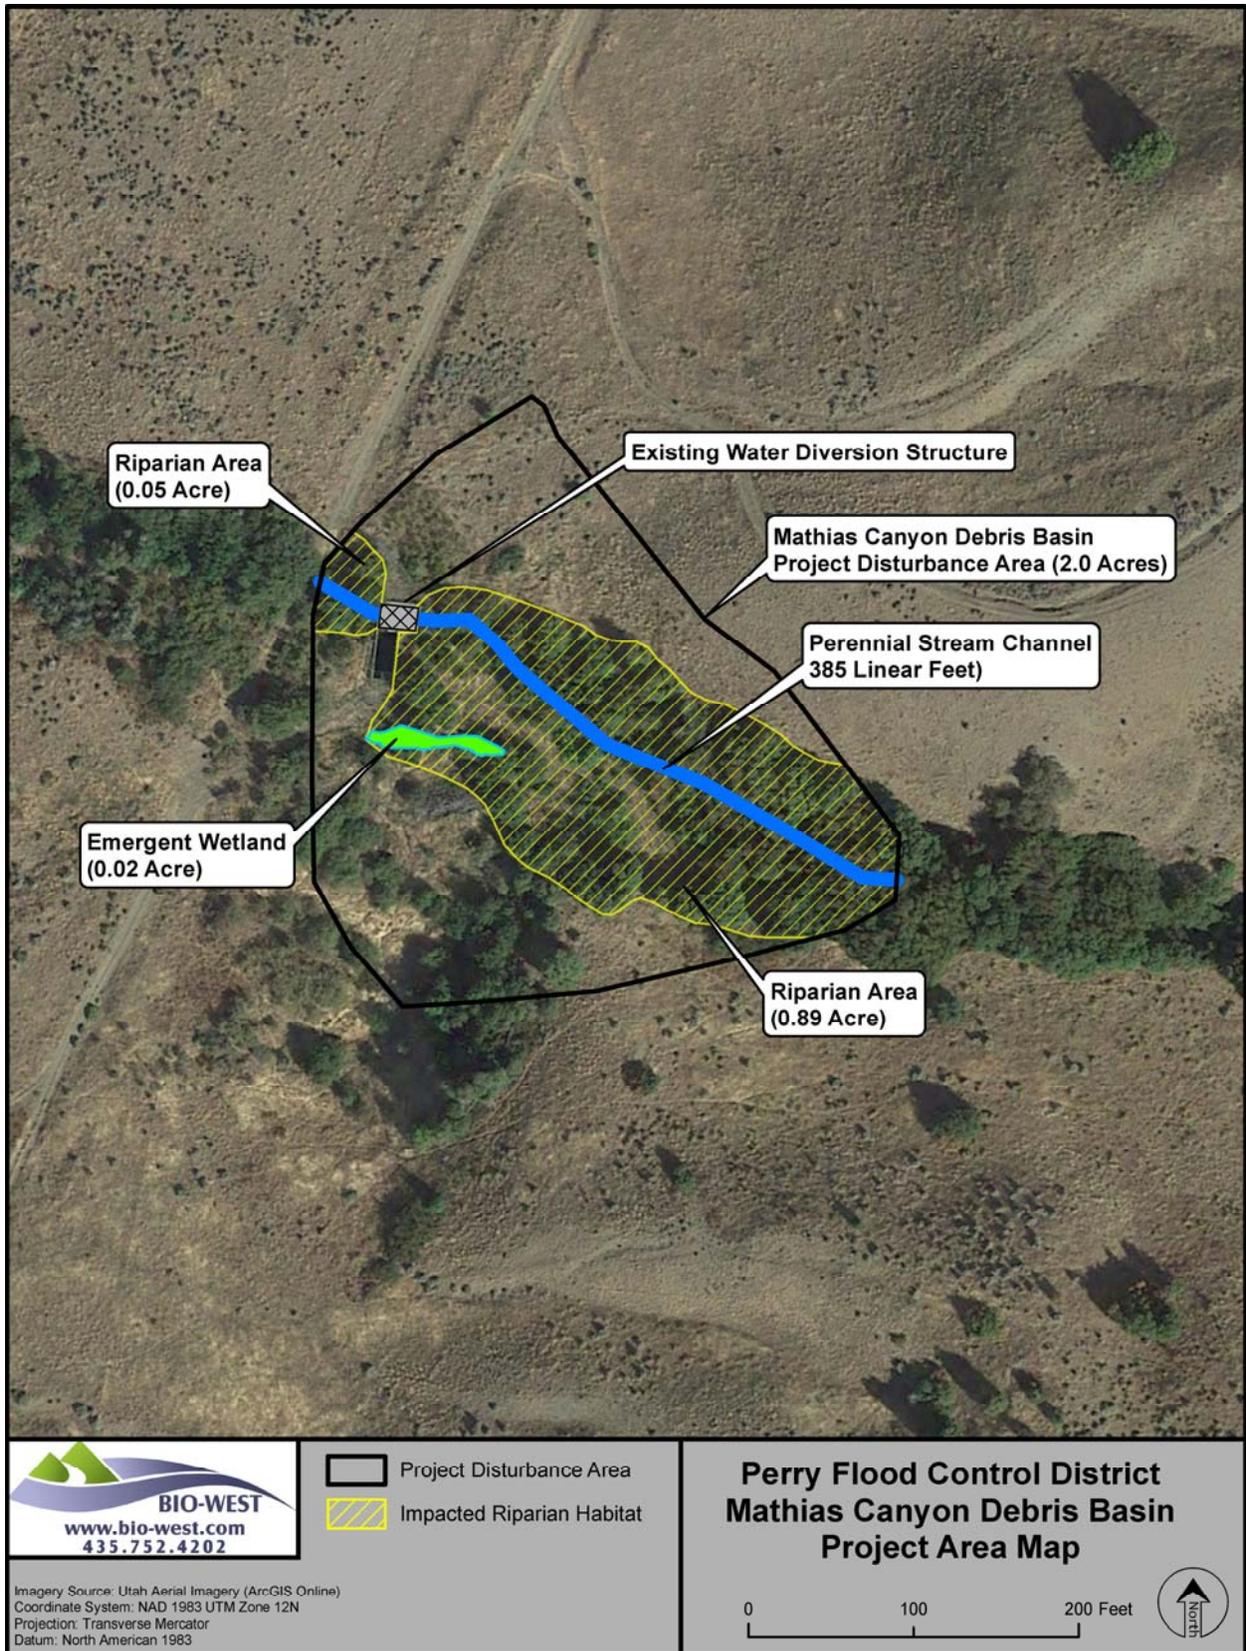
Figure 6. Perry Flood Control District Mathias Canyon Debris Basin Project Area Map.

Figure 2 illustrates the locations of debris-retention basins proposed by the Flood District. At Mathias Canyon, there is an existing concrete irrigation water diversion structure at the mouth of the canyon. That structure would be removed and replaced with an earthen embankment and adequately sized debris-retention basin for the estimated potential debris flow. At the Evans Canyon location, the Flood District has an existing debris-retention basin that was determined to be inadequately sized to contain the debris flow potential from the canyon. Therefore, the Flood District proposes to expand the size of the existing basin and also to construct a second basin upstream from the existing basin to provide additional debris flow containment capacity.

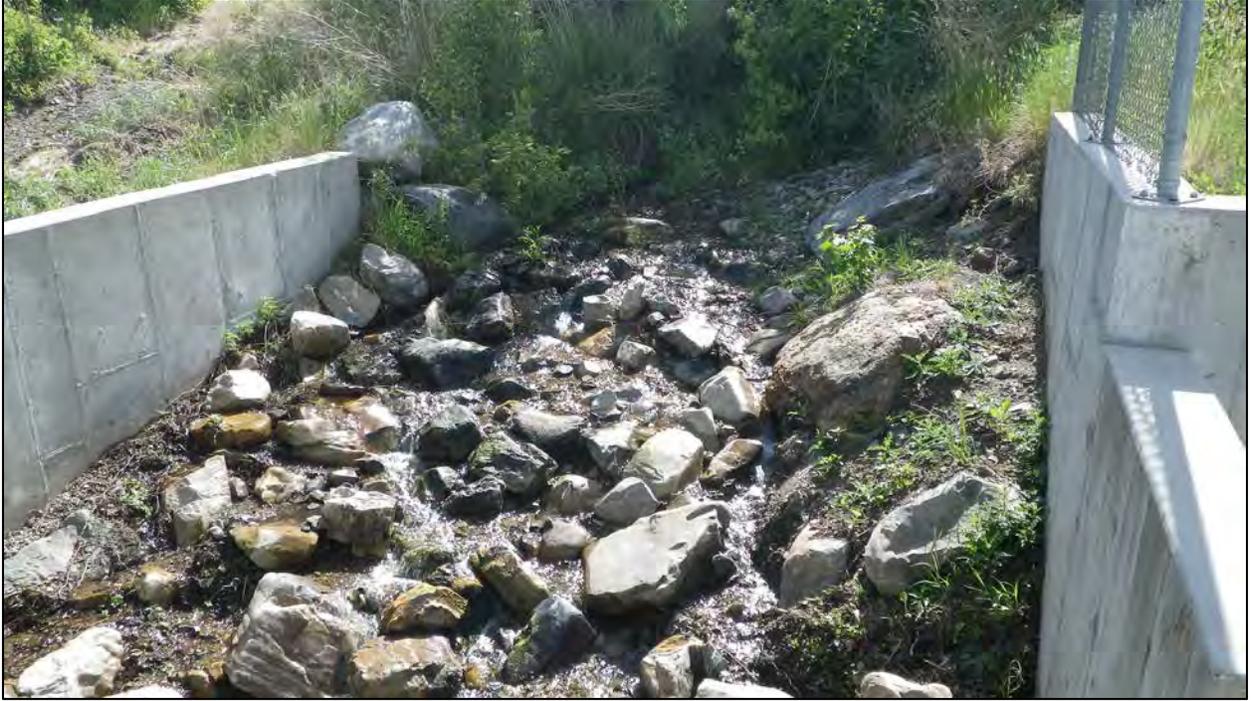
Mathias Canyon water diversion structure facing upstream.

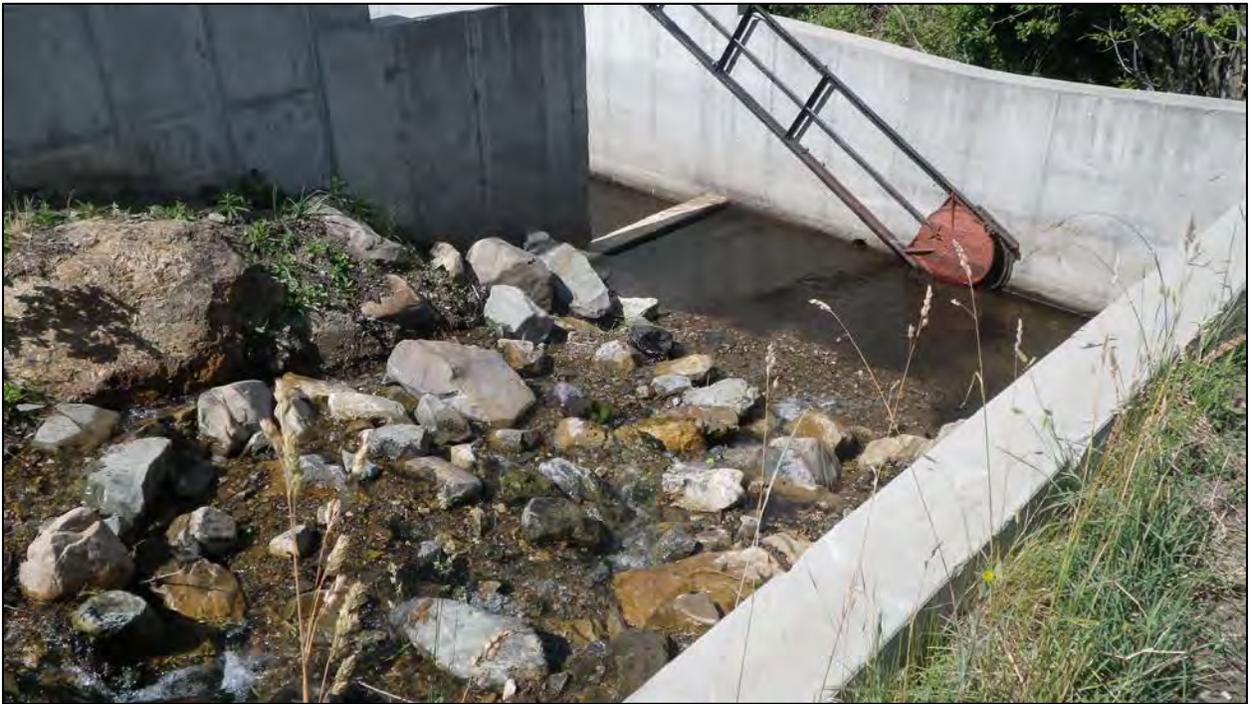
Mathias Canyon water diversion structure facing downstream.

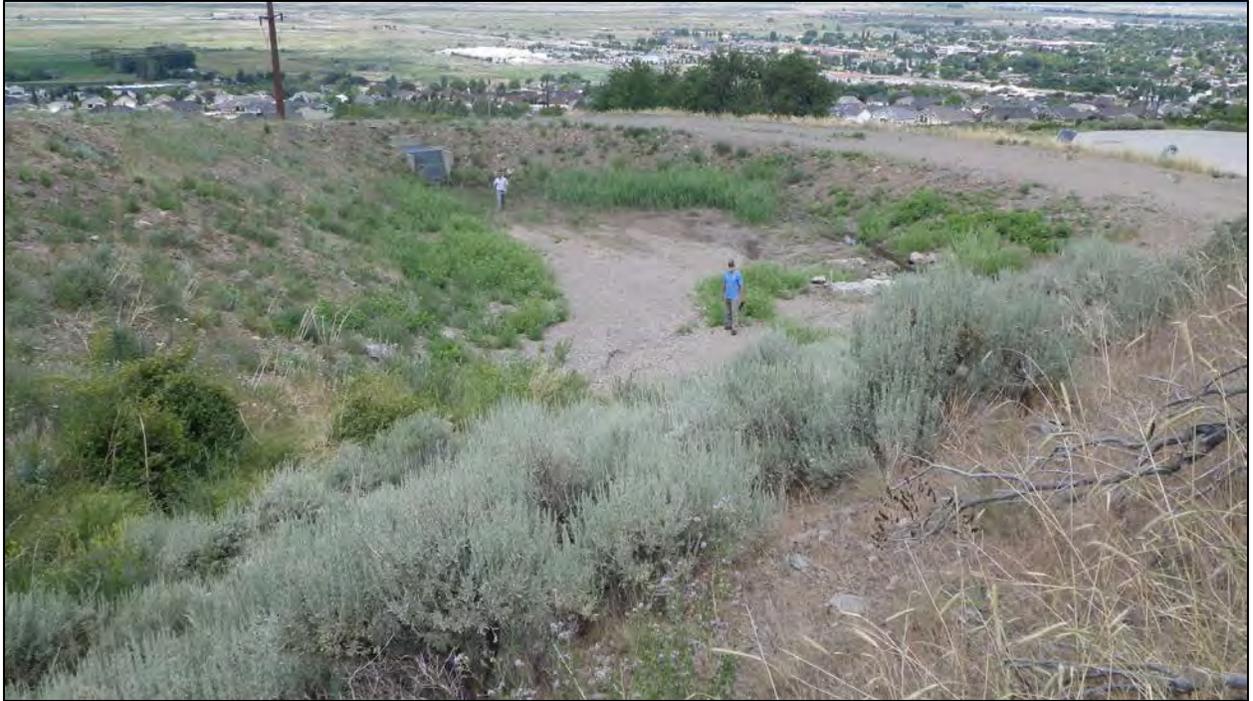
Existing Evans Canyon Lower Basin.

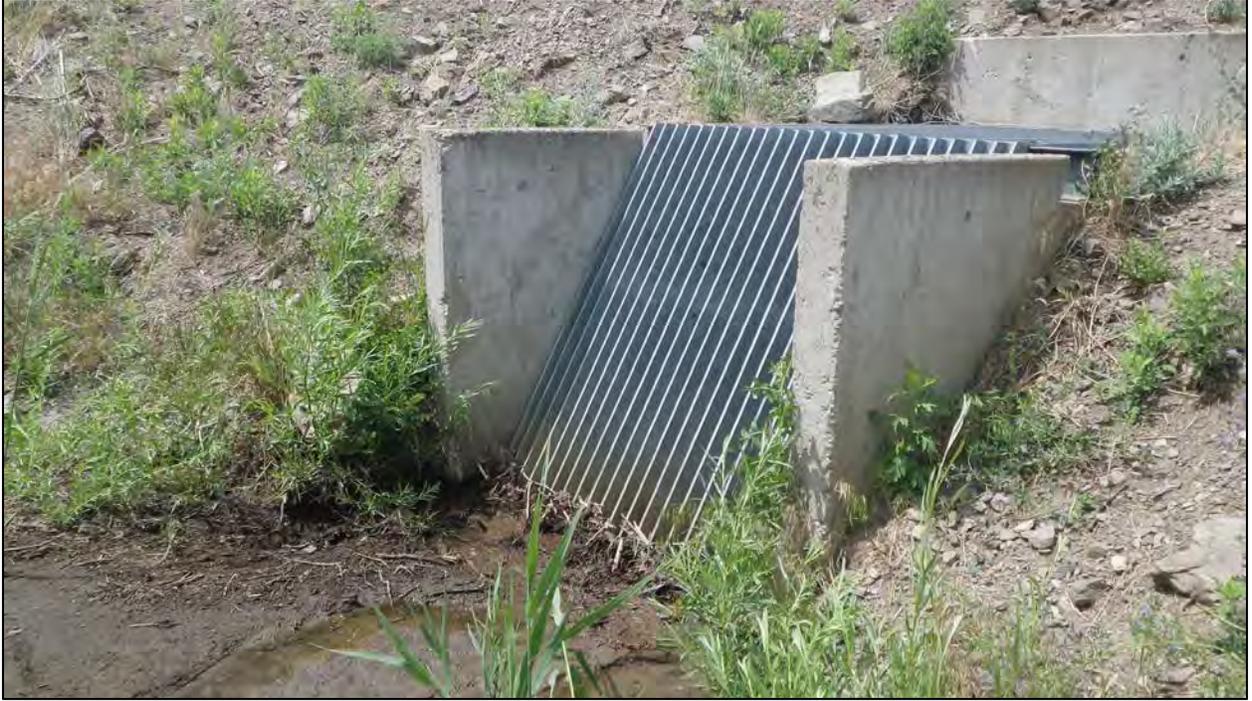
Existing Evans Lower Basin Canyon water diversion structure.

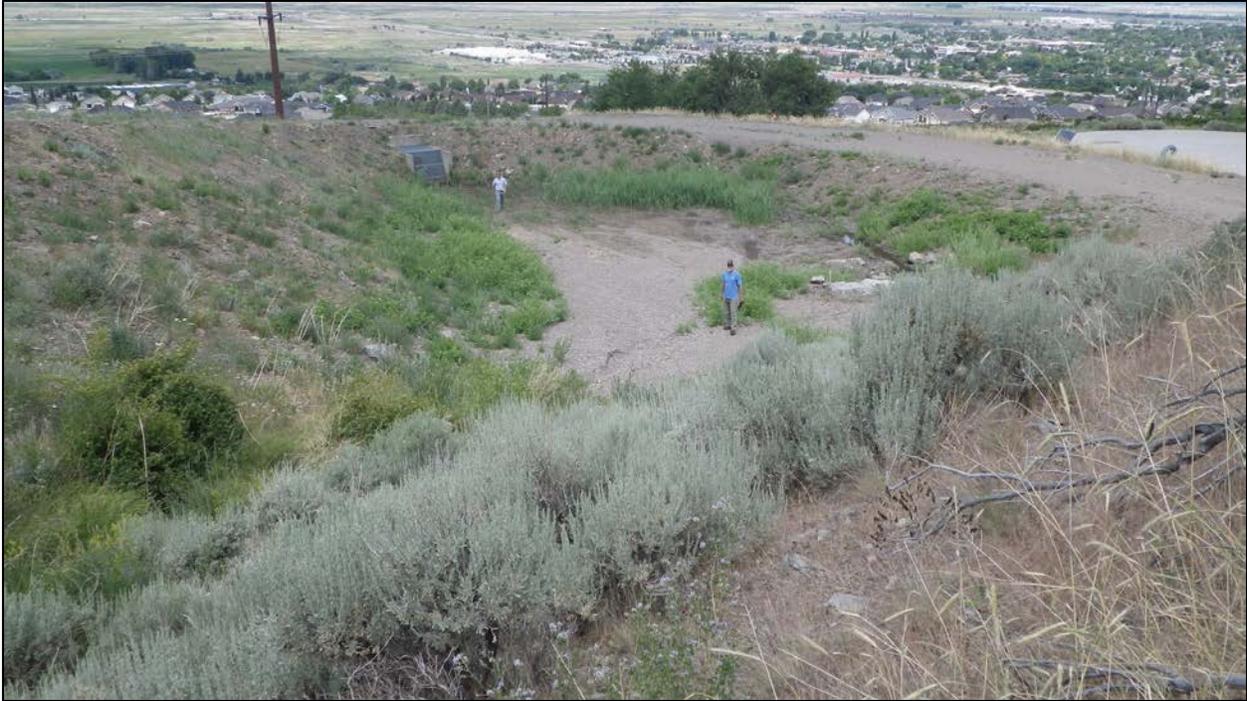
Existing Evans Drainage Lower Basin.
