North Clackamas Central Park – Mt. Scott Creek

YEAR
6

in Milwaukie, Oregon at 5695 Kellogg Creek Drive, in the west section of North Clackamas Central Park

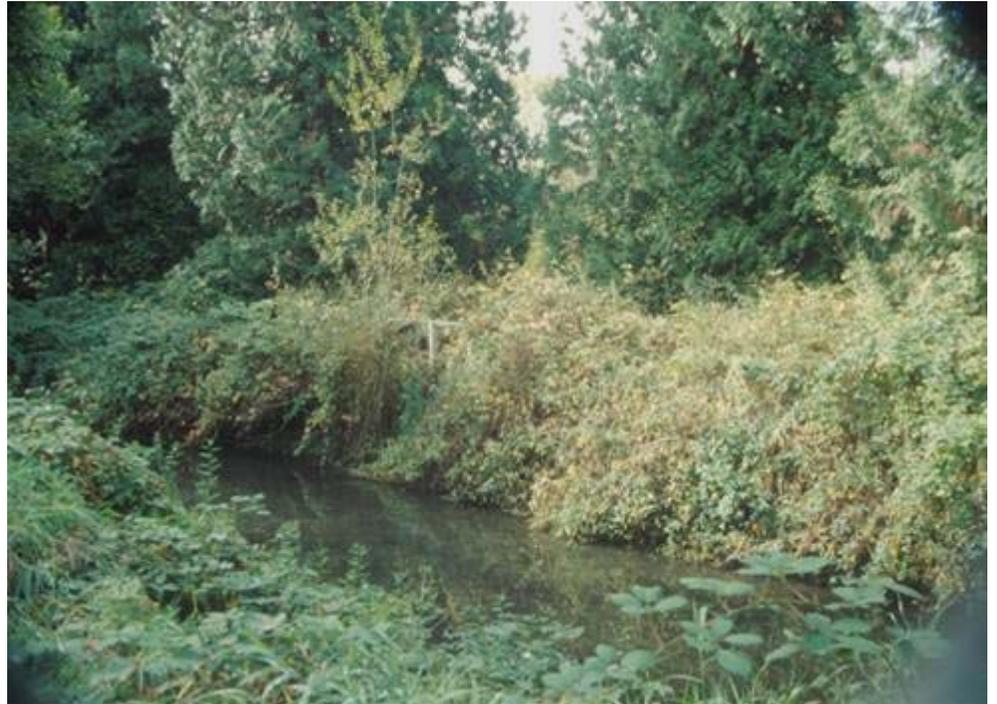
BEFORE

Excessive streambank erosion due to lack of native vegetation to stabilize soils and flashy stream flows.

This restoration site consisted of a 200-foot section of heavily-eroded and undercut streambanks along the south side of Mt. Scott Creek. Erosion had increased as a result of changes in stream hydrology due to rapid development in the upper part of the watershed, and by flooding during high rainfall events the past three winters. Existing riparian trees were in danger of being lost, and both sides of the stream were infested with Himalayan blackberries and reed canary grass. The proposed project would stabilize the eroding streambank, remove invasive blackberries and grass, and increase native riparian plant cover.

The eroded section of streambank was graded to a lesser slope and bioengineering techniques were used to stabilize the bank. A crib wall was constructed along the stream bank. Large boulders were placed at the toe of the slope, smaller rocks were placed between the large boulders, and brush and topsoil was placed and compacted. Blackberries and reed canary grass were manually removed and the site was seeded with native grass. A 900-coir matting was installed over the grass and staked with live willow cuttings. Western red cedar and red alder trees were later planted within the boundaries of the project to restore vegetation at the edge of the stream.

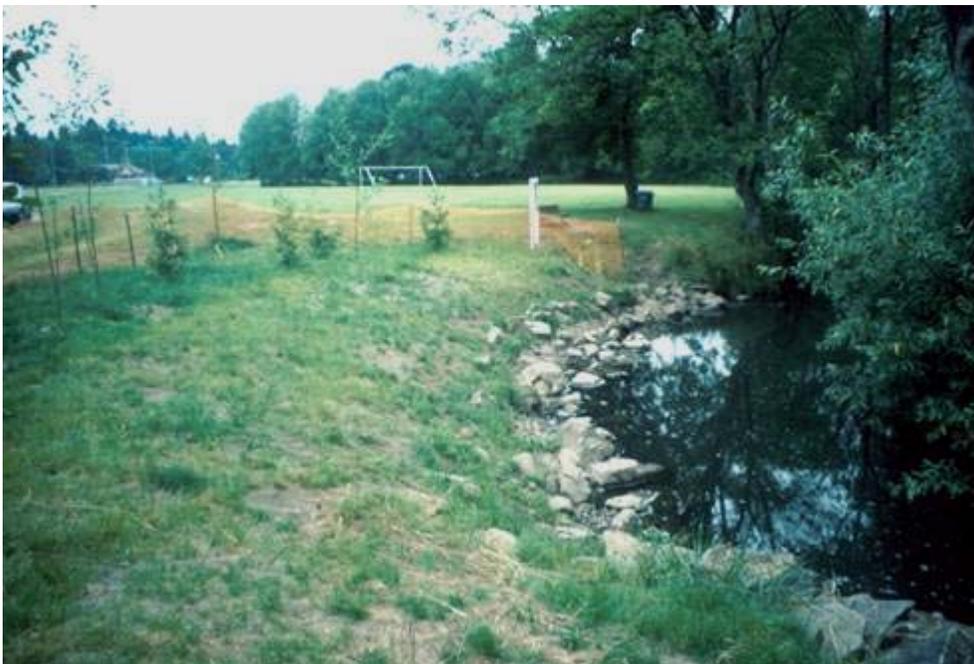
AFTER

Himalayan blackberry was removed, the toe of the bank was stabilized, coir matting was installed and native grasses, trees and shrubs are being planted

September-October 1997	Removed blackberries and reed canary grass; constructed crib wall, seeded exposed areas, and installed erosion control matting and willows.
Spring 1998	Planted cedar and alder trees.
