Gabriel Park

on the south side of Southwest Vermont Street between Southwest 37th Avenue and Southwest 45th Avenue

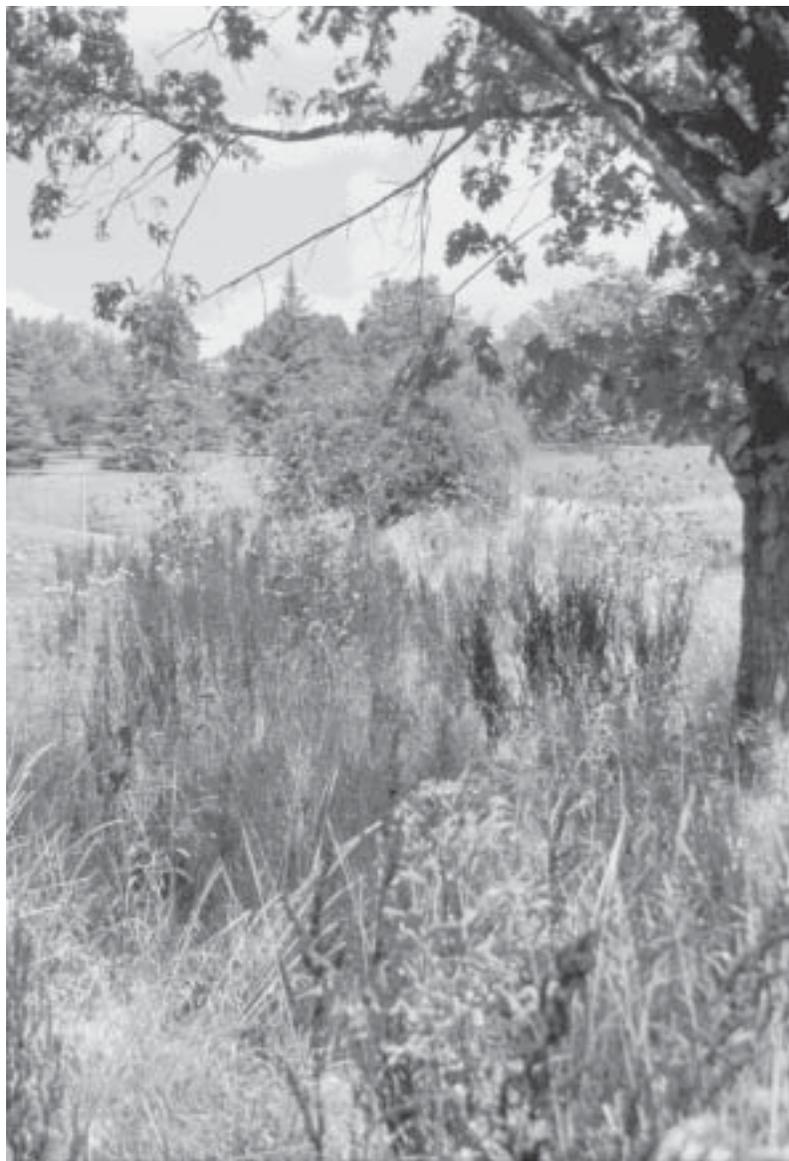
Gabriel Park is surrounded by residential neighborhoods that use surface storm drainage. The majority of roof drains flowed into the streets, where they collected in storm drains. The east side of the park has approximately 50 acres of drainage that culminated in a 24-inch outfall just inside the park at Southwest 37th, north of Southwest Nevada Court.

The drainage flows westerly for approximately 1,500 feet, where it joins Vermont Creek. A strip, ranging from 100 to 250 feet wide on each side, of this drainage was saturated most of the year. This drainage area was of primary concern to this project. The drainage channel had become deeply incised and contributed sediment into Vermont Creek. The project eliminated the existing erosive conditions and further reduced total suspended solids and other pollutants of concern in the storm water from entering Vermont Creek. The project provided educational opportunities for schools and residents of the area.

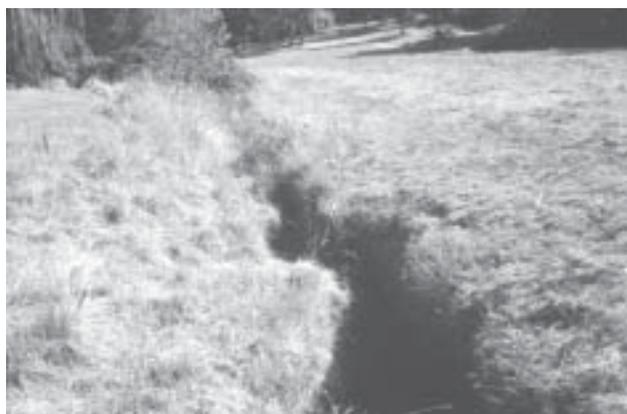
AFTER

Ditch is transformed into a biofiltration swale, providing water quality and wildlife habitat (above)

BEFORE

Deep drainage ditch sheds sediment into Vermont Creek (left)

The project goals have been carried out through lining the incised channel with medium (8-inch diameter) to large (4-foot diameter) boulders over a crushed gravel base. The low flows were diverted to a wet meadow area via a buried pipe with a
