Burnt Bridge Creek

YEAR
4

in Vancouver, from Divine Road to Thunderbird Village

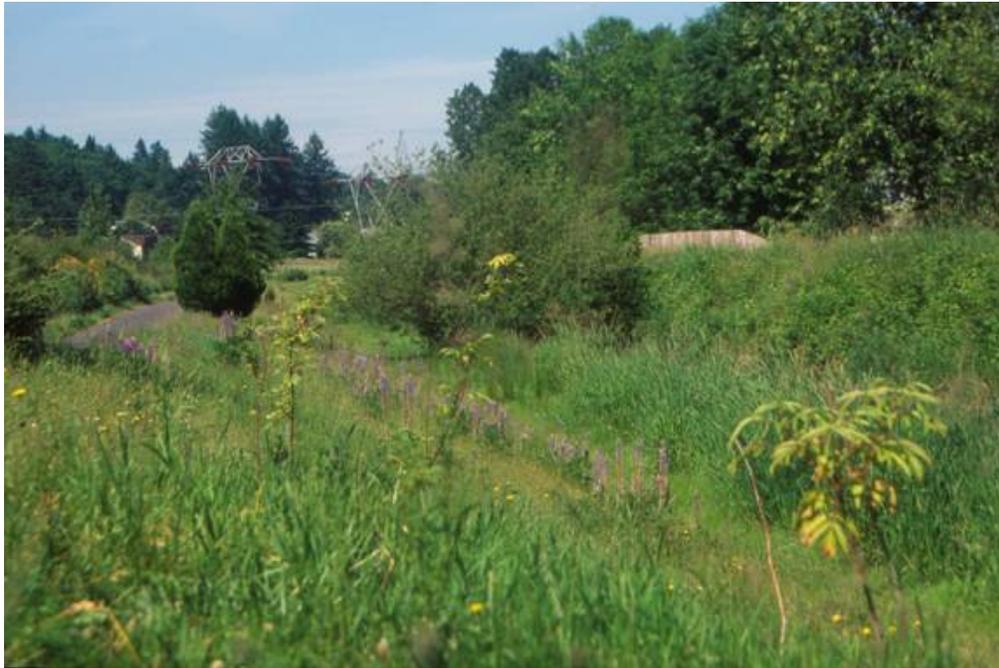
BEFORE

Lack of native riparian tree and shrub cover

The Burnt Bridge Creek Project was a collaborative effort between the City of Vancouver and Americorp's Vancouver Service Team. The scope of the project was to plant native shade trees throughout 4,500 yards of riparian habitat along Burnt Bridge Creek in order to reduce water temperature and increase the amount and diversity of habitat for fish and wildlife.

The restoration site was divided into three sections and western red cedars, Oregon ash, black cottonwood, elderberry, Douglas spirea, red osier dogwood, vine maple, Douglas fir, Pacific crabapple, western hazelnut, red flowering currant, and Indian plum were planted in October and November, 1995. A flood in December 1995, followed by a major flood event in 1996, wiped out 60% of all plants. A second planting took place in March and April 1996.
