Nofziger/Amberwood Park

YEAR
7

In Hillsboro, at 20900 NW Amberwood Drive, just west of NW 206th Ave.

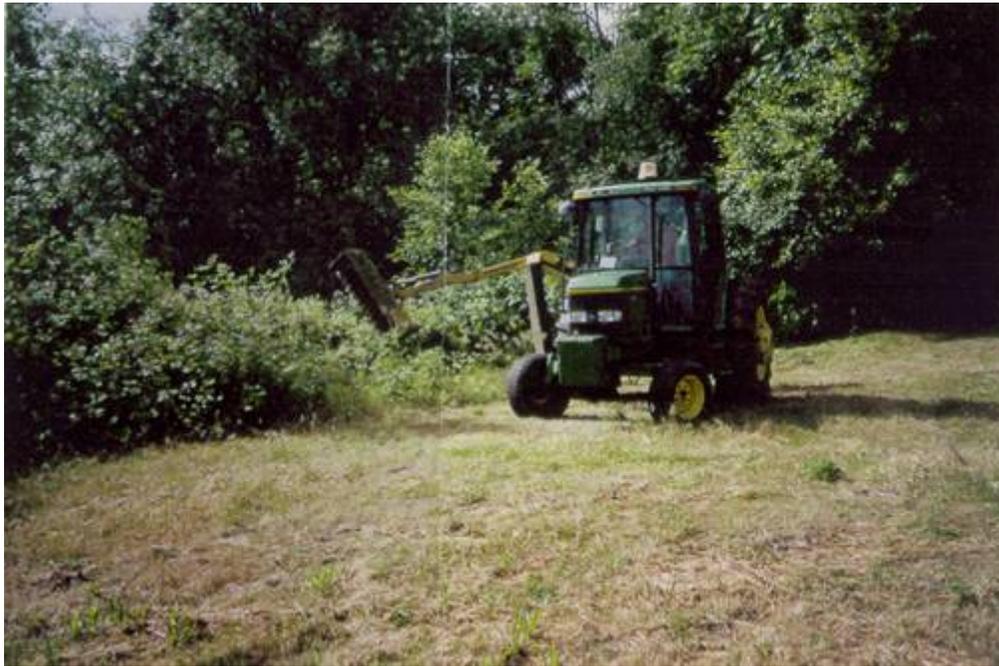
BEFORE

*Boom arm
mower helps
remove invasive
blackberry from
embankment*

In the first phase of the project, blackberries were removed from two areas to prepare them for planting: 1) a 120-foot by 30 foot thicket on an embankment separating the floodplain from upland areas, and 2) a 2/3-acre thicket on an open woodland (scattered tree canopy) on the east side of Rock Creek. Jute/coir erosion control fabric was then installed on the steepest sections of the embankment prior to planting. Crews planted and mulched native trees and shrubs in both areas. Non-woven weed block fabric squares were installed around plants to suppress growth of competing grasses and weeds around the plants.

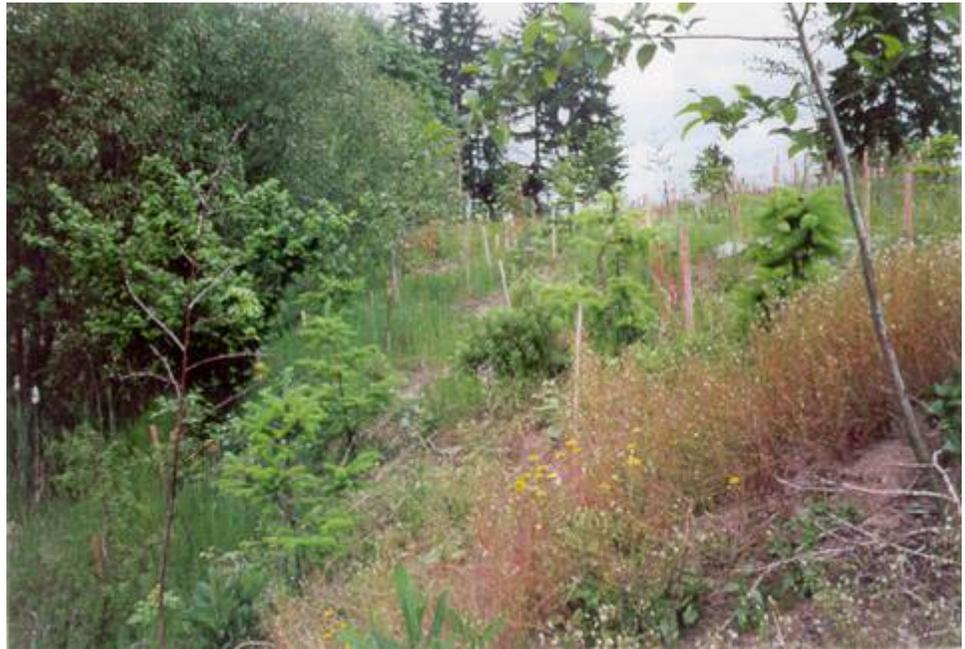
AFTER

*New growth of native
species enhances
habitat diversity and
cover*

In phase II, the riparian corridor was expanded by planting native trees and shrubs (red osier dogwood, red alder, Douglas fir, Oregon grape, salal, swordfern, etc.). This area had been cleared when a trunk sewer line was installed across the property many years prior. The resulting corridor consisted of a single layer of canopy trees along the stream with some sections having no trees at all. Formerly grazed, the rest of the corridor was an assortment of grasses, including pasture and reed canary grasses. Weed block fabric was installed around the base of most plantings to reduce future competition from the thick grasses. Mesh seedling tubes were placed around plants and short sections of drain pipe tubing were also installed around the base of plants to protect against damage by string trimmers.
