Return to the Blue Pacific

Jackson Creek Restoration

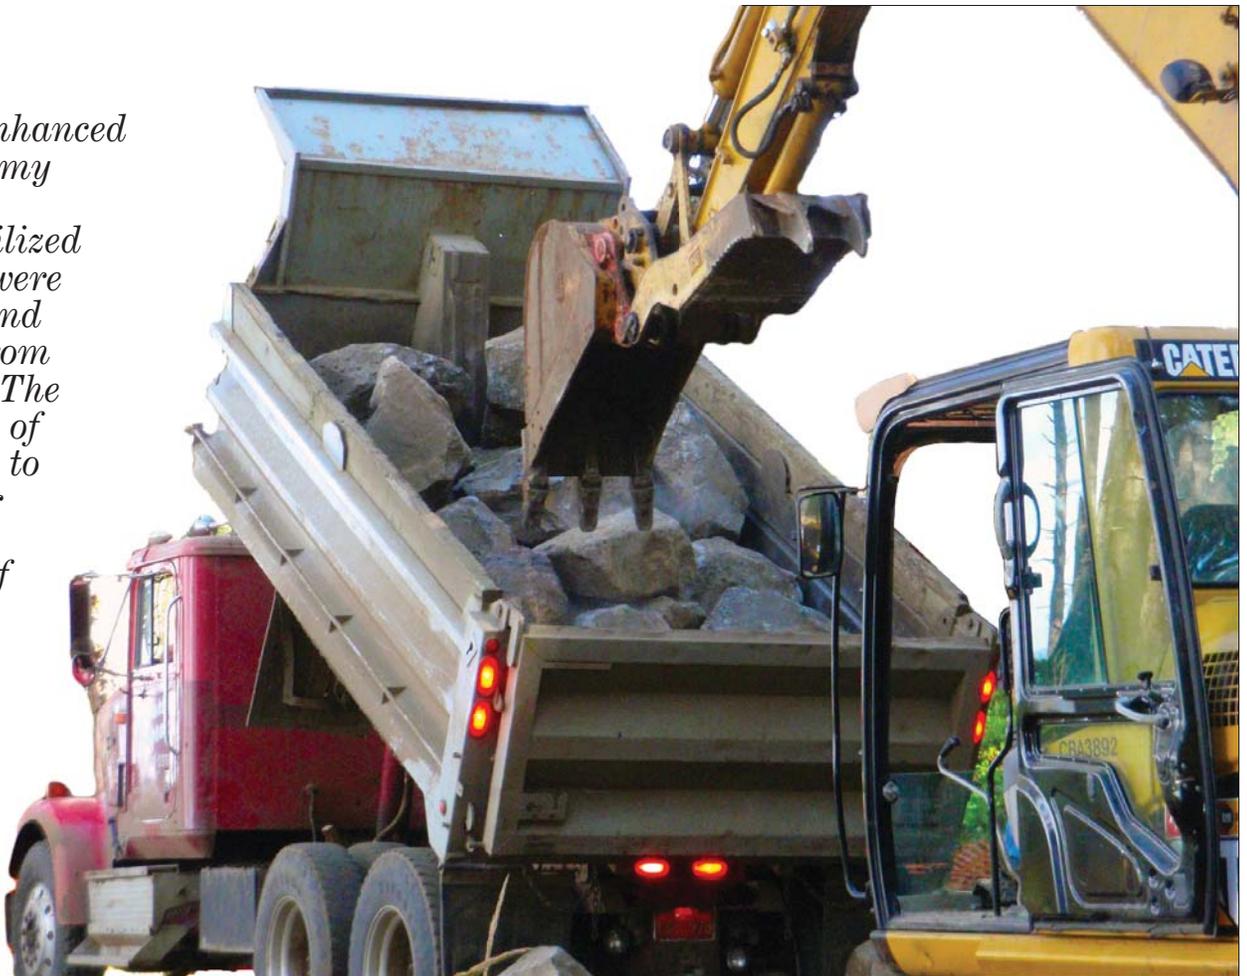
Boulders were trucked in for reconstruction of the Jackson Creek channel

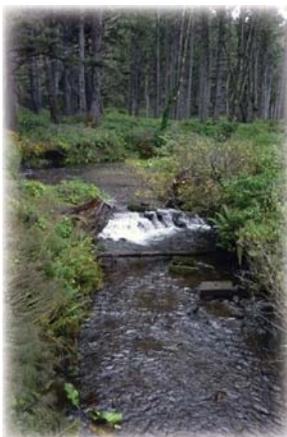
The ford prior to restoration

The U.S. Fish and Wildlife Service and our partners decided flow should be restored to the original channel, helping salmon and the area's campers. We conceived the project to also address two other fish passage issues: 1) the park's water intake, which uses Jackson Creek as its source, was oversized and insufficiently screened, and 2) a cement ford located near the ocean

entrance was a partial barrier to fish passage.

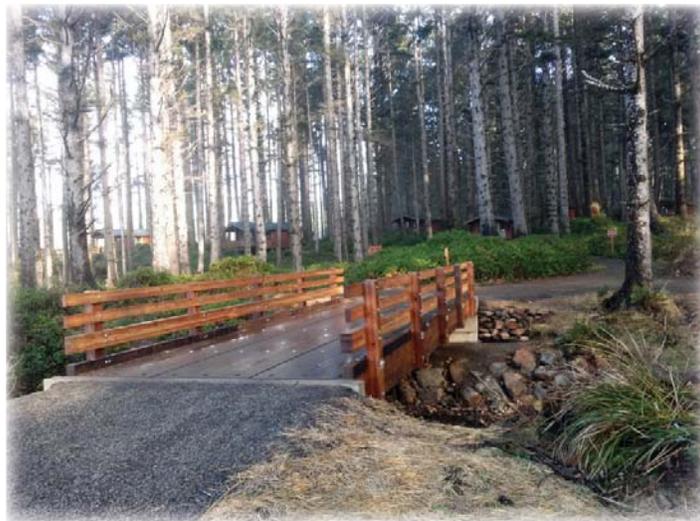
The newly built bridge provides easy access to facilities for visitors, as well as good passage for salmon

flow to Netarts Bay, remove and replace the existing water diversion with an appropriately sized and screened intake, remove the ford, re-grade the lower channel to provide full fish passage, and replace the ford with a bridge for park access.

We improved park infrastructure with the new water intake as well as the access bridge replacing the ford. Since the project is visible to
