Final Fish and Wildlife Coordination Act Report Upper Susquehanna Comprehensive Flood Damage Reduction Study

Prepared For: U.S. Army Corps of Engineers

Prepared By: Department of the Interior U.S. Fish and Wildlife Service New York Field Office Cortland, New York

February 2019

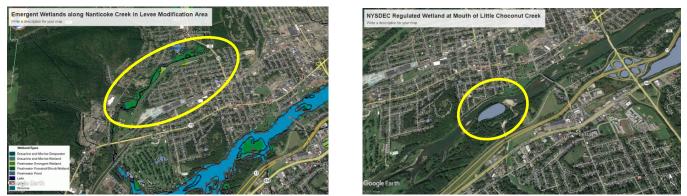
Figure 8. EJV Flood Risk Area -Wetlands Nanticoke Creek (left) & Choconut Creek (right)

Raising levees may have some environmental impacts if the base of the levee would need to be widened, potentially impacting riparian habitat within the footprint. Raising levees and floodwalls also increases flood peak flow, which can exacerbate flooding upstream and downstream. Replacing existing floodwalls and levees would create temporary disturbance, but long-term impacts would be no greater than those caused by the original levee or floodwall. Clearing, snagging, and shoal removal of ~ 66 acres of the Susquehanna River would negatively impact fish and wildlife resources, as described above. There are a few emergent wetlands along this reach of the Susquehanna River that may be adversely affected by the proposed levee modifications if the levee footprint is increased (Figure 8).
