ATTACHMENT 3.0
KARST MITIGATION PLAN

Mountain Valley Pipeline

DAA Project Number: B14188B-01

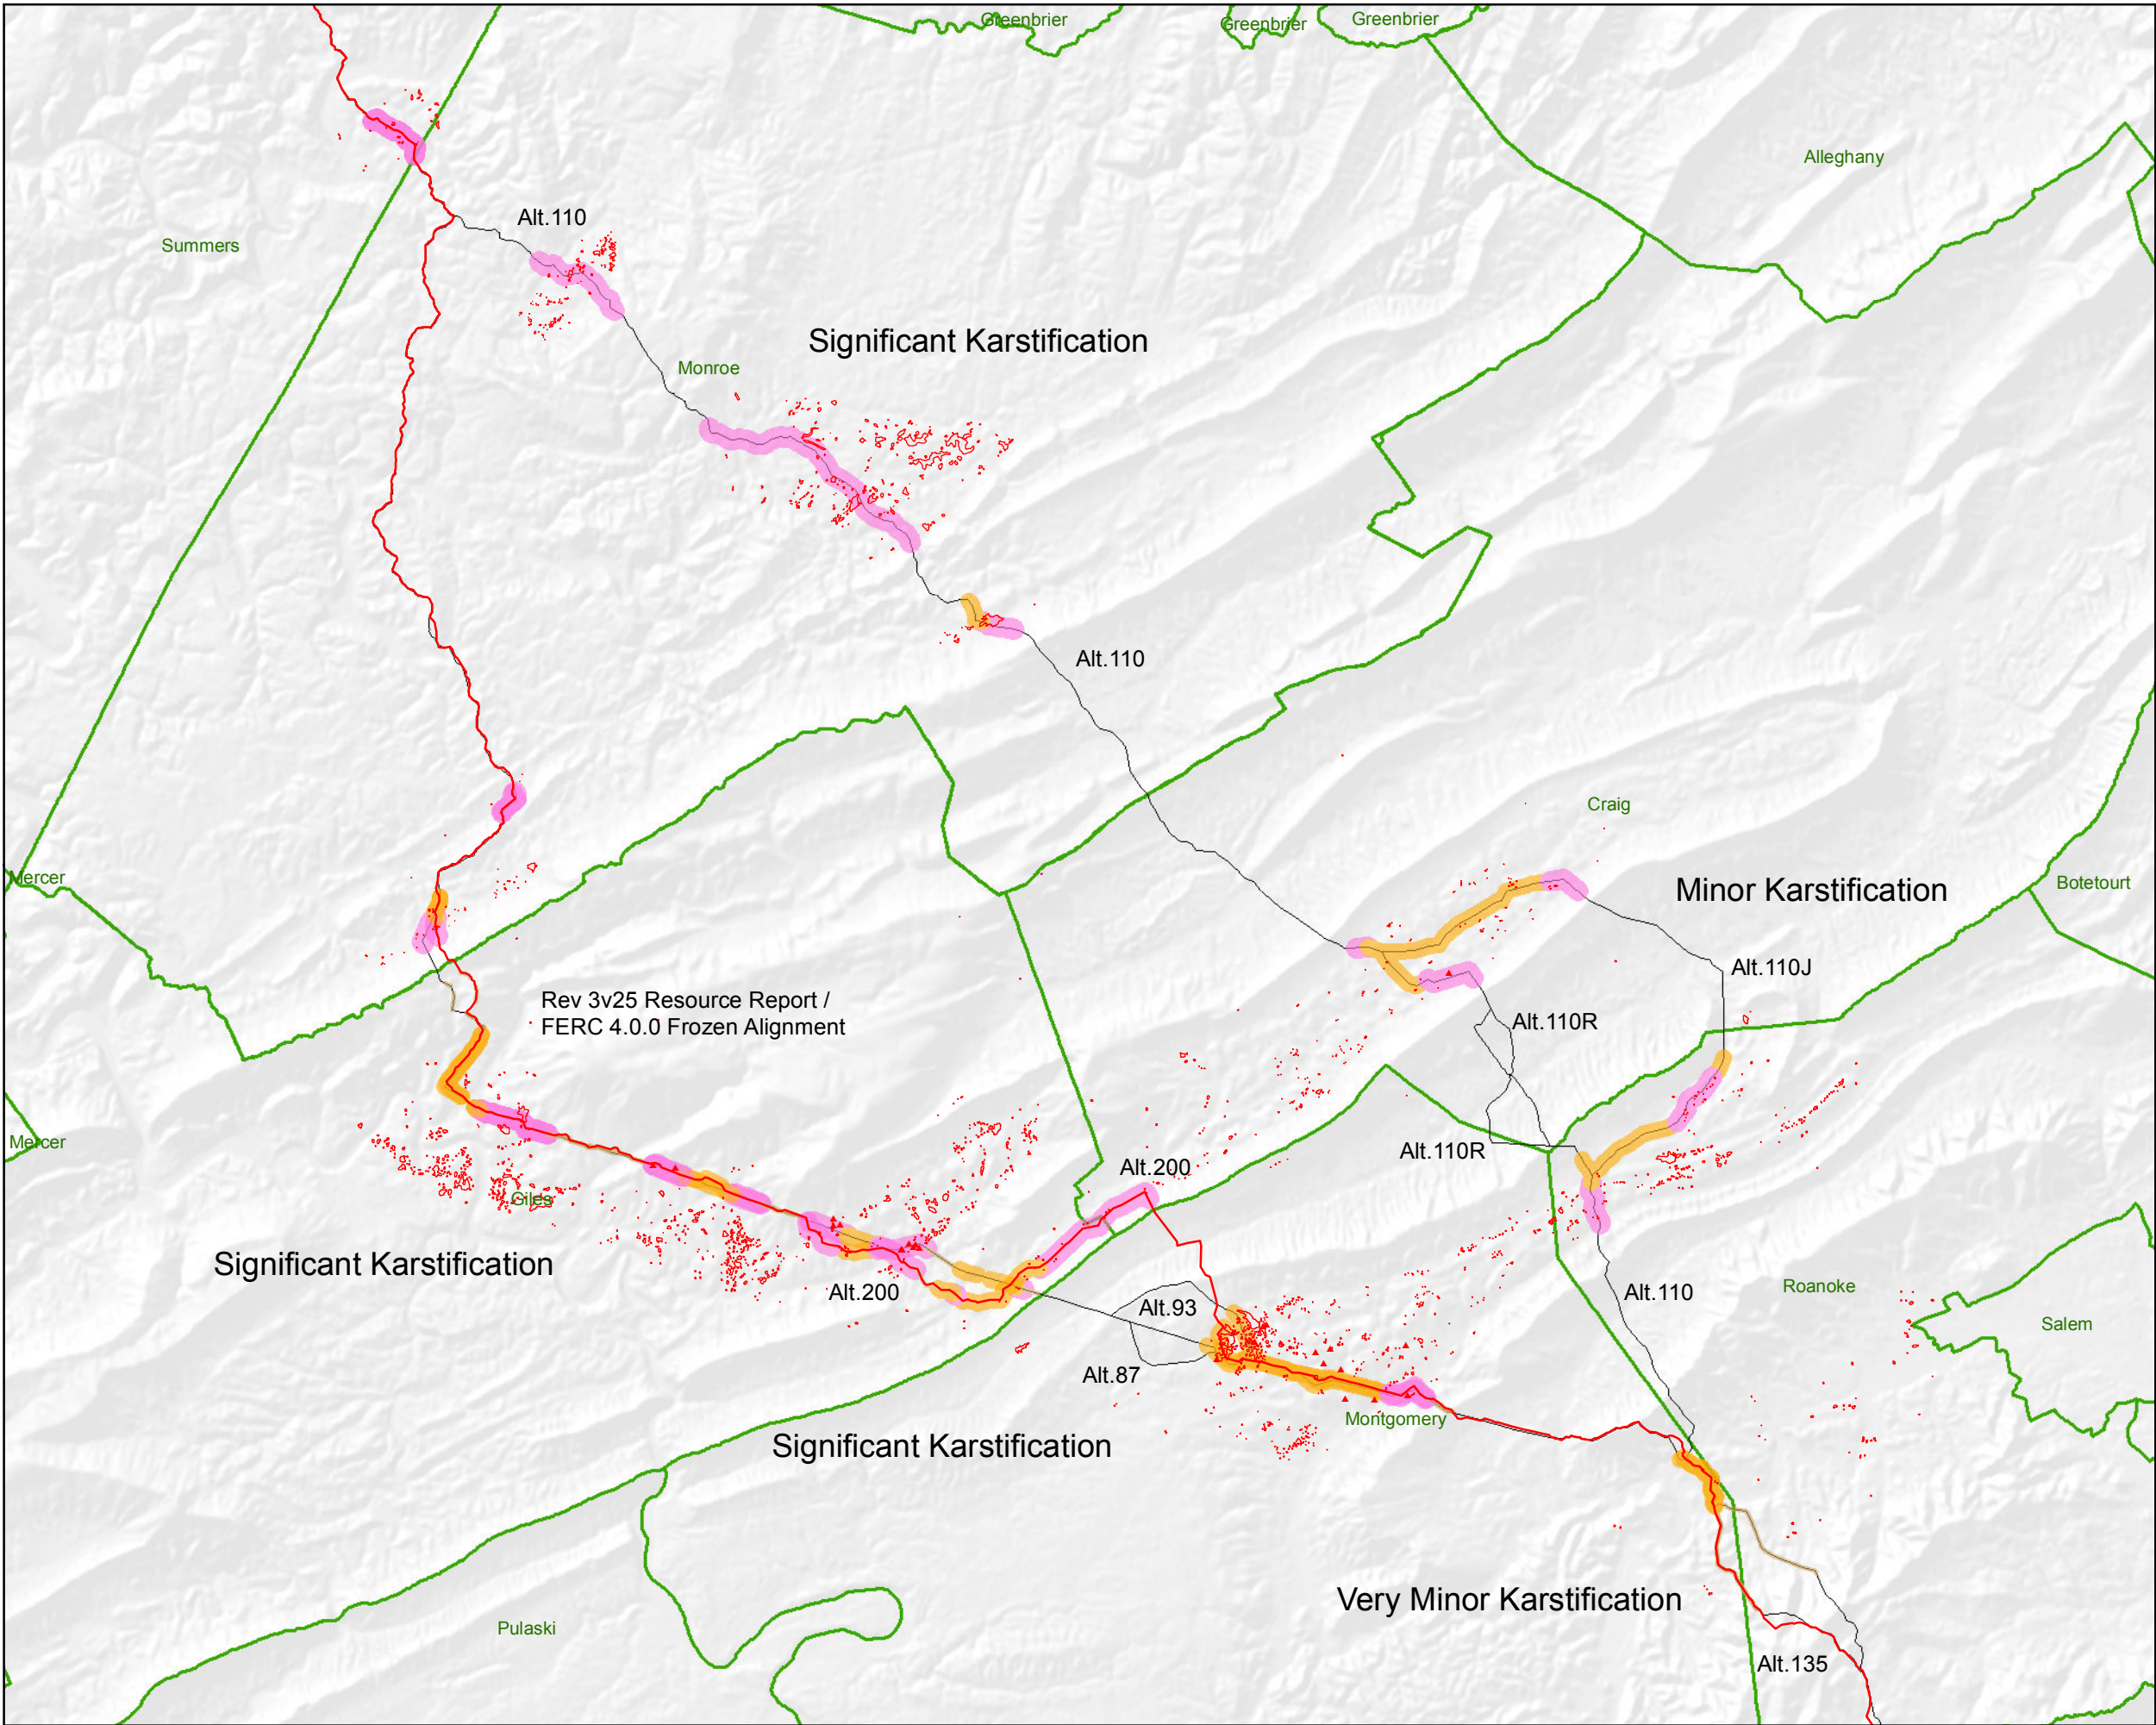
FIGURE NUMBER 3.1
Karst Zones

Karst Regions adapted from 1968 Geological Map of West Virginia. 1:250,000. West Virginia Geological and Economic Survey.
Digital Representation of the 1993 Geologic Map of Virginia; 1:500,000
U.S. Geological Survey, 2003; (Virginia Division of Mineral Resources Publication 174)
Geologic Map of Giles County, Virginia, 1986. Ed. E.K.Rader and T.M.Gathright II

The most prevalent type of karst feature observed at the ground surface along the proposed MVP alignment in karst terrain (**Figure 3.1**) are sinkholes. Sinkholes fall into two broad categories, termed “vault-collapse” sinkholes, or “cover-collapse” sinkholes. Vault-collapse type sinkholes (i.e., where a cavern “vault” or roof has failed catastrophically) are relatively rare in karst terrain along the proposed MVP alignment. However, cover-collapse type sinkholes are more commonly observed.

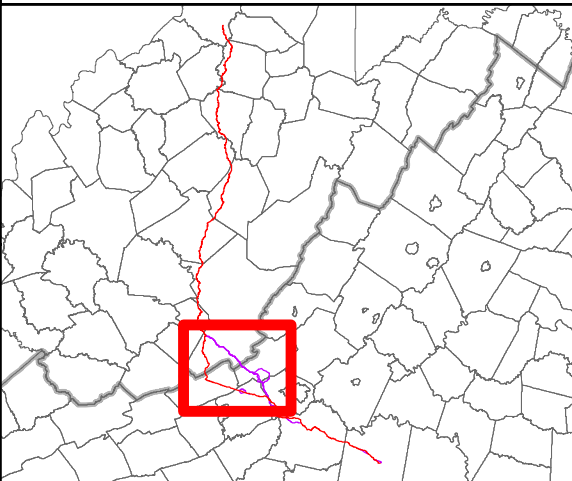
- Sinkholes in Proximity
- Limestone
- Dolomite
- Minor Carbonates
- MVP Ferc 4_0_0 Frozen Alignment
- MVP Alternate Routes
- MVP_Rev3v25_Resource_Reports
