June 21, 2017

Re: United States Forest Service letter Comments  
on the Hydrological Analysis of Sedimentation dated April 25, 2017  
OEP/DG2E/Gas3  
Mountain Valley Pipeline, LLC  
Docket No. CP16-10-000

Scientific Investigations Report 2009–5085

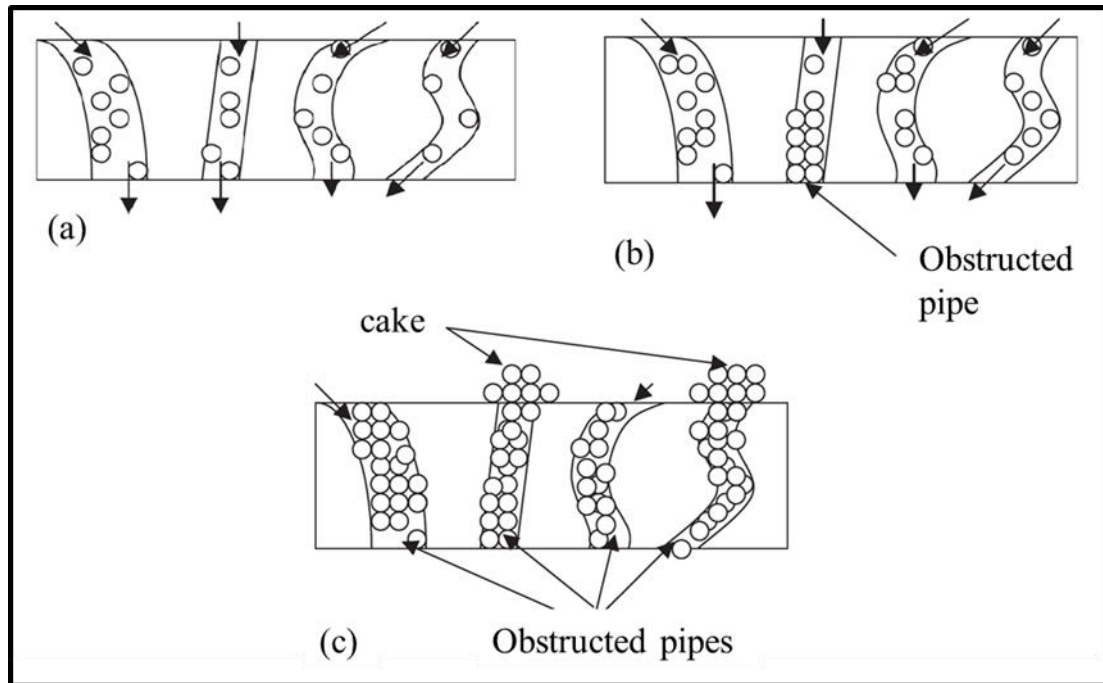
FIGURE 1 MECHANISM OF PARTICLE ACCUMULATION: (A) ALL PIPES ARE OPENED (SERIES FILTRATION), (B) FEW PIPES ARE OBSTRUCTED (SERIES AND PARALLEL FILTRATION), (C) FILTER CAKE FORMATION ABOVE COMPLETELY OBSTRUCTED PIPES (FAURE ET AL. 2006)

As particles continue to be filtered by the fabric, the impinged particles reduce the pore sizes of the pipes. The reduction in pore size limits the ease with which water can flow through the fabric and also increases the filtration ability of the fabric. These mechanism are discussed in more detail in the following sections.

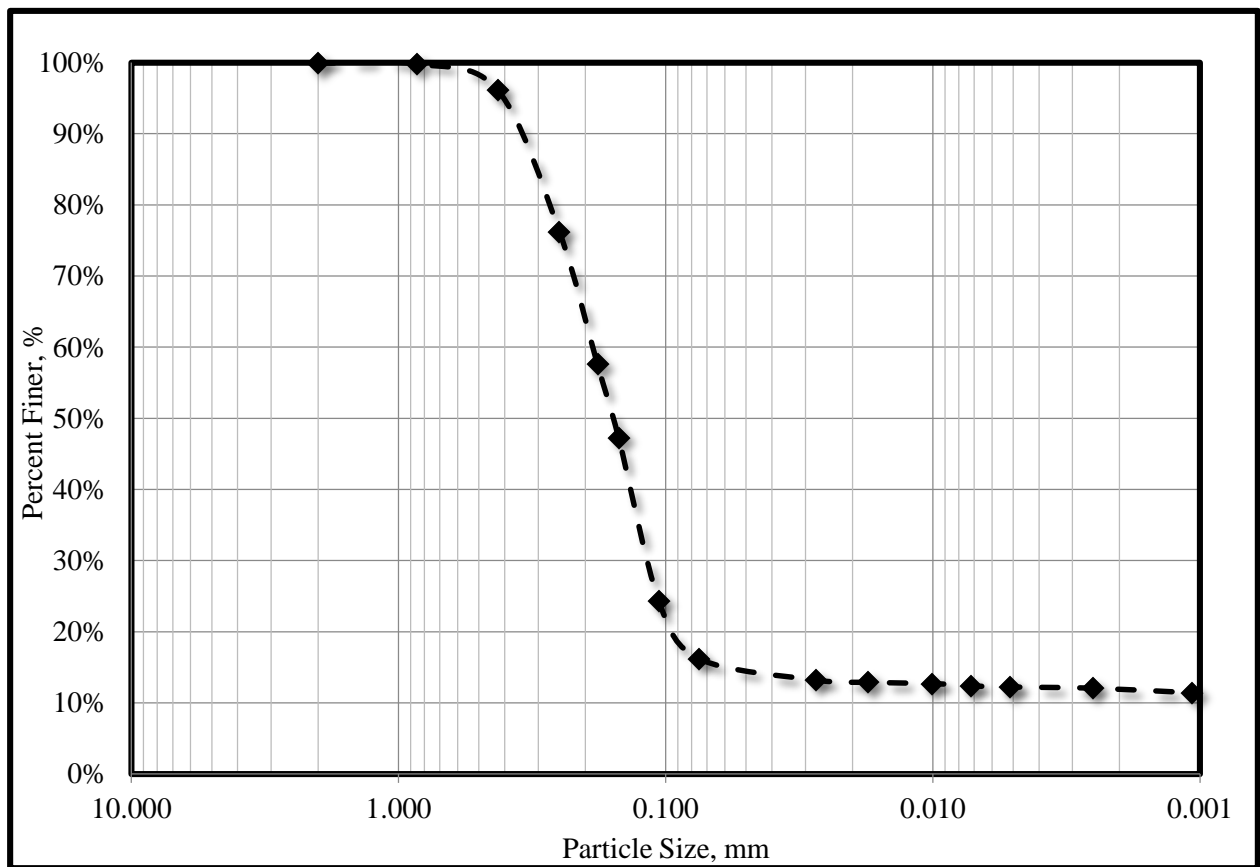
FIGURE 2 PARTICLE SIZE DISTRIBUTION CURVE

The results for material finer than  $75\ \mu\text{m}$  by washing, sieve for fine and coarse aggregates, and particle size analysis using hydrometer are shown in Table 21, Table 22 and Table 23, respectively, of Appendix A. A summary of these results and the particle-size distribution curve for this soil are also shown in Table 2 and Figure 2, respectively.

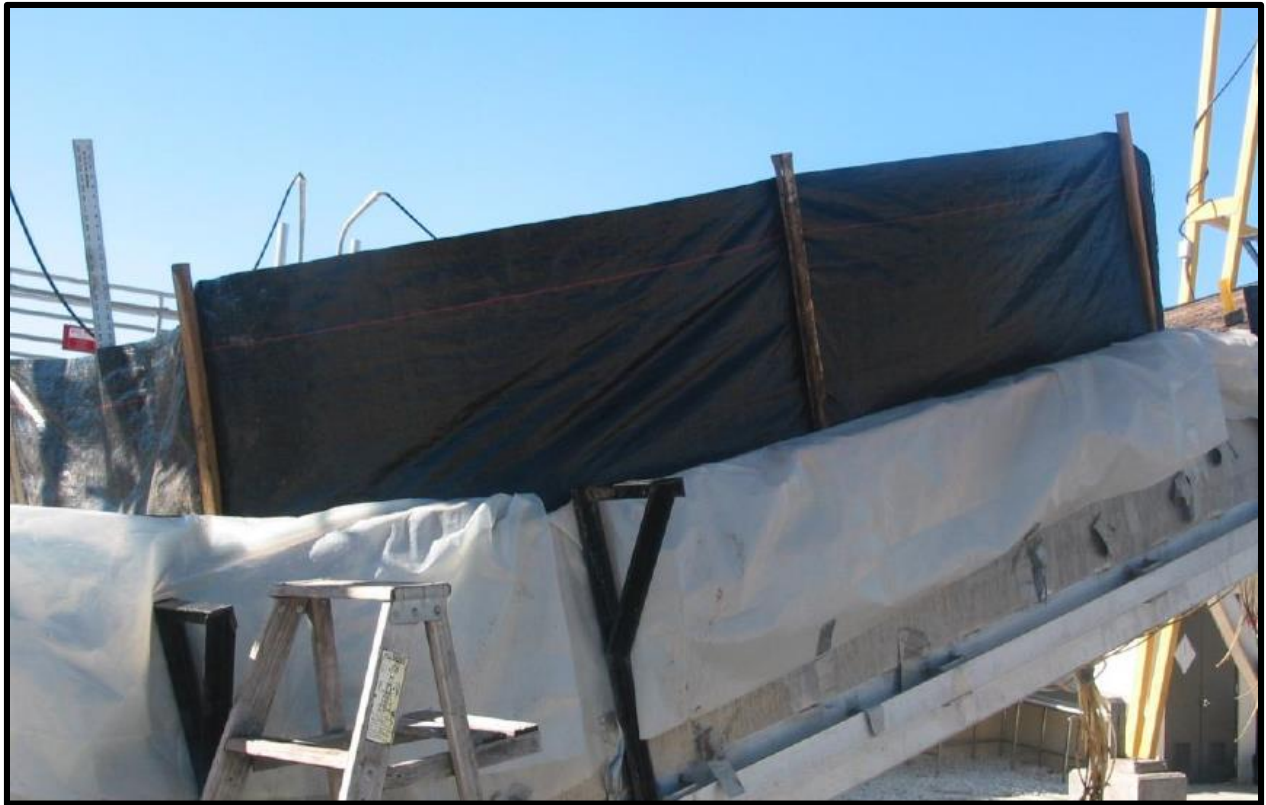
FIGURE 3 WOVEN (ASR 1400) SILT FENCE INSTALLED ON A TILTED TEST BED (GOGO-ABITE 2012)

Two silt fence fabrics were evaluated in this study. The first silt fence is a woven monofilament geosynthetic which was donated by Absolute Erosion Control, Incorporated and is referred to as an ASR 1400 silt fence. This woven fabric is shown in Figure 3.

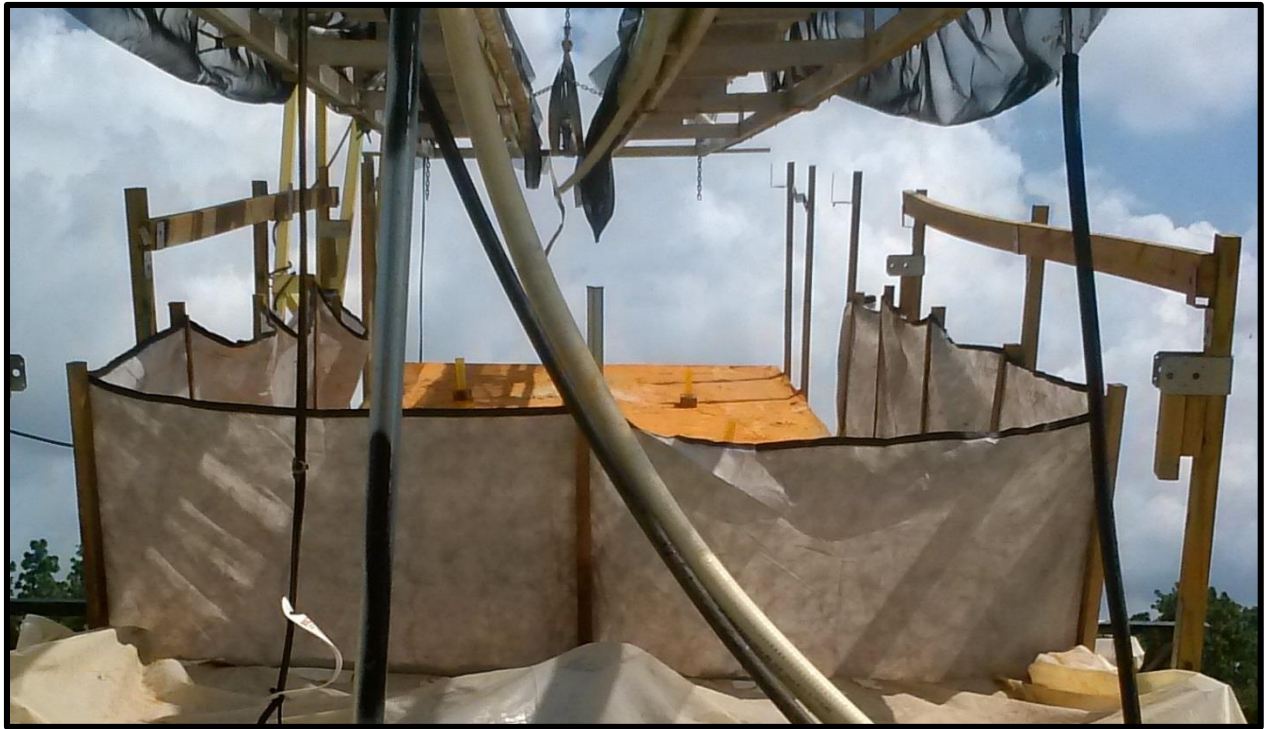
FIGURE 4 NONWOVEN (BSRF) SILT FENCE INSTALLED ON A TILTED TEST BED

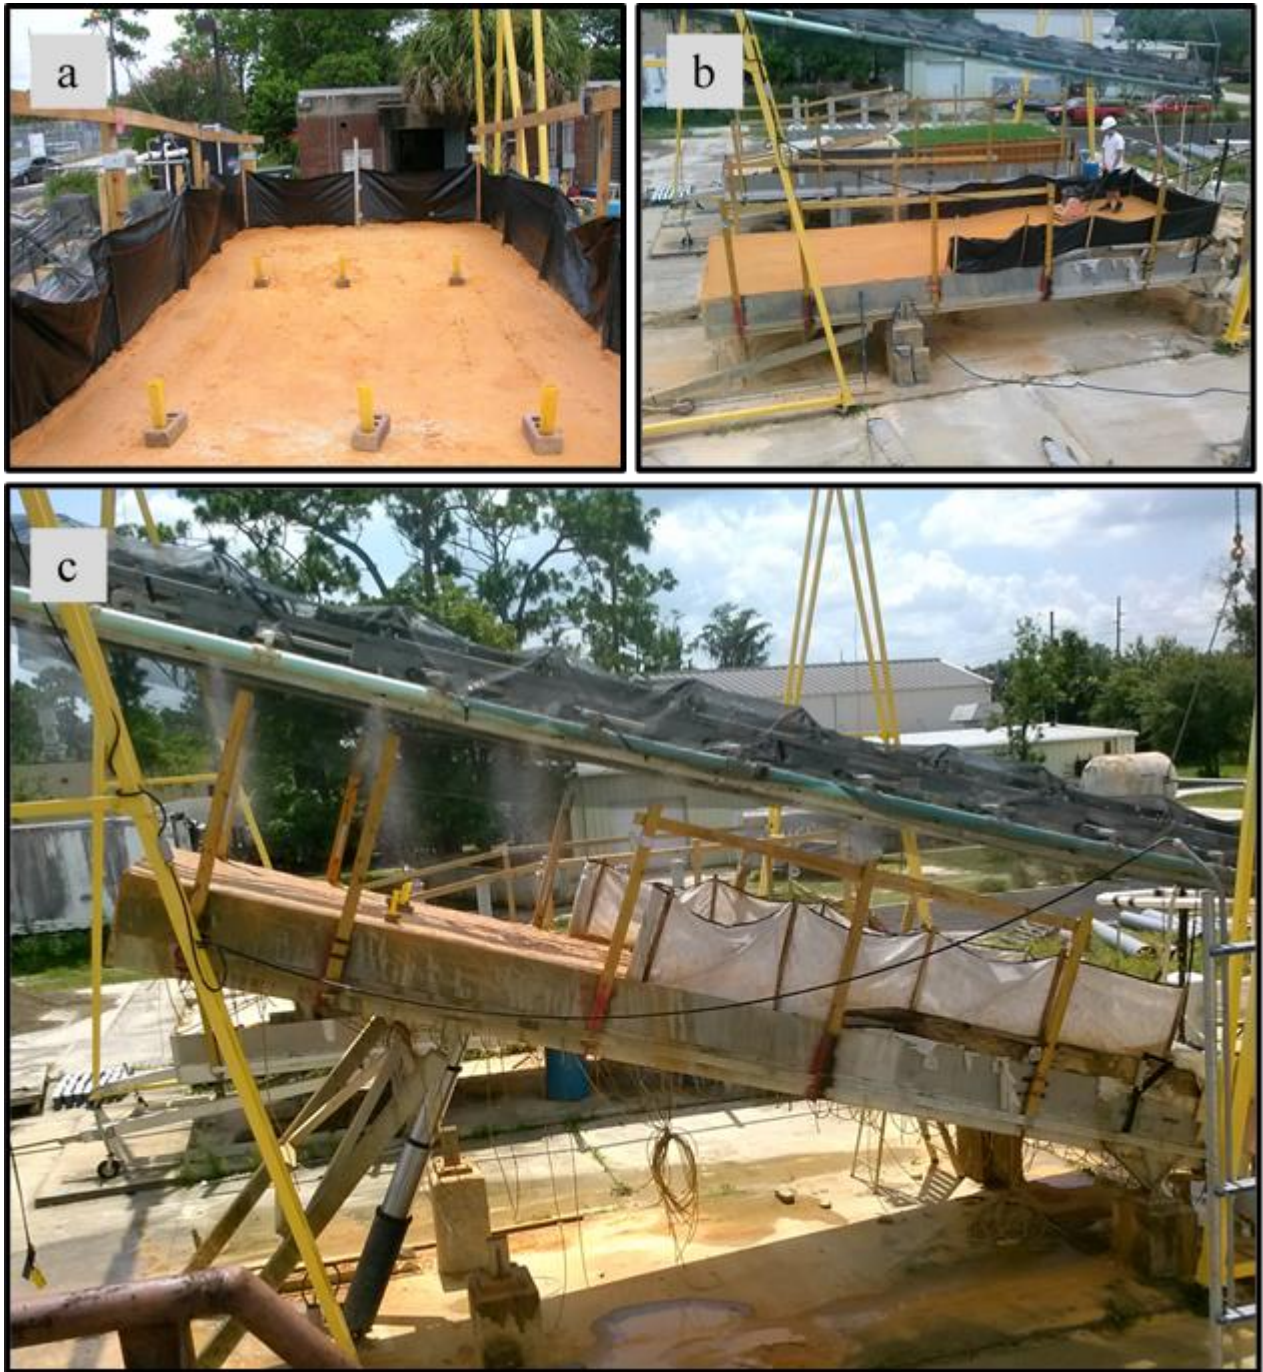
FIGURE 6 TEST BED SETUP (A) WOVEN FABRIC, RAIN GAGES, AND METER STICK INSTALLED, (B) TEST BED COMPACTION, (C) RAINFALL SIMULATOR AND TILTED TEST BED WITH NONWOVEN FABRIC INSTALLED

For this reason, 80 percent soil compaction was chosen. After test bed soil compaction, rain gages were placed on the test bed in order to measure the rainfall intensity over the test bed, and a meter stick was installed at the face of the silt fence in order to measure the ponding depth of water behind the fence (Figure 6a). The test bed was then raised to the proper embankment slope and the rainfall simulator was placed over the tilted test bed (Figure 6c).

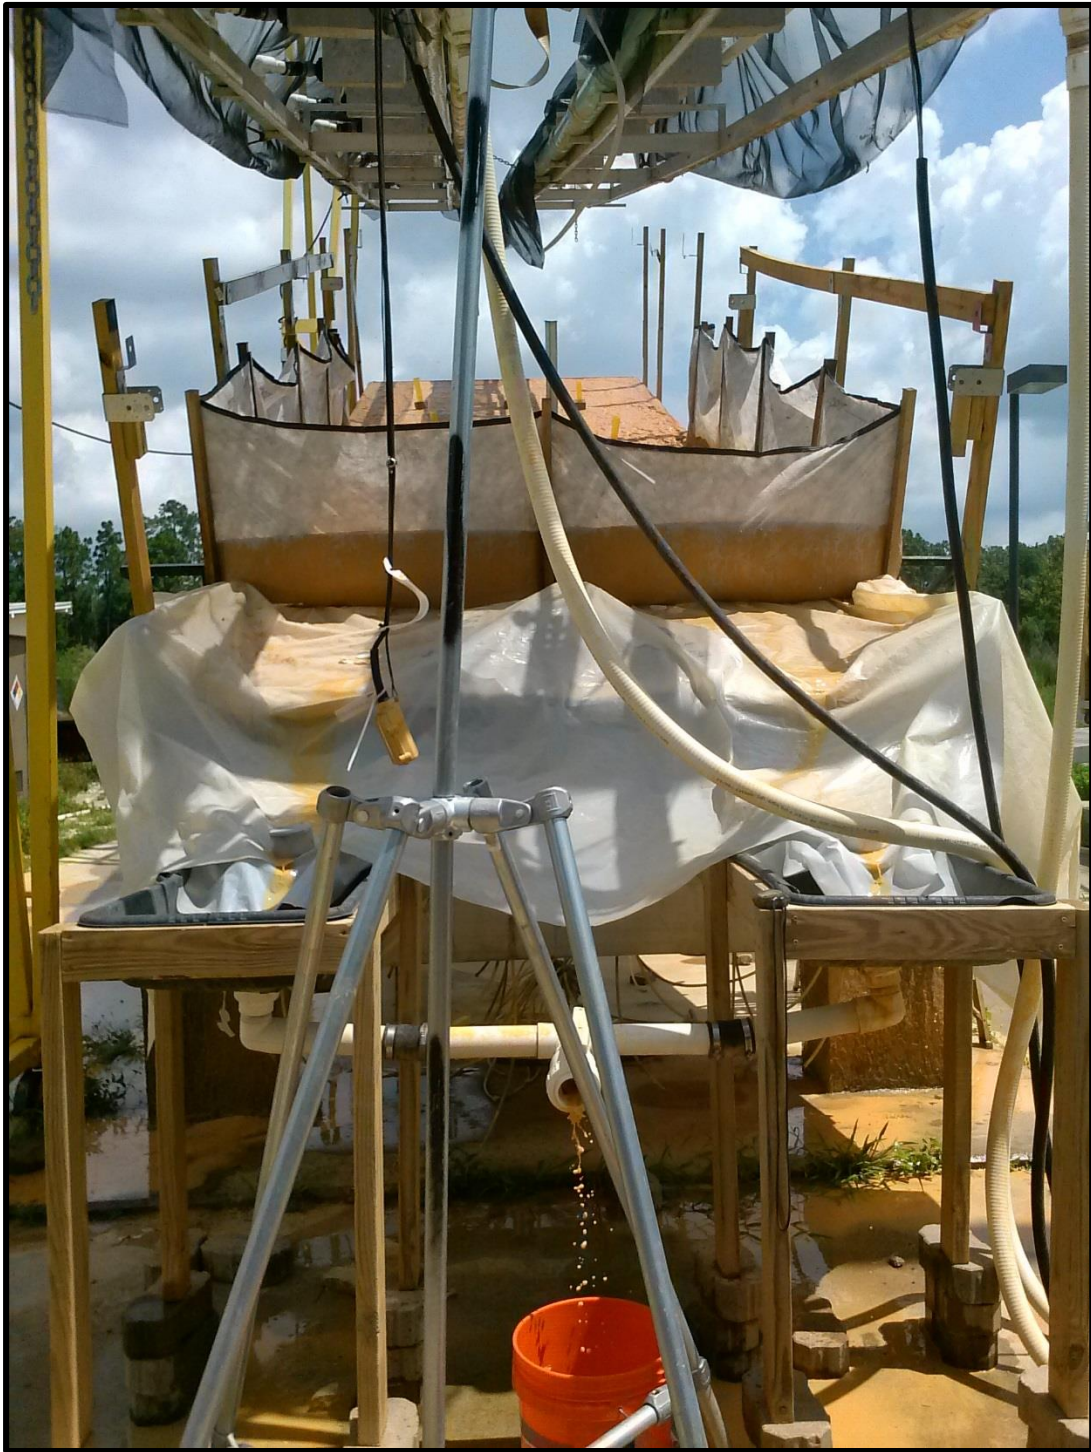
FIGURE 8 FIELD SCALE TESTING: DOWNSTREAM COLLECTION SYSTEM

Figure 8 shows the downstream collection system used during testing. Runoff water flowed through the silt fence and over a white visqueen where the runoff water was channeled into two separate troughs. Water then flowed through each trough and into a white PVC pipe that connected both troughs. The water then exited the PVC pipe and flowed into a bucket as shown in Figure 8. The bucket was changed every minute and the mass of water that flowed through the fence in that one-minute interval was recorded. In addition, a grab sample was taken from the bucket as well as upstream of the silt fence every five minutes as discussed previously. The upstream sample was taken from the middle of the ponding water depth and close to the silt fence.

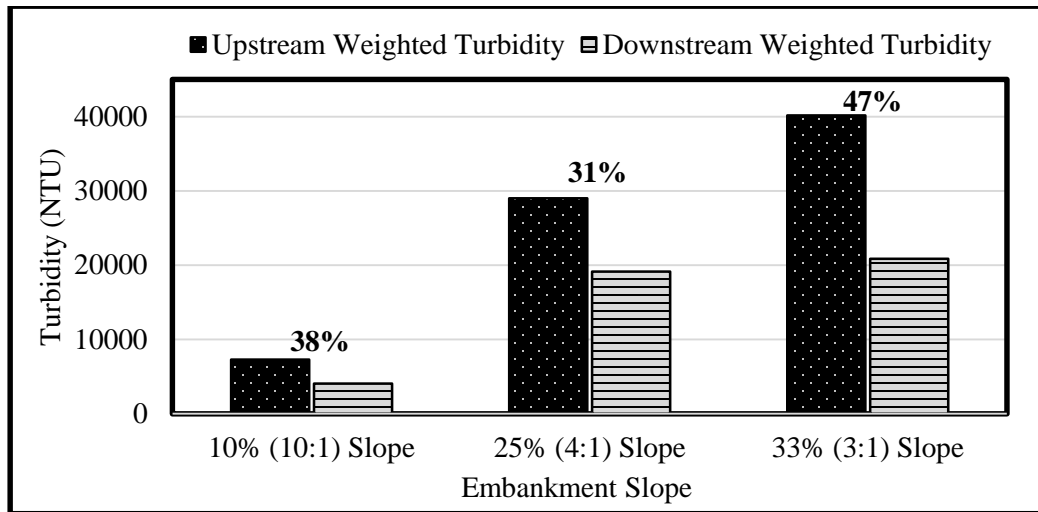
FIGURE 9 WOVEN FABRIC VOLUME-WEIGHTED MEAN TURBIDITY PERFORMANCE EFFICIENCY WITH EMBANKMENT SLOPE

Results showed that during rainfall, the woven fabric had 40 and 39 percent turbidity and SSC performance efficiencies, respectively, for all embankment slopes and rainfall intensities. Statistical analysis shows however that the efficiency values of both turbidity and SSC were significantly different when compared on different embankment slopes as shown in Table 32 of Appendix B. The changes in the turbidity and SSC performance efficiency with changes in slope are shown graphically in Figure 9 and FIGURE 10, respectively.

Shown directly above both bars on each embankment slope is the average performance efficiency on the respective embankment slope. The highest mean performance efficiency occurred on the 33 percent embankment slope and the lowest efficiency occurred on the 25 percent slope.

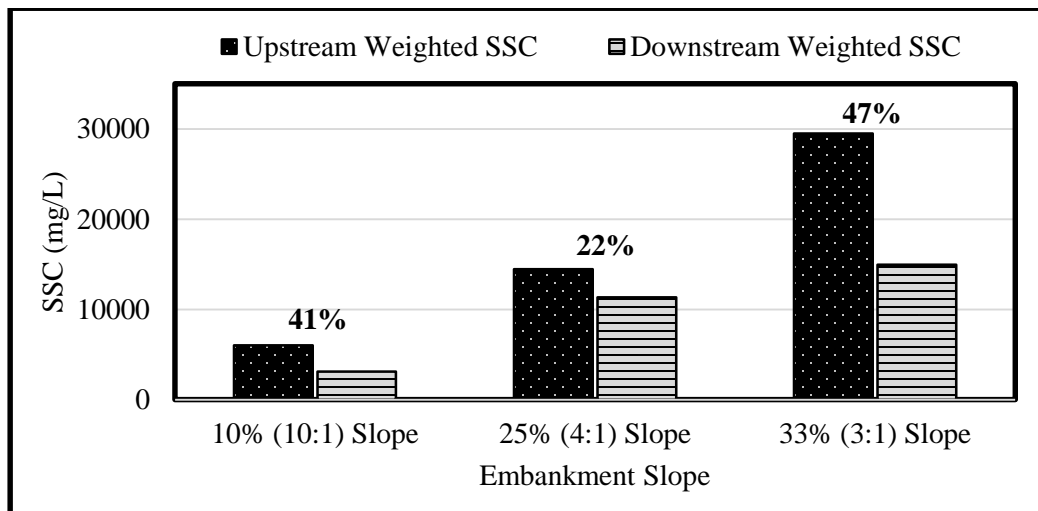
FIGURE 10 WOVEN FABRIC VOLUME-WEIGHTED MEAN SSC PERFORMANCE EFFICIENCY WITH EMBANKMENT SLOPE

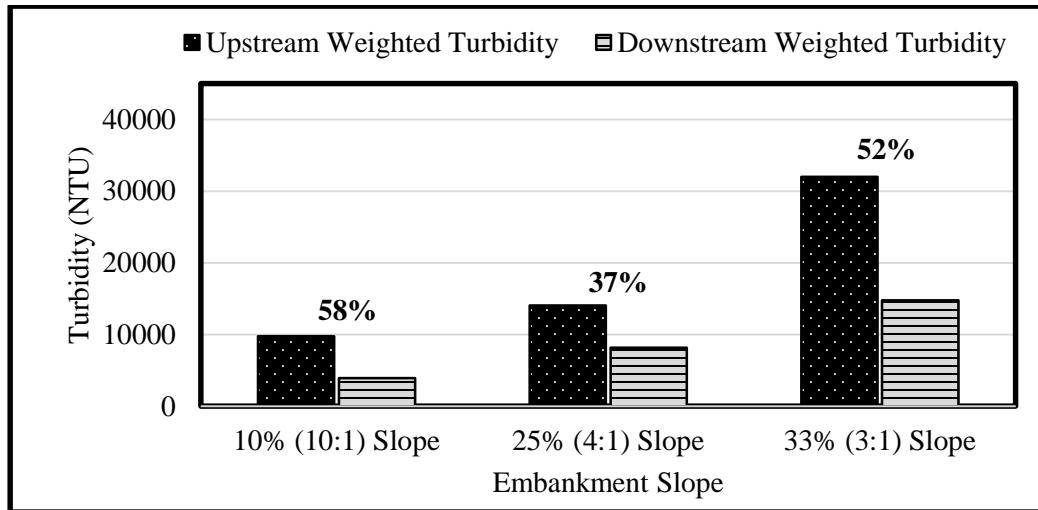
FIGURE 11 NONWOVEN FABRIC VOLUME-WEIGHTED MEAN TURBIDITY PERFORMANCE EFFICIENCY WITH EMBANKMENT SLOPE

the nonwoven fabric as shown in Table 33 of Appendix B showed that the efficiency values of both turbidity and SSC were significantly different when compared on different embankment slopes. The changes in the turbidity and SSC performance efficiency with changes in slope are shown in Figure 11 and FIGURE 12, respectively.

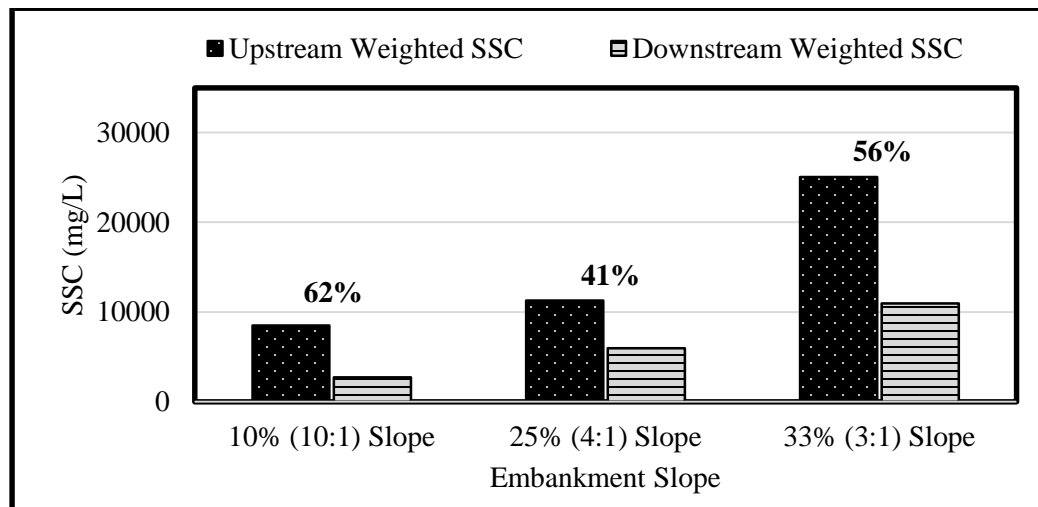
FIGURE 12 NONWOVEN FABRIC VOLUME-WEIGHTED MEAN SSC PERFORMANCE EFFICIENCY WITH EMBANKMENT SLOPE

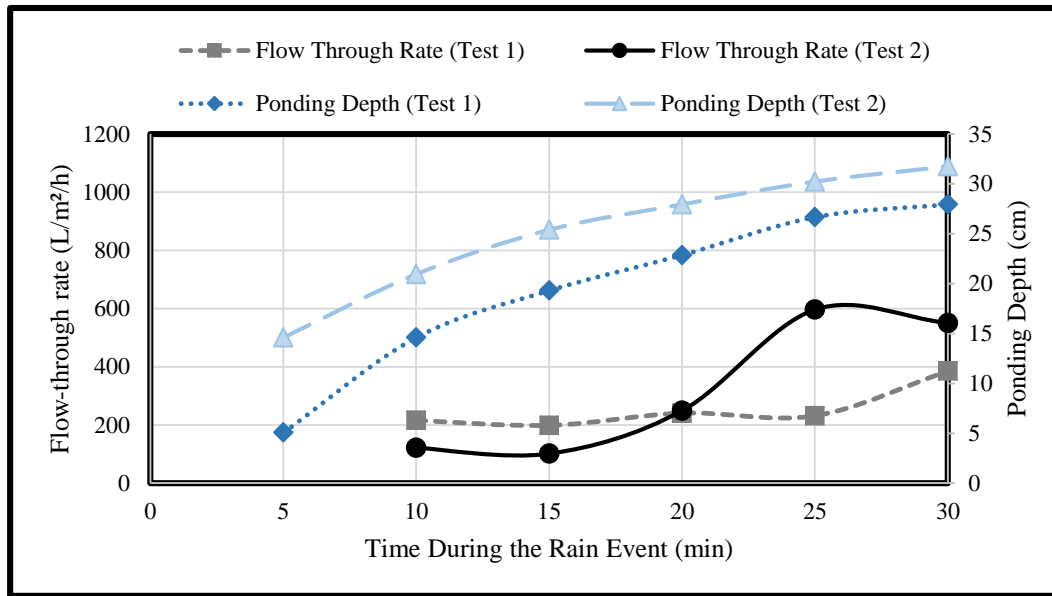
FIGURE 14 NONWOVEN FABRIC CHANGE IN FLOW RATE WITH CHANGE IN PONDING DEPTH BETWEEN TEST 1 AND TEST 2 ON A 33 PERCENT SLOPE

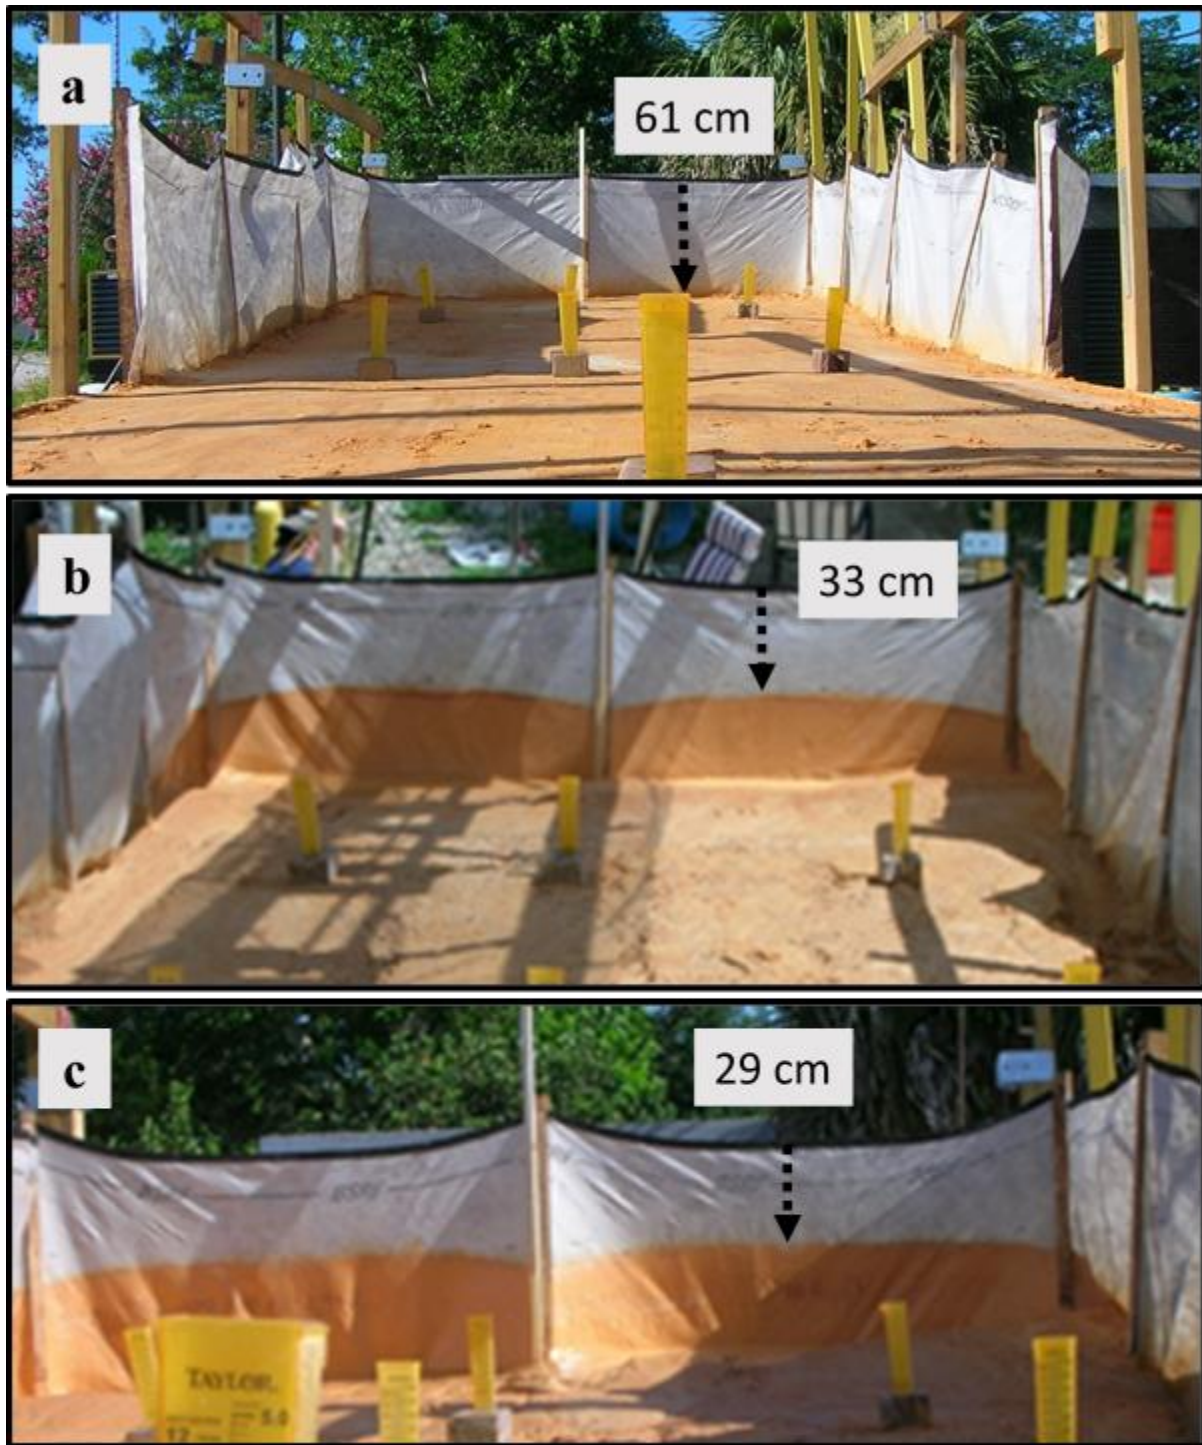
FIGURE 15 FILTER CAKE FORMATION ON NONWOVEN (A) UNTESTED FABRIC (B) CAKE FORMATION AFTER COMPLETION OF TEST 1 (C) CAKE FORMATION AFTER COMPLETION OF TEST

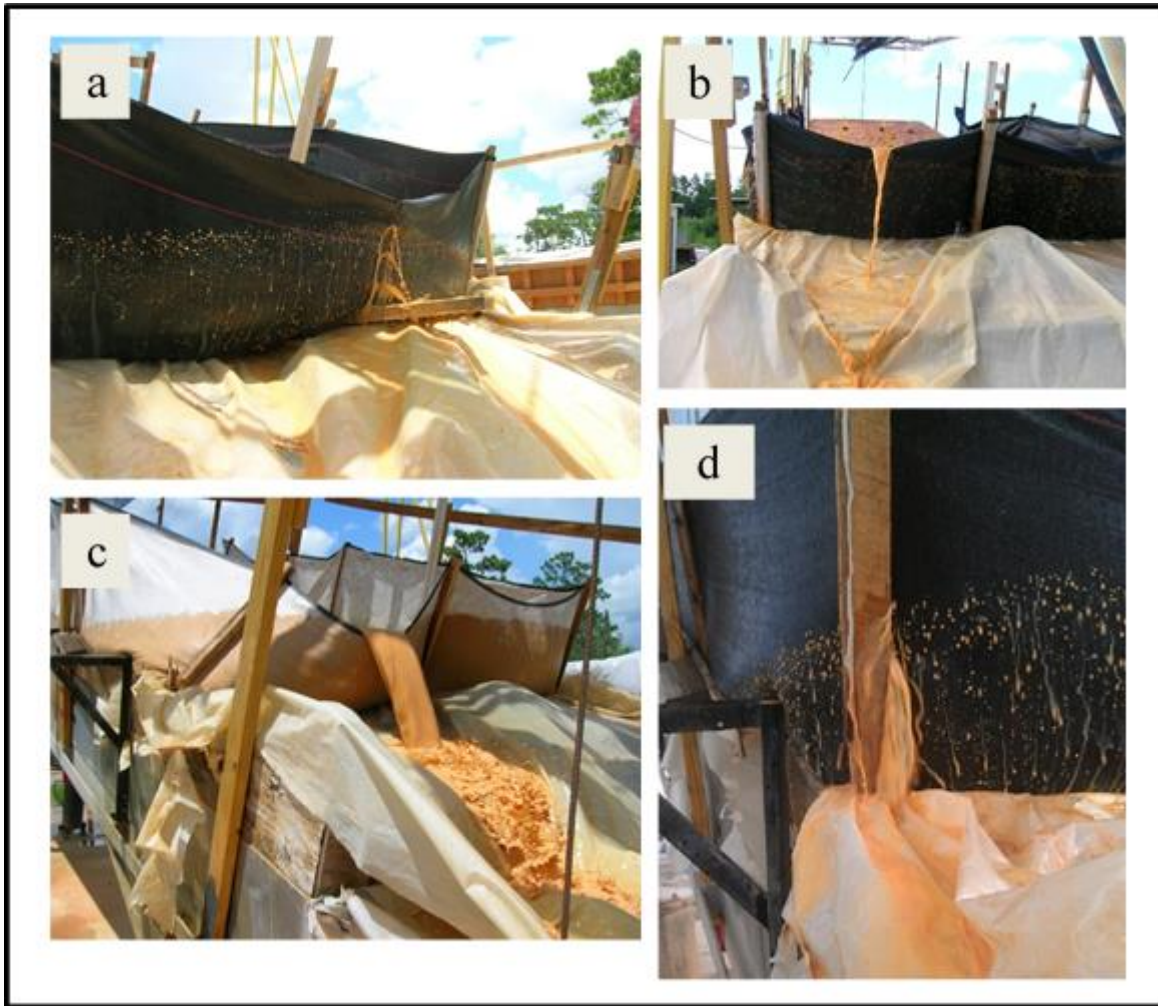
FIGURE 16 SILT FENCE FAILURES: (A) PULLOUT OF FABRIC FROM MIDDLE STAKE ON 33% SLOPE (B) OVERTOPPING ON 33% SLOPE (C) CORNER STAKE FAILURE ON 33% SLOPE (D) CORNER STAKE TEAR ON 25% SLOPE

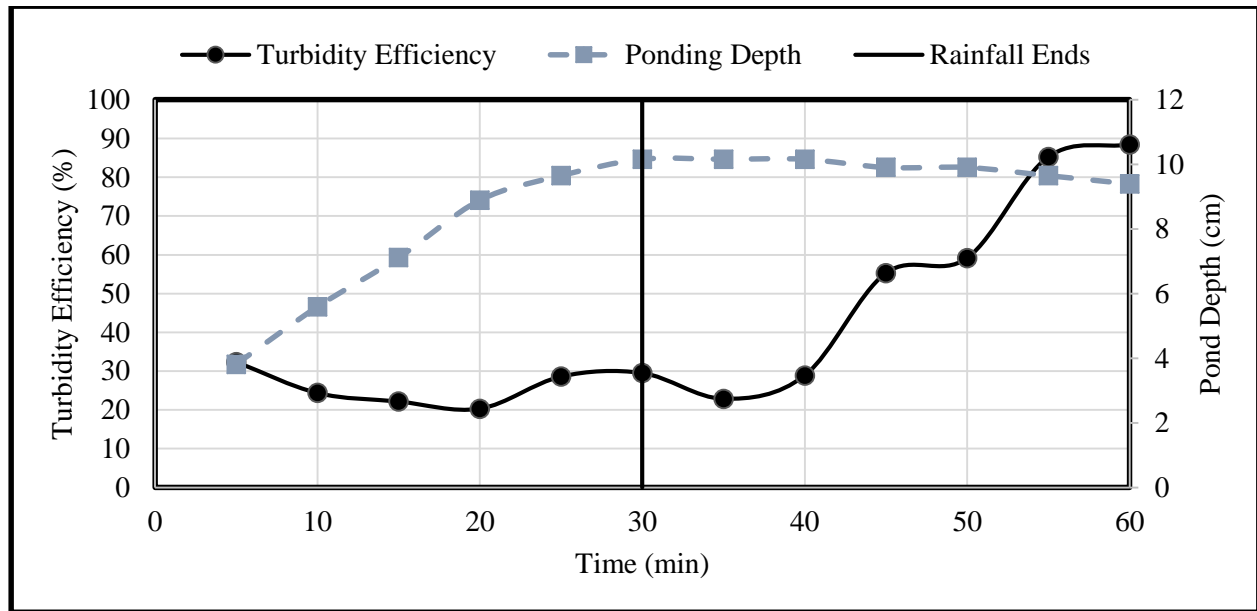
FIGURE 18 WOVEN FABRIC TIME DEPENDENT EFFICIENCY VALUES AND PONDING DEPTH ON 25 PERCENT SLOPE AND 25 MM/H RAINFALL INTENSITY

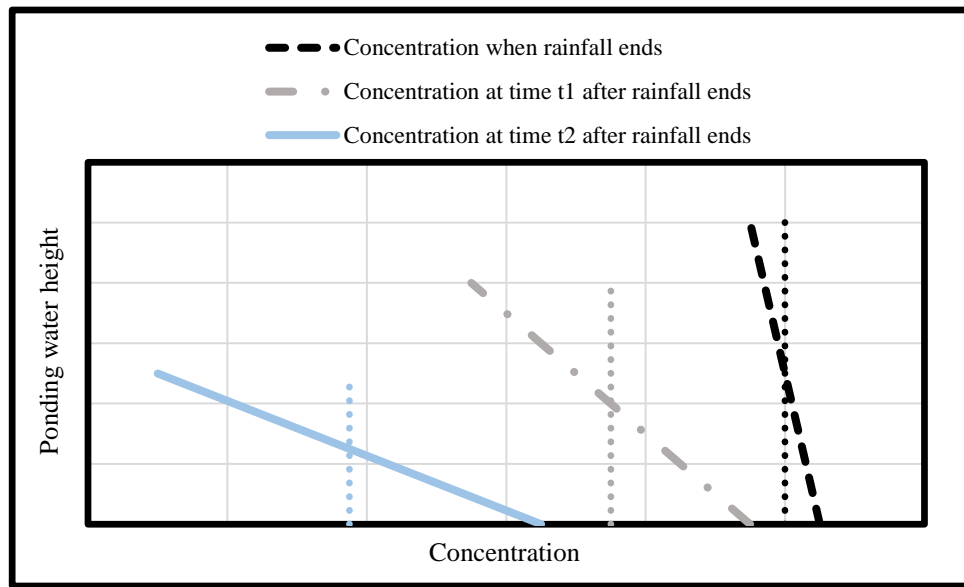
FIGURE 19 CONCEPTUAL EXAMPLE OF HOW CONCENTRATION GRADIENT IN PONDING VOLUME MAY CHANGE OVER TIME AFTER RAINFALL ENDS

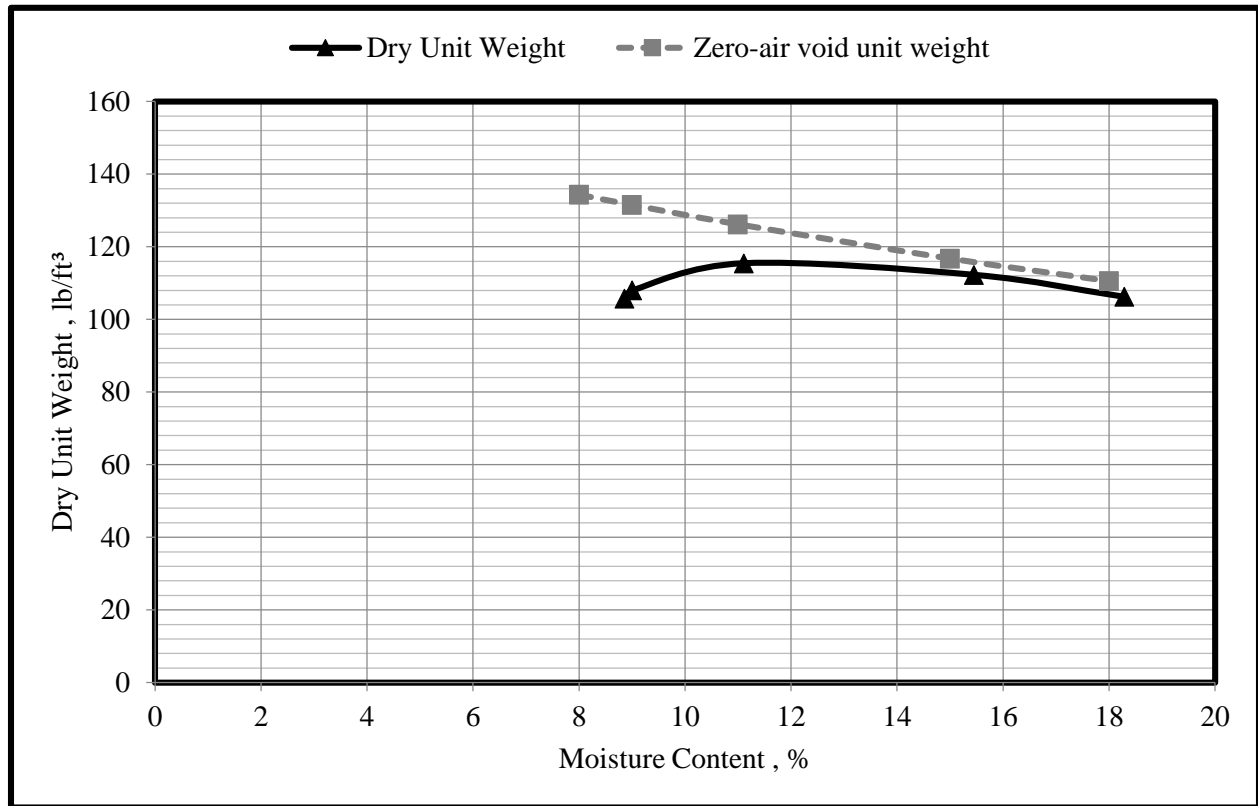
FIGURE 20 MAXIMUM DRY UNIT WEIGHT OF SILTY-SAND SOIL

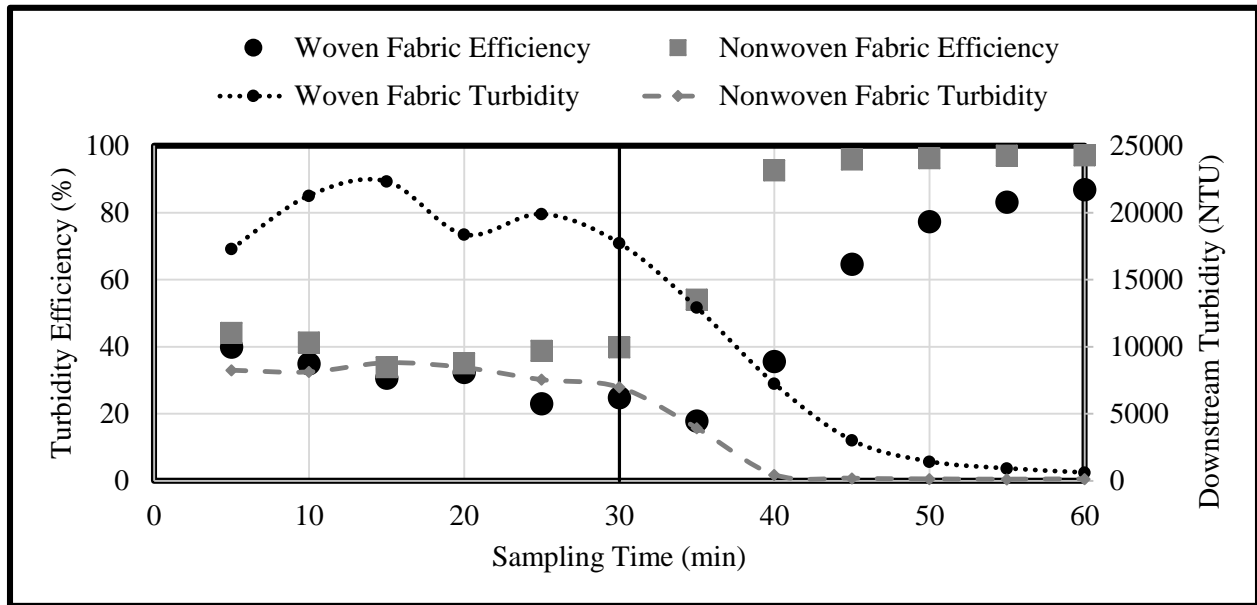
FIGURE 21 TIME DEPENDENT AVERAGE TURBIDITY PERFORMANCE EFFICIENCY AND DOWNSTREAM VALUE ON 25 PERCENT SLOPE

concentrations. Plots associated with the other embankment slopes as well as the SSC reductions are shown in Figure 21 through Figure 25 in Appendix D.

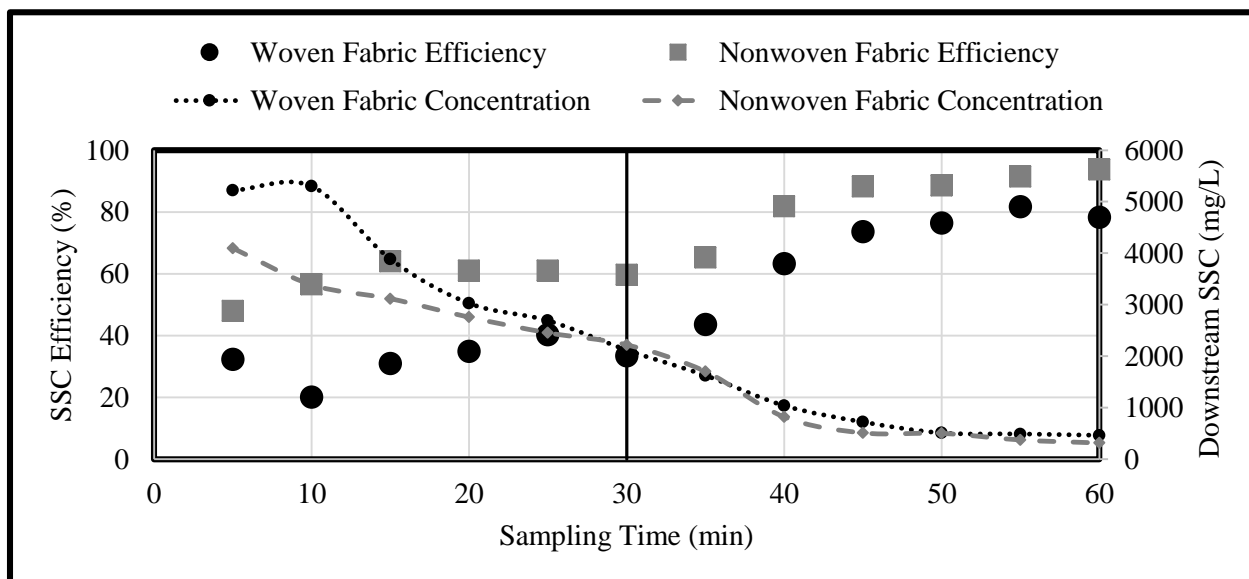
FIGURE 23 TIME DEPENDENT AVERAGE SSC PERFORMANCE EFFICIENCY AND DOWNSTREAM VALUE ON 10 PERCENT SLOPE

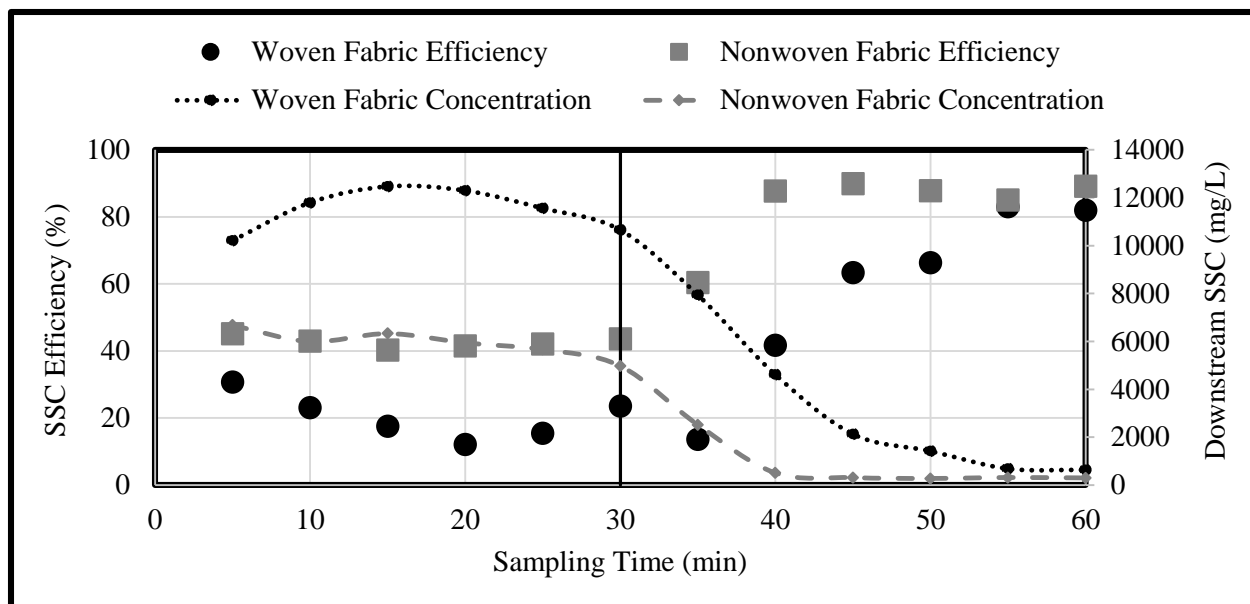
FIGURE 24 TIME DEPENDENT AVERAGE SSC PERFORMANCE EFFICIENCY AND DOWNSTREAM VALUE ON 25 PERCENT SLOPE

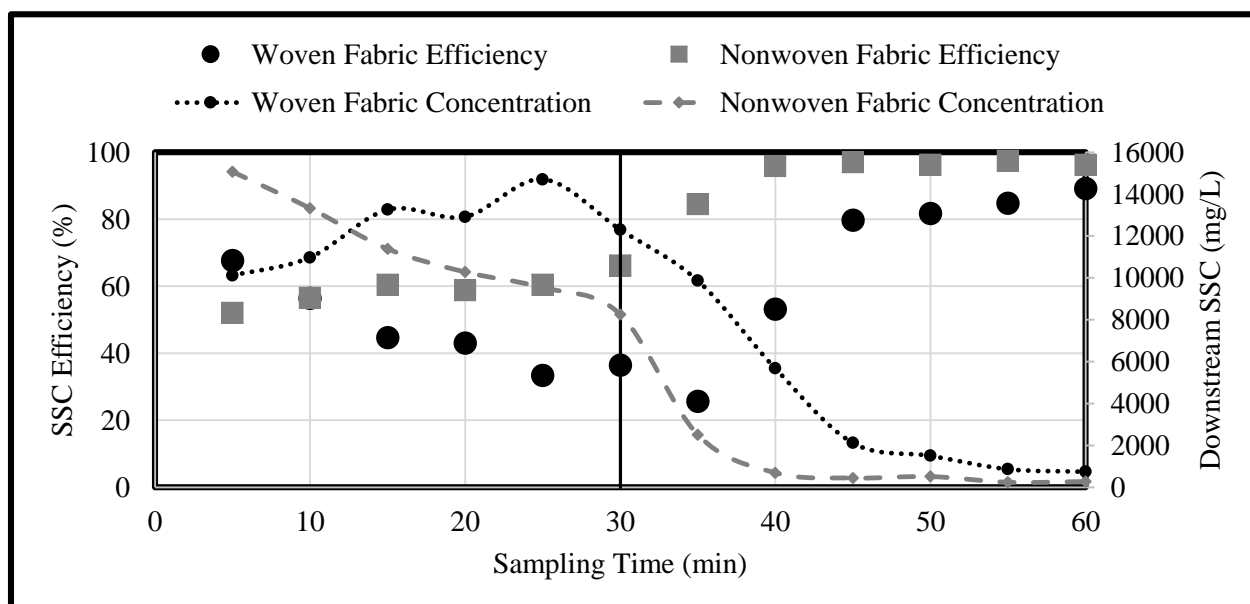
FIGURE 25 TIME DEPENDENT AVERAGE SSC PERFORMANCE EFFICIENCY AND DOWNSTREAM VALUE ON 33 PERCENT SLOPE

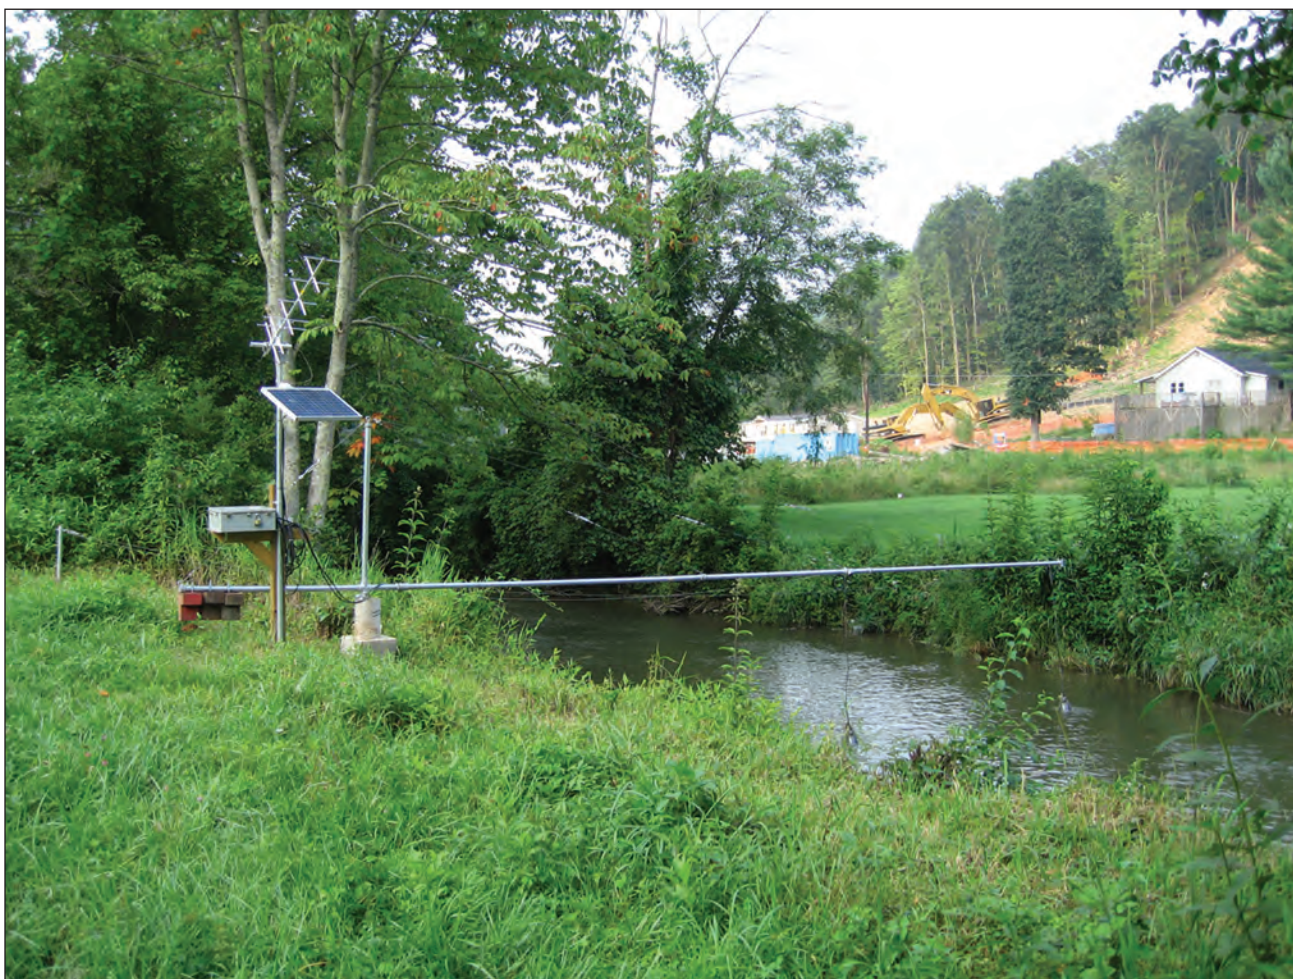
**Cover photograph.** The water-quality monitoring station located on Indian Creek above Route 631 near Cedar Bluff, Virginia; view looking upstream.

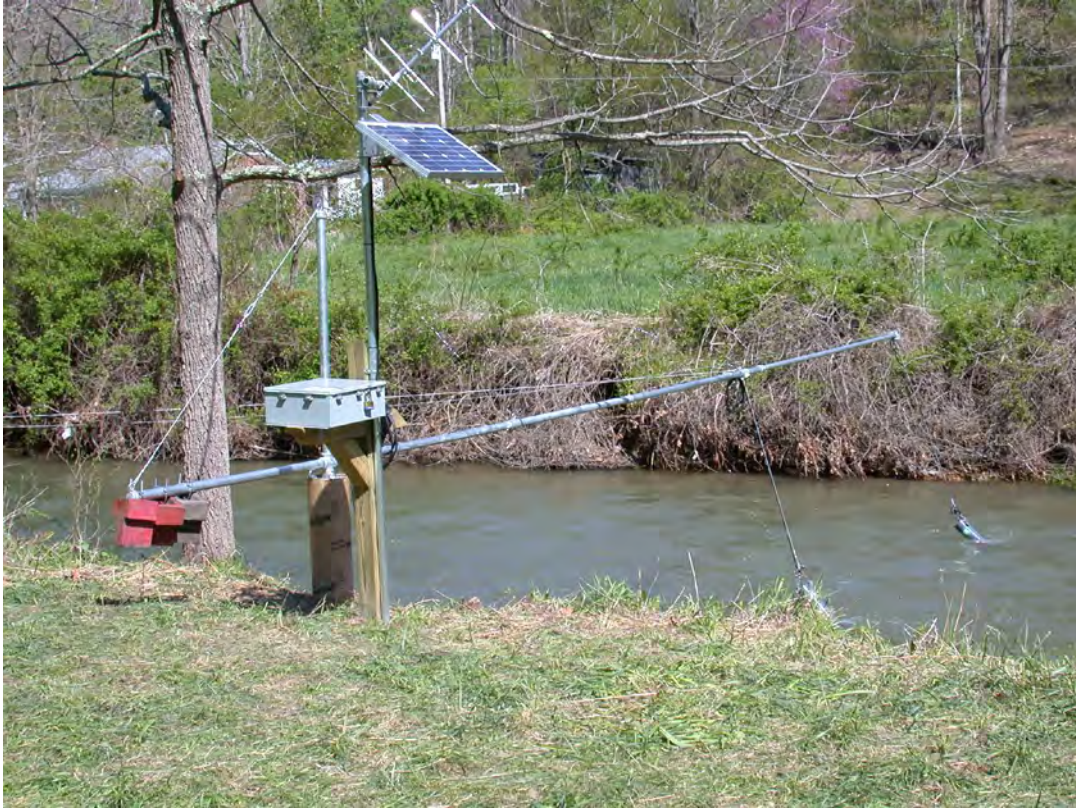
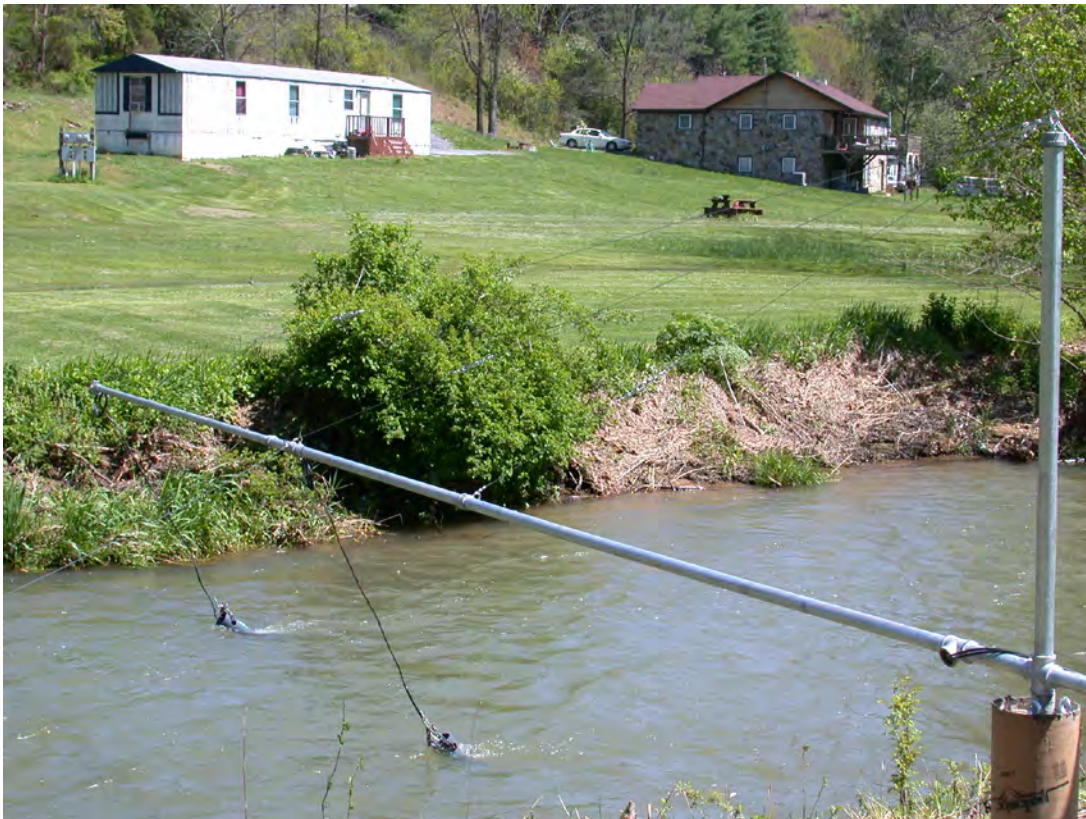
**Figure 4.** Indian Creek water-quality monitoring stations located (A) upstream (Station number 03520967) and (B) downstream (Station number 03520968) from the Jewell Ridge Lateral natural gas pipeline crossing, Tazewell County, Virginia.
