June 21, 2017

Re: United States Forest Service letter Comments  
on the Hydrological Analysis of Sedimentation dated April 25, 2017  
OEP/DG2E/Gas3  
Mountain Valley Pipeline, LLC  
Docket No. CP16-10-000

Scientific Investigations Report 2009–5085

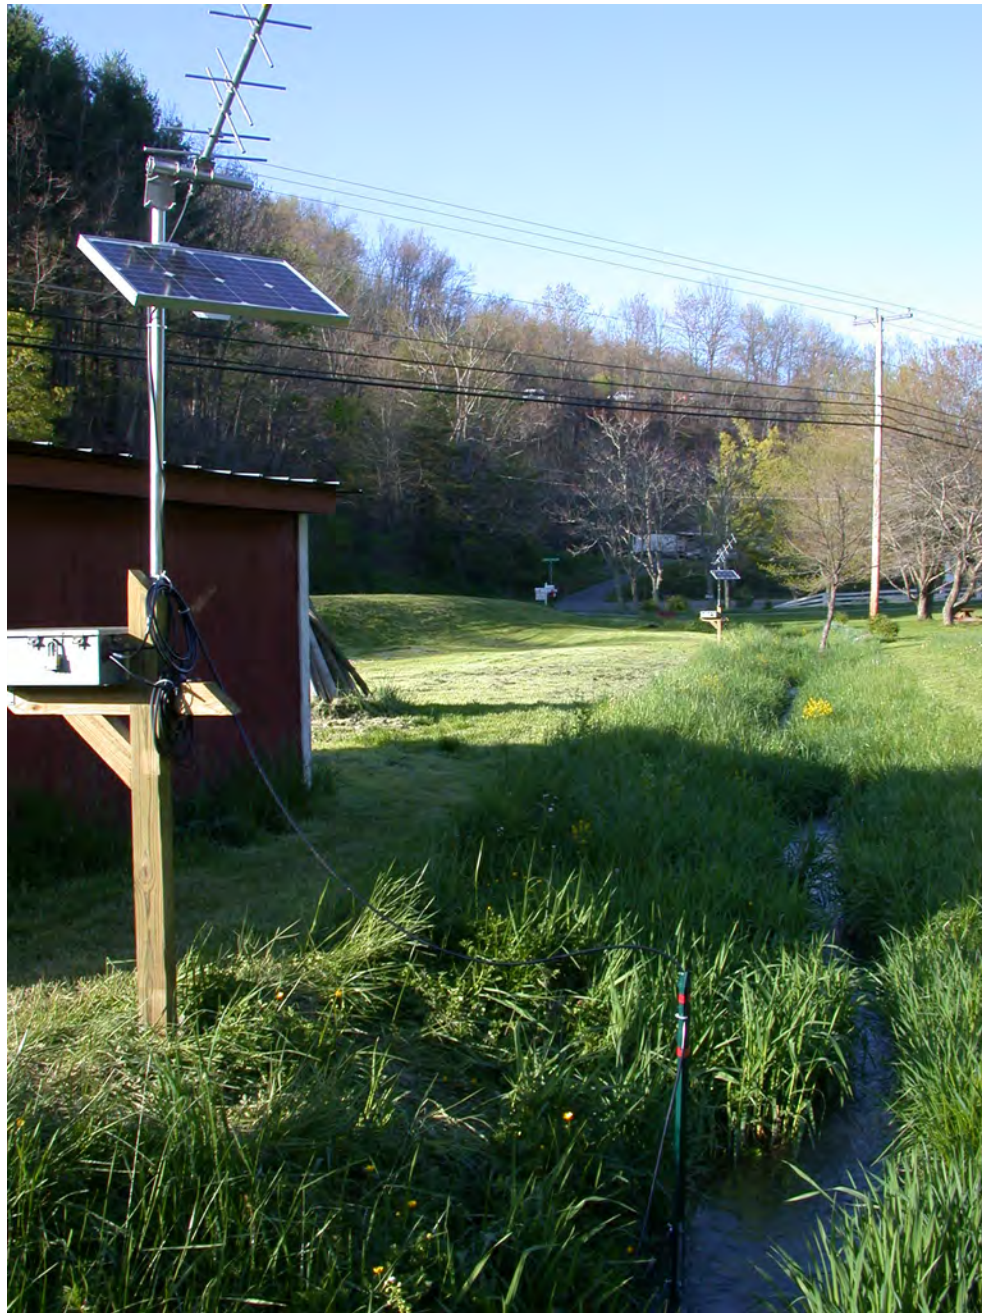
**Figure 5.** Water-quality monitors located on the unnamed tributary to Indian Creek, Tazewell County, Virginia. The monitoring station located in the foreground is the downstream monitor (Station number 03520980). The monitoring station in the background is the upstream monitor (Station number 03520981).

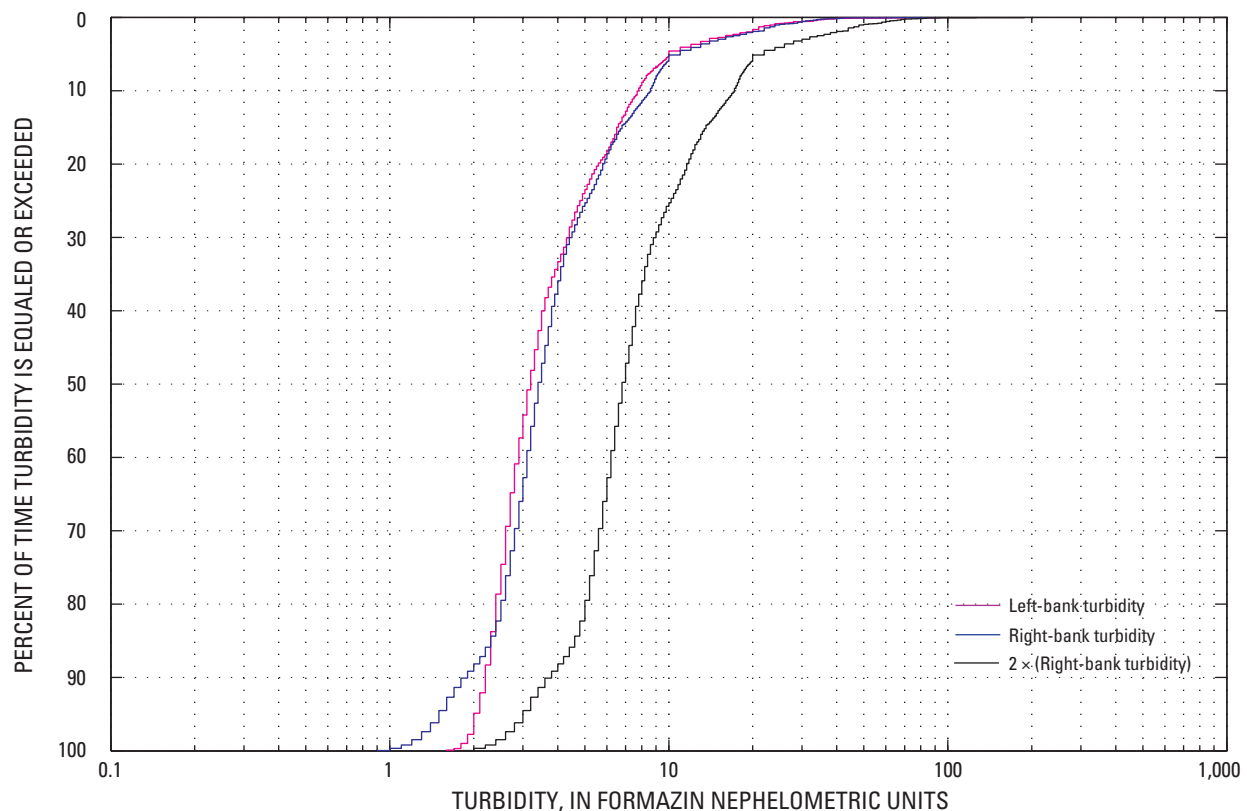
**Figure 6.** Exceedance plots for left-bank and right-bank turbidity collected at the upstream Indian Creek water-quality monitor (Station number 03520967) Tazewell County, Virginia. The black line represents the right-bank turbidity values multiplied by 2.

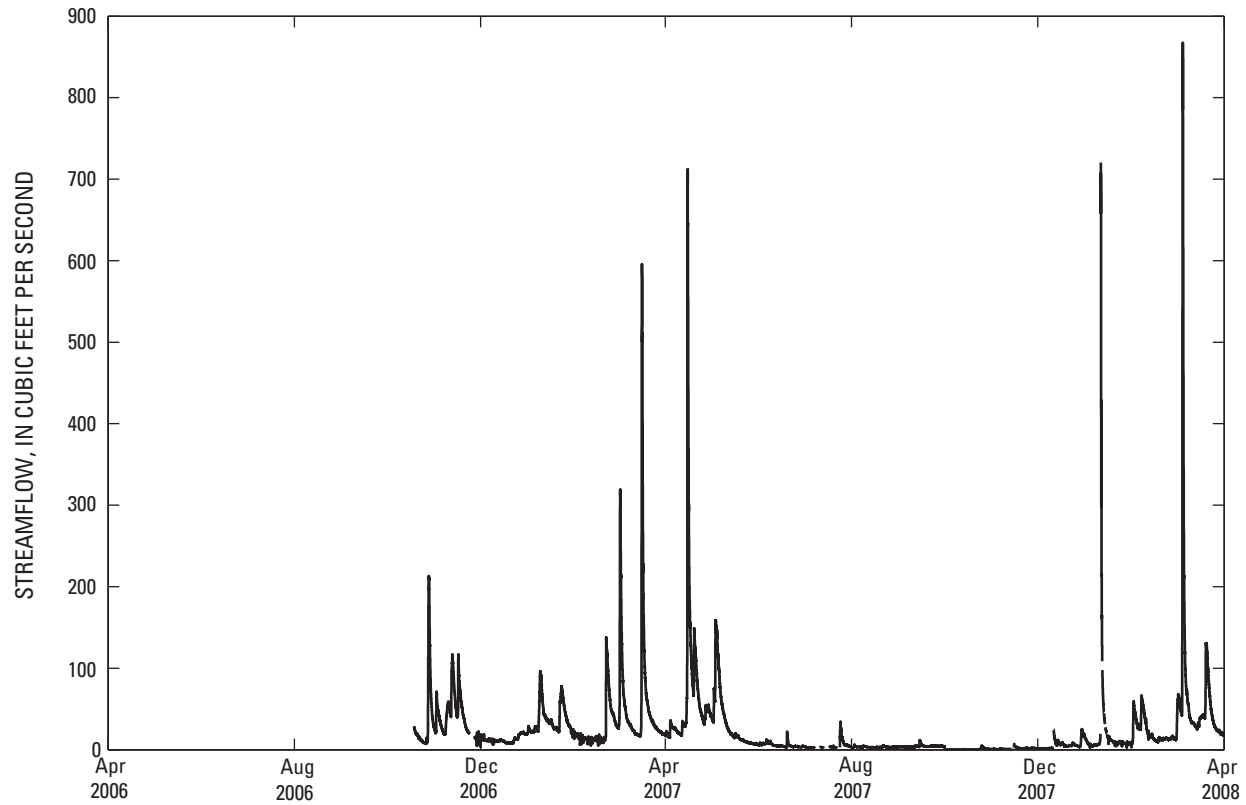
**Figure 7.** Computed unit values (15-minute) of streamflow collected from Indian Creek near Cedar Bluff, Virginia (Station number 03520967).

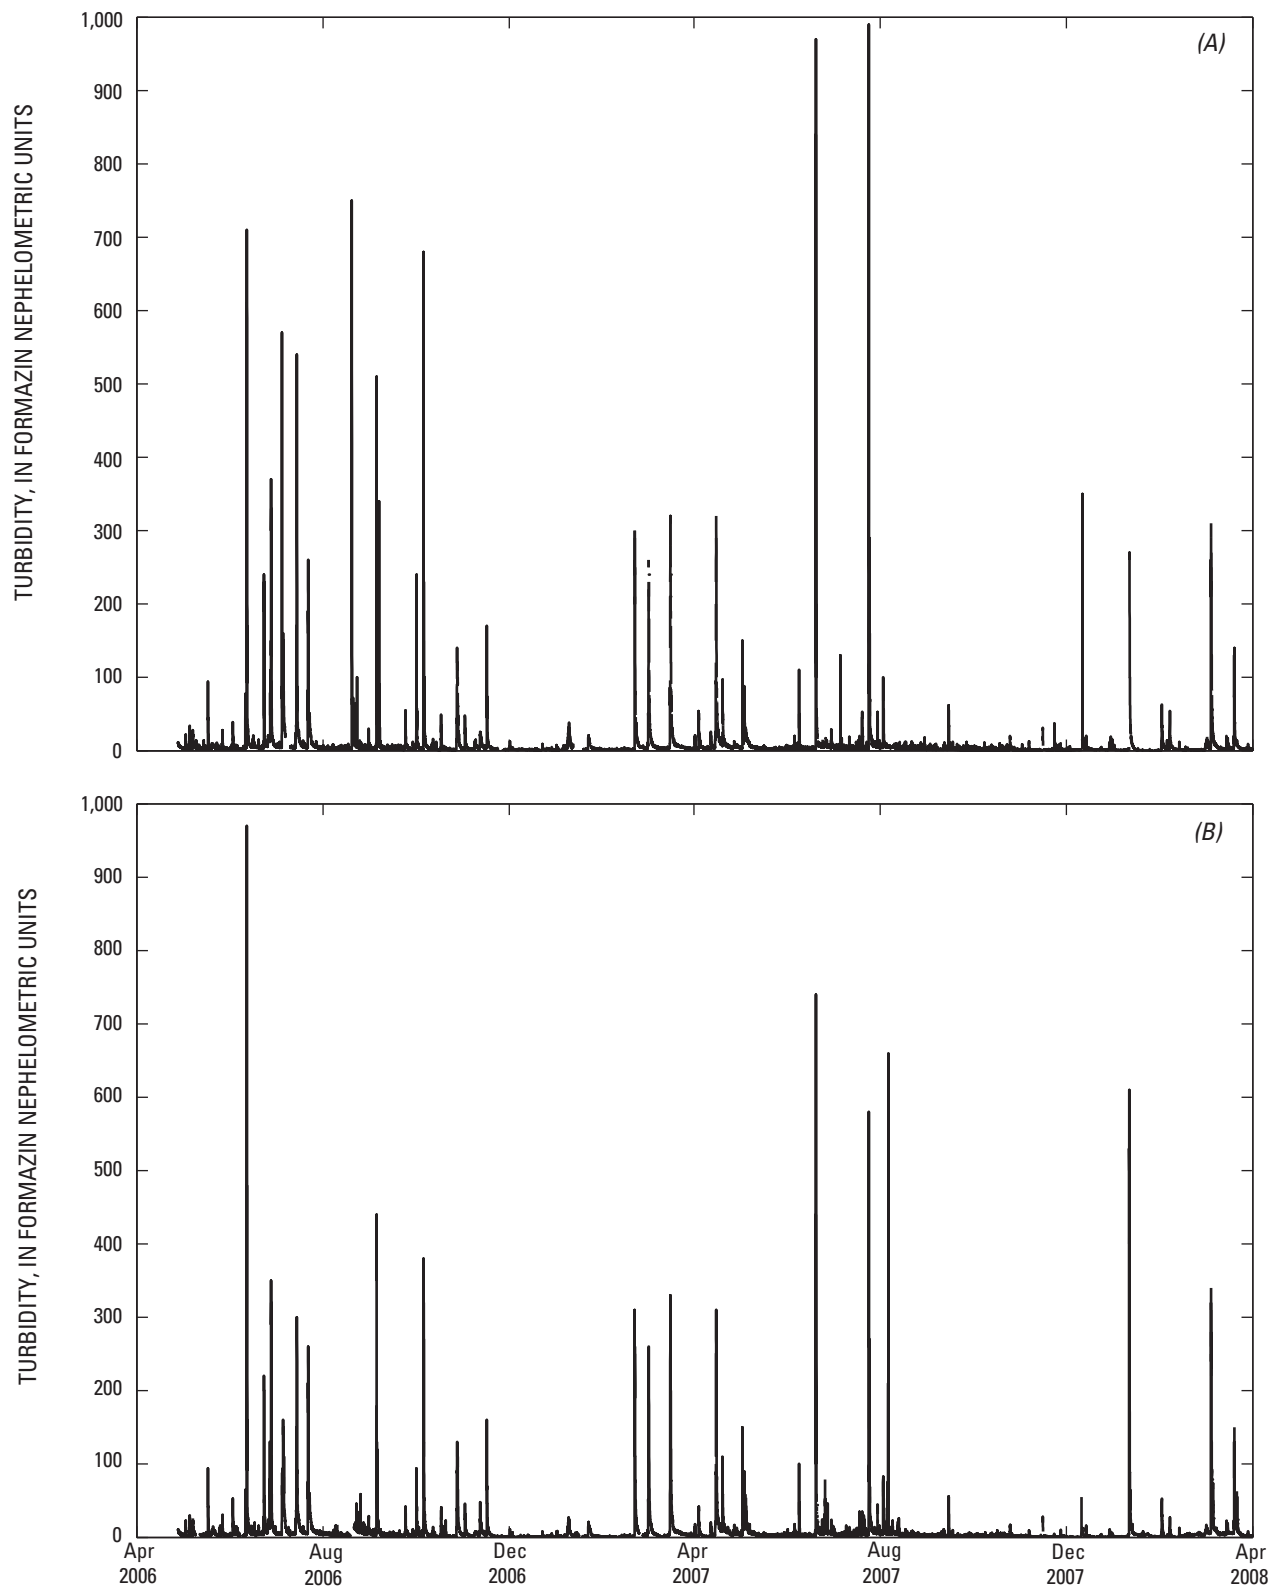
**Figure 8.** Turbidity data (15-minute interval) collected from Indian Creek, Tazewell County, Virginia, at the (A) upstream (Station number 03520967) and (B) downstream (Station number 03520968) left-bank water-quality monitors.

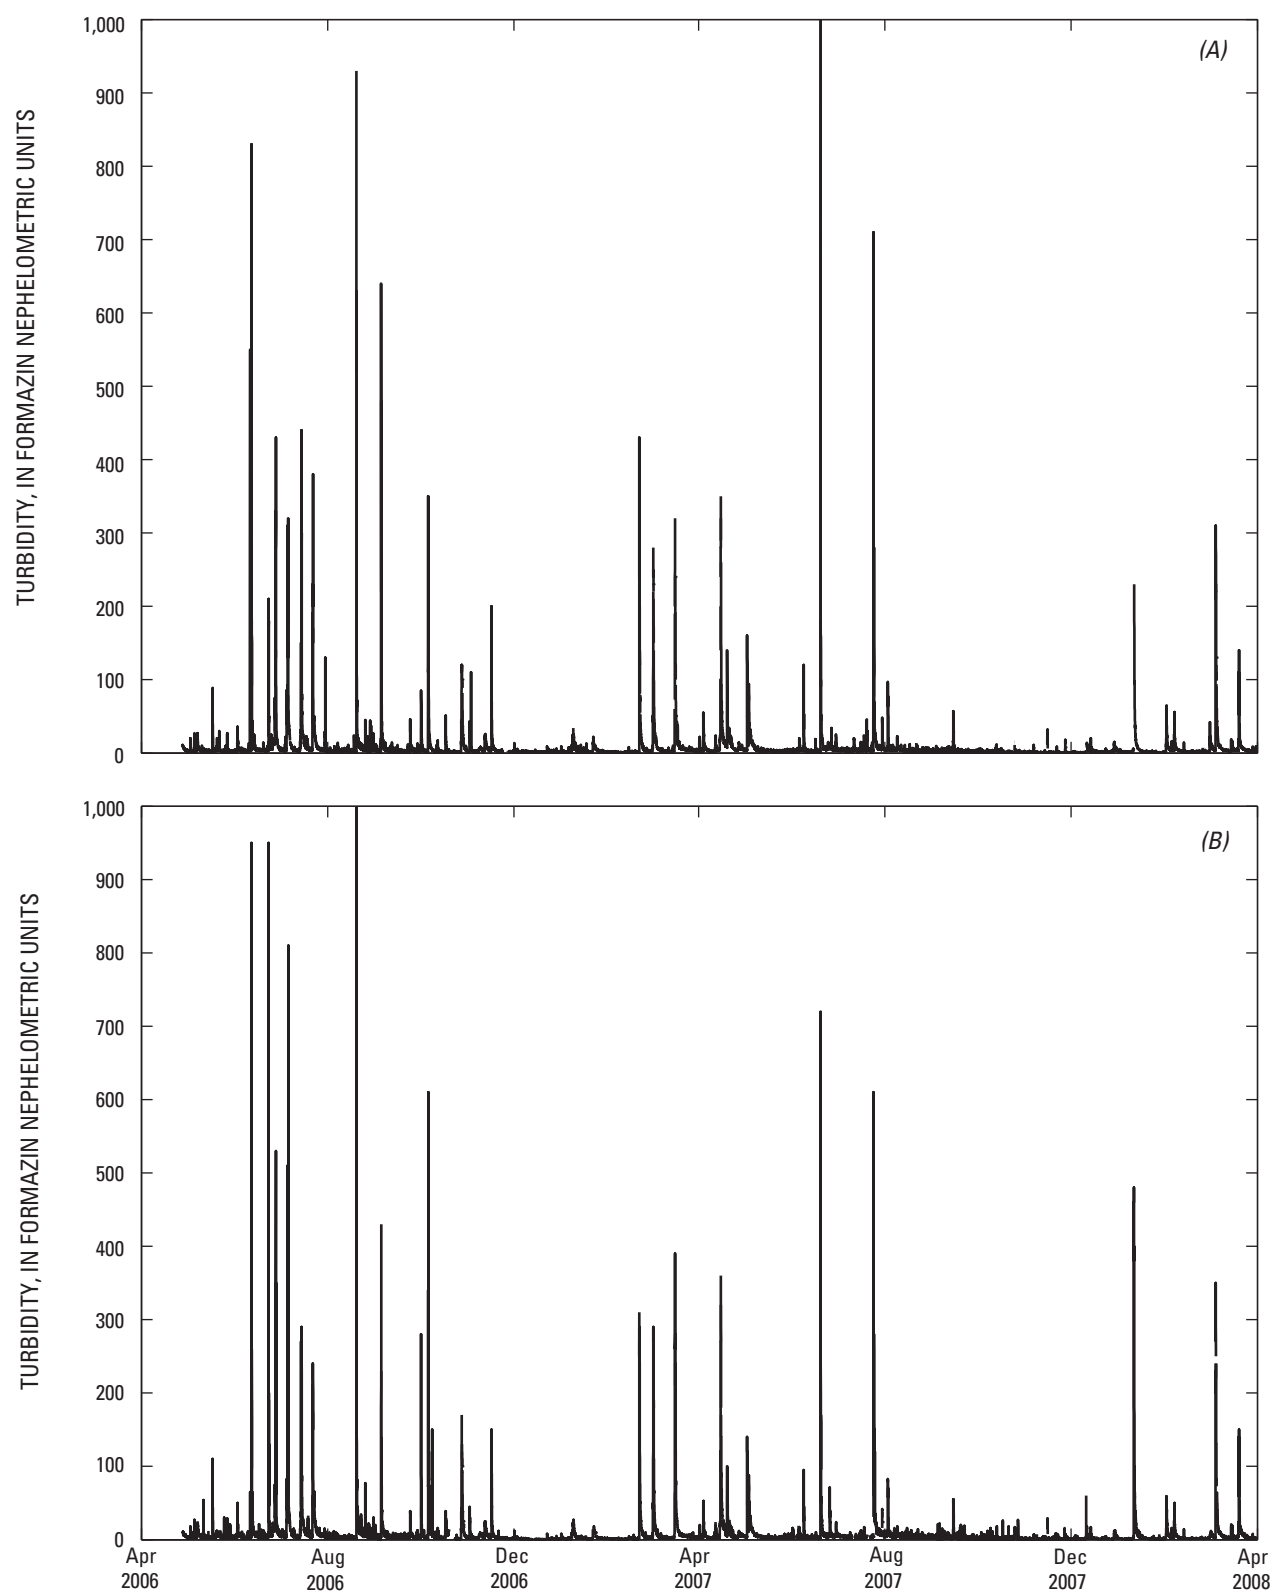
**Figure 9.** Turbidity data (15-minute interval) collected from Indian Creek, Tazewell County, Virginia, at the (A) upstream (Station number 03520967) and (B) downstream (Station number 03520968) right-bank water-quality monitors.

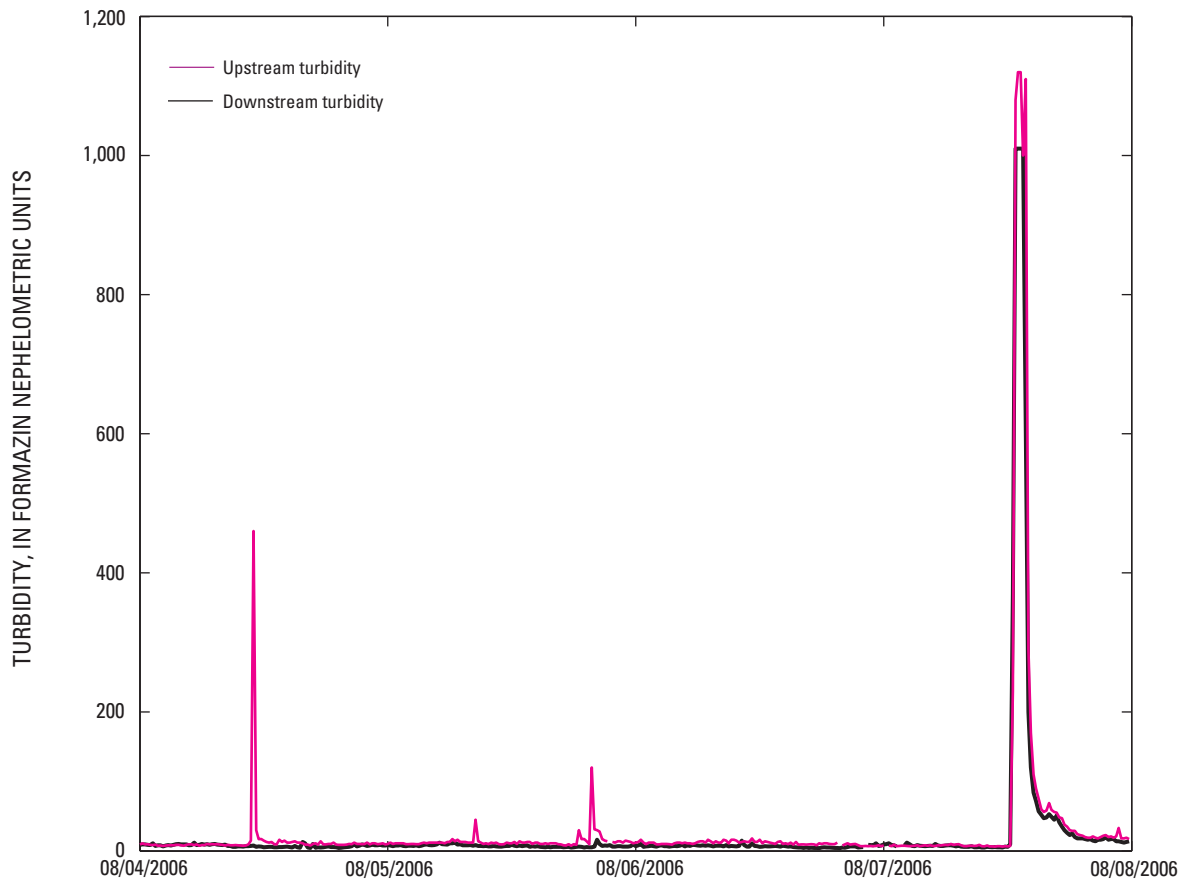
**Figure 15.** Turbidity data (15-minute interval) collected from the unnamed tributary at the upstream (Station number 03520980) and downstream (Station number 03520981) water-quality monitors during active pipeline construction August 4–8, 2006, Tazewell County, Virginia.

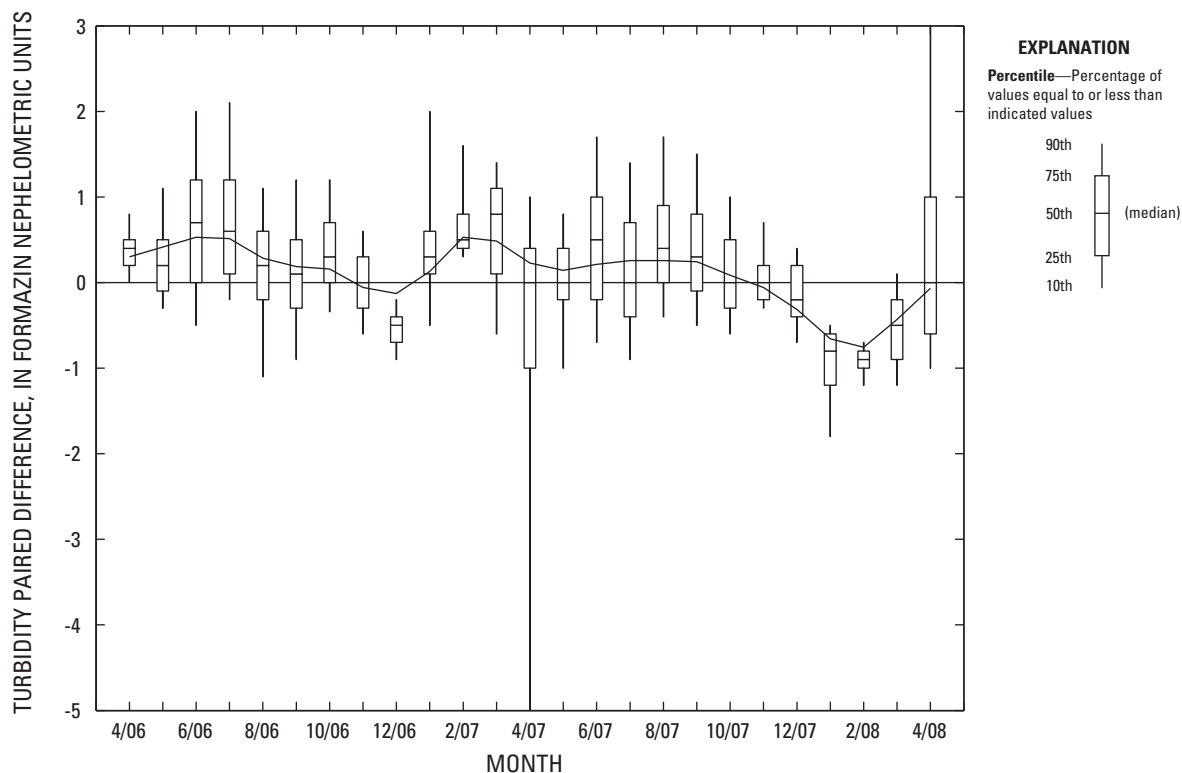
**Figure 16.** Monthly differences for paired turbidity values collected at the left-bank and right-bank upstream Indian Creek water-quality monitors (Station number 03520967, fig. 3), Tazewell County, Virginia. Turbidity paired difference equals left-bank turbidity minus right-bank turbidity. The black line represents the LOWESS smoothed fit line through the monthly medians.

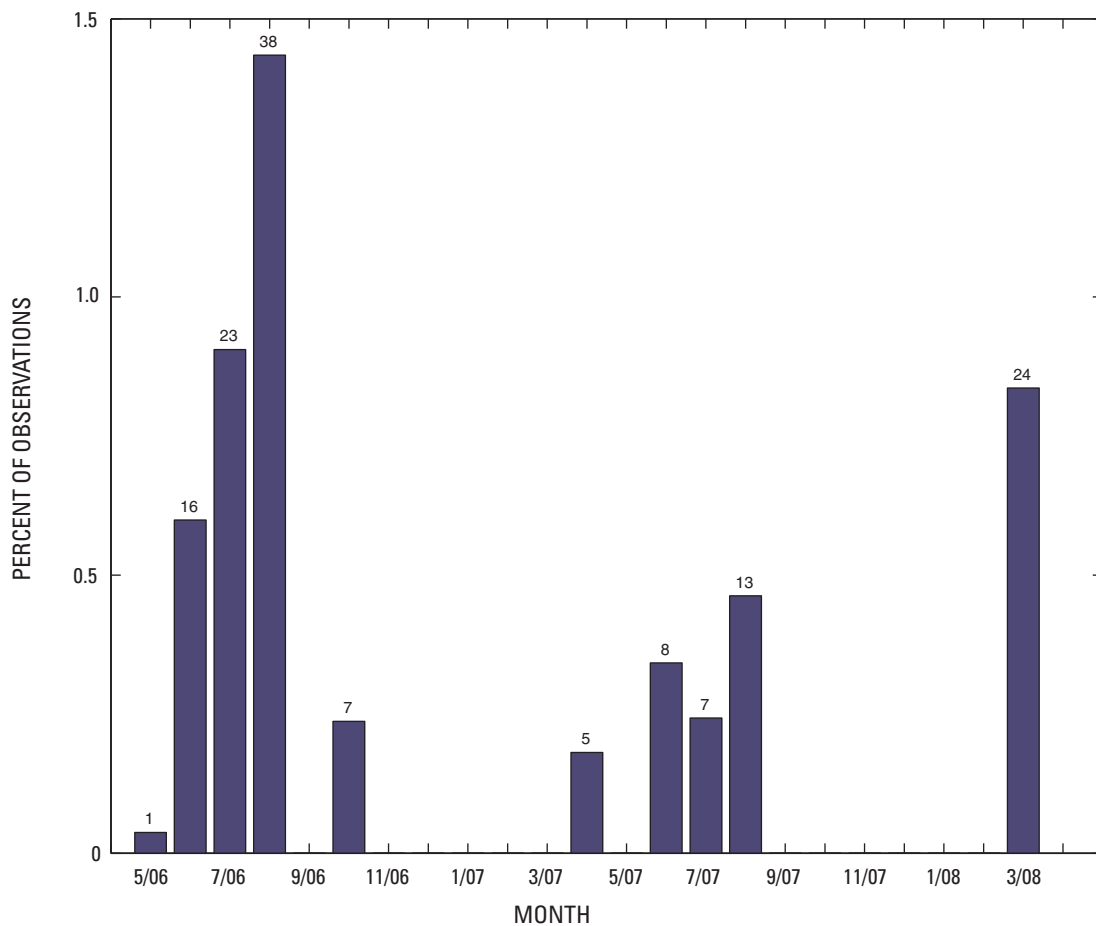
**Figure 19.** Monthly bar plot showing the percentage of turbidity paired differences that resulted in a warning for exceeding the turbidity threshold along the left bank of Indian Creek, Tazewell County, Virginia. The number above each bar plot represents the actual number of warnings.

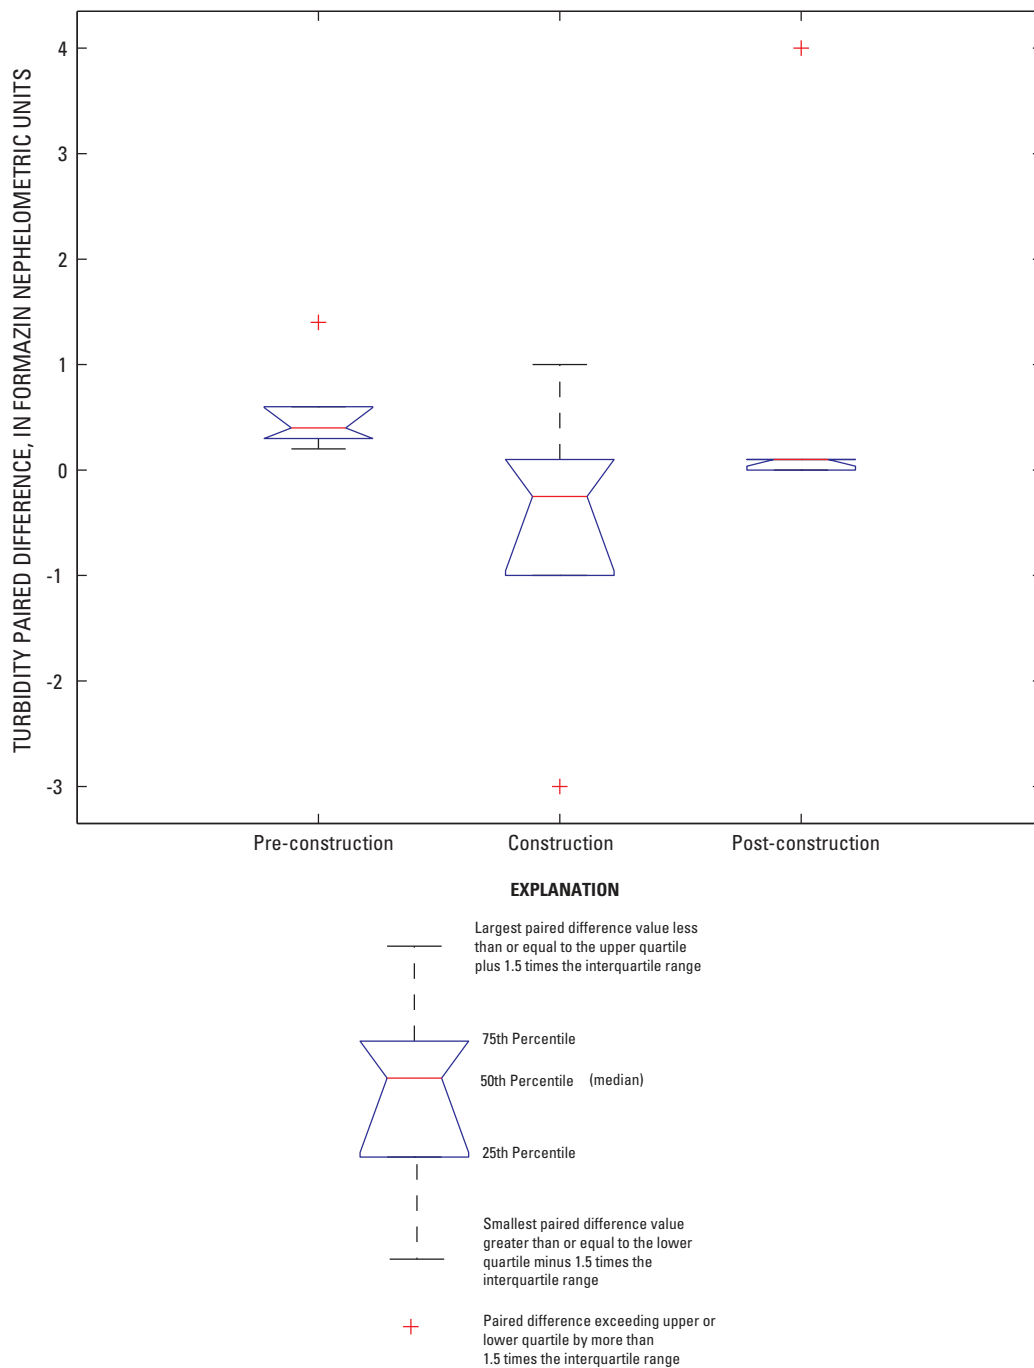
**Figure 21.** Boxplots of turbidity paired differences for turbidity collected at the left-bank and right-bank upstream Indian Creek water-quality monitors (Station number 03520967), Tazewell County, Virginia. Turbidity paired difference equals left-bank turbidity minus right-bank turbidity for values at the 50th, 75th, 80th, 90th, 95th, and 99th percentiles.

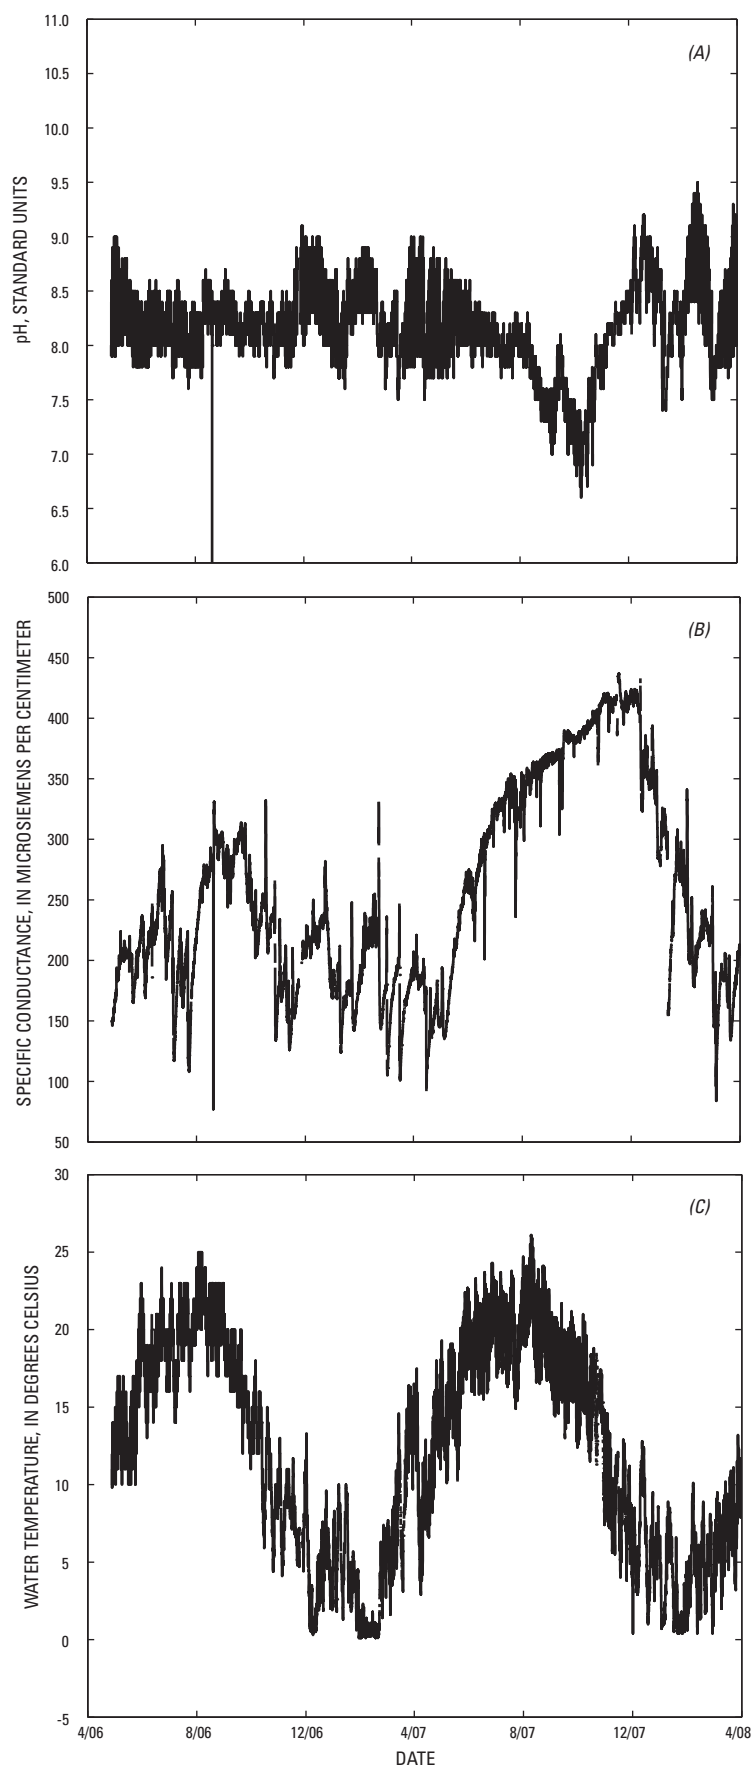
**Appendix 2.** Continuous water-quality data (15-minute interval) collected from Indian Creek, Tazewell County, Virginia, at the upstream (Station number 03520967) right-bank water-quality monitor: (A) pH, (B) specific conductance, and (C) water temperature.

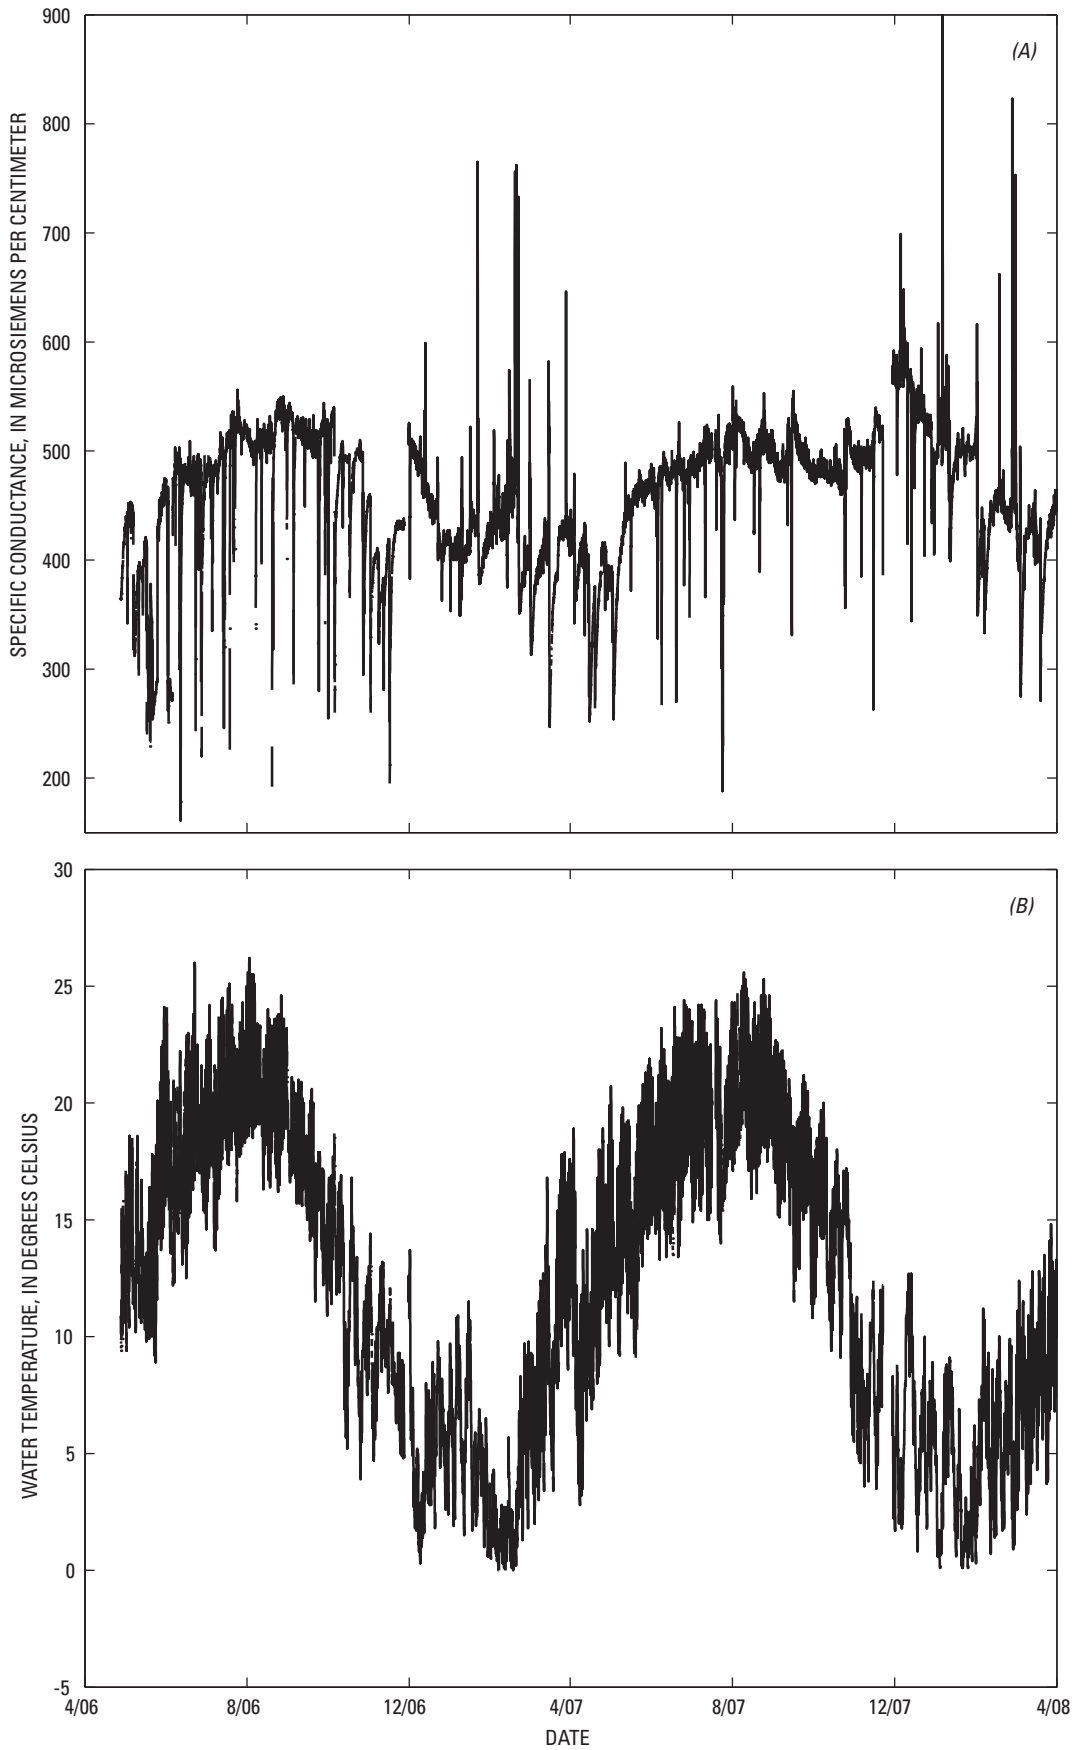
**Appendix 5.** Continuous water-quality data (15-minute interval) collected from the unnamed tributary, Tazewell County, Virginia, at the upstream (Station number 03520980) water-quality monitor: (A) specific conductance and (B) water temperature.

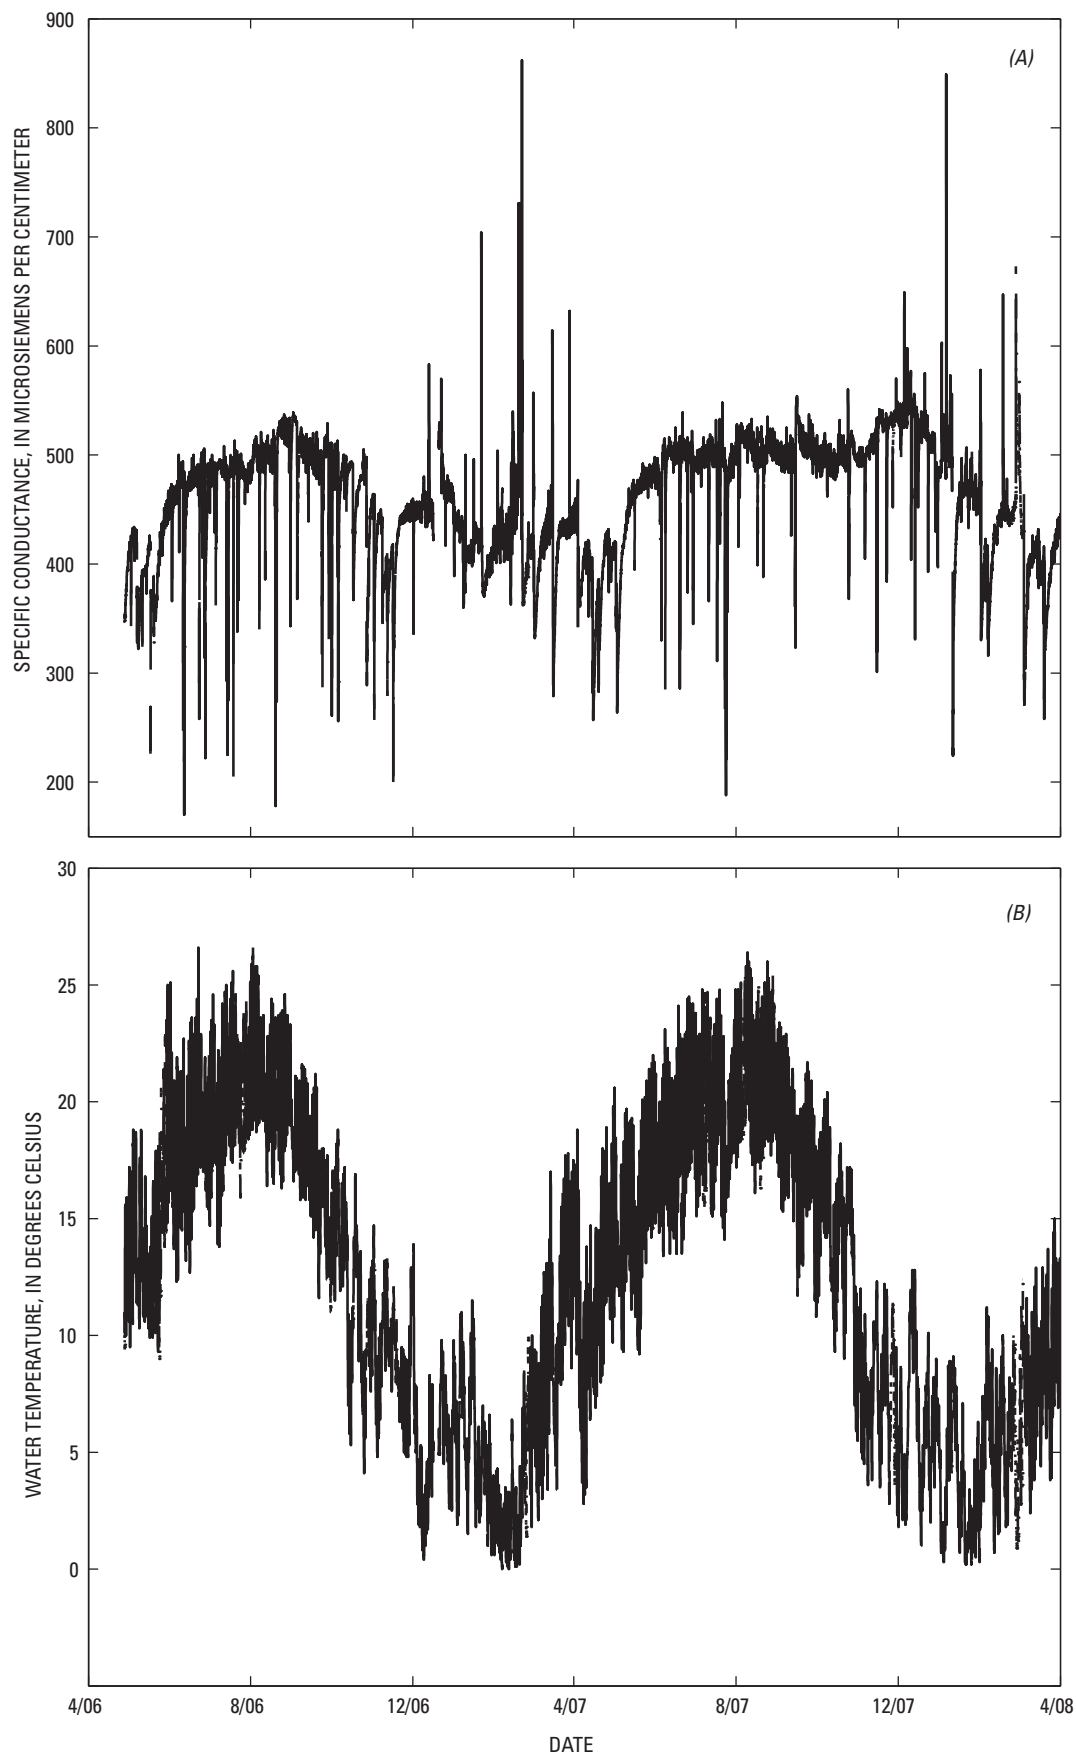
**Appendix 6.** Continuous water-quality data (15-minute interval) collected from the unnamed tributary, Tazewell County, Virginia, at the downstream (Station number 03520981) water-quality monitor: (A) specific conductance and (B) water temperature.
