APPENDIX D: Bridge/Structure Bat Assessment Form Guidance

Federal Transportation Agency/State Department of Transportation (DOT) Preliminary Guidelines for Using the Bridge/Structure Bat Assessment Form

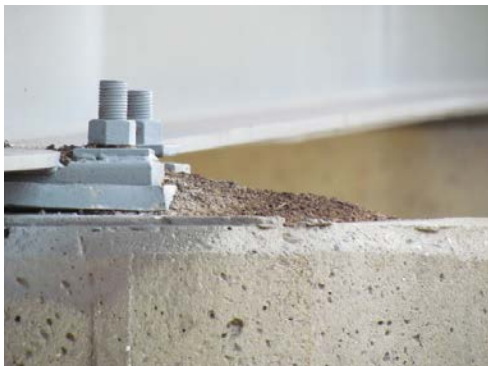
Photo 5: Guano deposit on pier, obscuring structural features.

Expansion joints can provide protected cover for bats (Photos 2 and 5), but do not always provide habitat, depending upon whether they are obstructed by road debris or other blockages. If possible during the assessment, individuals should use a flashlight to look into expansion joints or cracks. Guano may be present under joints if being used by bats (Photos 7 and 8).

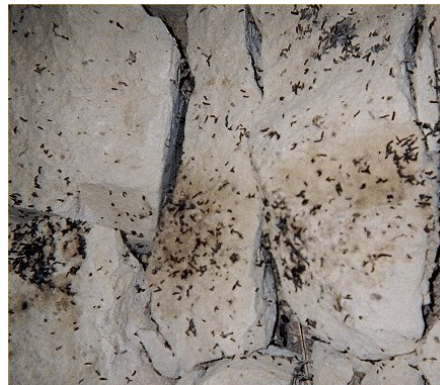
Photo 6: Bat Guano on Riprap

Bat droppings are small (mouse-like in appearance but less regular) brown or black pellets (Photos 6 - 8). Older droppings may be gray in color. These droppings will accumulate on the ground, floor of a covered bridge or on structural components below where bats roost. Droppings may also adhere to support beams and walls below roosts.

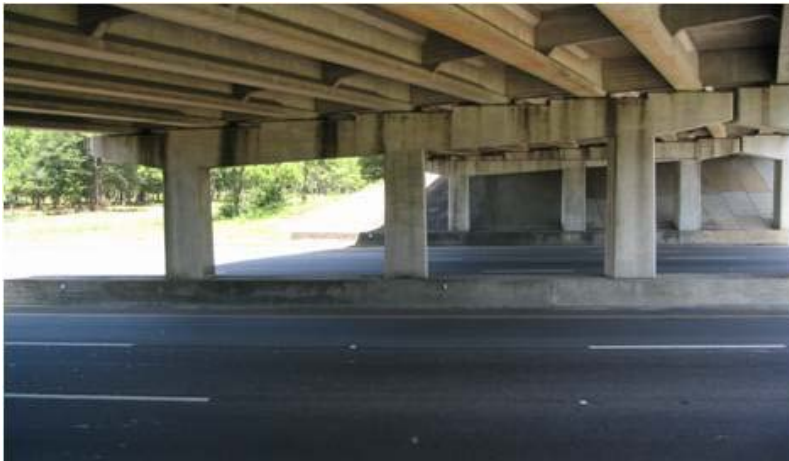
Photo 9: Staining on sides of pier caps

Stains may appear wet and are usually found in dark places. Look for four to six inch wide dark stains located on concrete support beams and walls immediately below the ceiling of the bridge, and beneath joints (Photos 8 - 11).

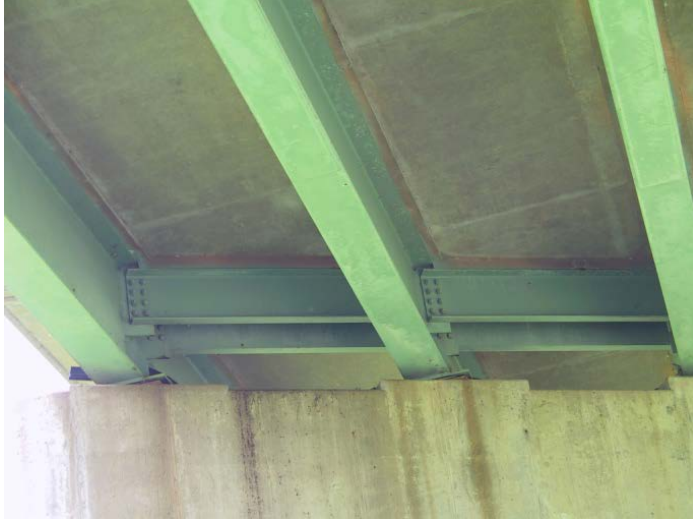
Photo 10: Guano staining on side of pier

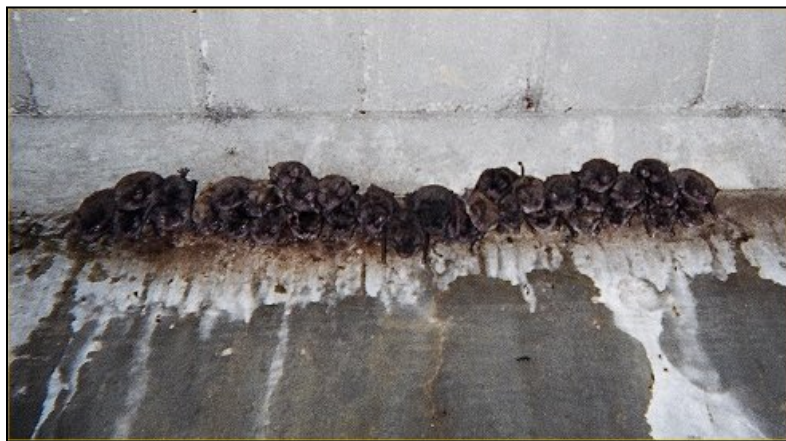
Photo 11: Bats roosting & associated staining

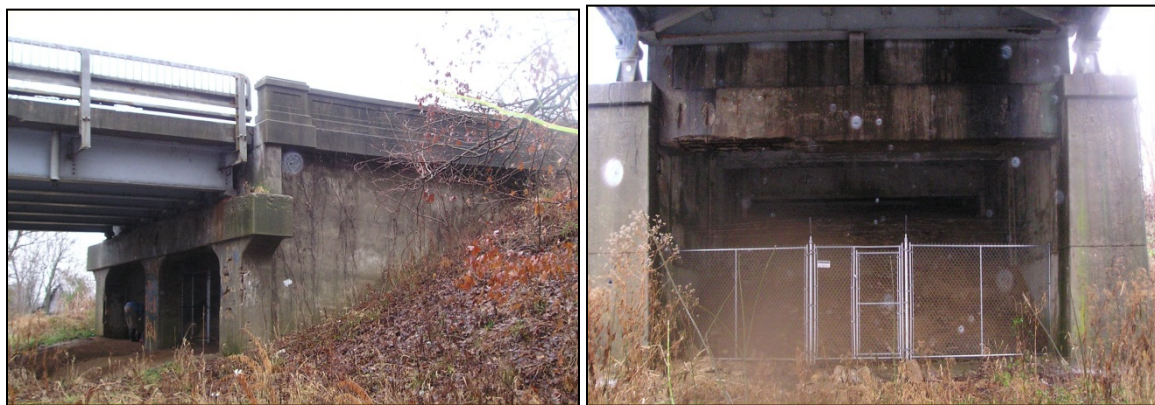
Photo 12 and 13: Bridge design mimicking “cave-like” atmosphere

While assessing bridges or structures, look for dark environments that mimic cave-like conditions such as under the deck in the case of a bridge (Photos 12 and 13) or an attic in the case of a structure. This may involve crawling under low areas so a hard hat is recommended. Such places (e.g., a concrete bunker secreted into a hillside with an open front) provide protection from wind, rain, sleet, hail and predators. Bats do not roost near the ground where predators (cats, raccoons, etc.) can reach them. Roosting is usually at least 4 ft. from the ground.
