United States Department of the Interior

Consultation # 2-15-F-2005-0087

This document transmits the U.S. Fish and Wildlife Service's (Service) biological opinion based on: (1) our review of the U.S. Army Corps of Engineers (USACE) funding of a proposed aquatic ecosystem restoration project at Spring Lake, in San Marcos, Hays County, Texas, and its vicinity in partnership with Texas State University – San Marcos (TxStU) and (2) the project's effects on four federally listed species. Those species are Texas wild-rice (*Zizania texana*), Comal Springs riffle beetle (*Heterelmis comalensis*), fountain darter (*Etheostoma fonticola*), and San Marcos salamander (*Eurycea nana*).

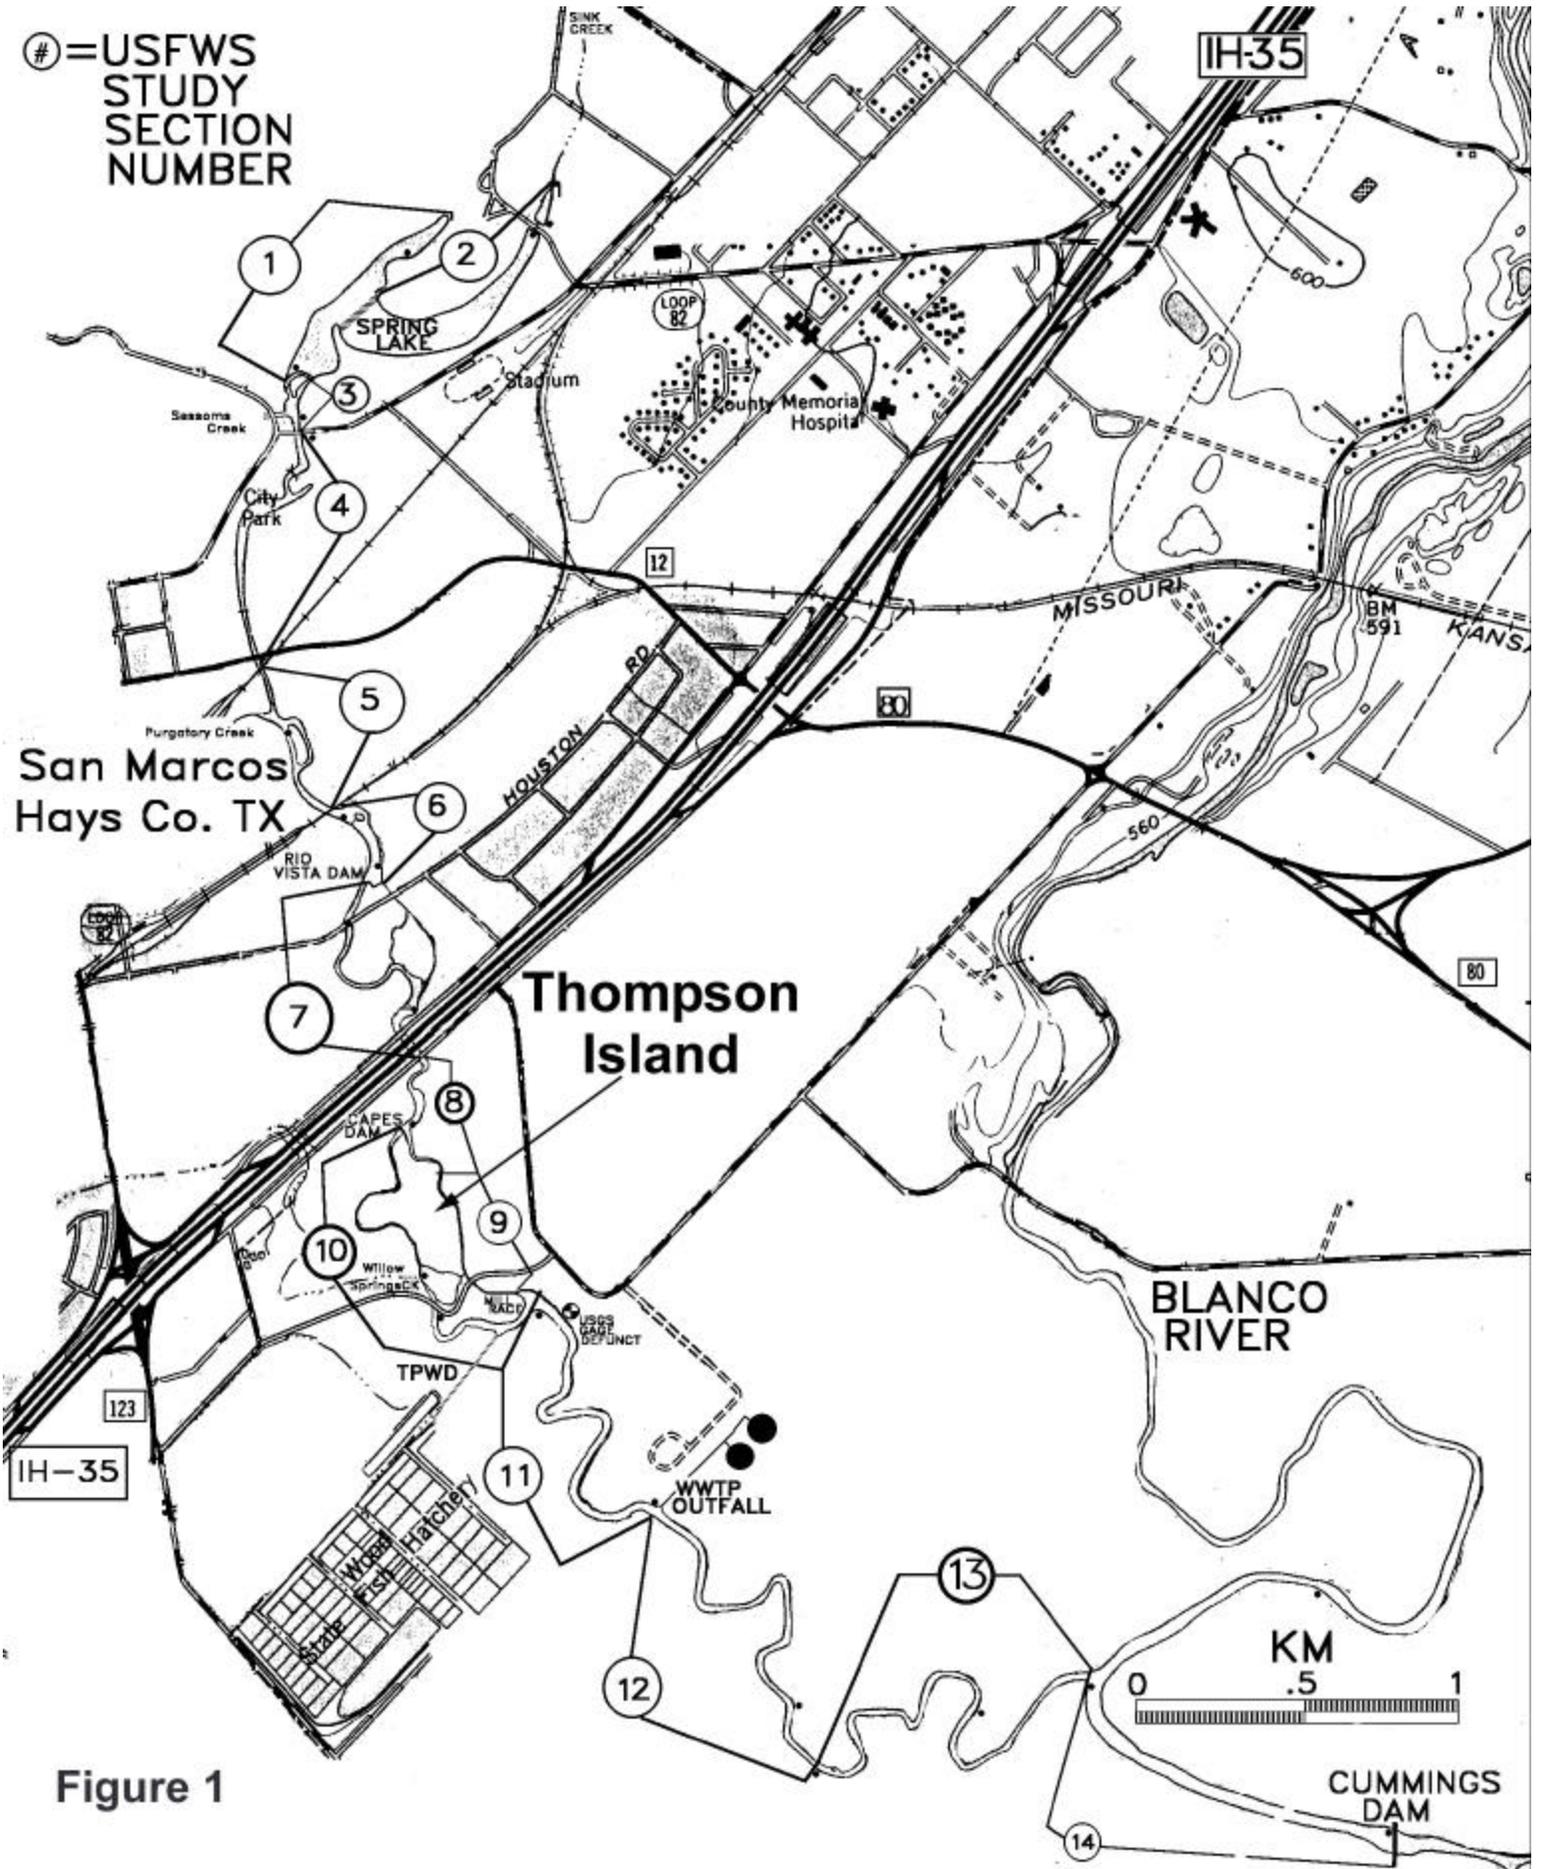
Figure 1

The current distribution of fountain darters in the upper San Marcos River includes all of section 1 through 12 and the upper reaches of section 13 in Figure 1.

Fountain darter densities for Spring Lake and upper San Marcos River are provided in Table 3. The study sections are shown in Figure 1. These samples were made using a 1 meter (3.28 feet) wide, 2 meter (6.56 feet) long drop net, which was open on the bottom and top with adjustable height (up to 1.5 meters (5 feet)). Darters, other fish, and invertebrates were captured by clearing the area enclosed with a dip net. Each section had samples with no fountain darters found. Collections by the Service and cooperators in 1994, 1995, and 1996 were pooled for Table 3.

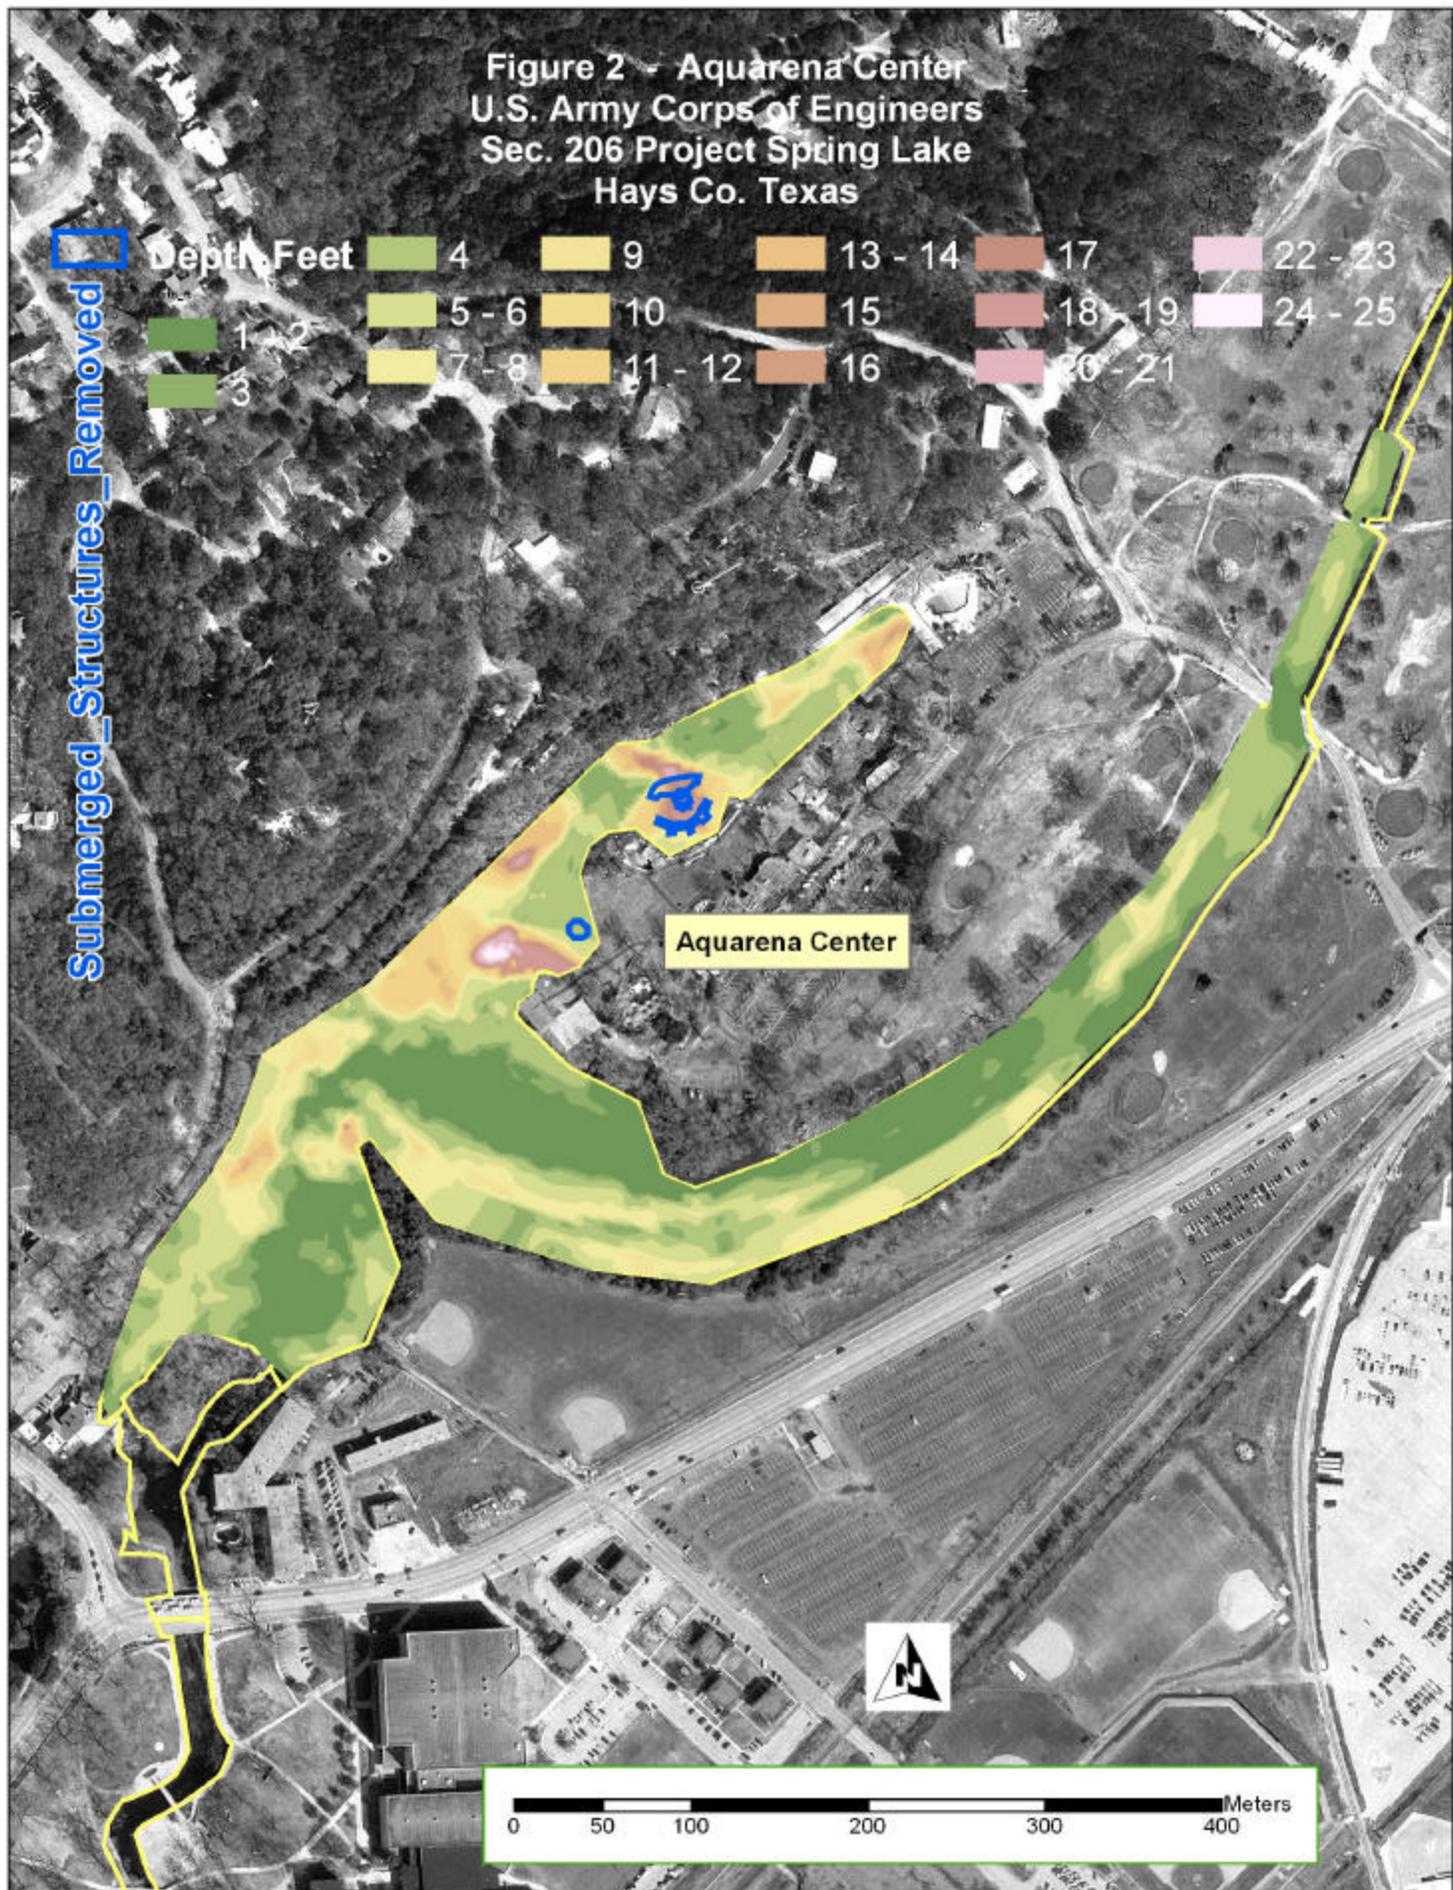
Figure 2 - Aquarena Center
U.S. Army Corps of Engineers
Sec. 206 Project Spring Lake
Hays Co. Texas

Spring Lake and Aquarena Center are located at the headwaters of the San Marcos River in the City of San Marcos, Hays County, Texas (Figures 1 and 2). The following is excerpted from Section 1.3.1 of the BA, which provides a description of the proposed restoration measures.

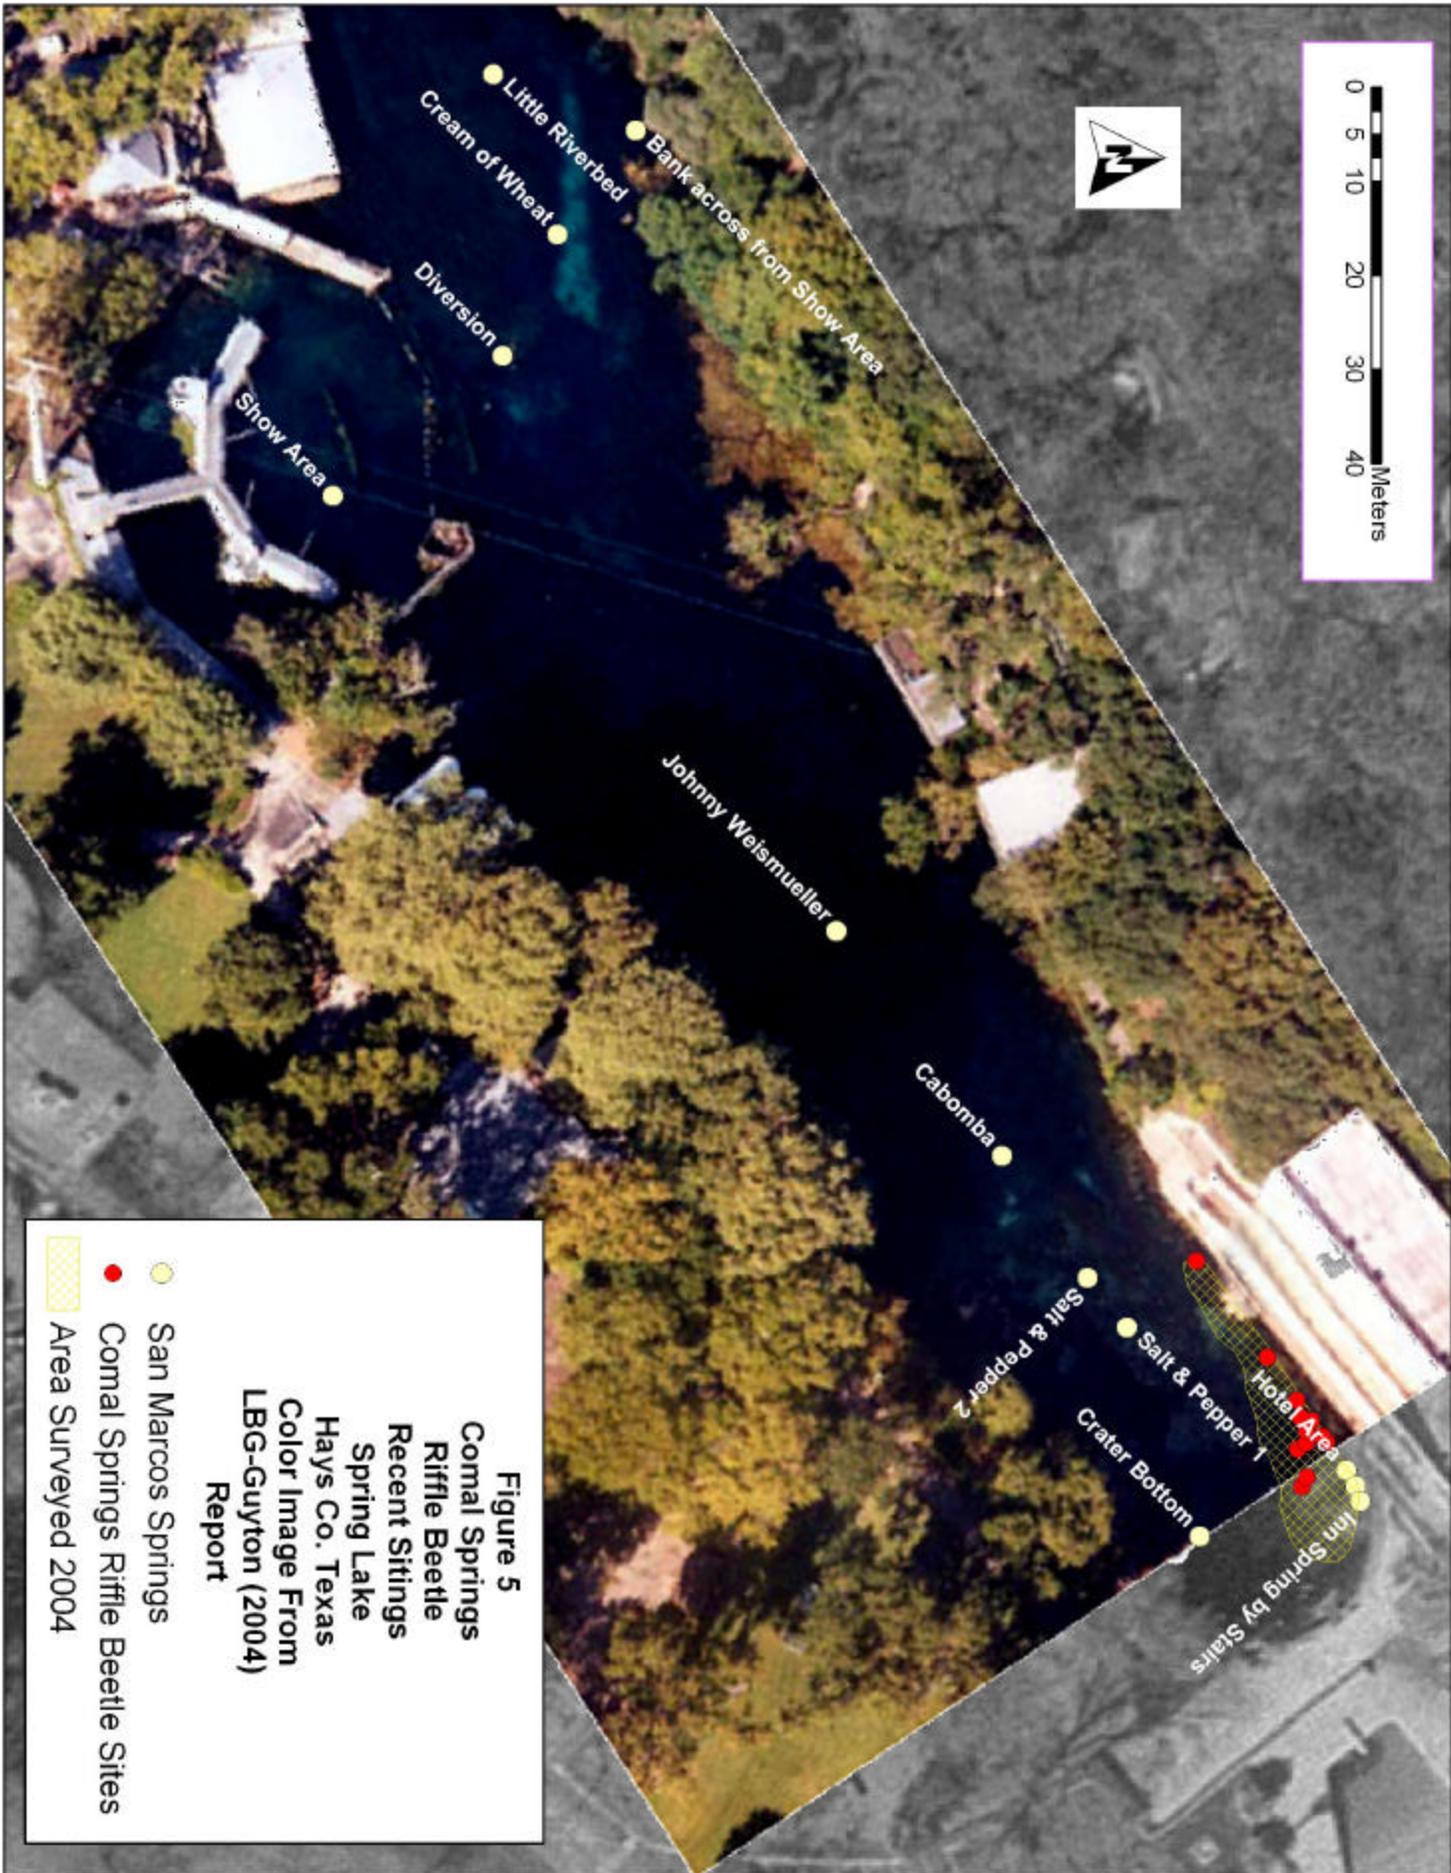
Figure 5
 Comal Springs
 Riffle Beetle
 Recent Sitings
 Spring Lake
 Hays Co. Texas
 Color Image From
 LBG-Guyton (2004)
 Report

The current range of the Comal Springs riffle beetle includes: (1) the springs and spring runs of Landa Lake (BIO-WEST 2005), and (2) an undetermined number of springs in Spring Lake in San Marcos (Service 2005) (Figure 5, yellow crosshatched area is the extent of the Service's surveys in 2004). On October 5th, 2000, Kristin Terpening and Lori Tolley-Jordan surveyed for riffle beetles in the aquatic habitats where dam repairs were proposed (Terpening 2000). Their survey indicated that while another riffle beetle was present, the Comal Springs riffle beetle was not found in the cascade habitat downstream from Spring Lake Dam. To date, critical habitat has not been designated. However, pursuant to a court agreement, the Service will begin work on the critical habitat determination for the Comal Springs riffle beetle on or before October 1, 2005.

● San Marcos Springs
 ● Comal Springs Riffle Beetle Sites
 ■ Area Surveyed 2004

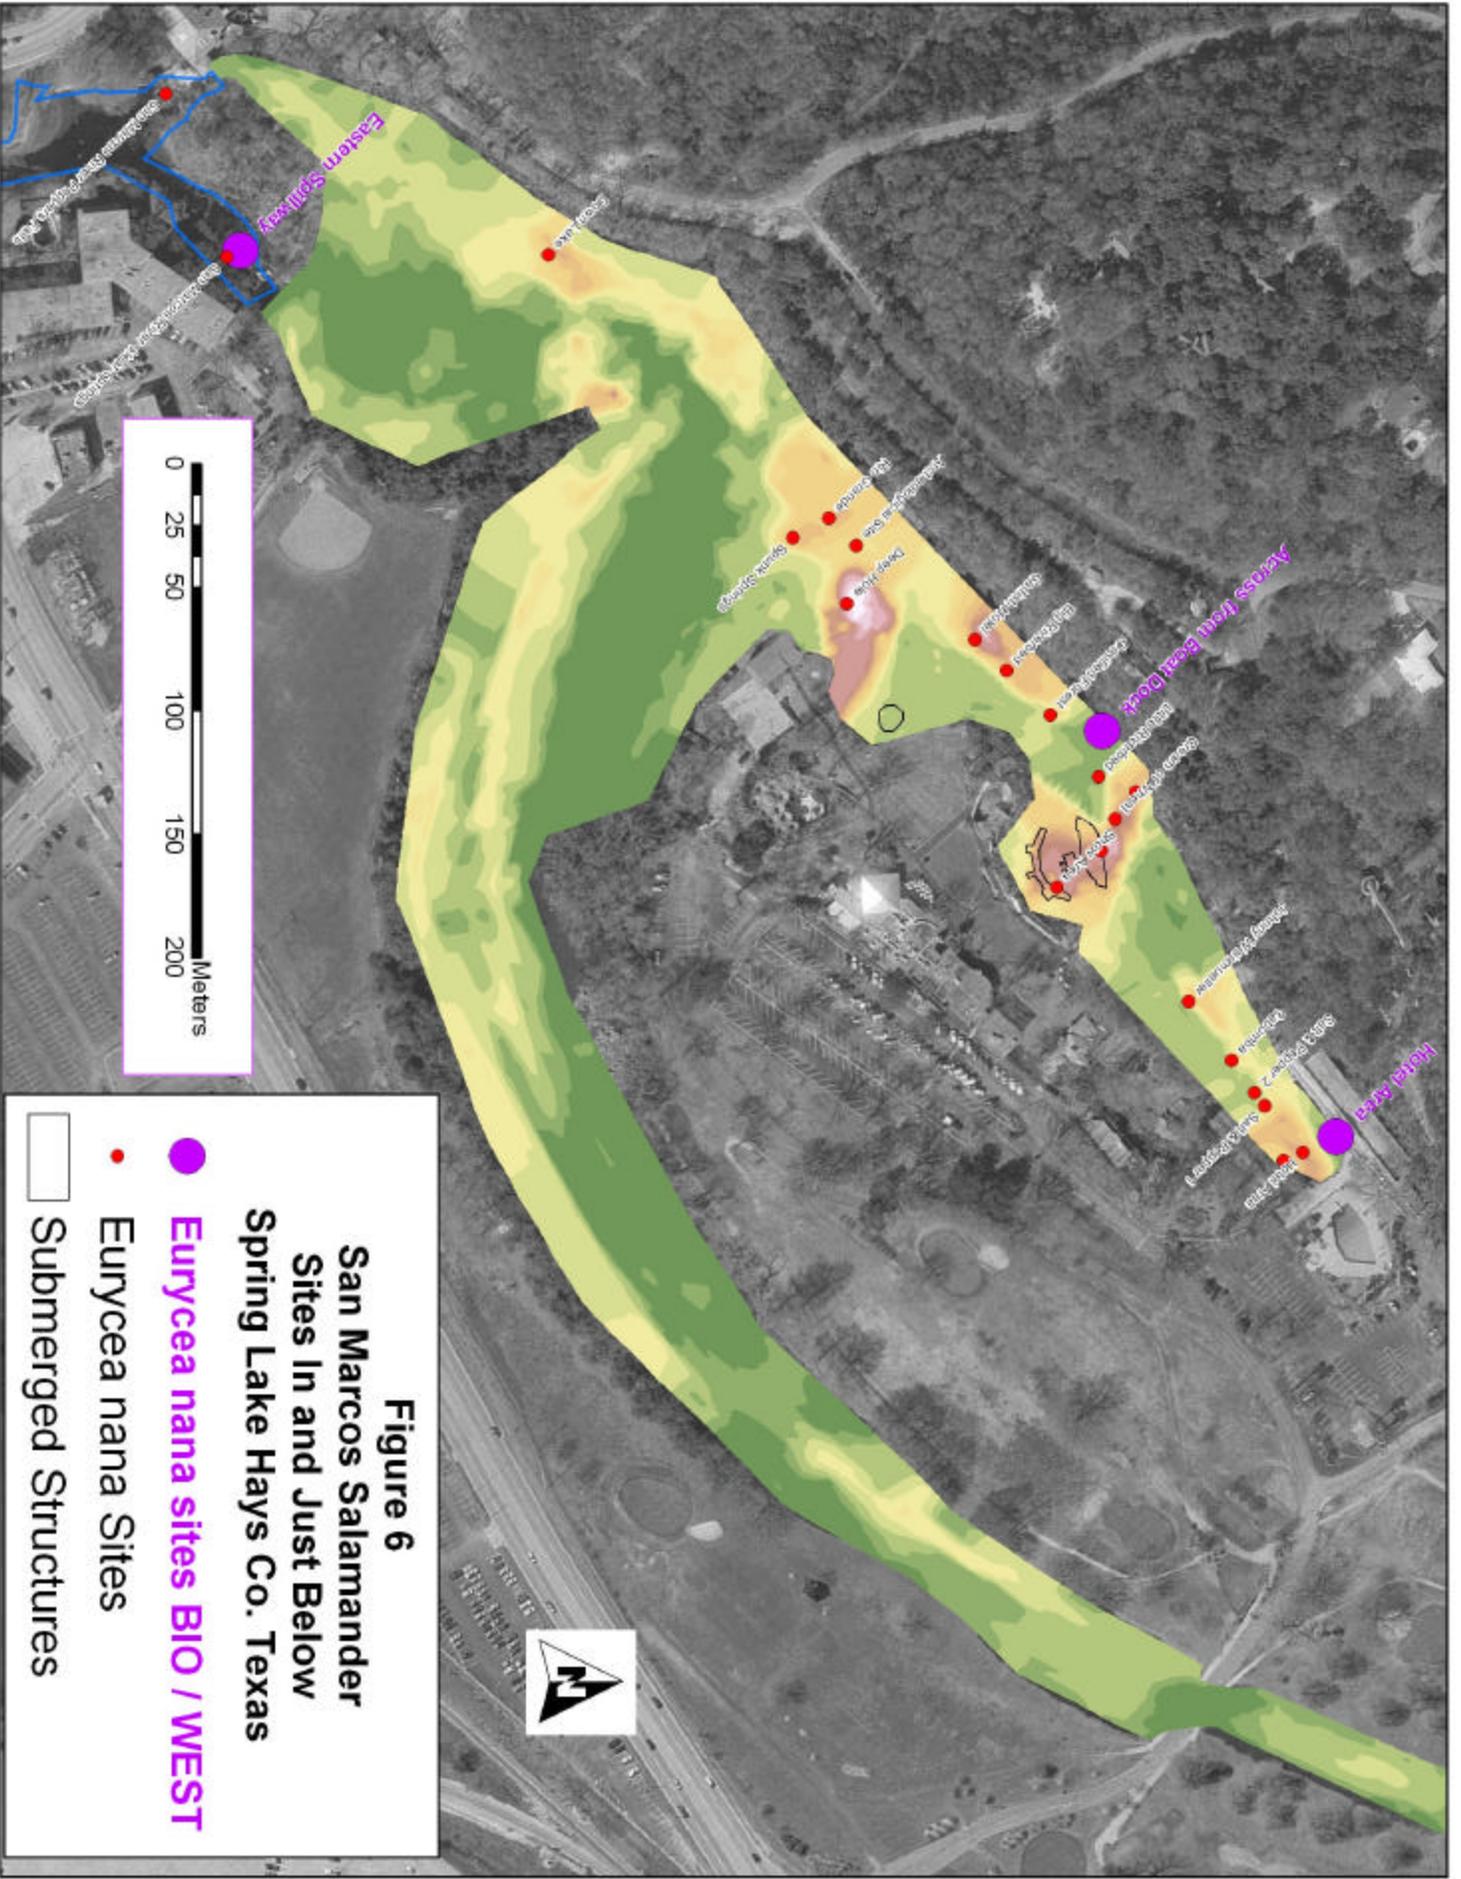
Figure 6
San Marcos Salamander Sites In and Just Below Spring Lake Hays Co. Texas

The San Marcos salamander (*Eurycea nana*) is a member of the family Plethodontidae (lungless salamanders) and is found only in spring dominated sections of Spring Lake and areas immediately downstream of Spring Lake. Sweet (1978) indicated that a population of *Eurycea* inhabiting Comal Springs in New Braunfels is very similar to *E. nana* and probably conspecific. However, recent biochemical, molecular, and morphometric studies (Chippindale et al. 1992, 1993, 1994) indicate that the salamander at Comal Springs is clearly a different species. The only other San Marcos salamander populations other than spring dominated portions of Spring Lake, are the two associated with the eastern and western spillways of Spring Lake Dam (Figure 6).

- *Eurycea nana* sites BIO / WEST
- *Eurycea nana* Sites
- Submerged Structures
