Mid-Brazos River Watershed Riparian Wildlife Habitat Evaluation

*U. S. Fish and Wildlife Service
Region 2*

July 2004

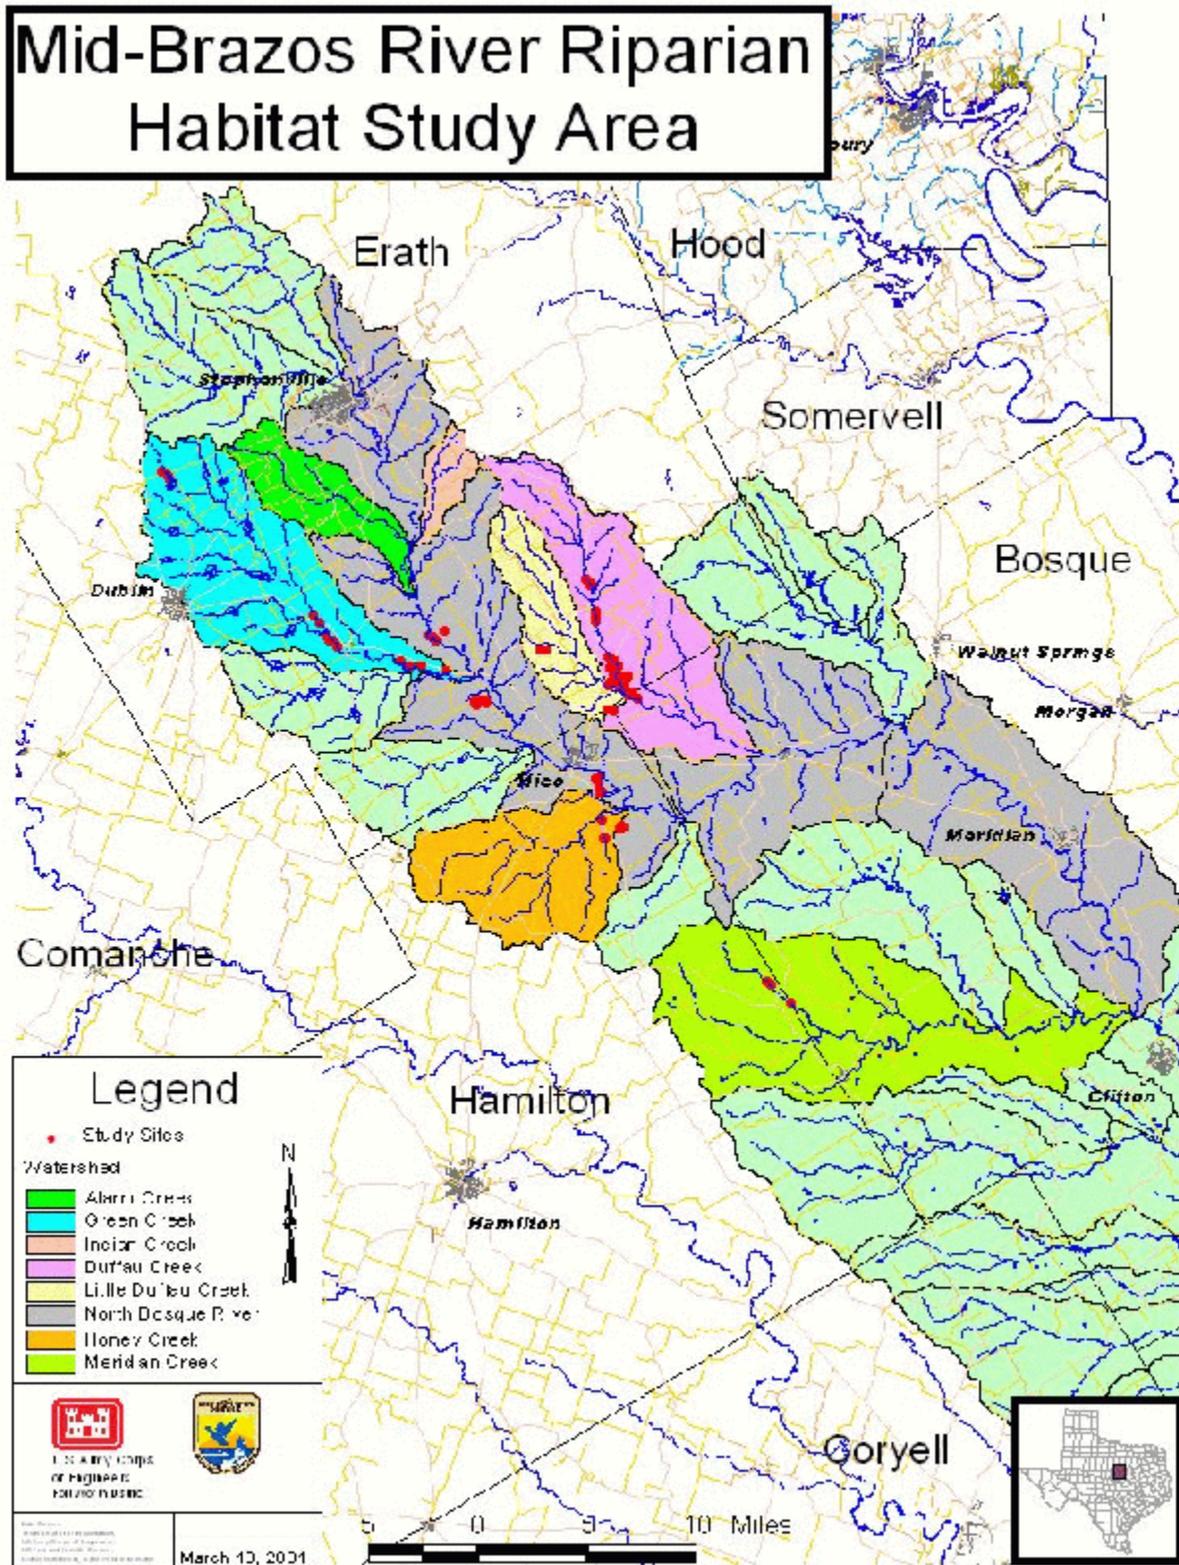
Page
Figure 1. The Mid-Brazos River Riparian Habitat Study Area	4
Figure 2. Distance from the Center of the Plot to a Major Topographical Change	16

Duffau, and Duffau Creeks and the main stem of the North Bosque River. None were located in the Indian Creek watershed which was included in the original study plan (Figure 1). The project sites on Stephenville and Meridian city-owned lands have since been divided into separate projects and are no longer included in this project. Thirteen of the volunteer sites are clustered along Duffau Creek, presenting an opportunity for an evaluation of the existing riparian habitat conditions at a landscape scale in the Duffau Watershed. (See Appendix F, Page F-1.) An interagency assessment team was formed to visit the sites and provide expert advice on each site's habitat restoration or enhancement potential. The team consisted of representatives from the Natural Resource Conservation Service, Texas State Soil and Water Conservation Board, Texas Farm Bureau, Tarleton State University, BRA, USACE, private landowners, and Service. A Service biologist participated in the project planning, public meetings, and assessment team. The Service provided preliminary field data results and restoration recommendations to the USACE after the field work was completed. The USACE developed draft habitat restoration plans for each landowner, which included a 25-year conservation easement agreement.
