Vanishing ponds/lakes show drying

by Ed Berg

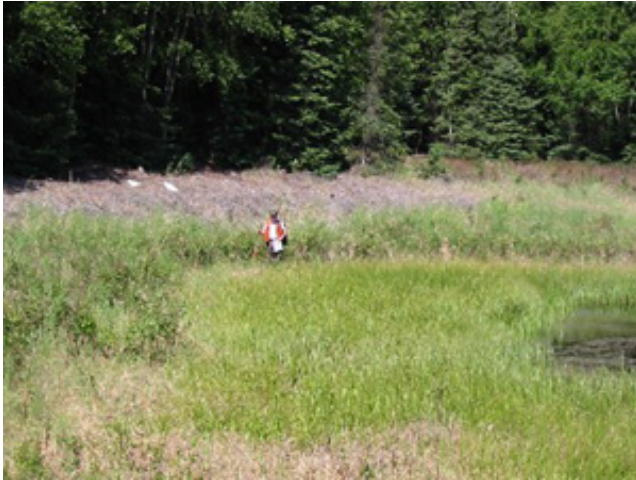
A pond where the water has fallen more than 10 feet in the last decade.

On the other extreme, we found a pair of ponds where the water has fallen more than 10 feet in the last decade (see photo). Less dramatically, we observed many former ponds and shallow lakes that were colored “blue” on the 1950 USGS topographic maps that are now simply grassy pans, often with small spruce and birch saplings poking up through the grass.
