**APPENDIX J:
HAZARDOUS TOXIC AND
RADIOACTIVE WASTE
ASSESSMENT**

J3: Appendices F-G

Appendix F

Observed Field Survey Sites
 Mid-Barataria Sediment Diversion
 Phase I Environmental Site Assessment
 Jefferson and Plaquemines Parish

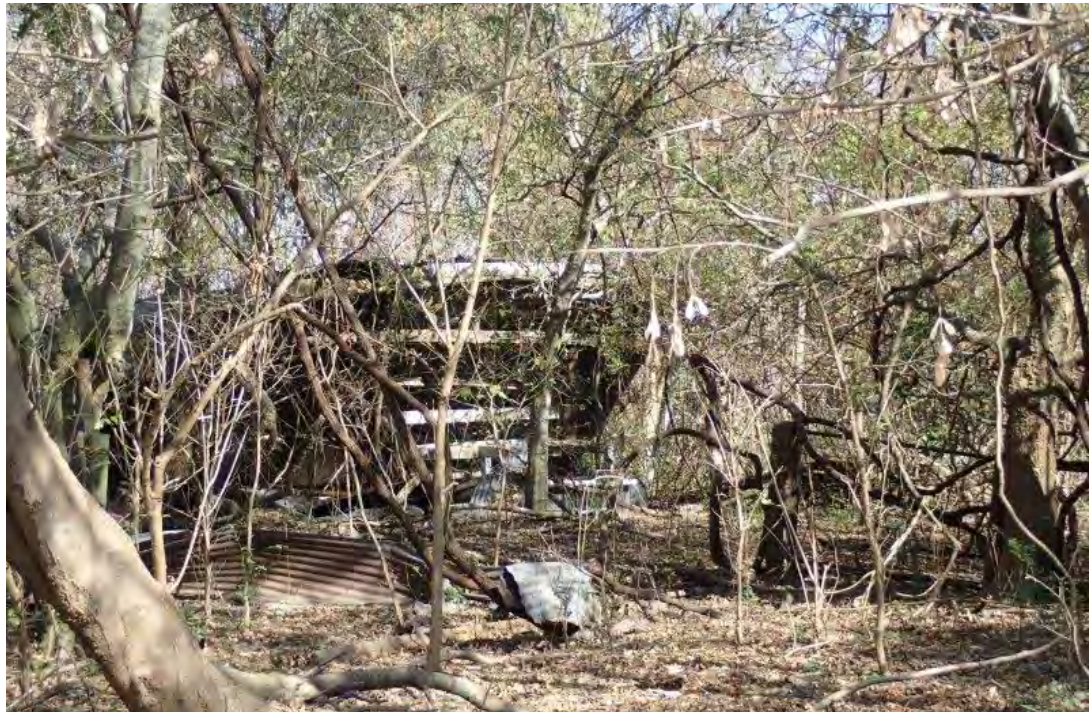
Photograph 65. Abandoned Barn
(29°39'49.62"N, 89°57'59.57"W)

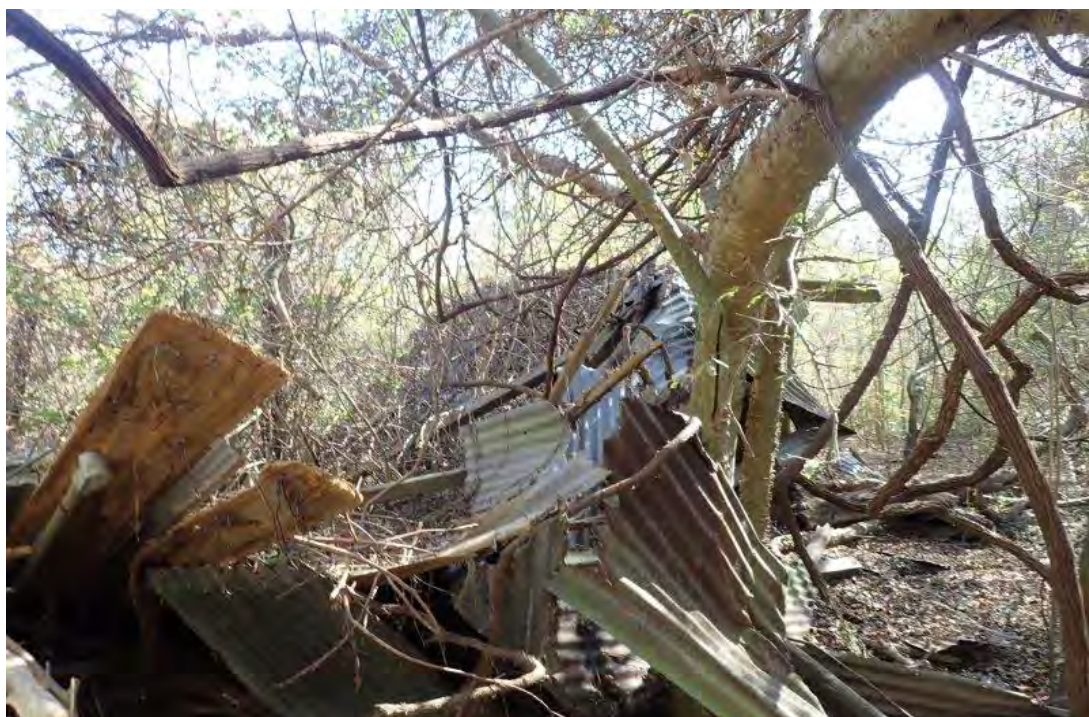
Photograph 66. Abandoned Barn

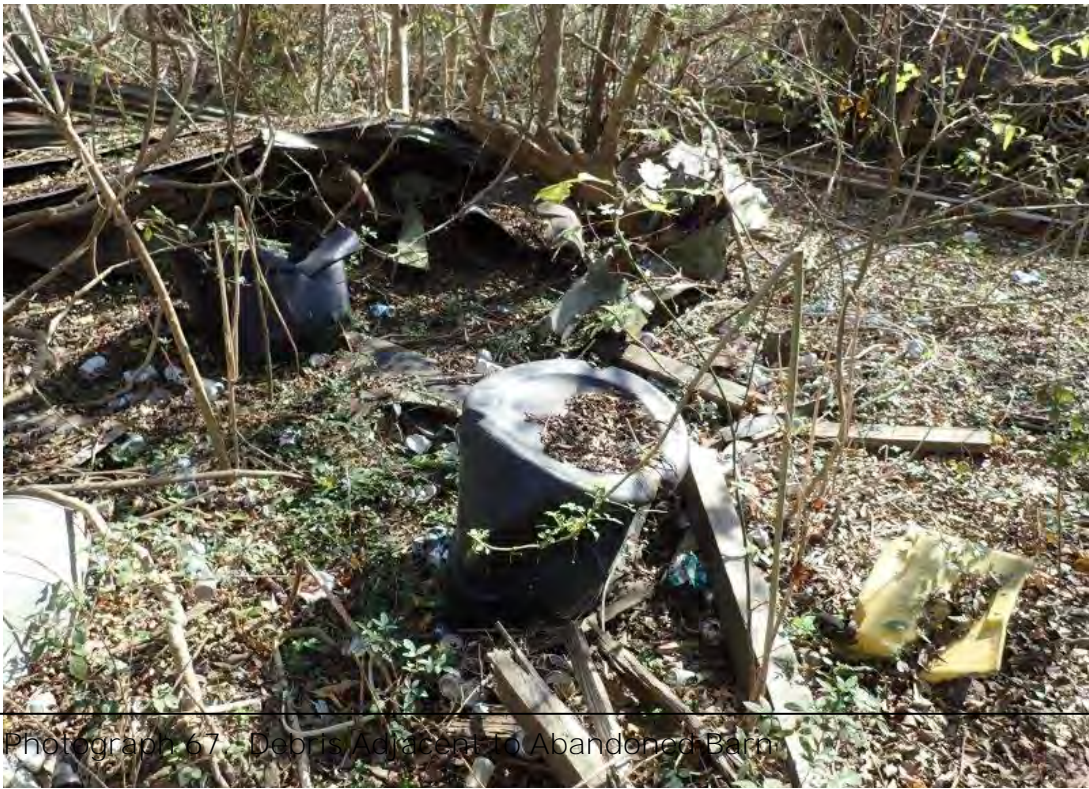
Photograph 67. Debris Adjacent to Abandoned Barn

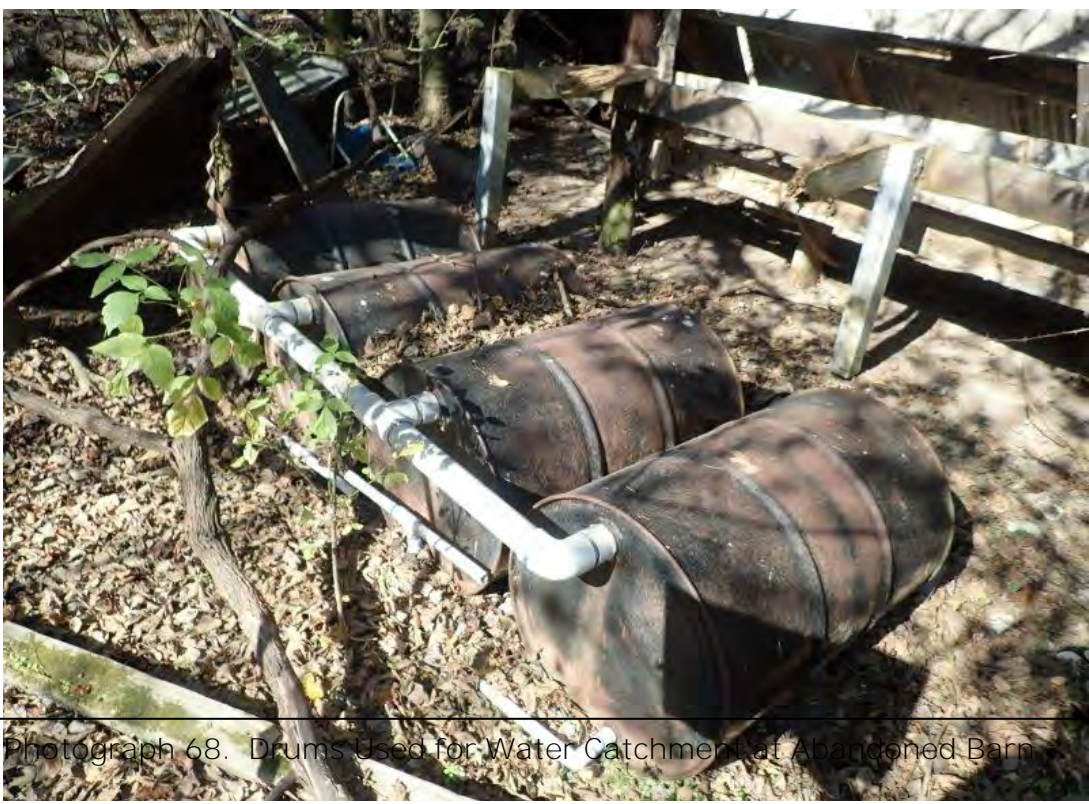
Photograph 68. Drums Used for Water Catchment at Abandoned Barn

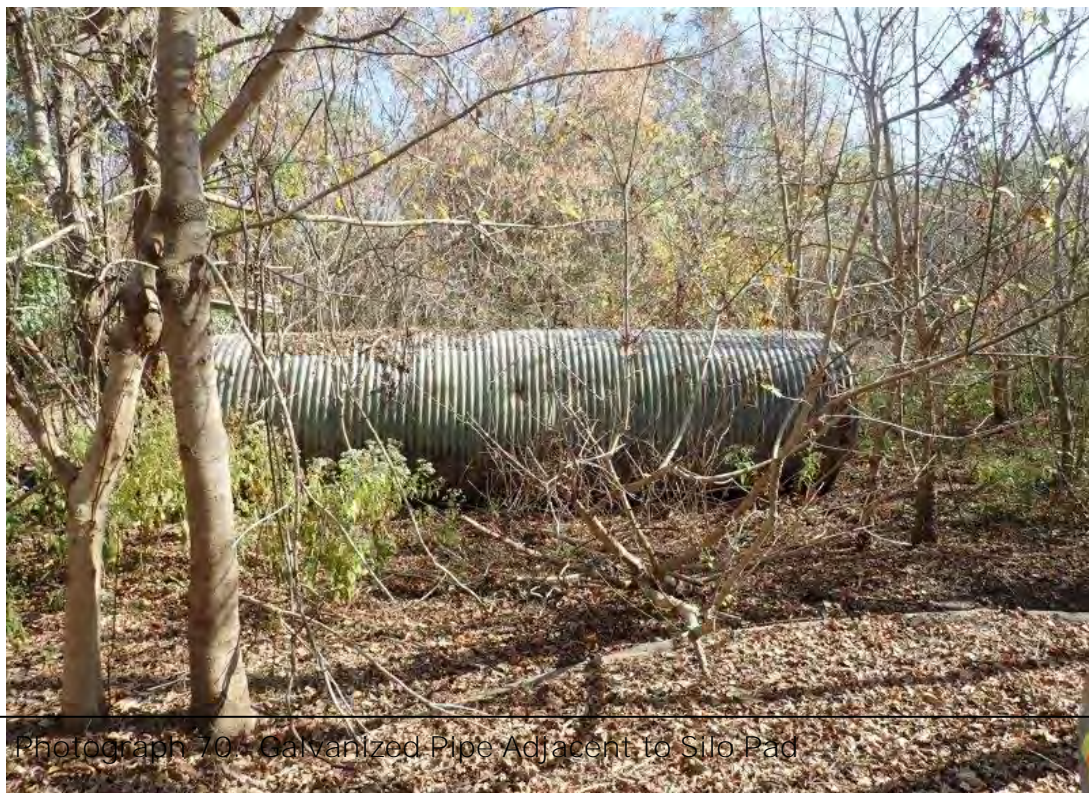
Photograph 70. Galvanized Pipe Adjacent to Silo Pad

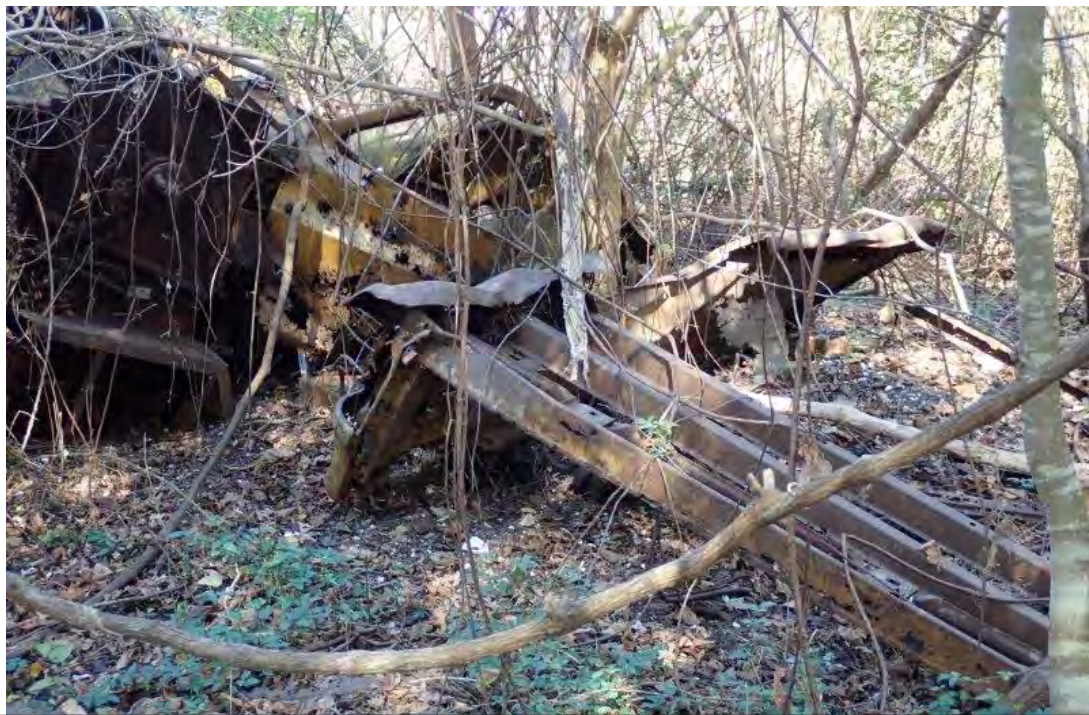
Photograph 73. Metal Waste Pile

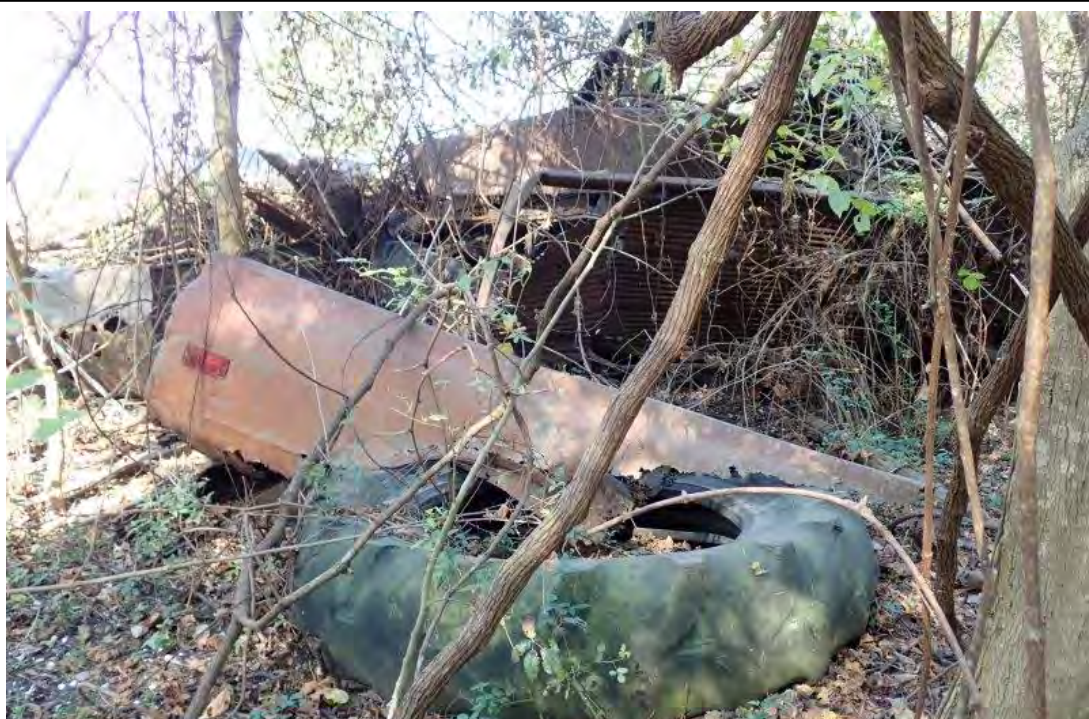
Photograph 74. Metal Waste Pile

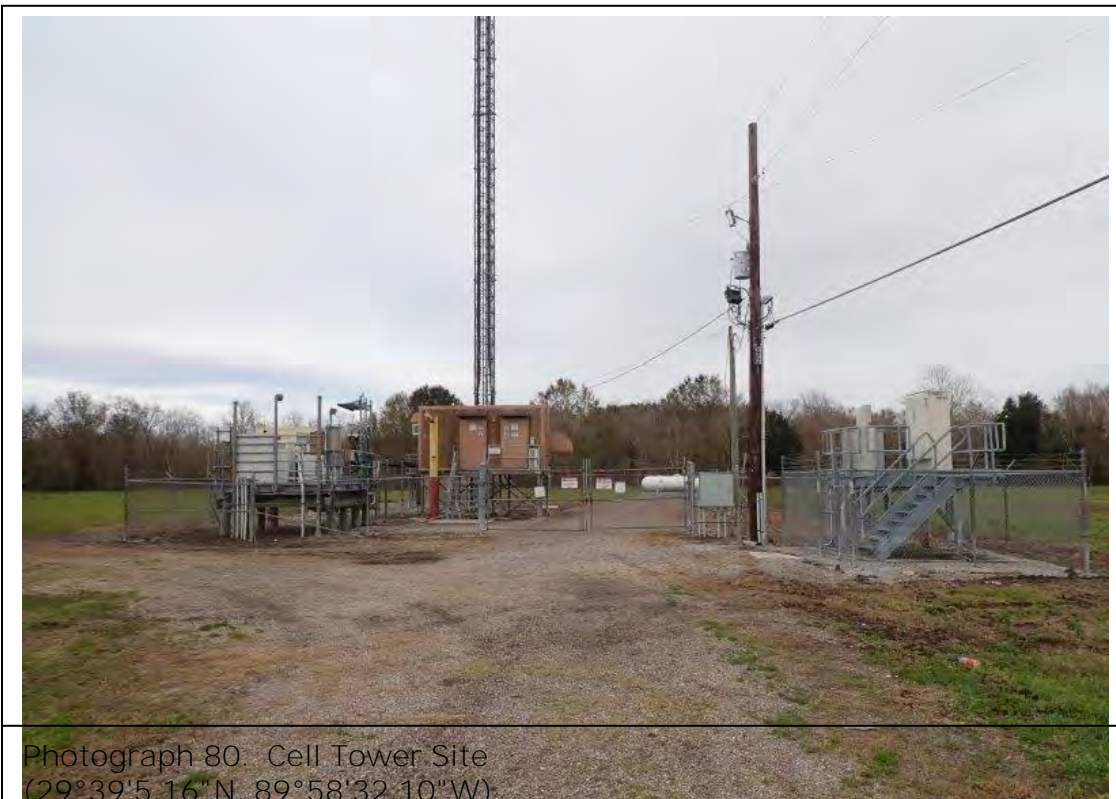
Photograph 80. Cell Tower Site
(29°39'5.16"N, 89°58'32.10"W)

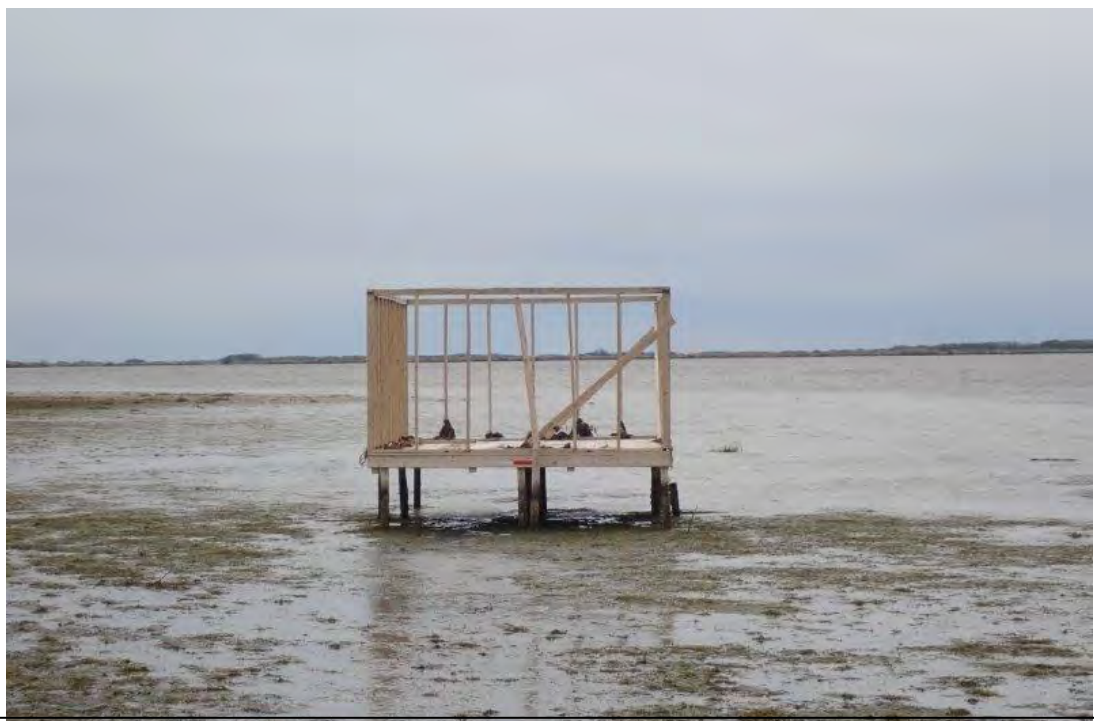
Photograph 83. Partially Constructed Camp
(29°38'35.02"N, 90°0'6.35"W)

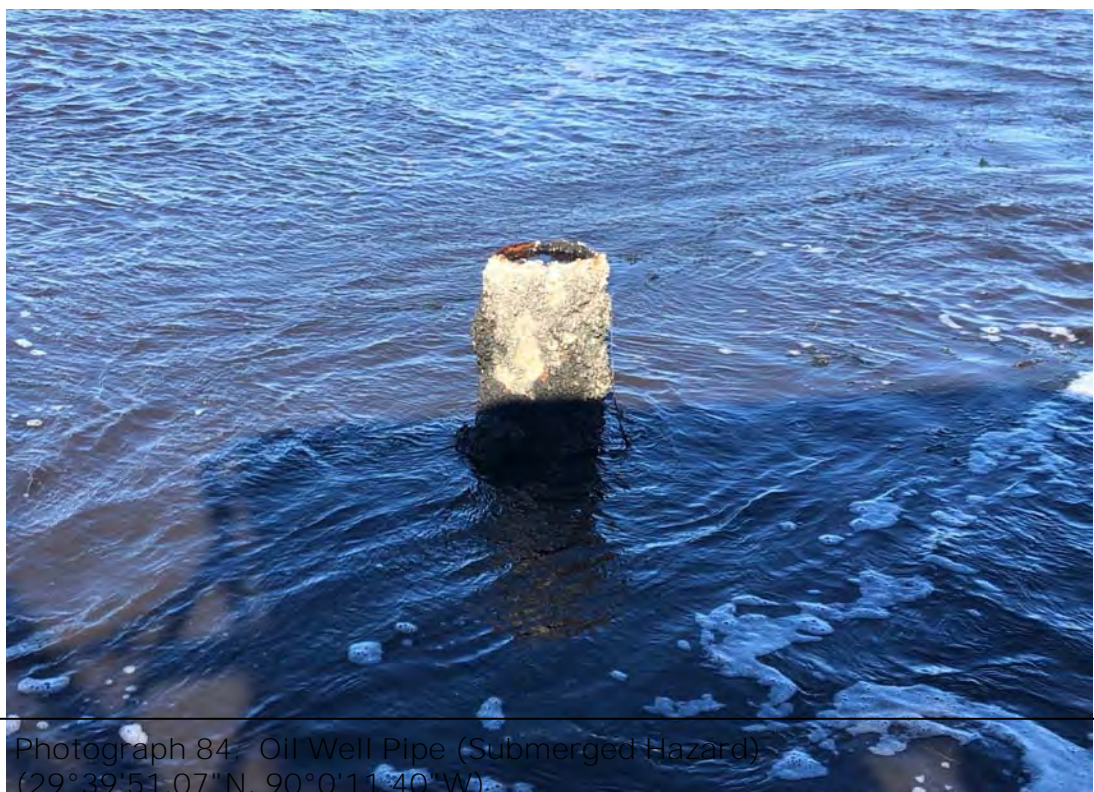
Photograph 84. Oil Well Pipe (Submerged Hazard)
(29°39'51.07"N, 90°0'11.40"W)

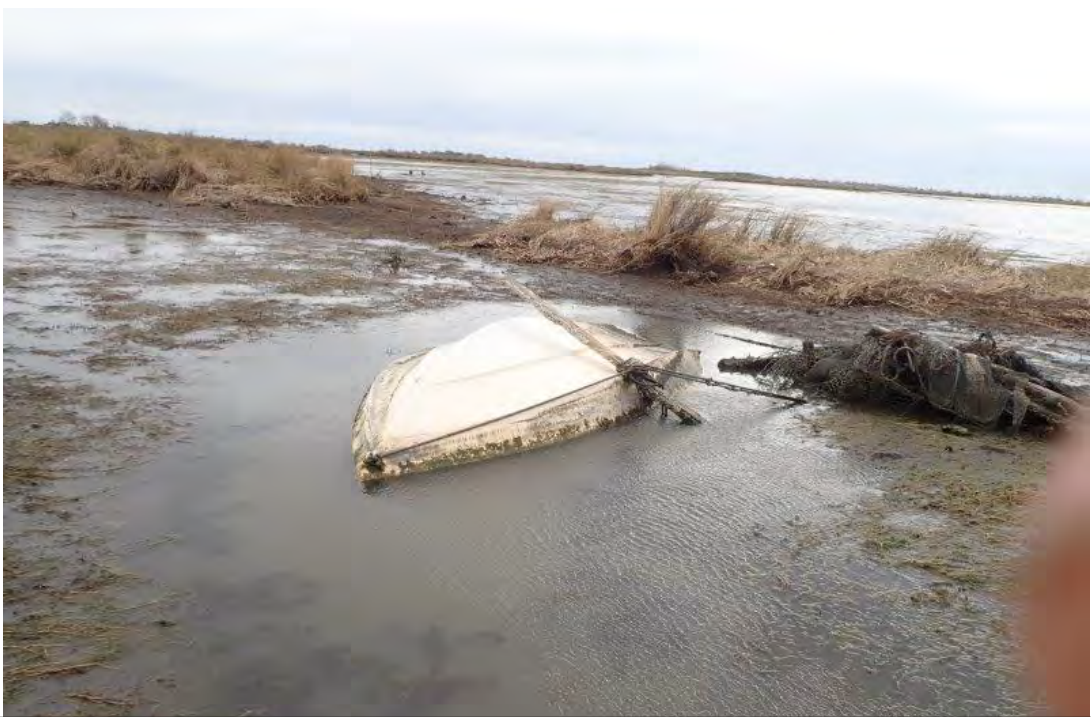
Photograph 85. Site 1: Capsized Boat
(29°37'46.83"N, 89°58'59.19"W)

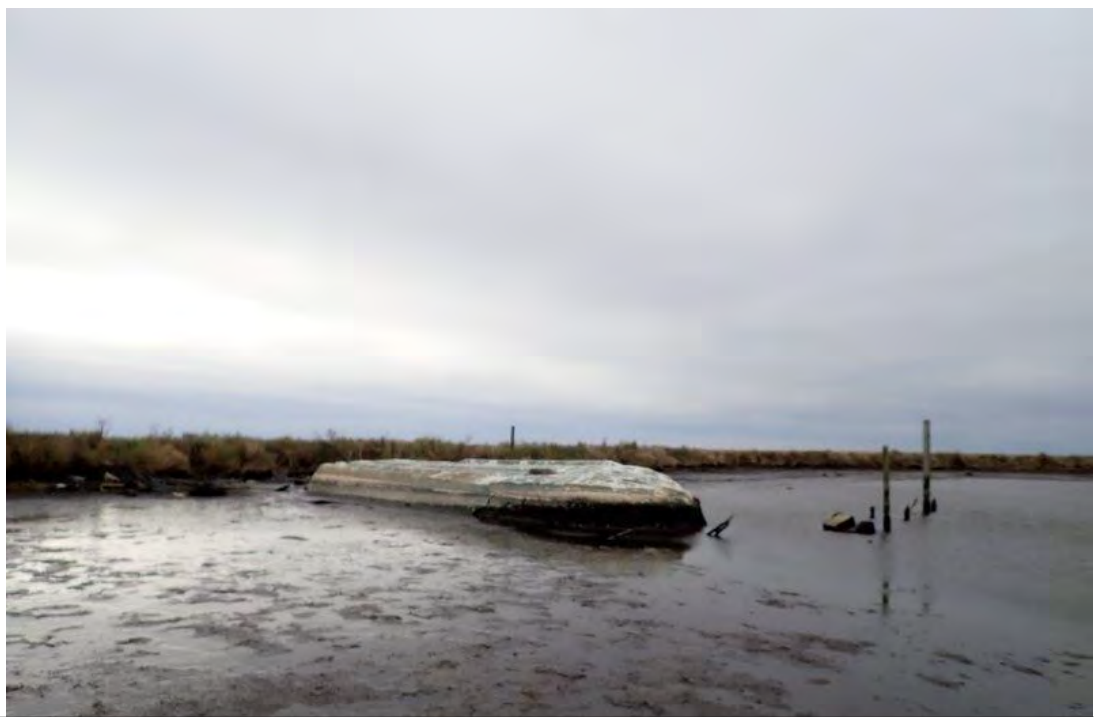
Photograph 91. Site 4: Capsized Boat
(29°35'20.83"N, 89°58'28.13"W)

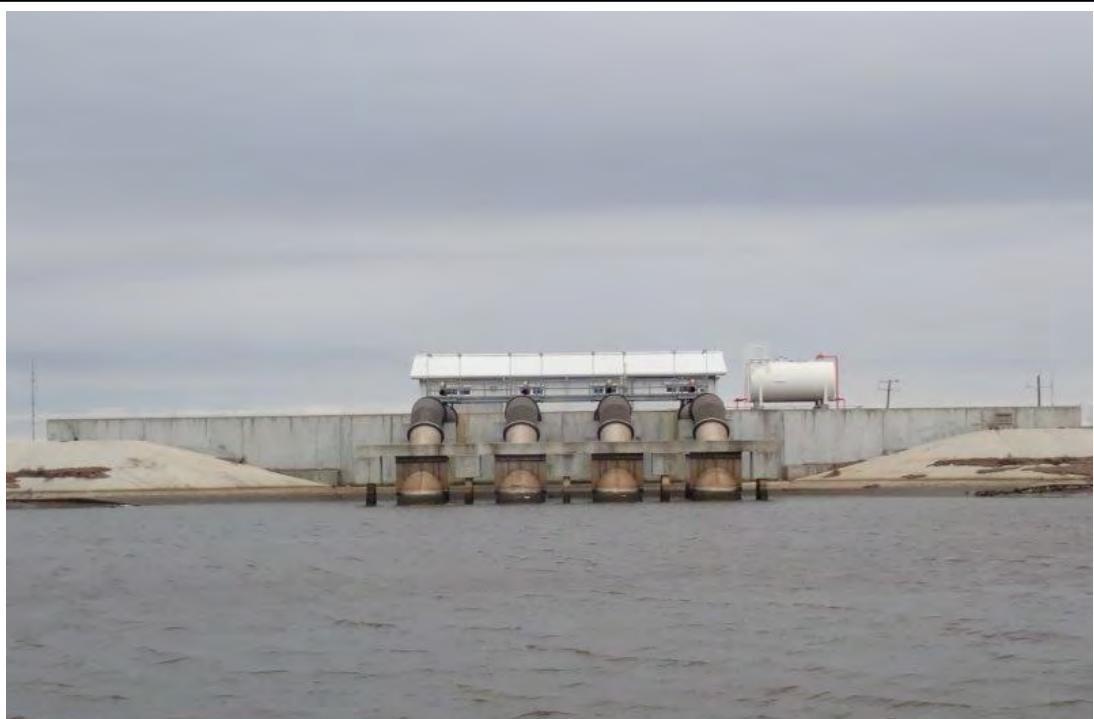
Photograph 92. Site 5: Myrtle Grove Pump Station
(29°37'22.64"N, 89°57'20.24"W)

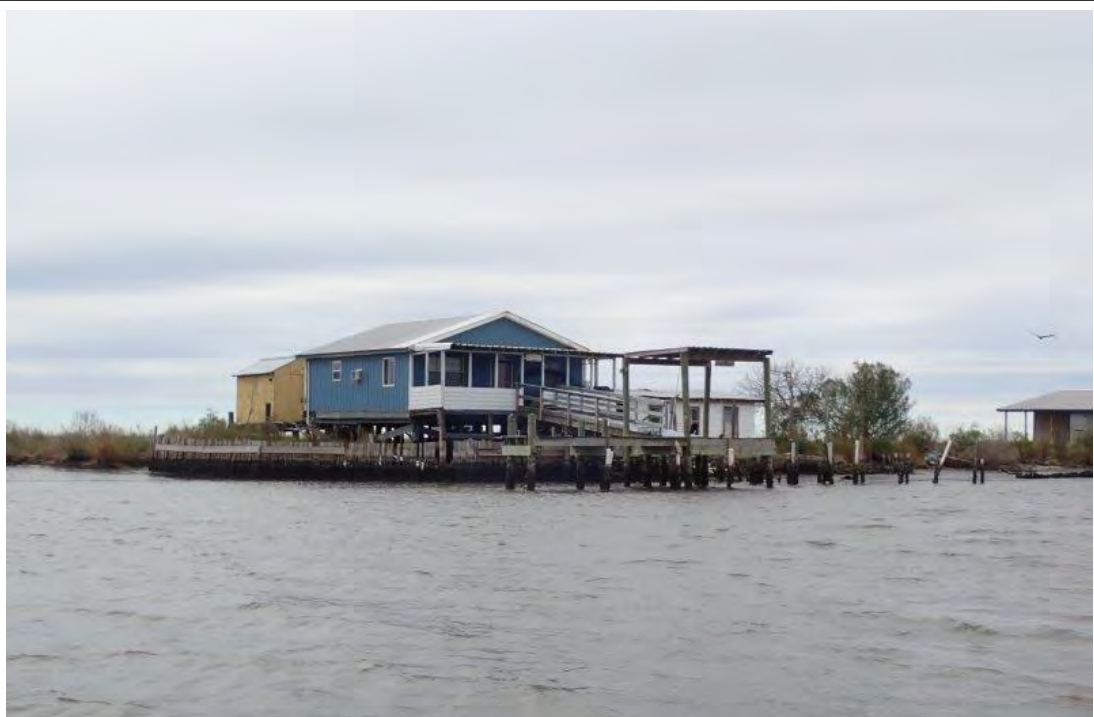
Photograph 93. Site 6: Multiple Camp Structures
(29°36'1.46"N, 89°57'14.04"W)

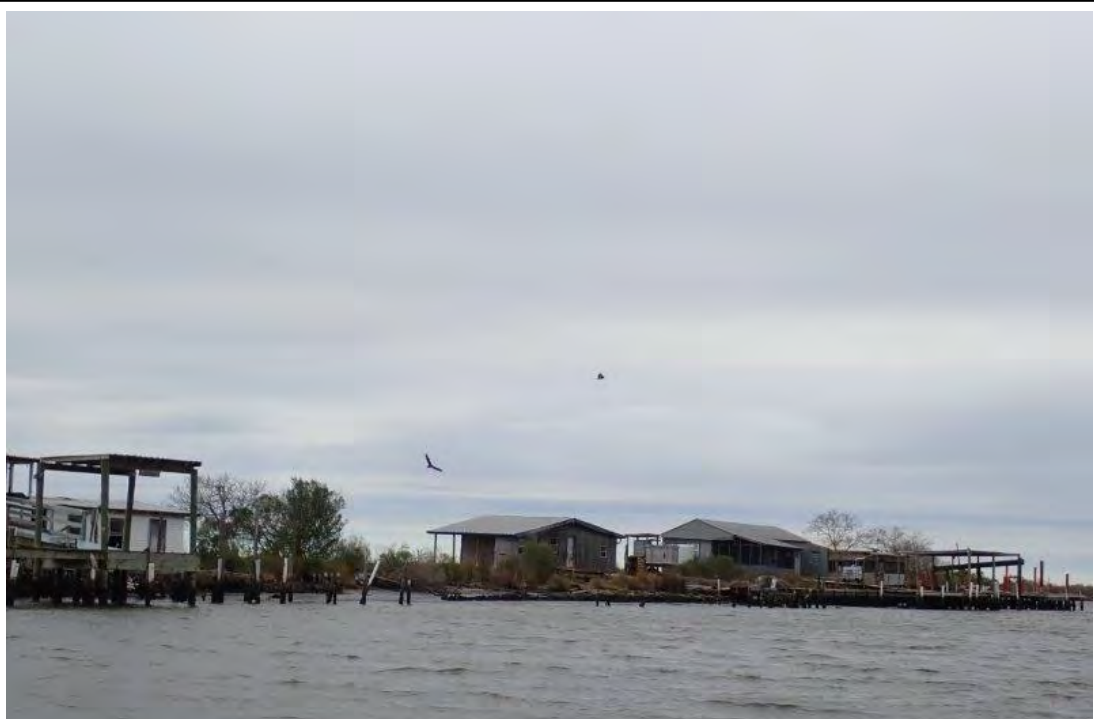
Photograph 94. Site 6: Multiple Camp Structures

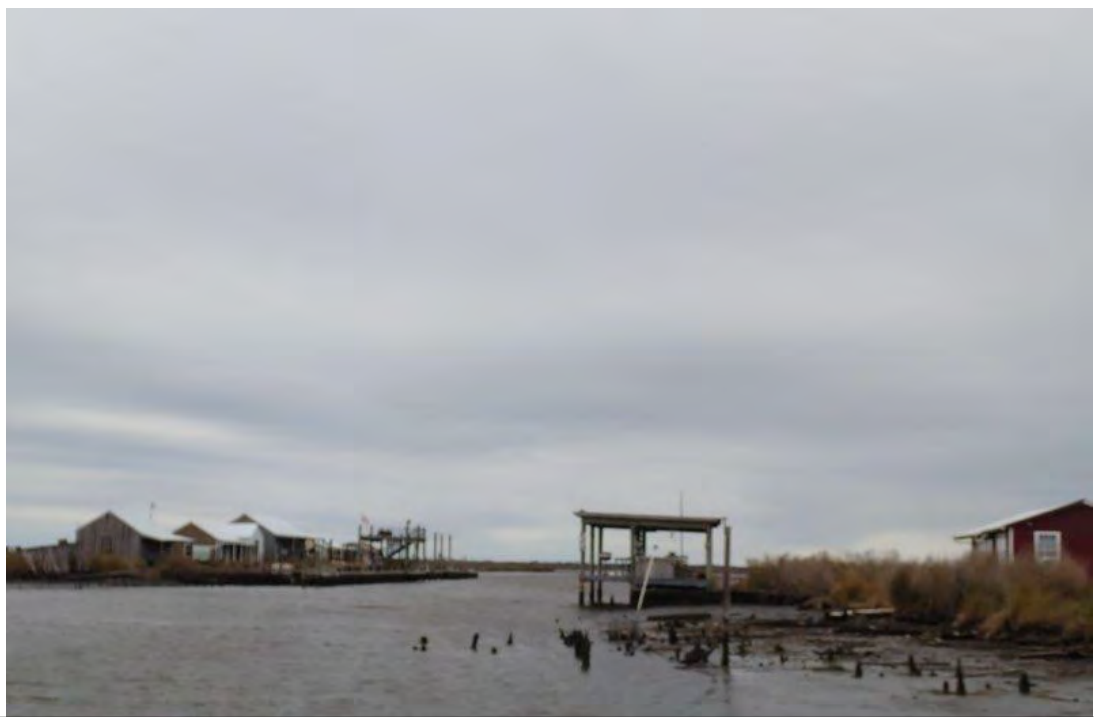
Photograph 95. Site 7: Multiple Camp Structures
(29°35'31.93"N, 89°56'38.79"W)

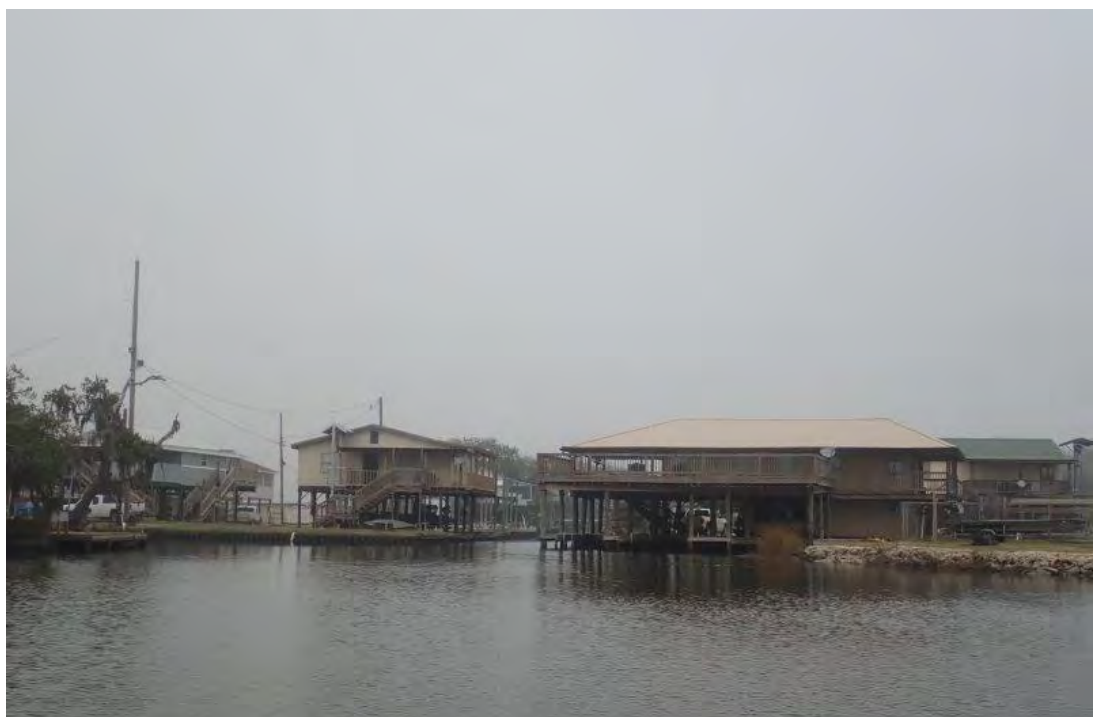
Photograph 96. Site 8: Camps Along Lake Hermitage Road
(29°35'36.24"N, 89°54'28.14"W)

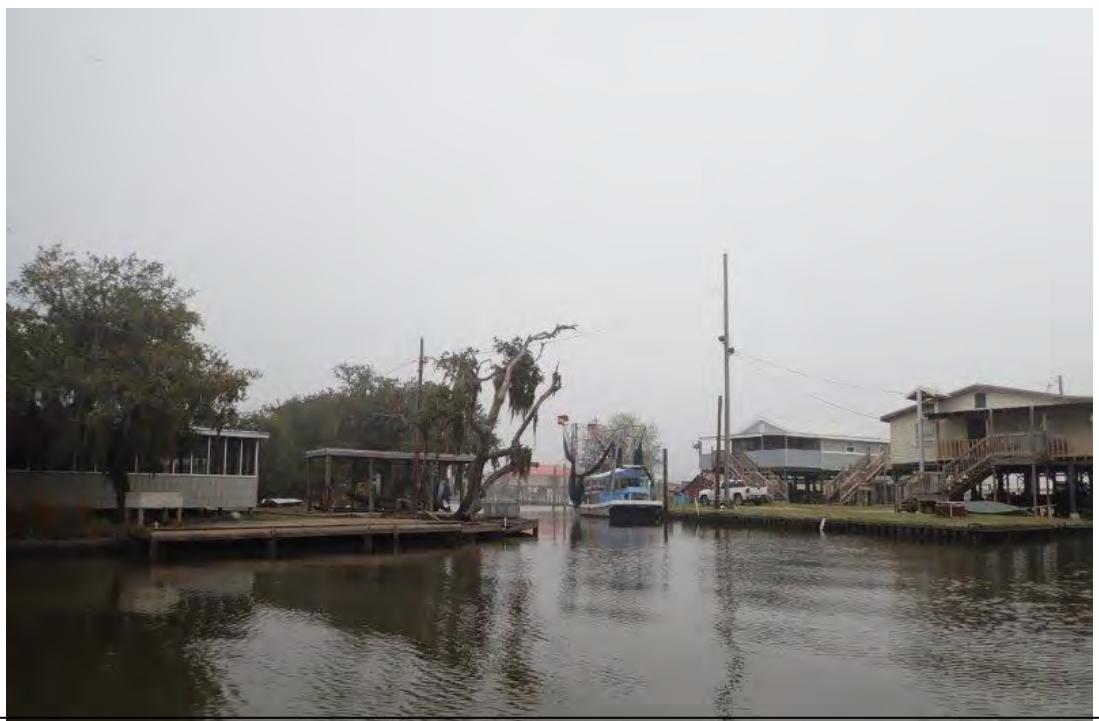
Photograph 97. Site 8: Grouping of Camps Along Lake Hermitage Road

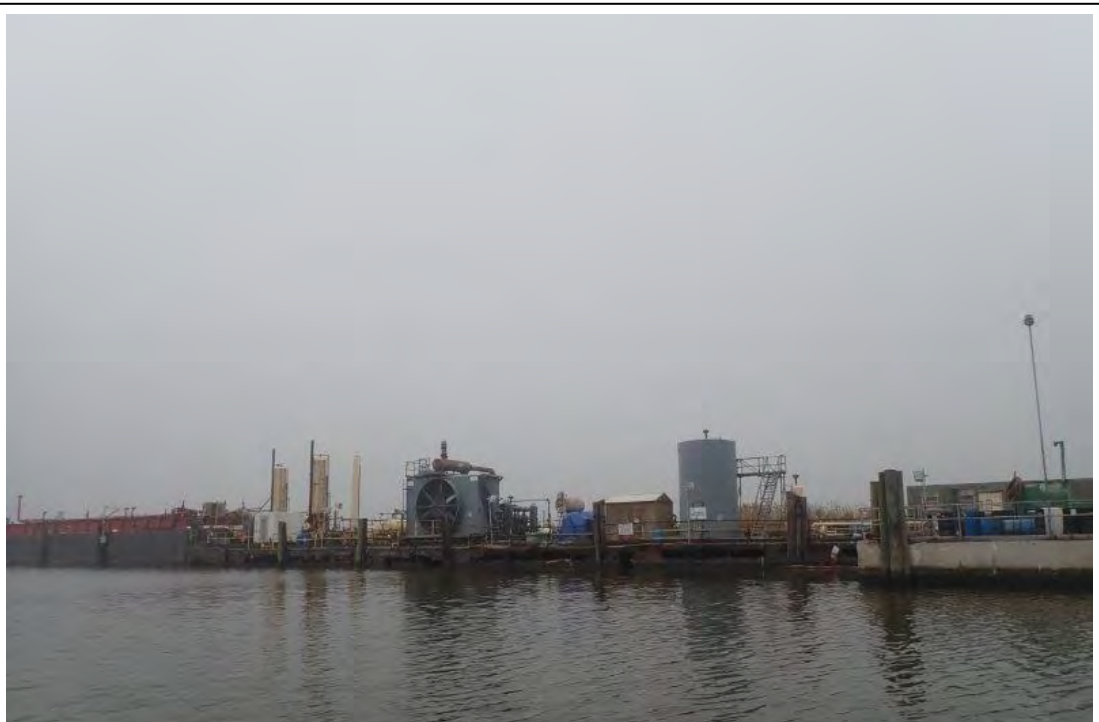
Photograph 98. Site 9: Oil Field Facility on Barges
(29°33'17.01"N, 89°54'14.32"W)

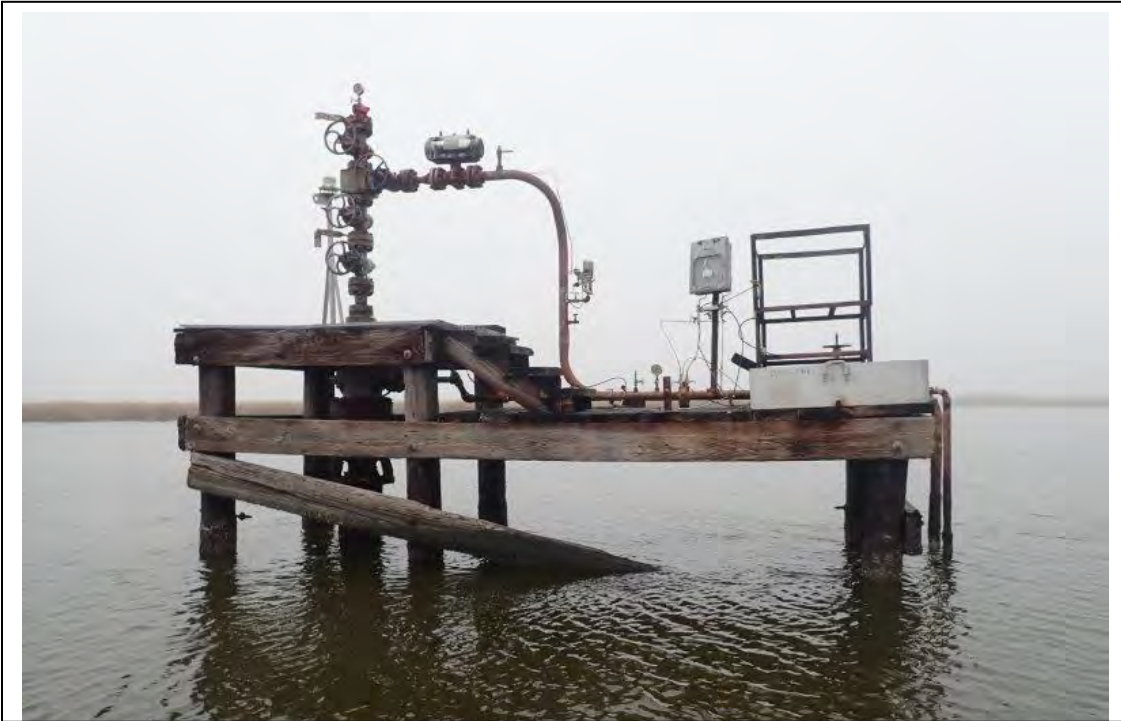
Photograph 99. Site 10: Well Platform
(29°33'2.33"N, 89°54'36.00"W)

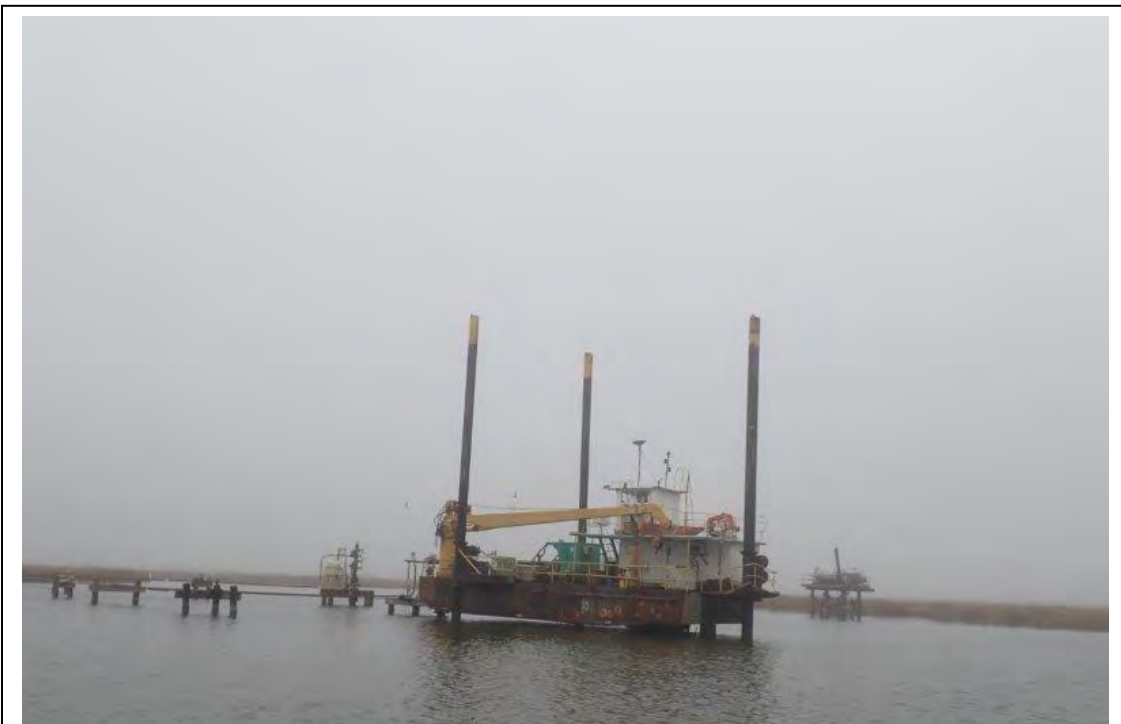
Photograph 100. Site 11: Well Field Structures
(29°32'33.60"N, 89°53'32.08"W)

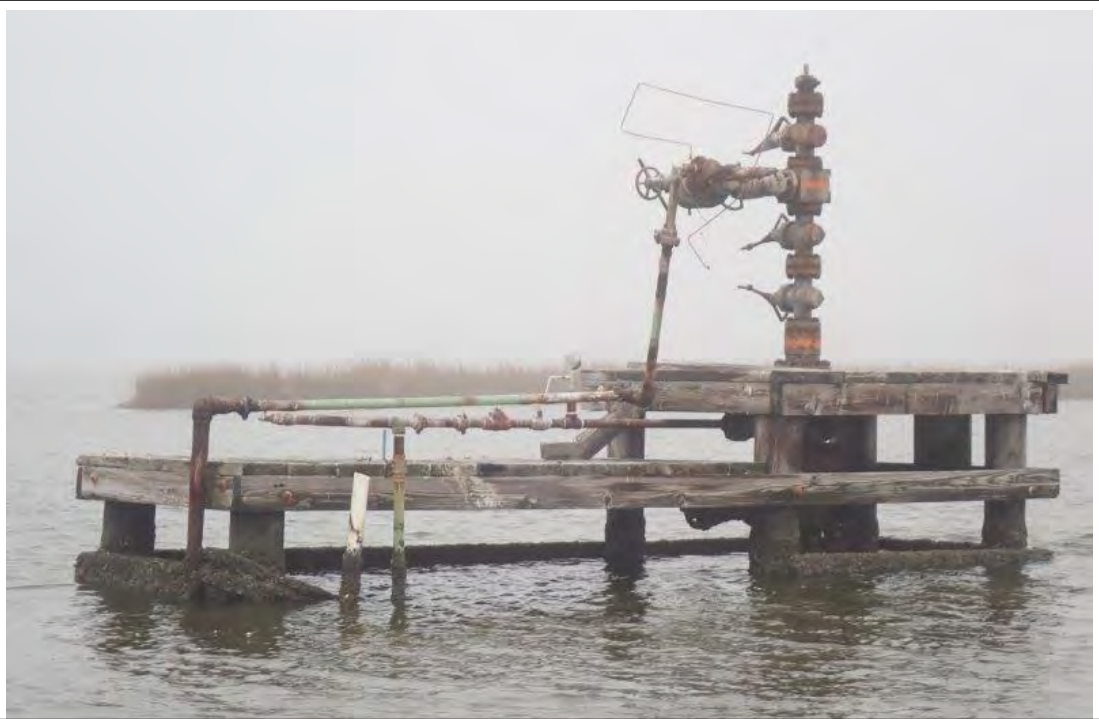
Photograph 101. Site 12: Well Platform
(29°31'52.16"N, 89°54'12.25"W)

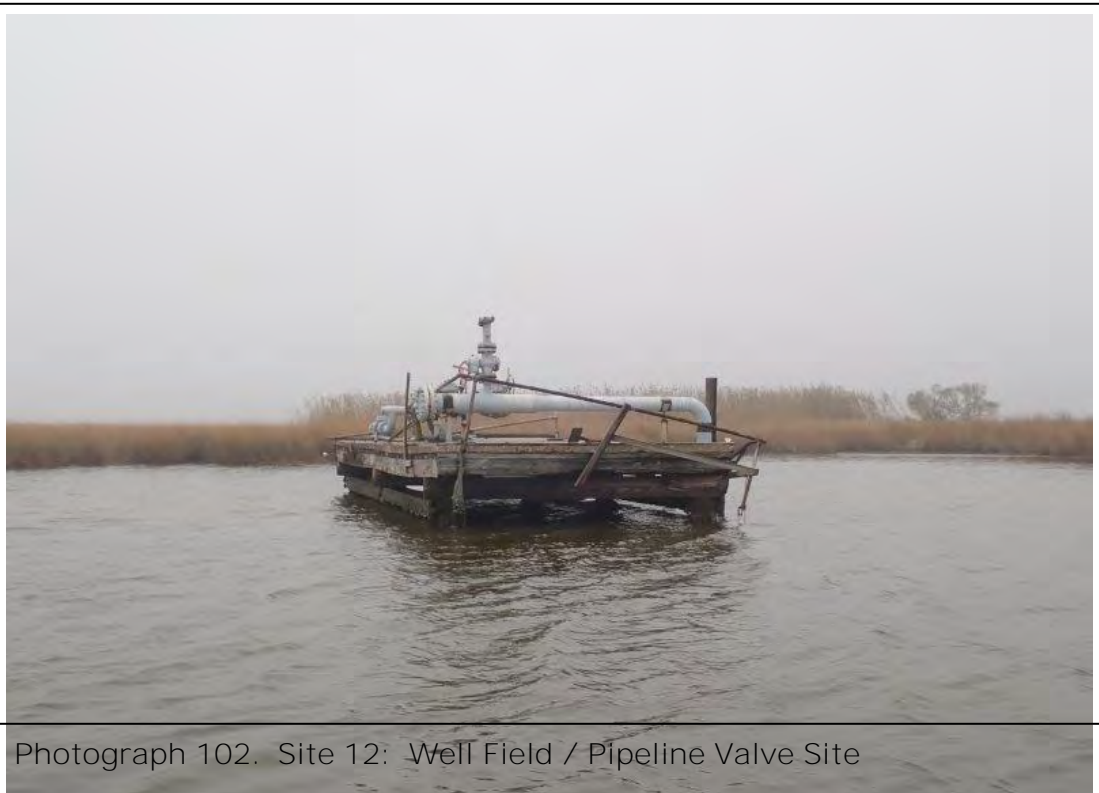
Photograph 102. Site 12: Well Field / Pipeline Valve Site

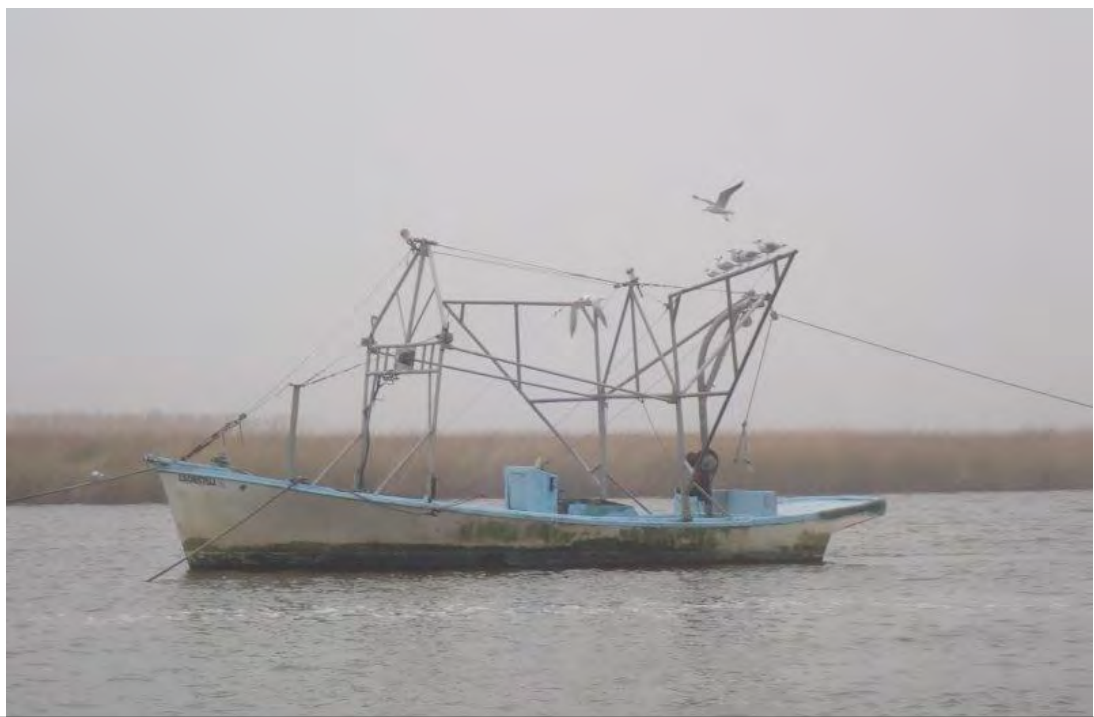
Photograph 103. Site 13: Moored Shrimp Boat
(29°31'46.20"N, 89°54'5.84"W)

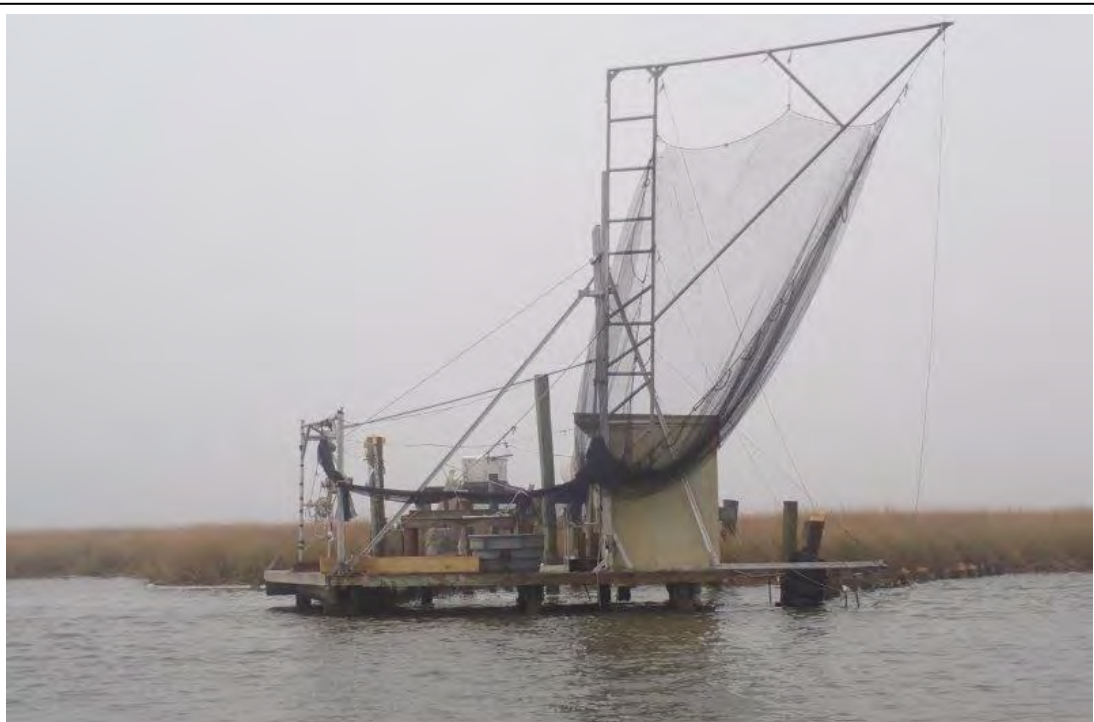
Photograph 104. Site 14: Shrimp Net Platform
(29°31'38.24"N, 89°54'12.39"W)

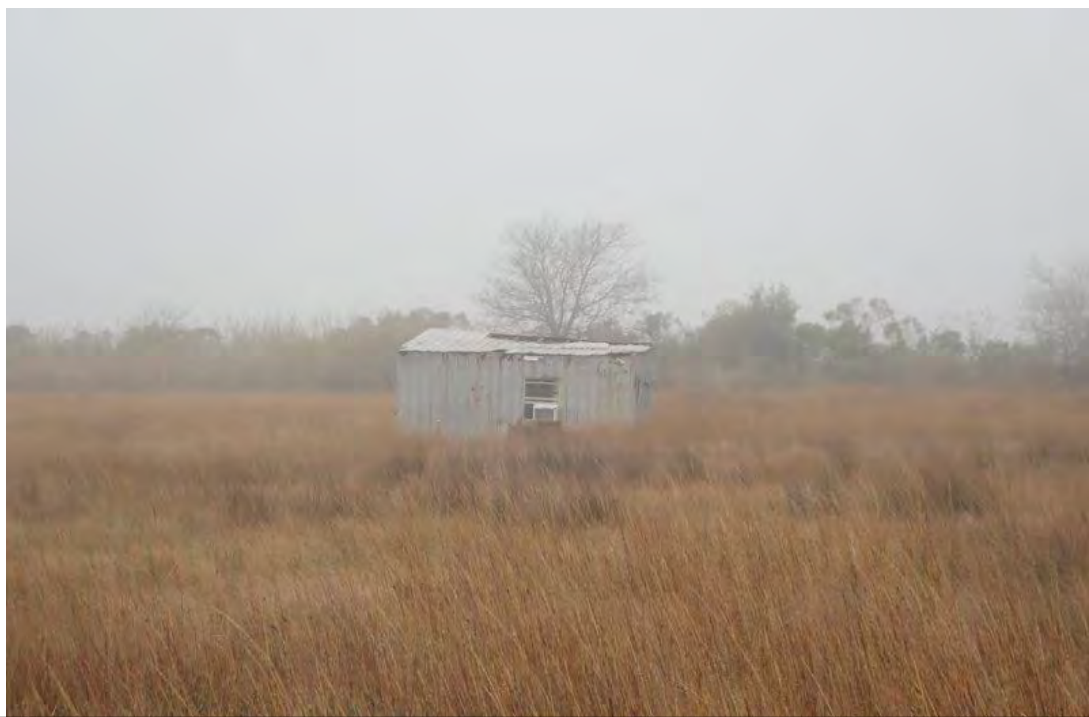
Photograph 105. Site 15: Displaced Camp Structure
(29°31'44.24"N, 89°54'15.17"W)

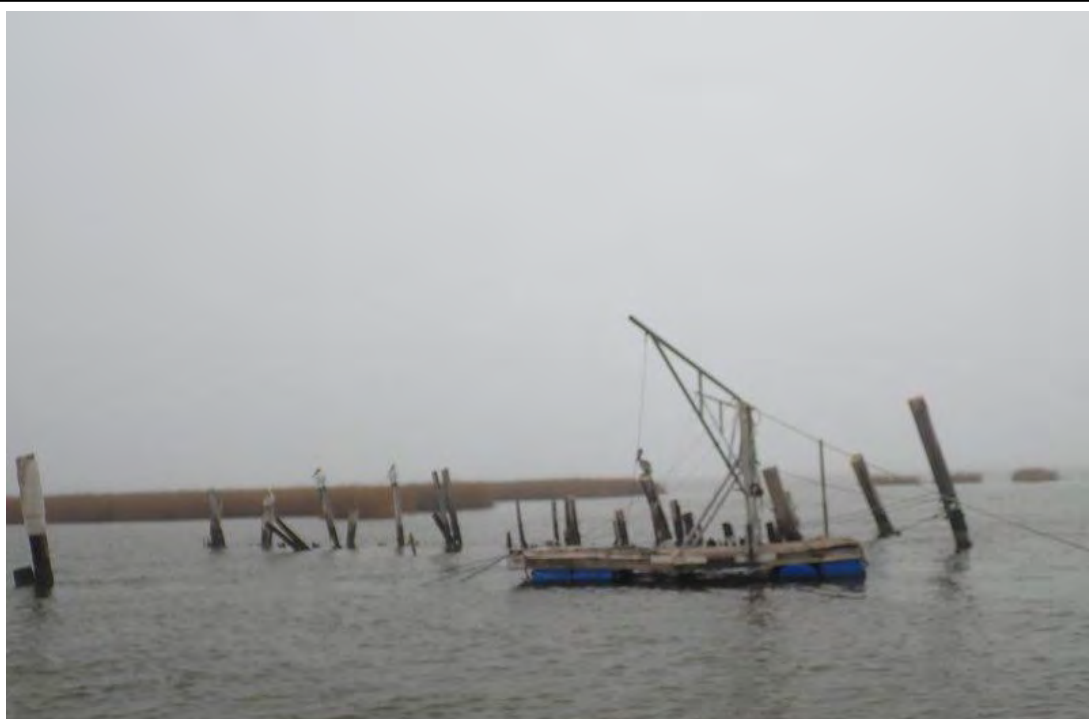
Photograph 106. Site 16: Shrimp Net Platform and Pilings
(29°32'12.28"N, 89°54'9.78"W)

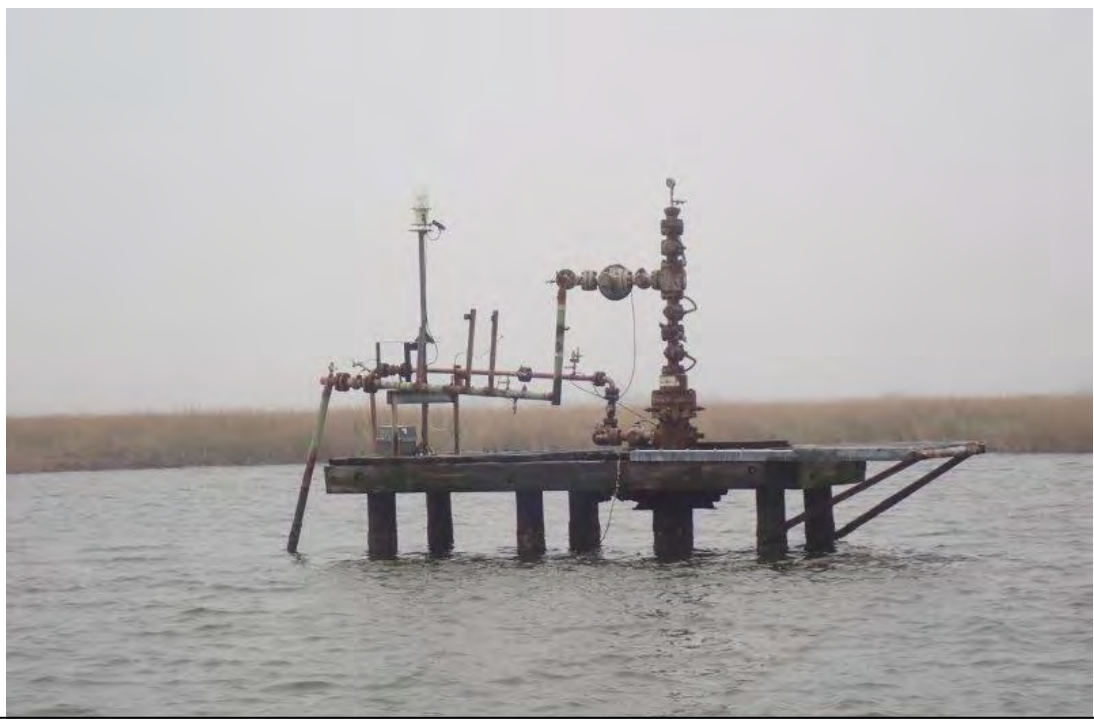
Photograph 107. Site 17: Well Platform
(29°32'19.86"N, 89°54'22.60"W)
