**APPENDIX J:
HAZARDOUS TOXIC AND
RADIOACTIVE WASTE
ASSESSMENT**

J3: Appendices F-G

Appendix F

Observed Field Survey Sites
 Mid-Barataria Sediment Diversion
 Phase I Environmental Site Assessment
 Jefferson and Plaquemines Parish

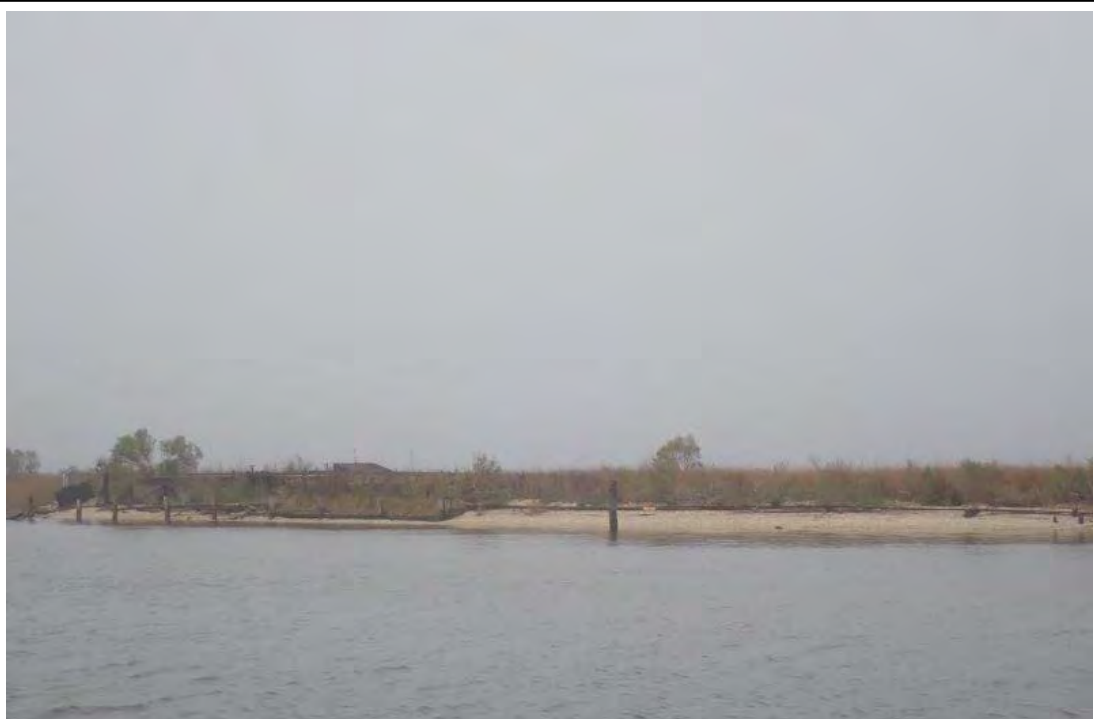
Photograph 108. Site 18: Damaged Oil Field Facility
(29°32'22.89"N, 89°54'16.42"W)

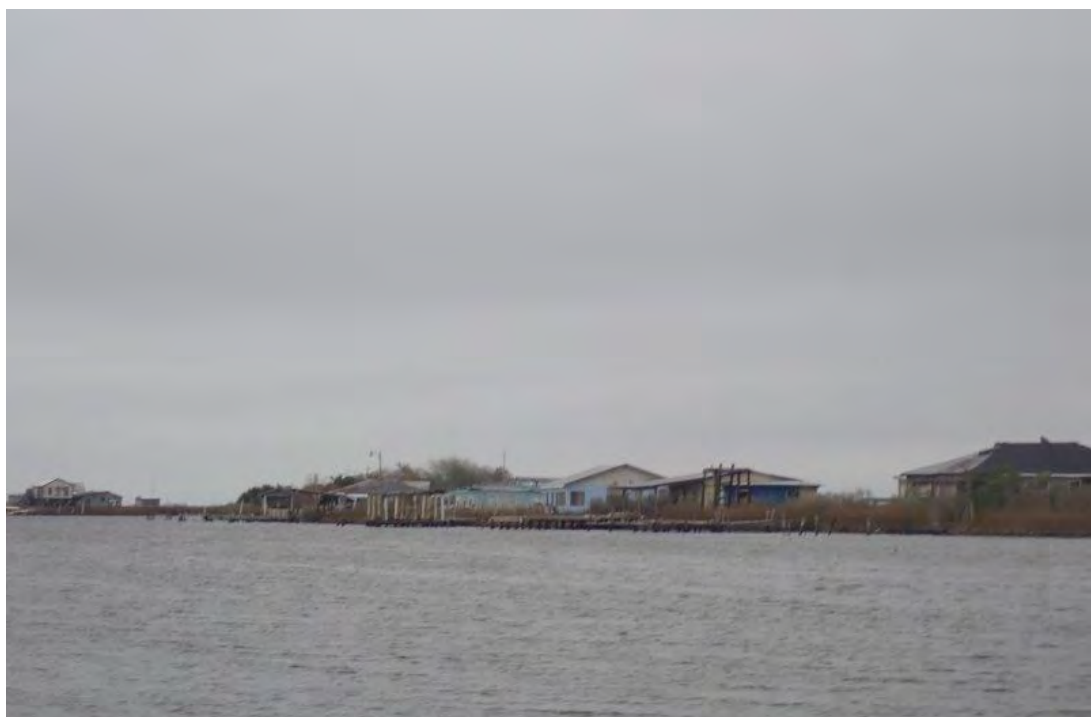
Photograph 112. Site 20: Grouping of Camps
(29°32'38.78"N, 90°1'56.68"W)

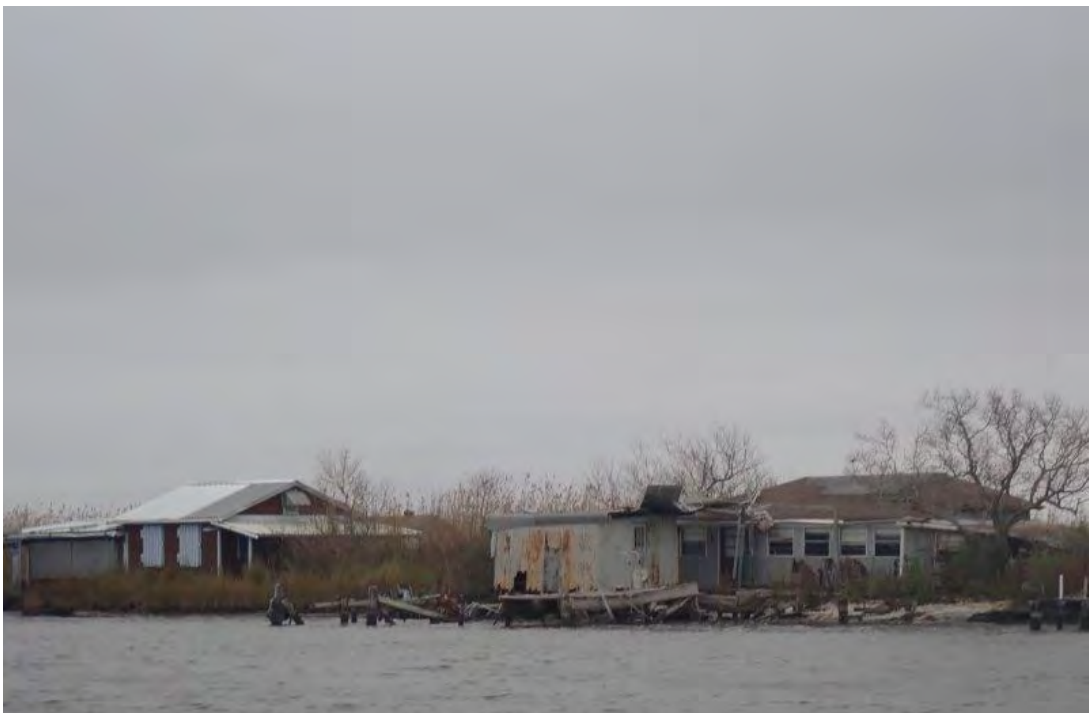
Photograph 113. Site 21: Grouping of Camps
(29°33'8.49"N, 90°1'25.49"W)

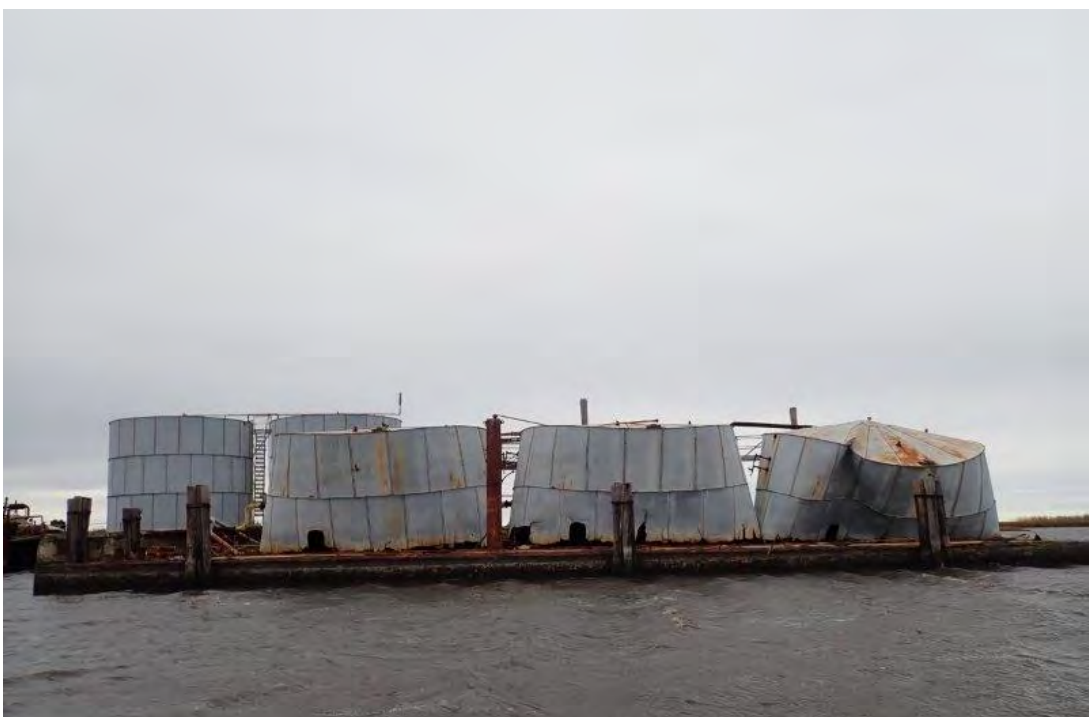
Photograph 114. Site 22: Damaged Oil Field Facility
(29°30'39.01"N, 89°59'9.13"W)

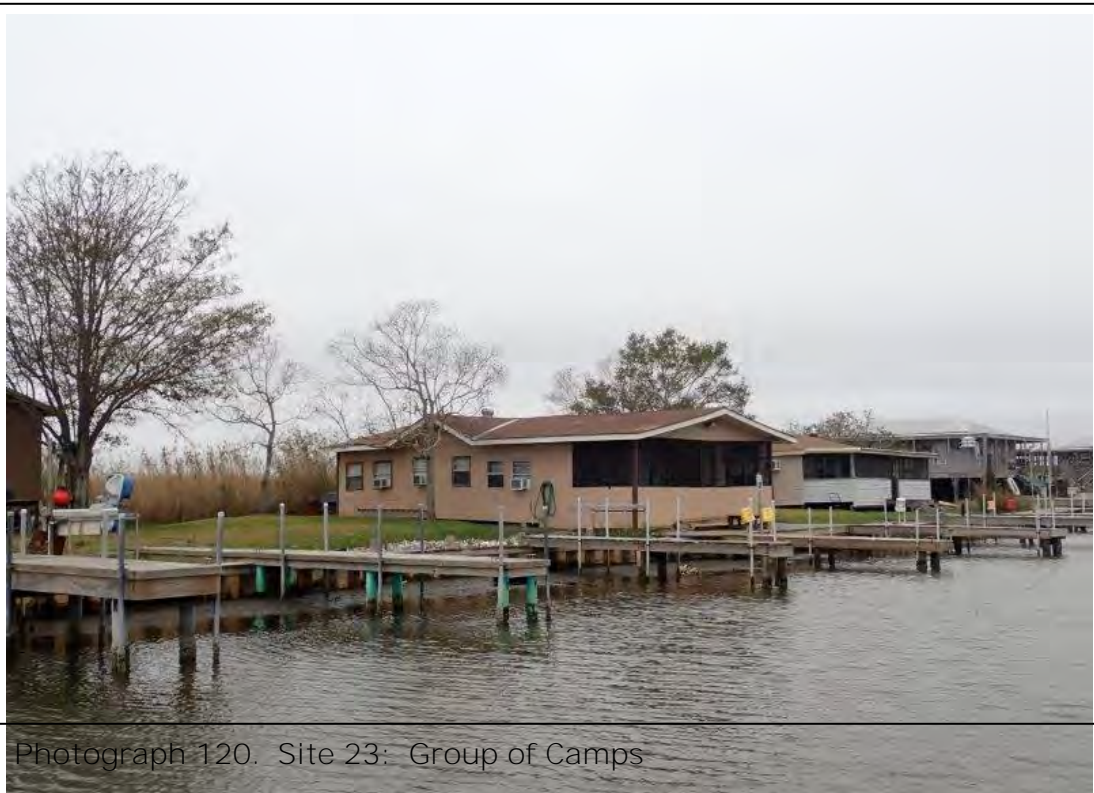
Photograph 120. Site 23: Group of Camps

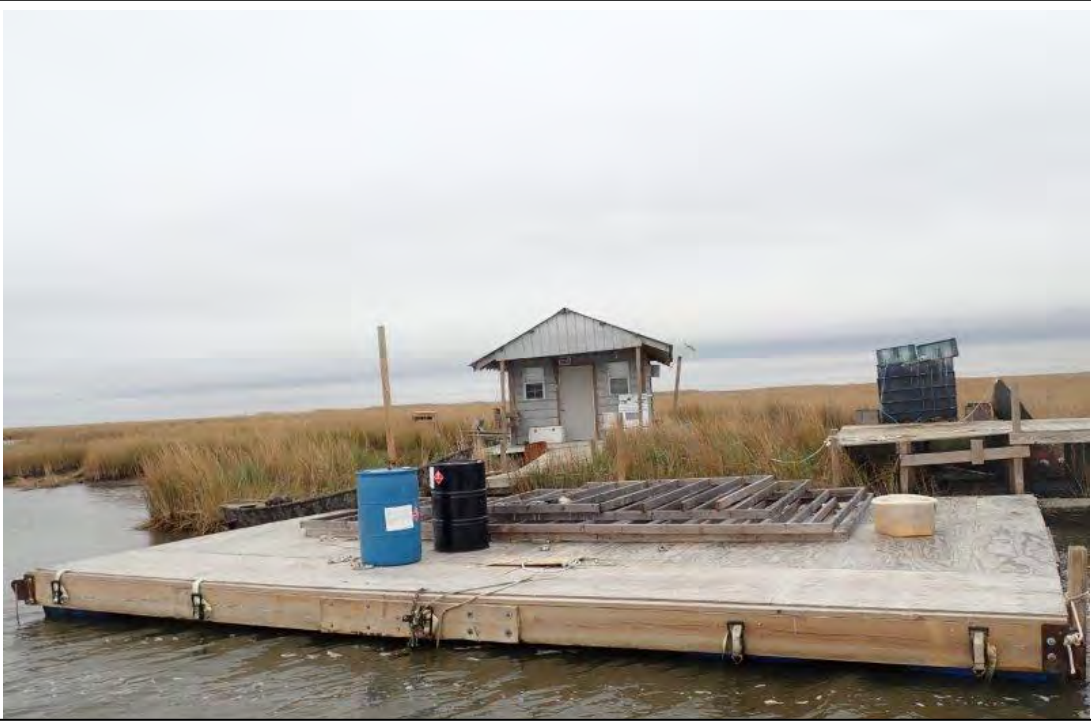
Photograph 121. Site 24: Camp with Pier
(29°30'51.50"N, 90°3'31.52"W)

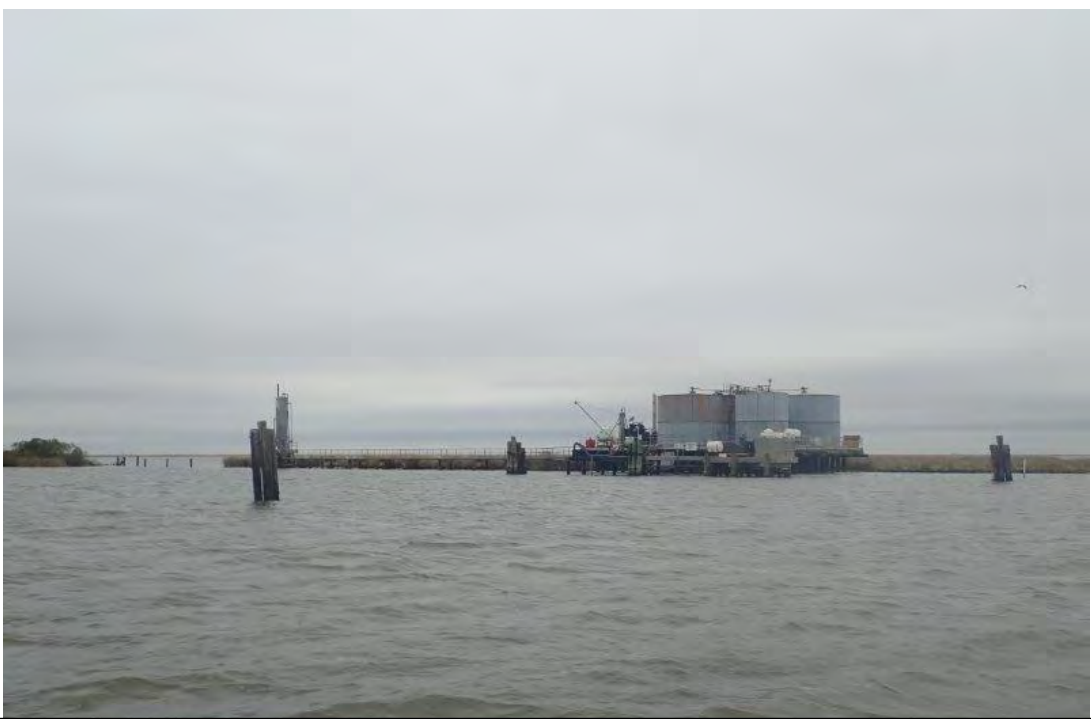
Photograph 122. Site 25: Oil Field Tank Battery with Flare Unit
(29°32'21.78"N, 90°3'5.60"W)

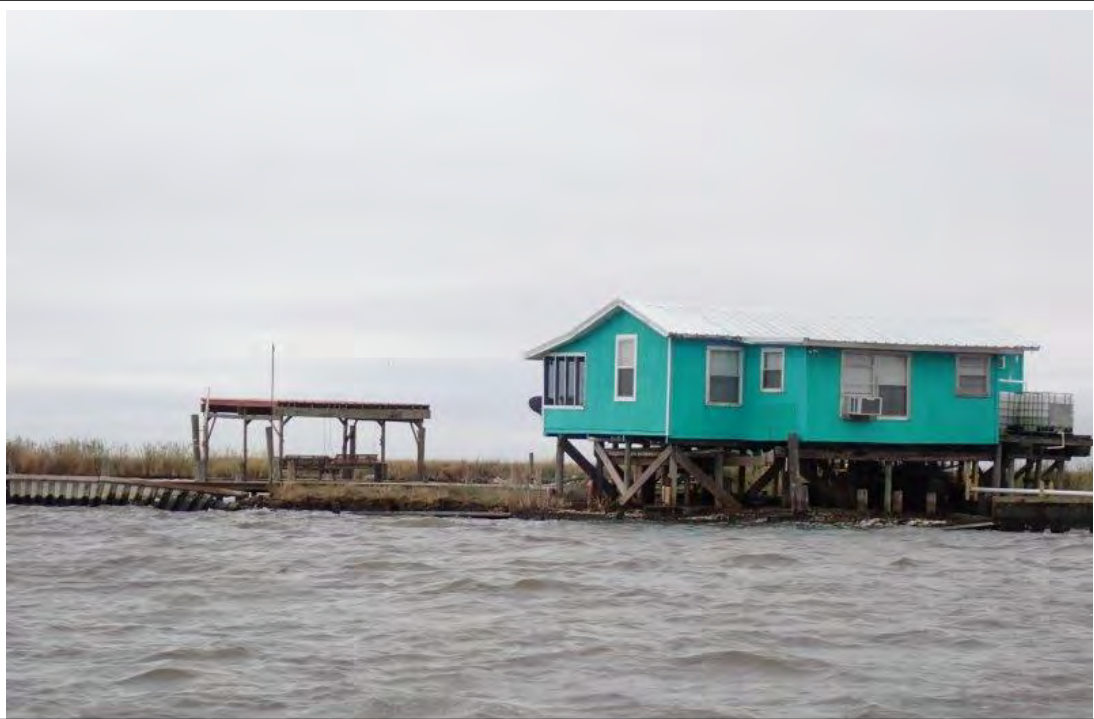
Photograph 123. Site 26: Camp Structures
(29°32'7.74"N, 90°3'58.79"W)

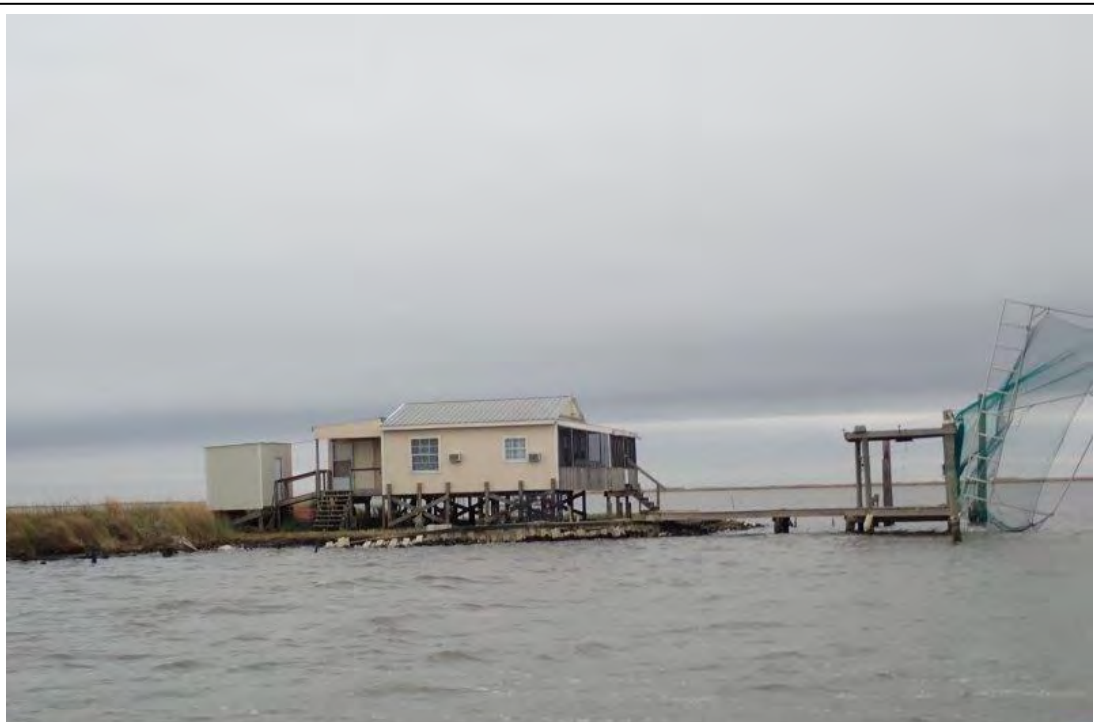
Photograph 124. Site 26: Camp Structures

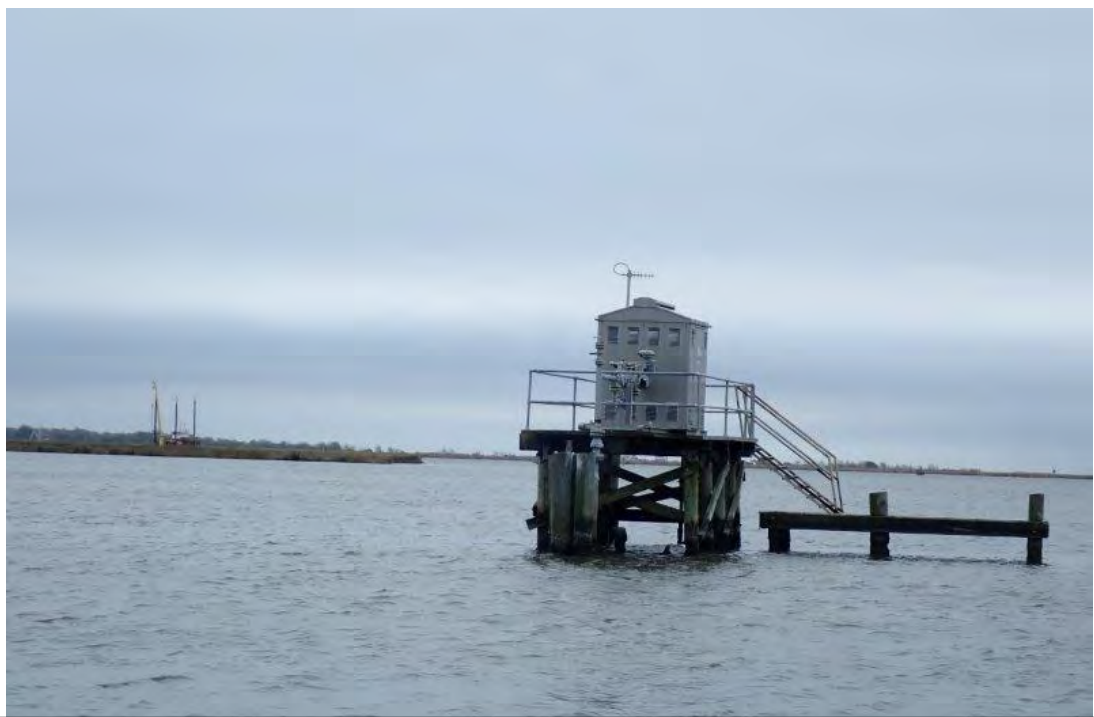
Photograph 125. Site 27: Oil Field / Pipeline Metering Platform
(29°32'40.15"N, 90°3'36.20"W)

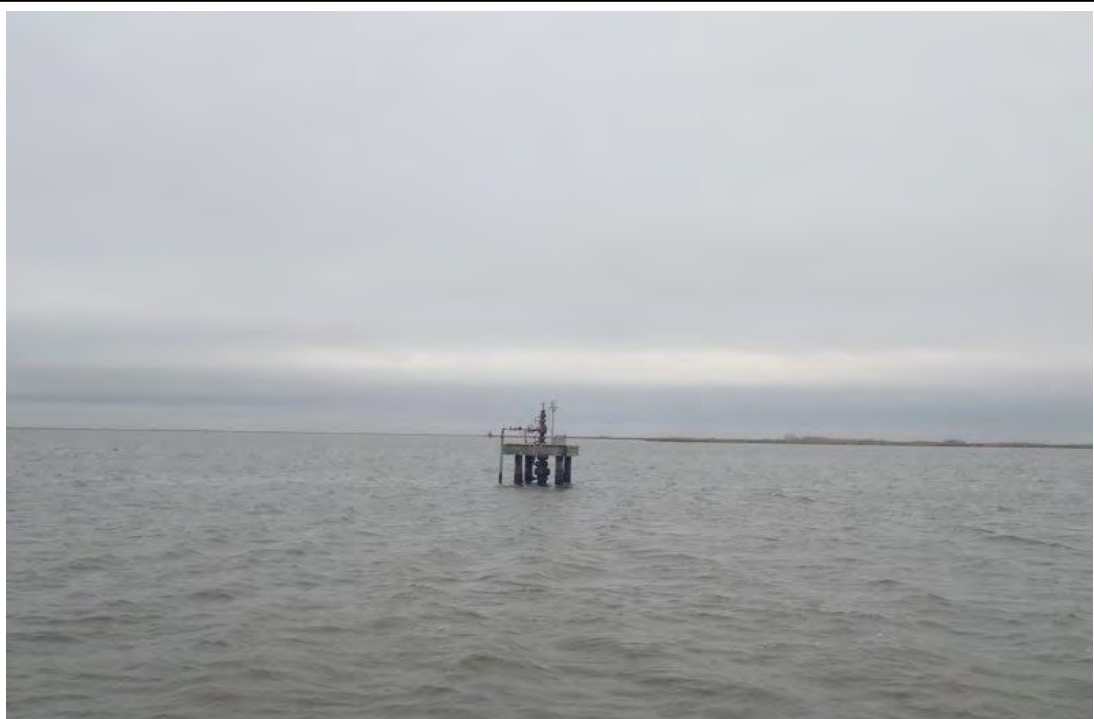
Photograph 126. Site 28: Well Platforms
(29°32'33.33"N, 90°3'5.48"W)

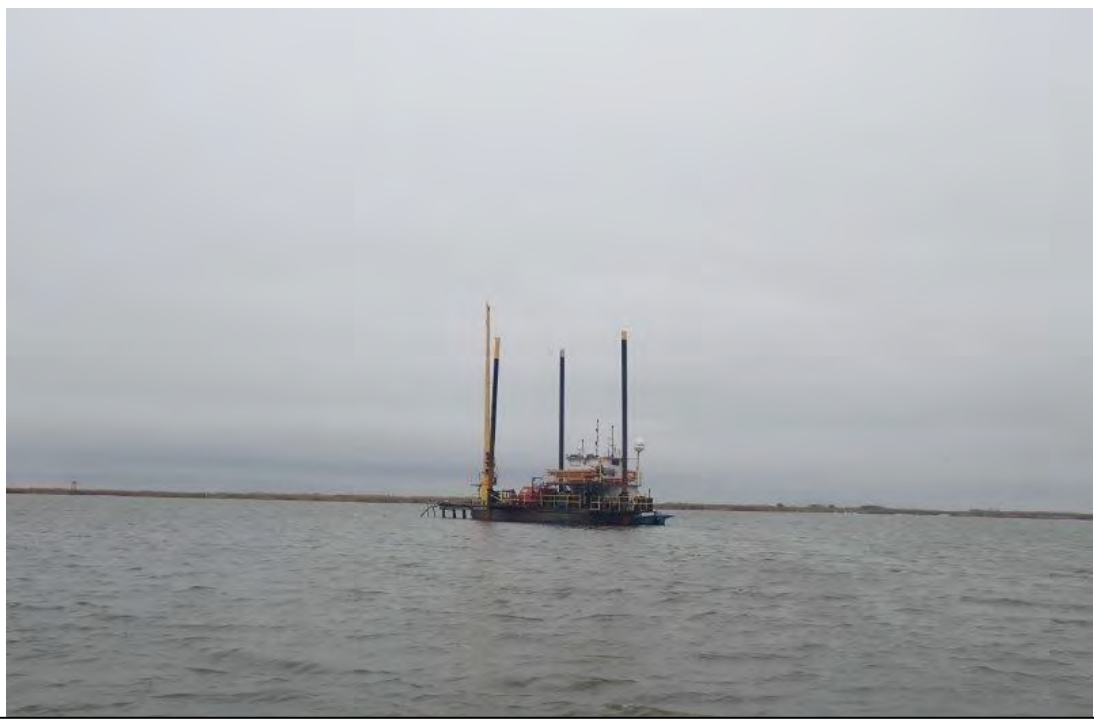
Photograph 127. Site 28: Well Platforms

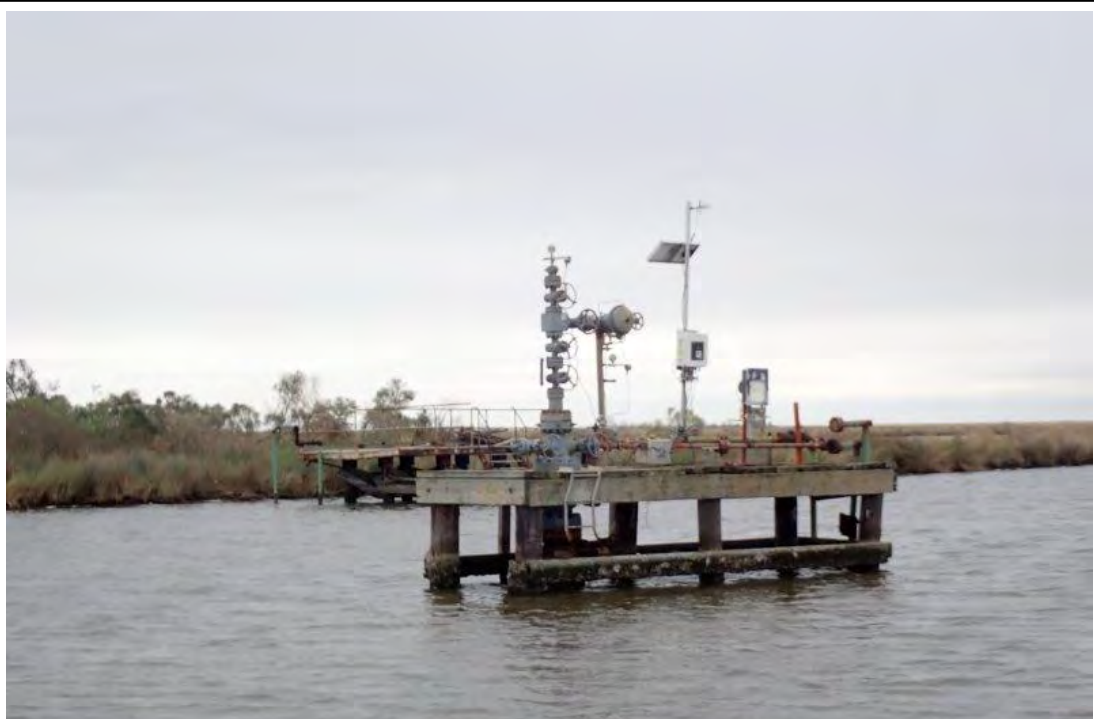
Photograph 128. Site 29: Oil Field Platforms
(29°32'34.68"N, 90°3'43.28"W)

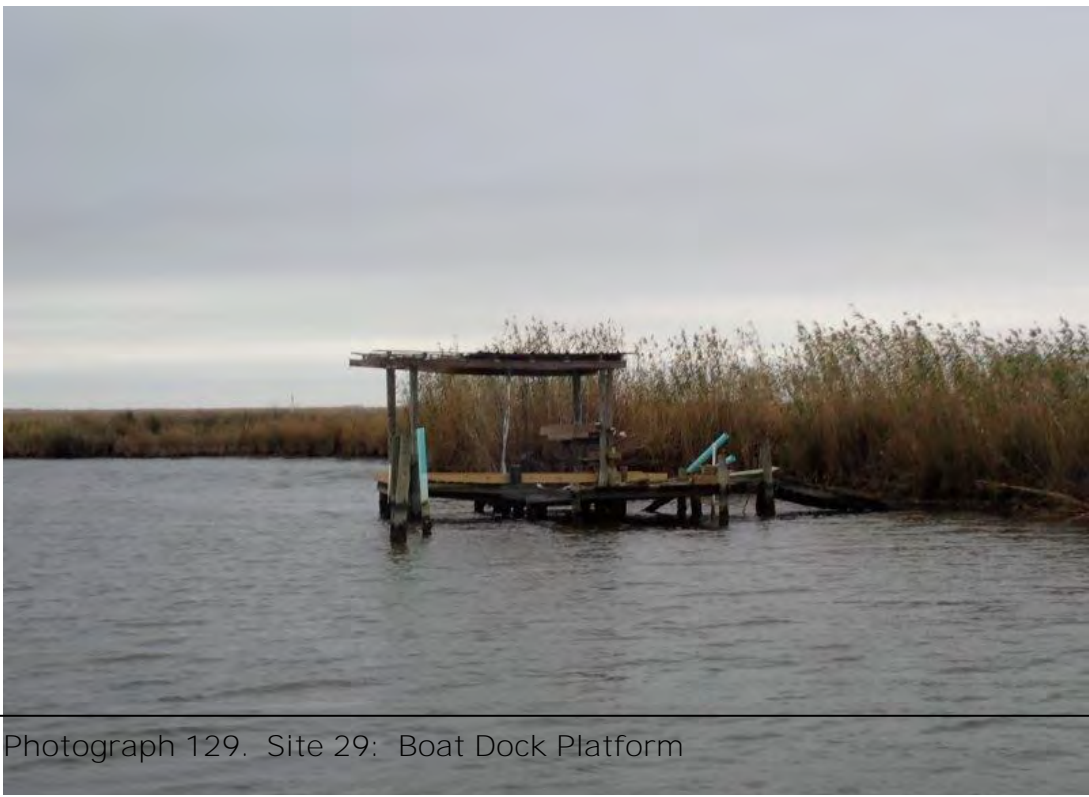
Photograph 129. Site 29: Boat Dock Platform

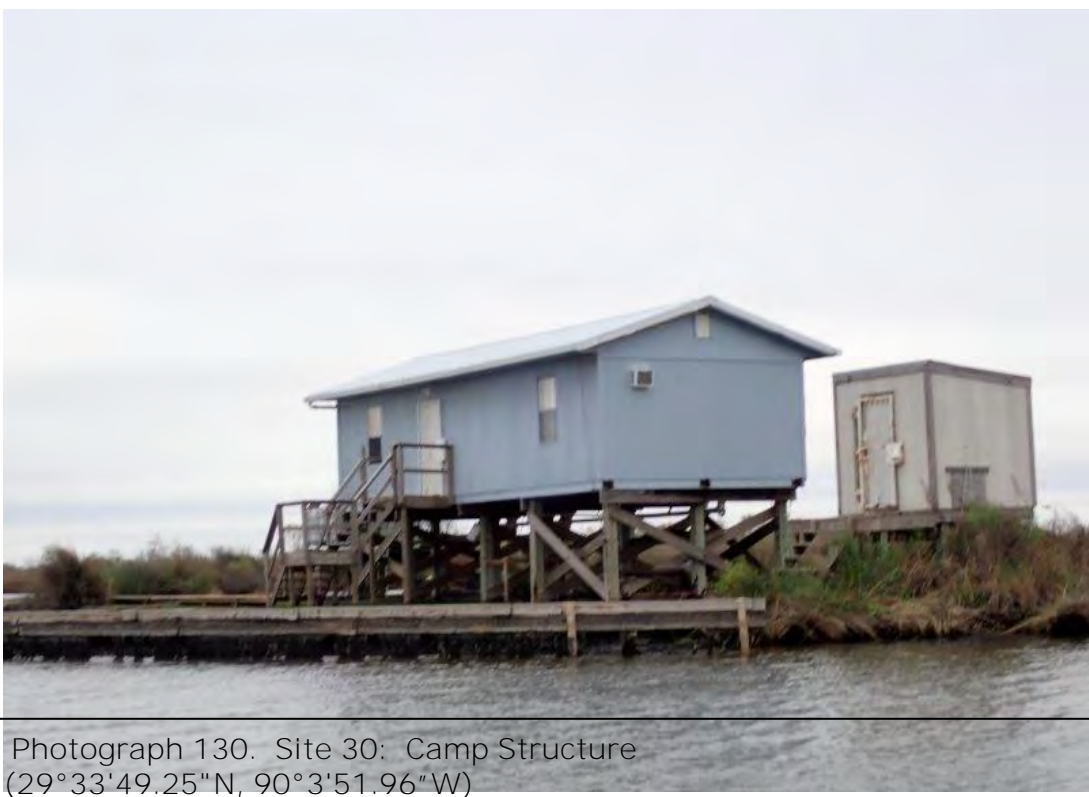
Photograph 130. Site 30: Camp Structure
(29°33'49.25"N, 90°3'51.96"W)

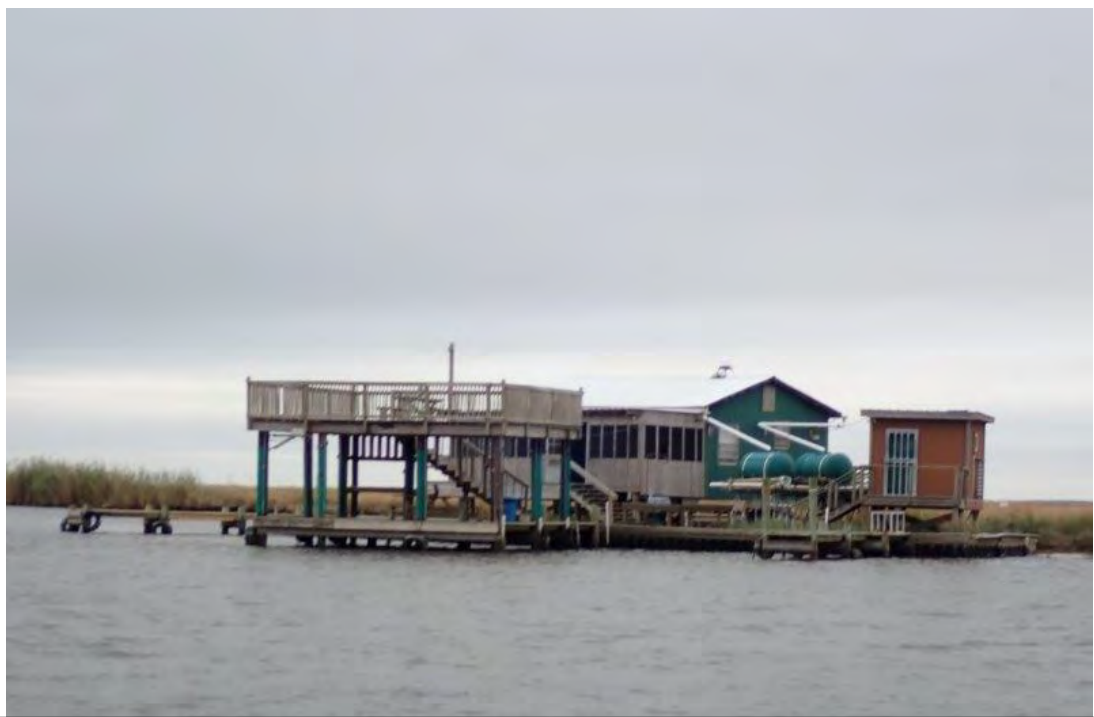
Photograph 131. Site 31: Camp Structure
(29°33'24.44"N, 90°4'25.75"W)

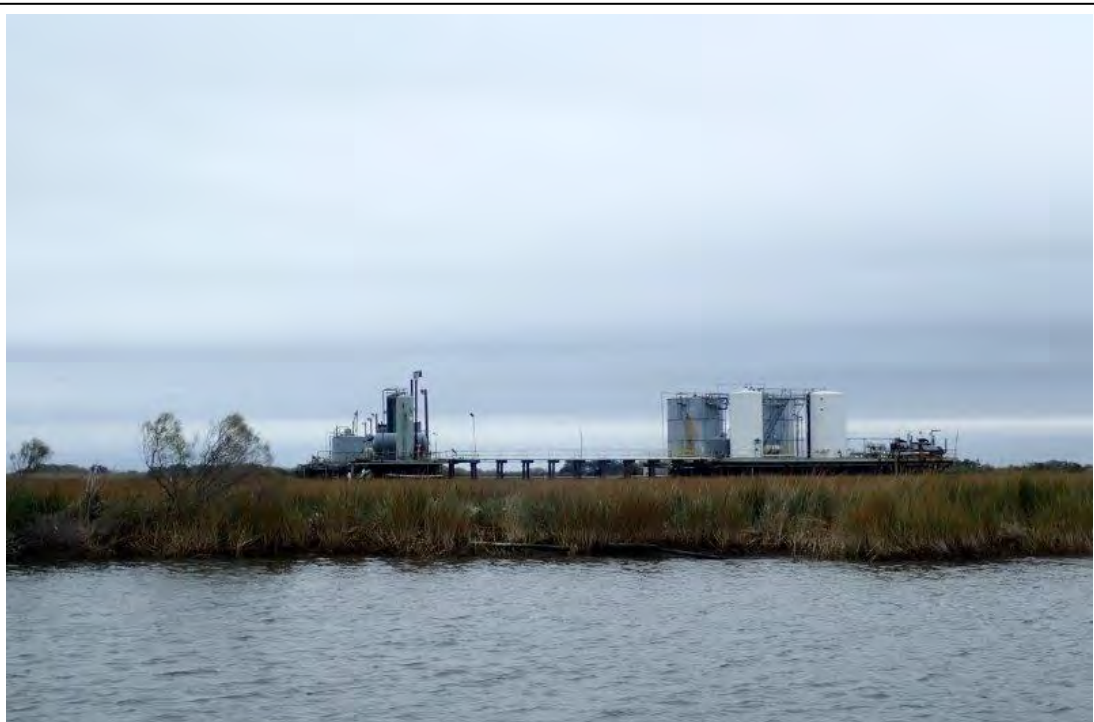
Photograph 132. Site 32: Oil Field Facility Structures
(29°34'55.88"N, 90°3'40.42"W)

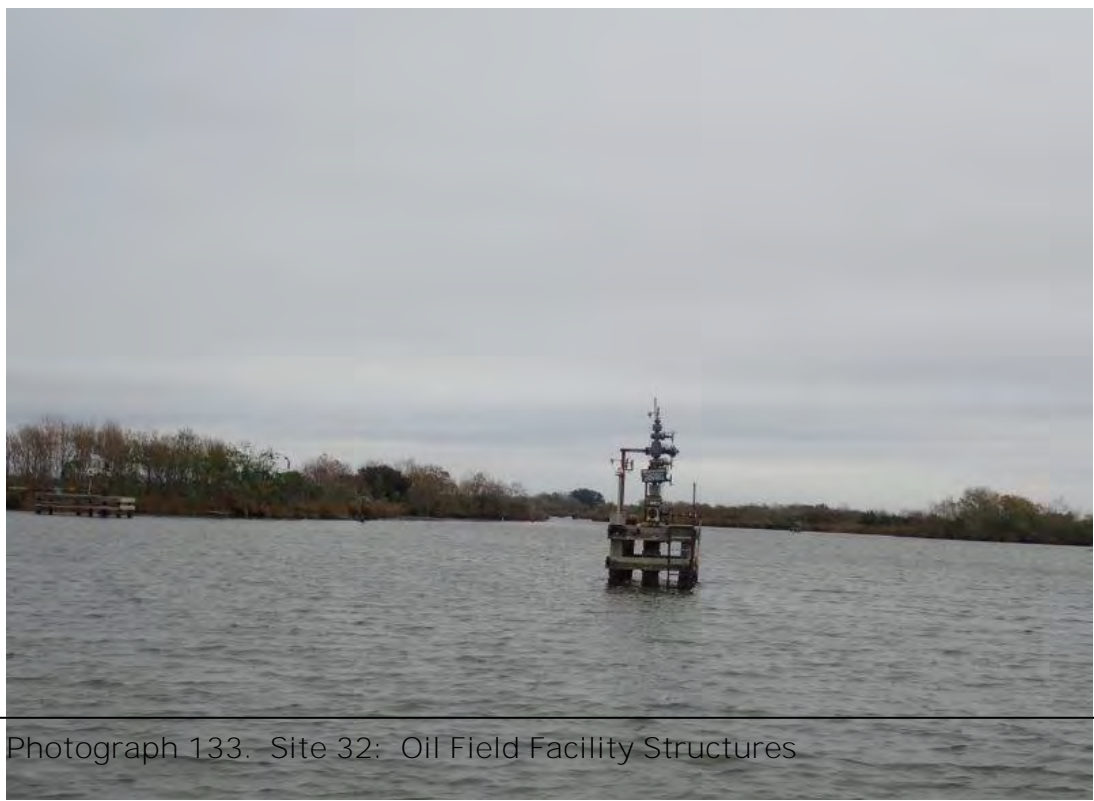
Photograph 133. Site 32: Oil Field Facility Structures

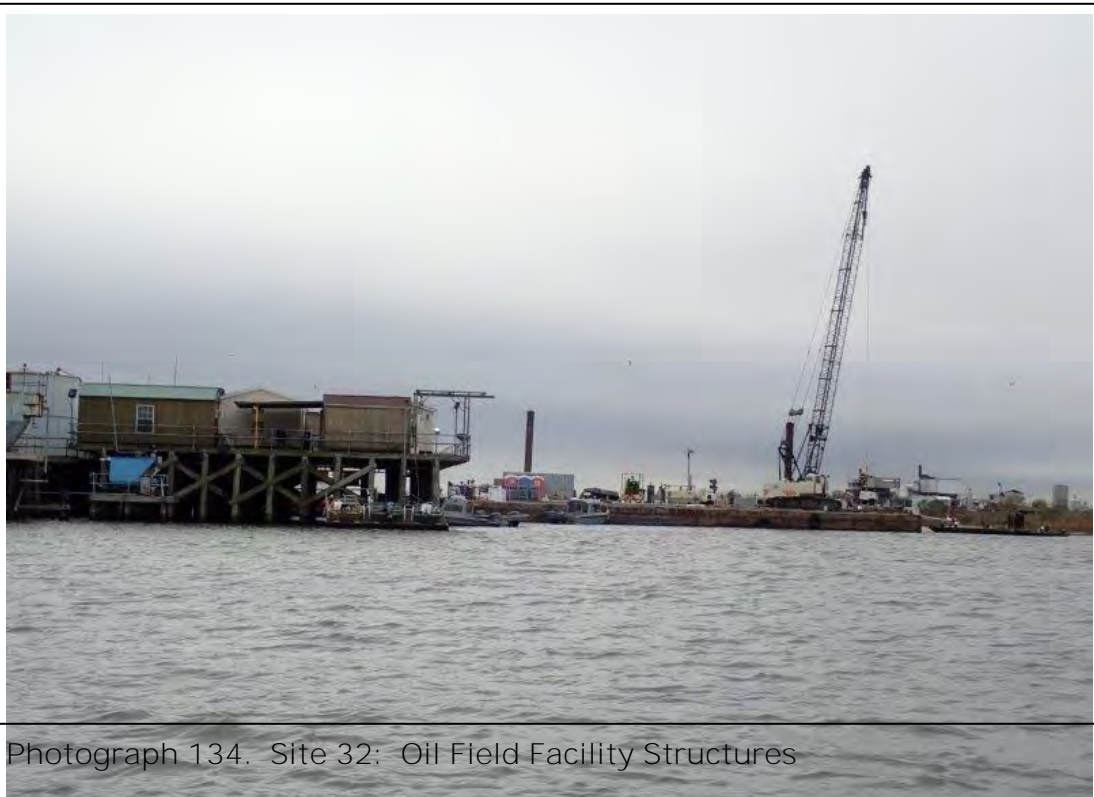
Photograph 134. Site 32: Oil Field Facility Structures

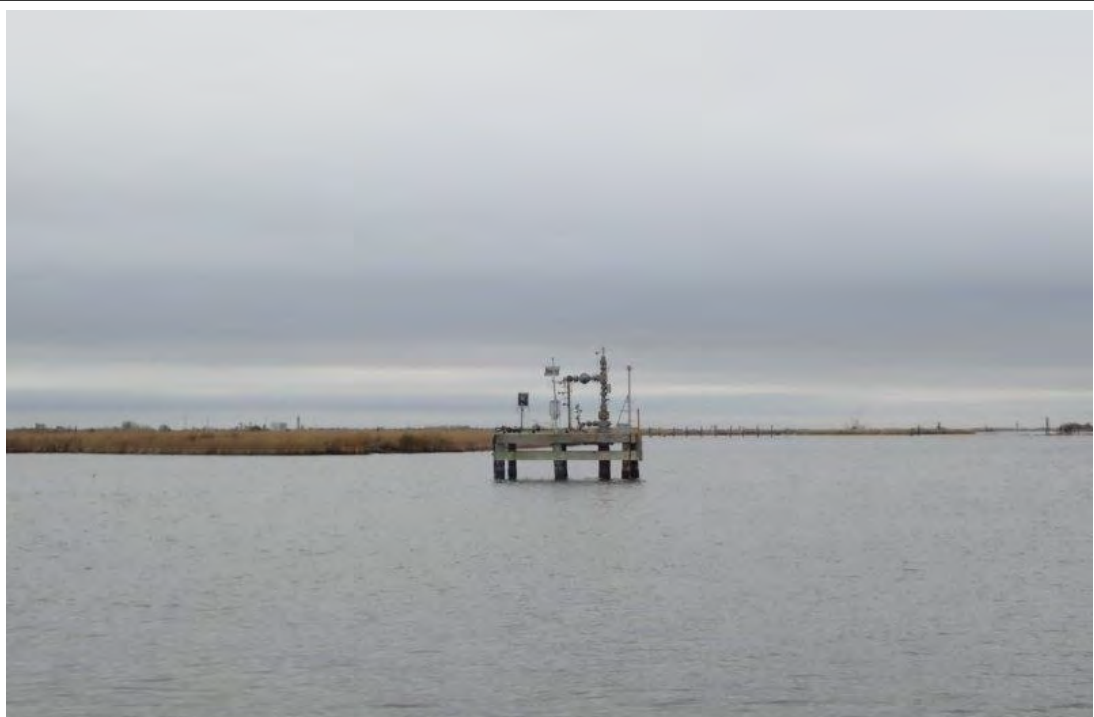
Photograph 135. Site 32: Oil Field Facility Structures

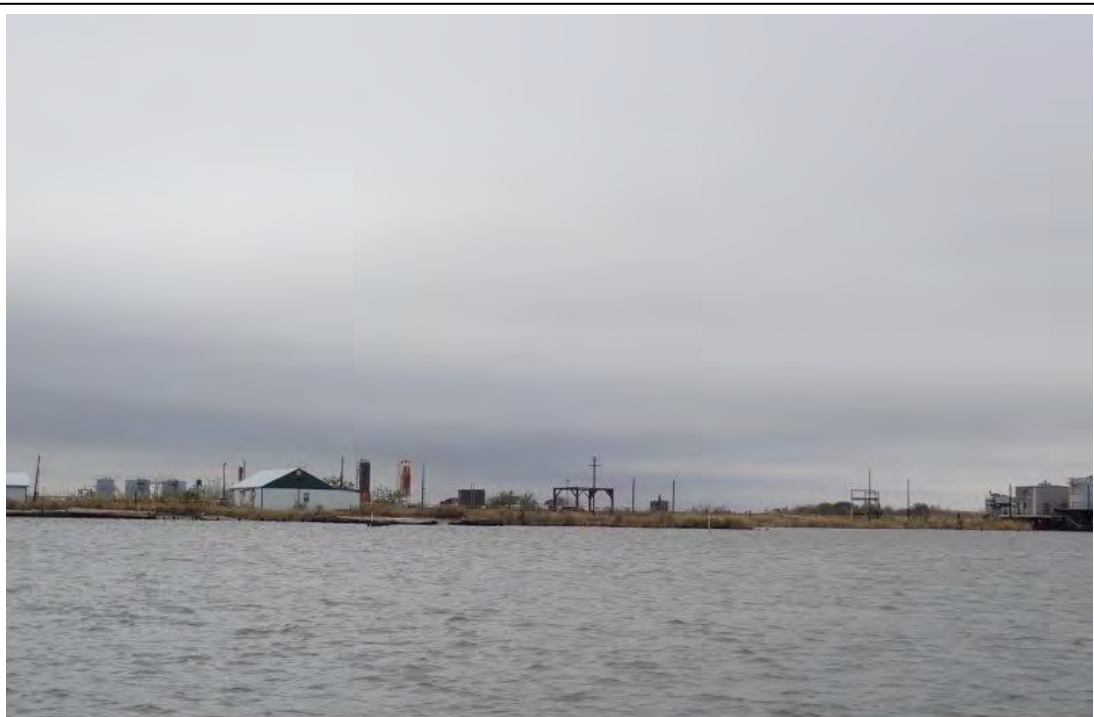
Photograph 136. Site 32: Oil Field Facility Structures

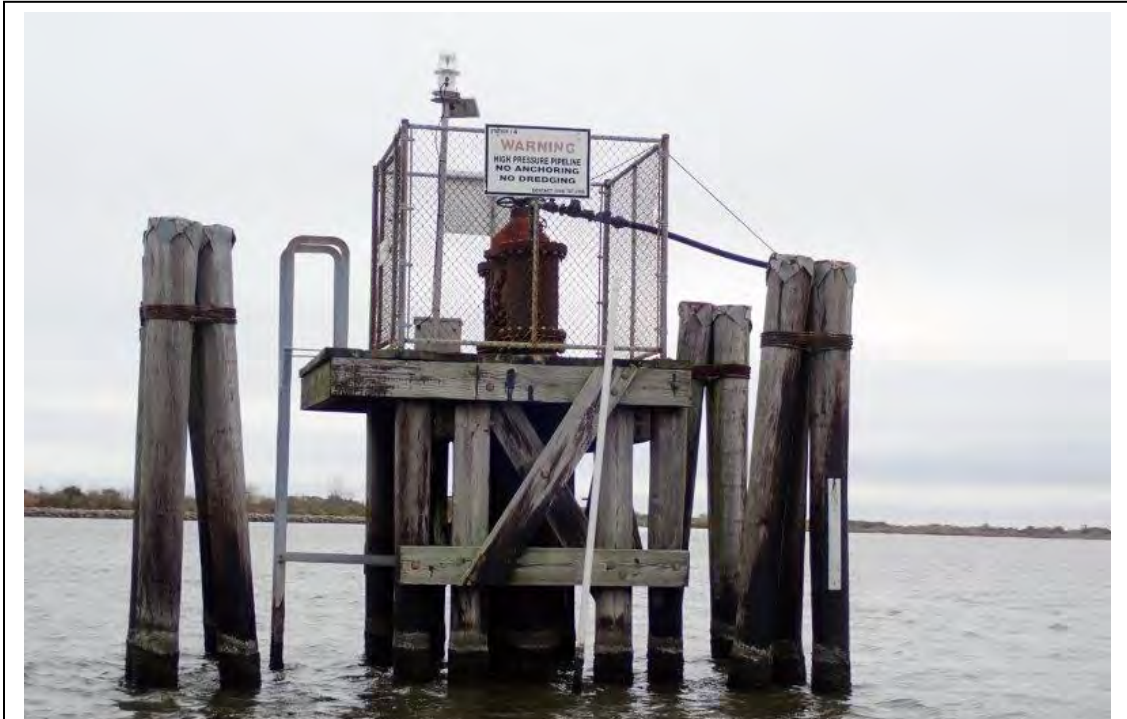
Photograph 137. Site 33: Pipeline Valve Platform
(29°36'11.77"N, 90°4'28.50"W)

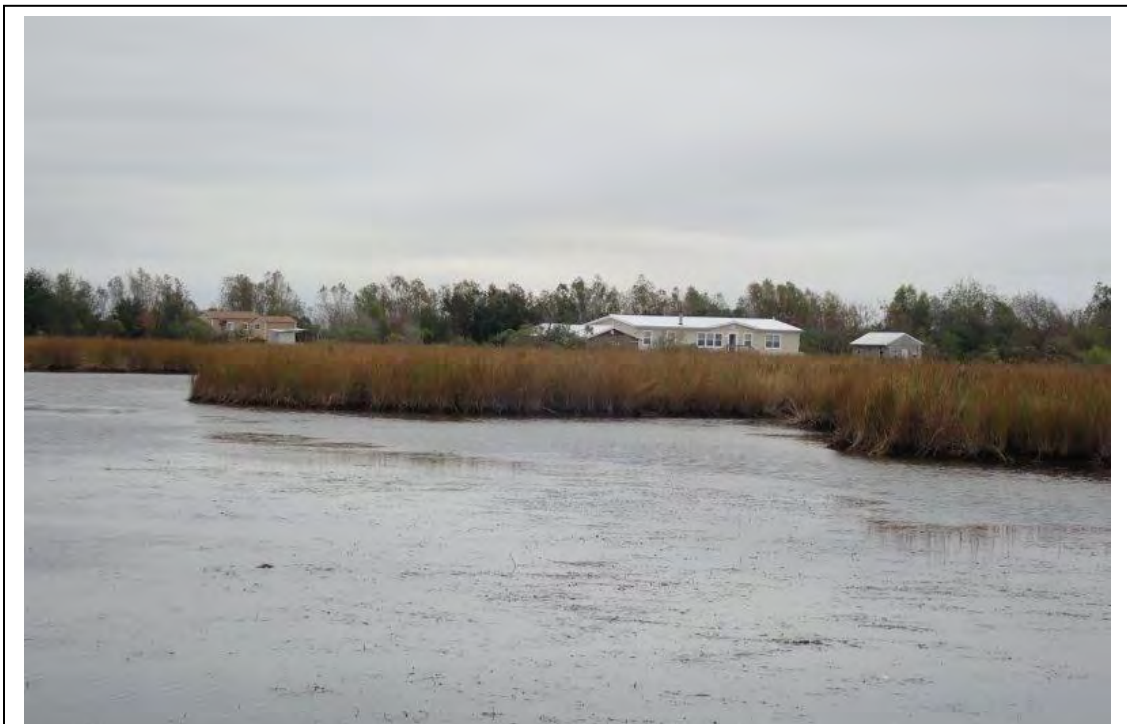
Photograph 138. Site 34: Camp and Boatshed Complex
(29°36'13.14"N, 90°3'37.24"W)

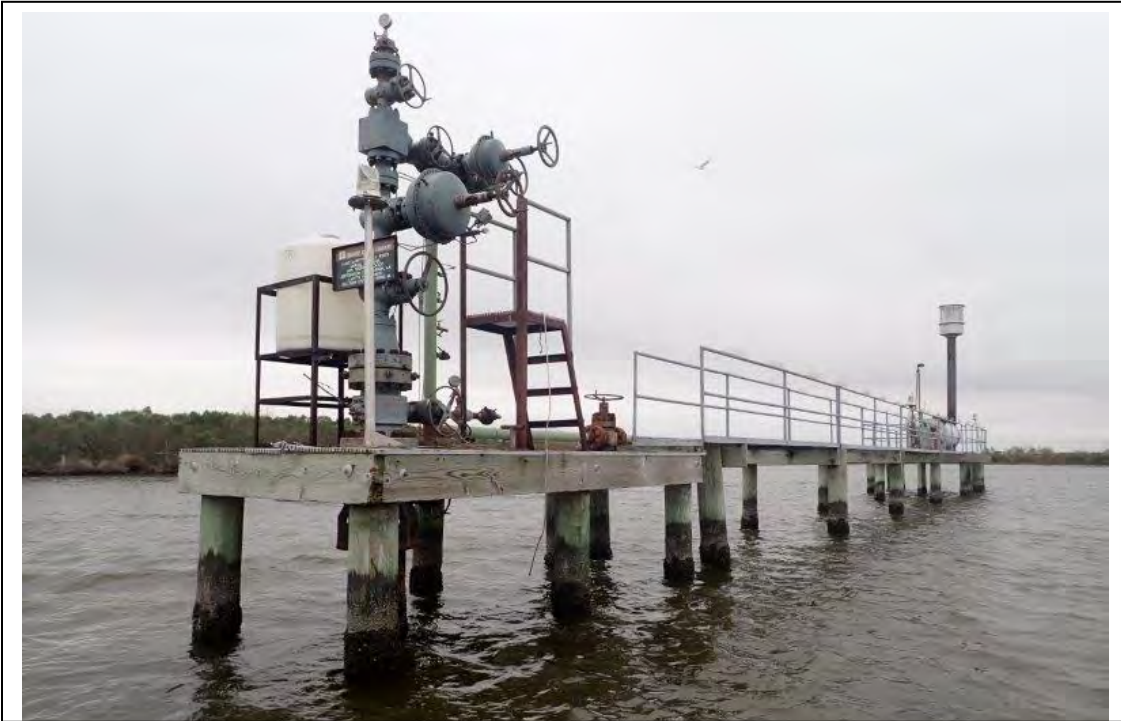
Photograph 139. Site 35: Well Platform with Flare Unit
(29°36'40.16"N, 90°3'13.17"W)

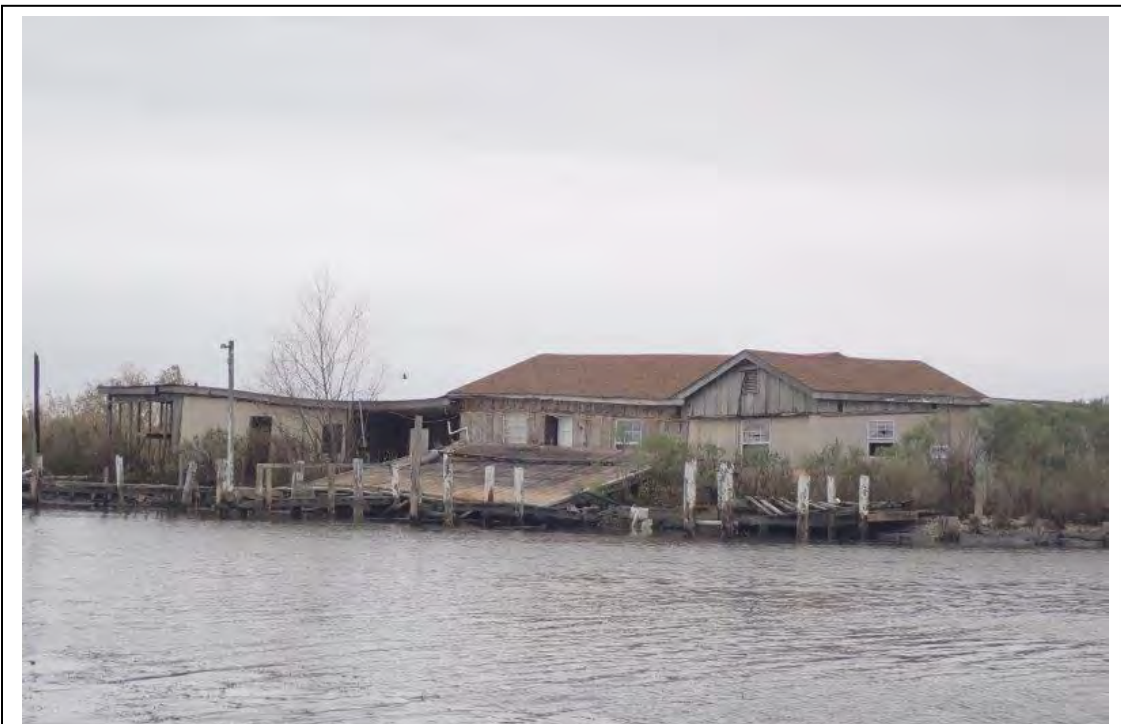
Photograph 140. Site 36: Abandoned Camp and Boatshed Complex
(29°36'47.12"N, 90°2'59.27"W)

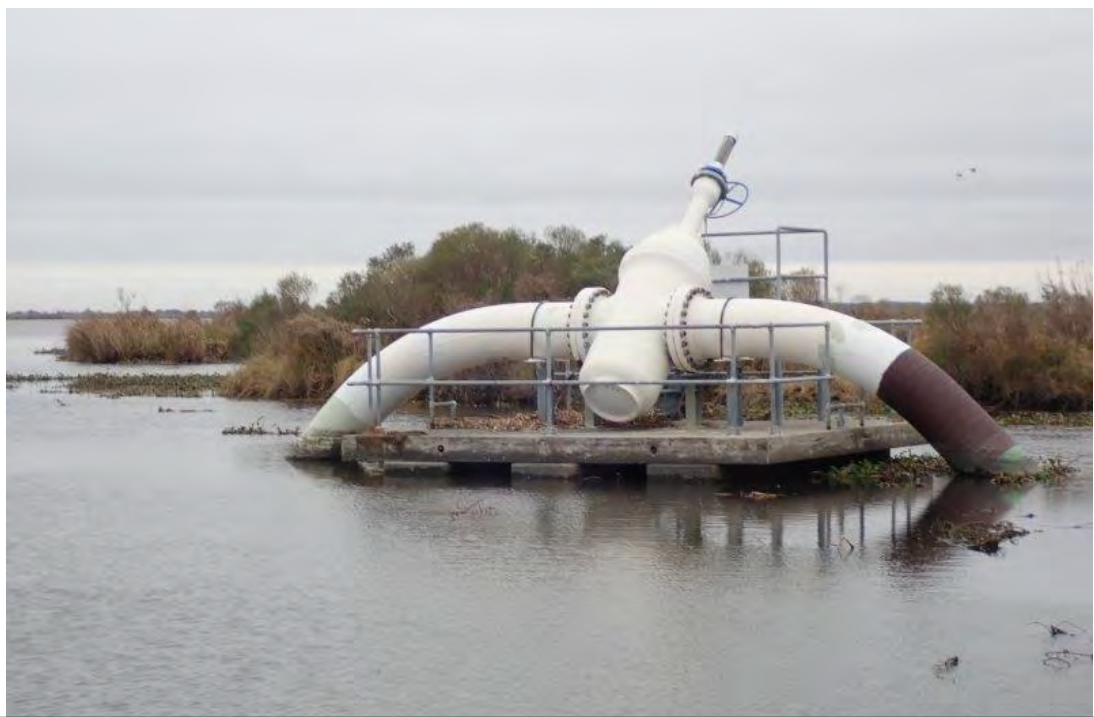
Photograph 141. Site 37: Pipeline Valve Structure
(29°38'3.95"N, 90°3'52.48"W)

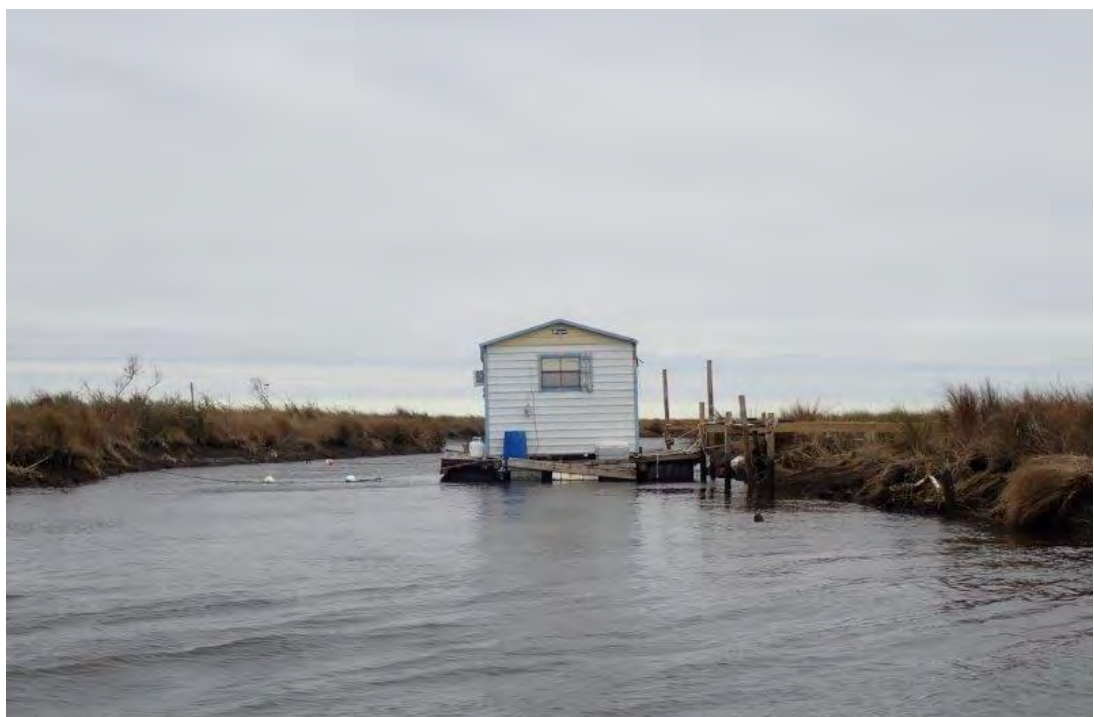
Photograph 142. Site 38: Floating Camp Structure
(29°34'35.29"N, 89°59'12.66"W)

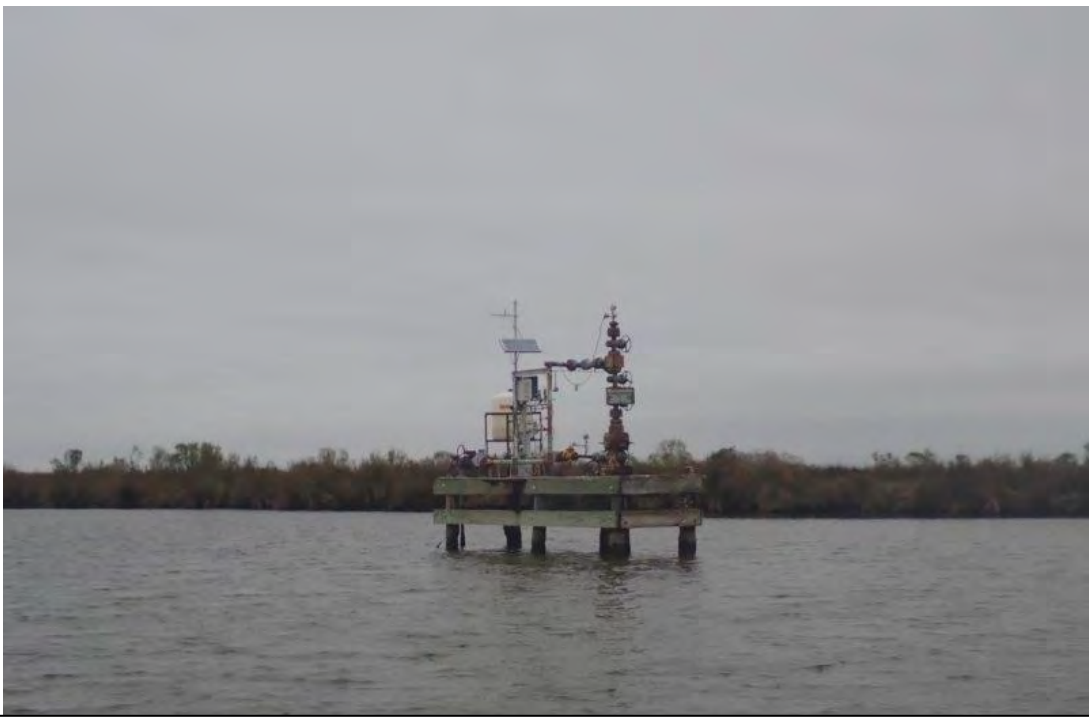
Photograph 143. Site 39: Well Platform
(29°34'7.73"N, 90°1'21.76"W)
