**APPENDIX J:
HAZARDOUS TOXIC AND
RADIOACTIVE WASTE
ASSESSMENT**

J3: Appendices F-G

Appendix F

Observed Field Survey Sites
 Mid-Barataria Sediment Diversion
 Phase I Environmental Site Assessment
 Jefferson and Plaquemines Parish

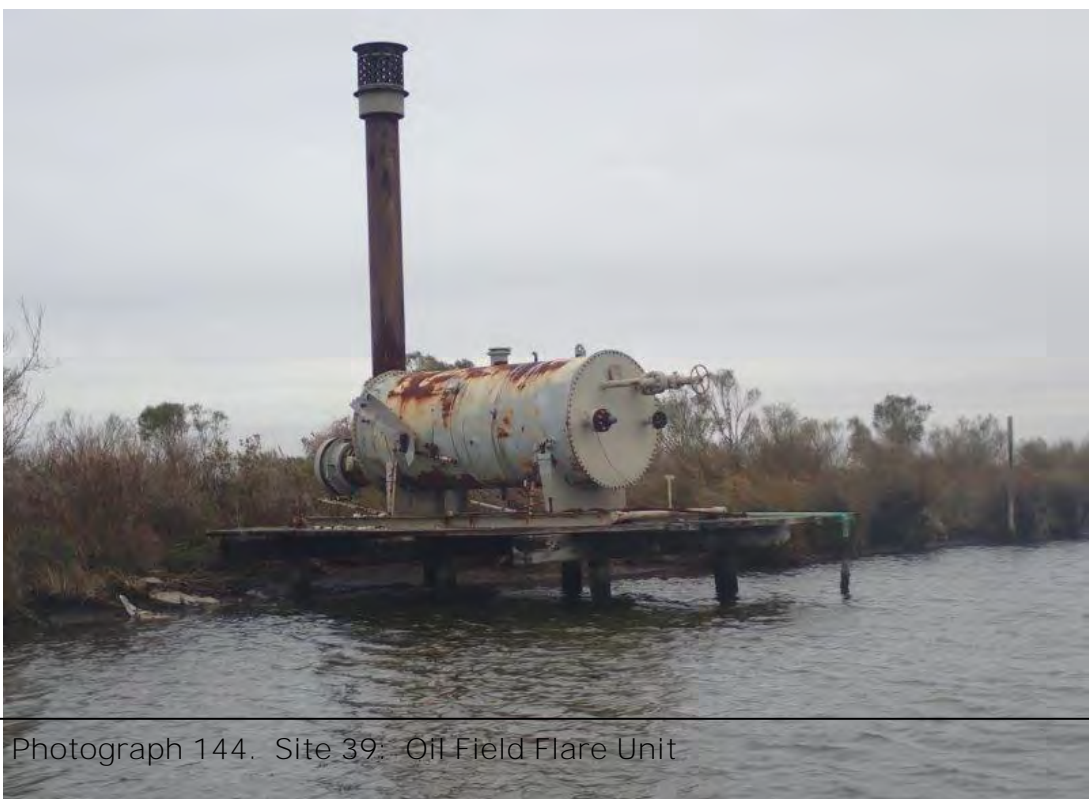
Photograph 144. Site 39: Oil Field Flare Unit

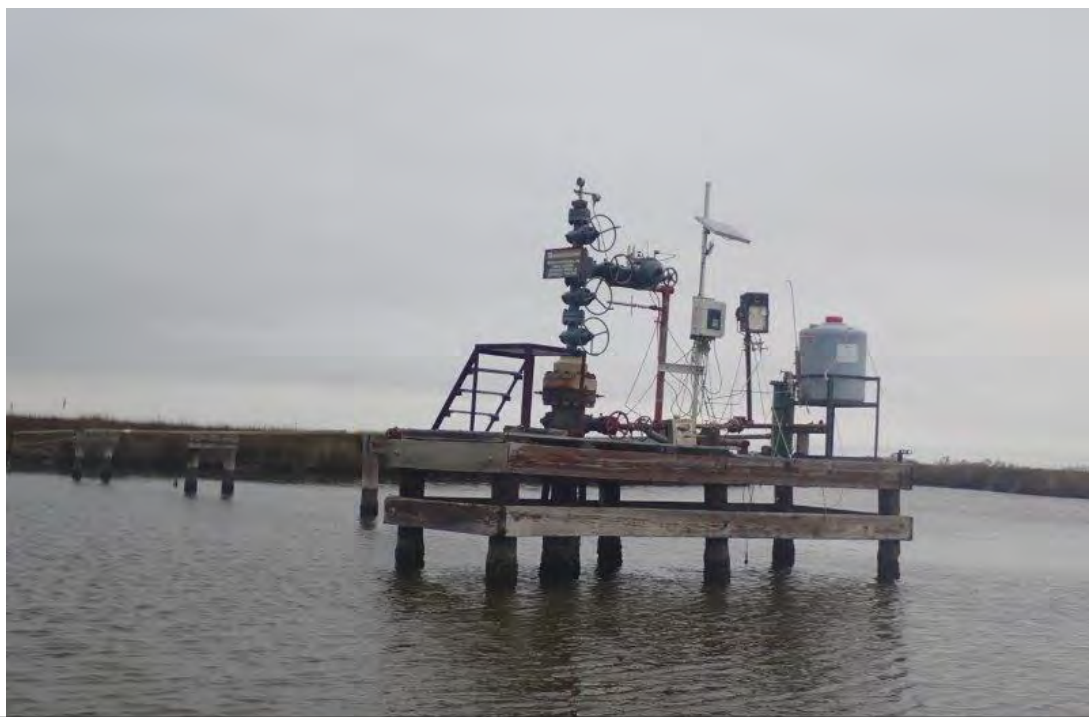
Photograph 145. Site 40: Well Platform
(29°35'40.39"N, 90°1'37.96"W)

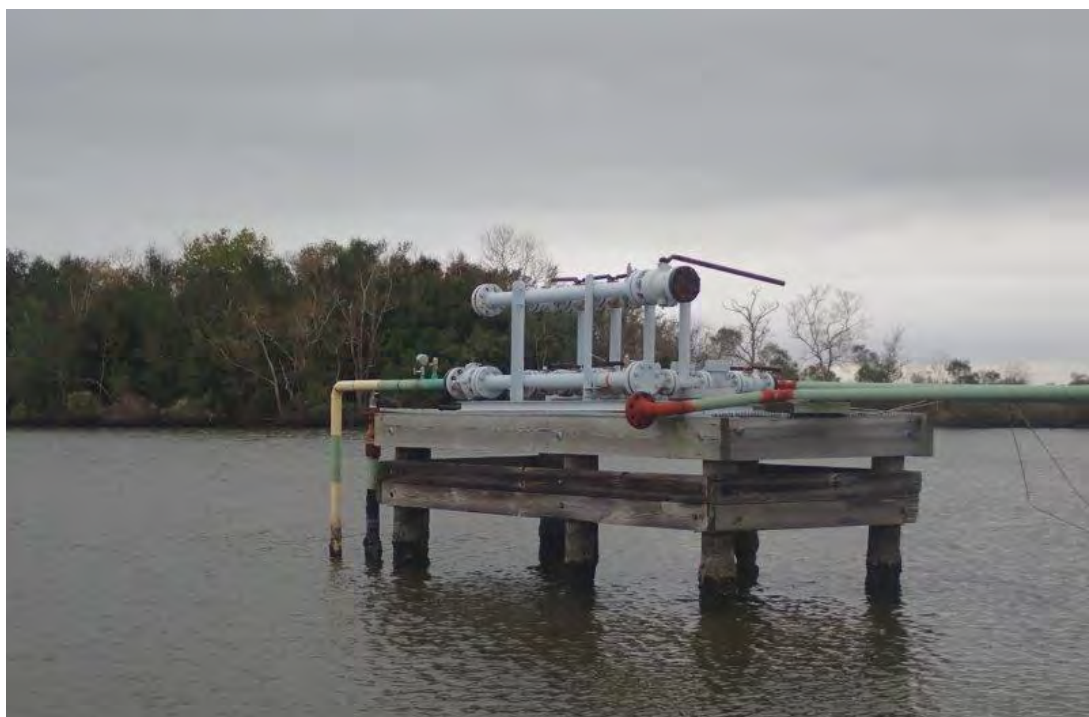
Photograph 146. Site 41: Oil Field Valve Platform
(29°35'44.26"N, 90°1'49.46"W)

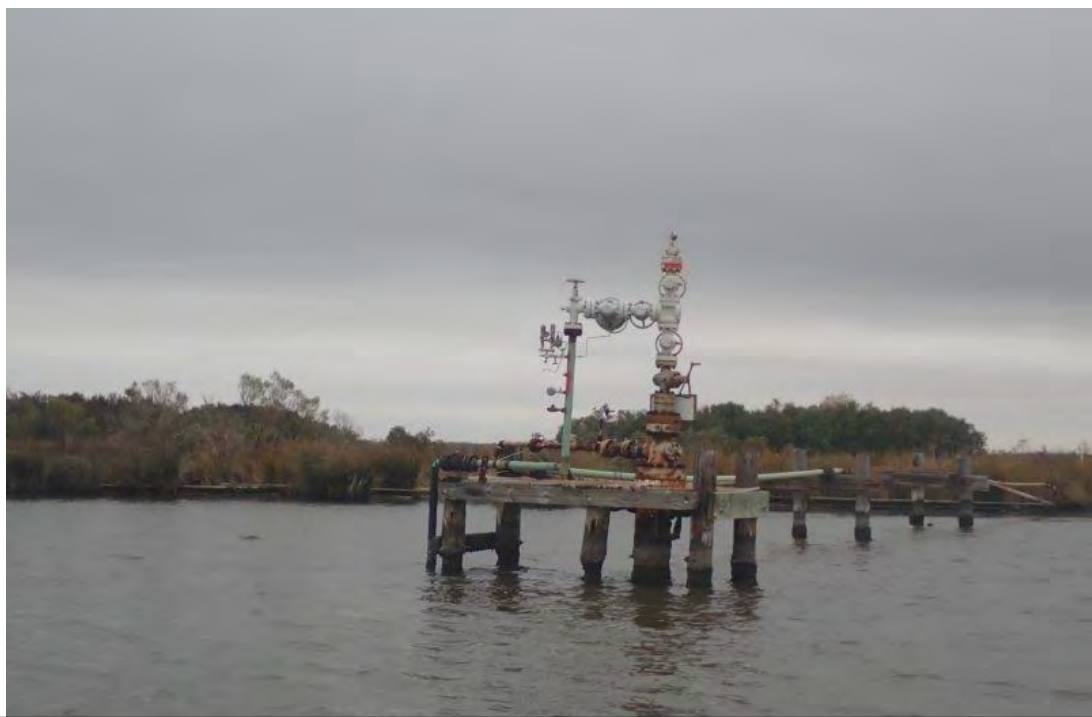
Photograph 147. Site 42: Well Platform
(29°35'49.93"N, 90°1'43.70"W)
