Pigg River Restoration at Power Dam Post Construction Monitoring Report

Wetland Studies and Solutions, Inc.
1402 Grandin Road SW, Suite 211
Roanoke, VA 24015
WSSI #22906.01

NOVEMBER 2016

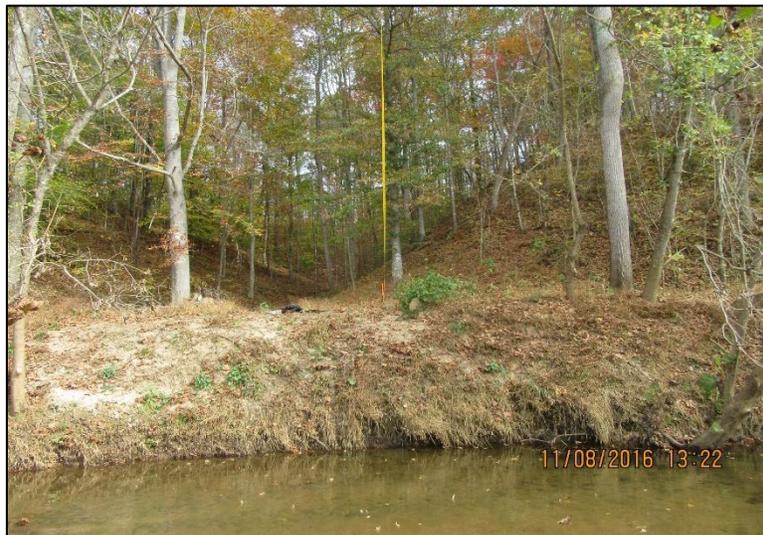
Photo 1-3

Description: View looking left from the middle of Cross Section 1

Vegetation: 70% herbaceous cover, few trees at top of bank

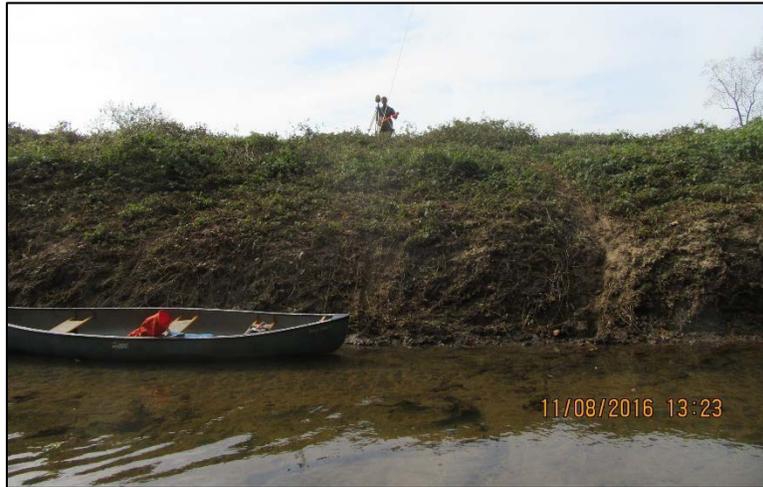
Photo 1-4

Description: View looking right from the middle of Cross Section 1

Vegetation: 90% herbaceous cover, no trees

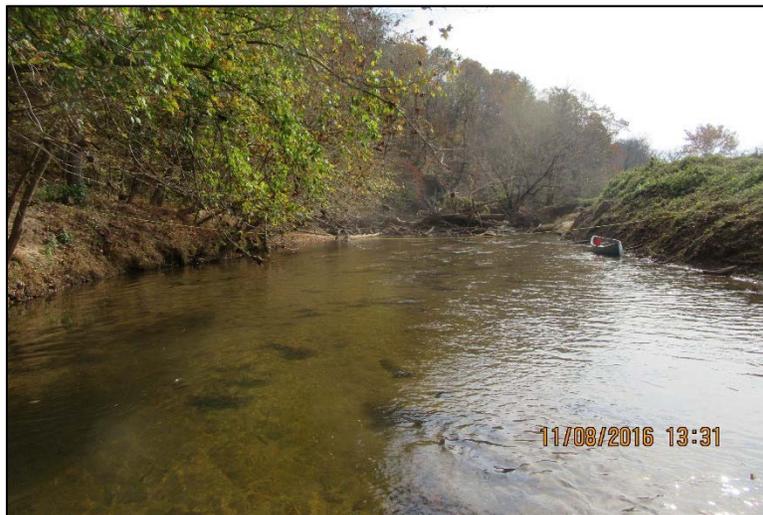
Photo 1-5

Description: View looking downstream at Cross Section 1 from an upstream position

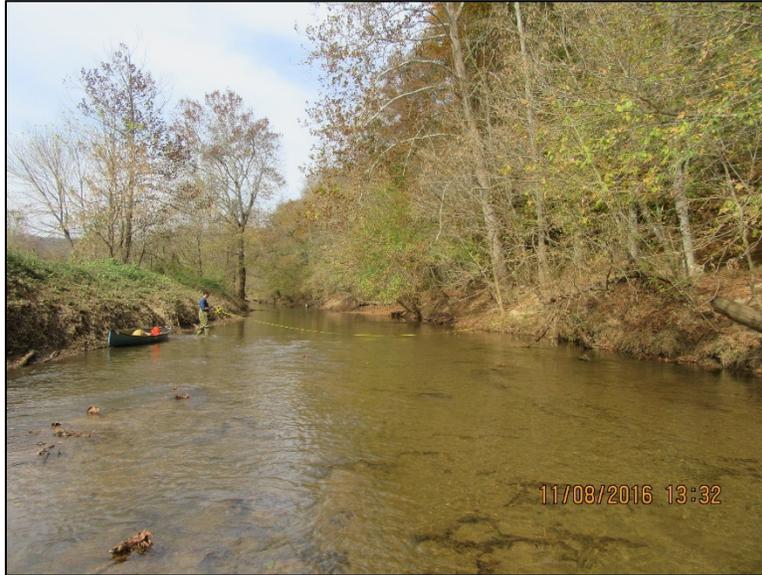
Photo 1-6

Description: View looking upstream at Cross Section 1 from a downstream position

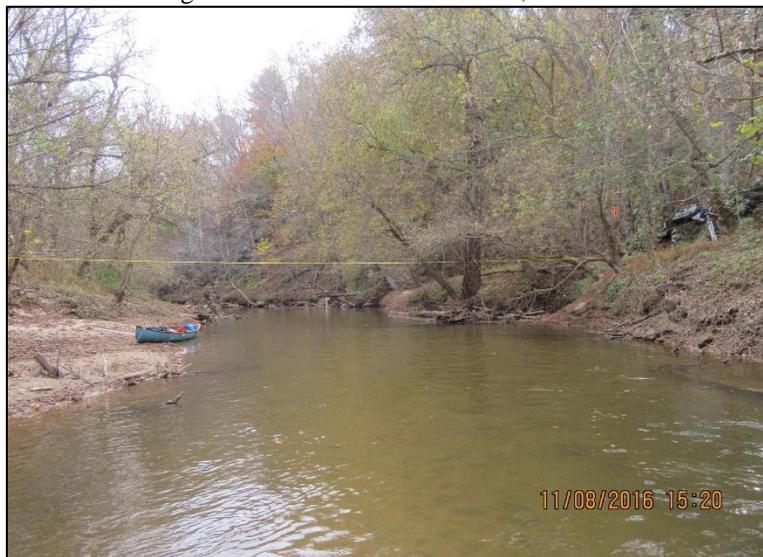
Photo 2-5
Location, Orientation: XS 2, Upstream looking down
Permit Number: JPA #15-1551
Wetland Data Sheet Reference: n/a
11/8/16, 2:20 PM

Description: View looking downstream at Cross Section 2 from an upstream position

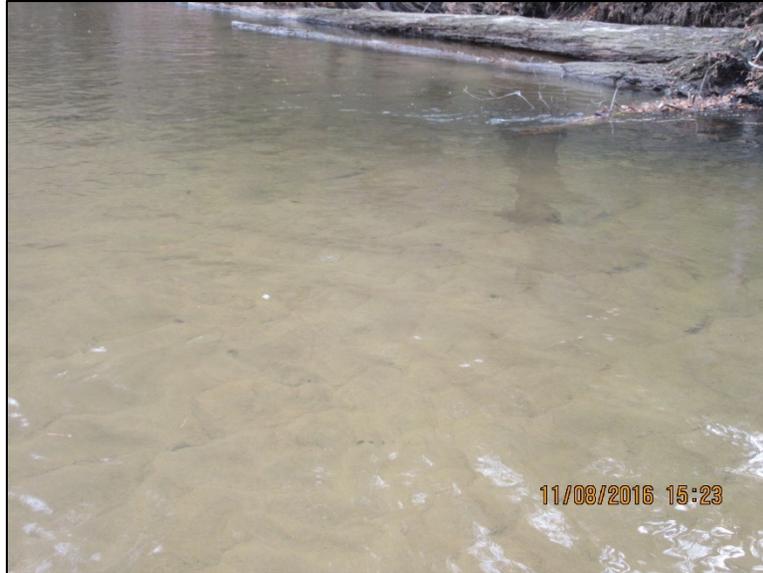
Photo 2-7

Description: Bed material at Cross Section 2 was almost entirely silt

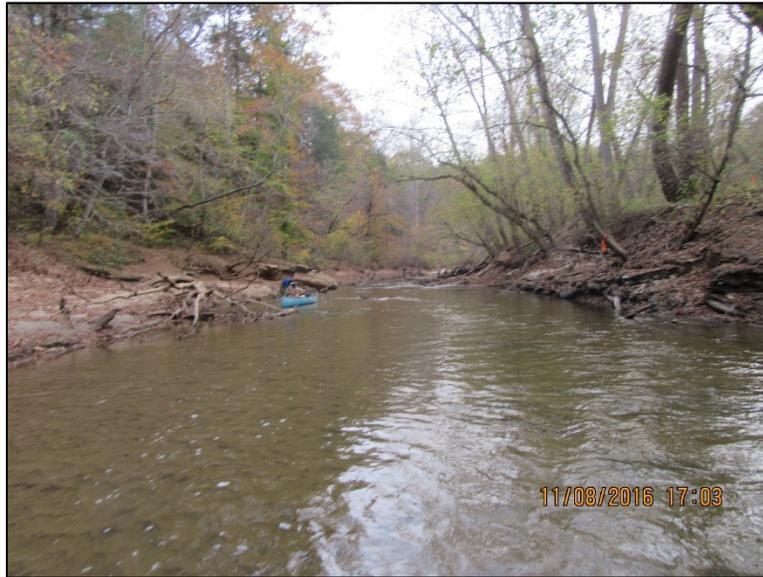
Photo 3-6

Description: View looking upstream at Cross Section 3 from a downstream position

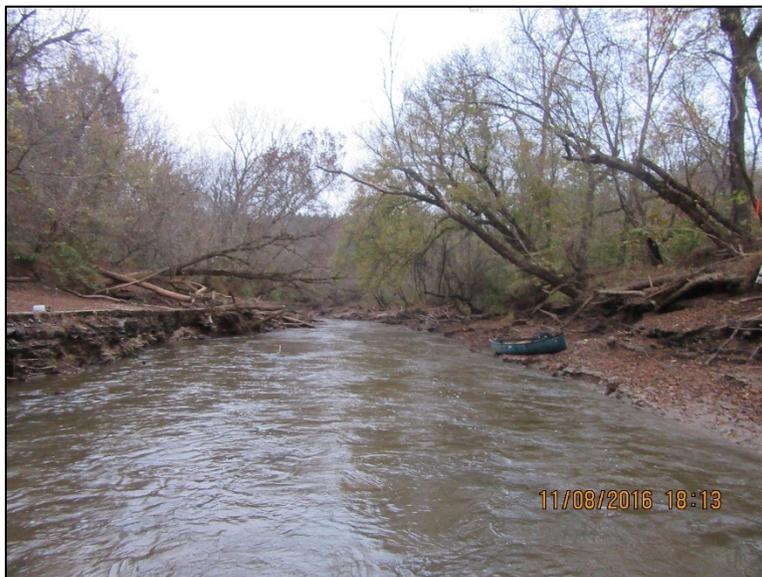
Photo 4-5

Description: View looking downstream at Cross Section 4 from an upstream position

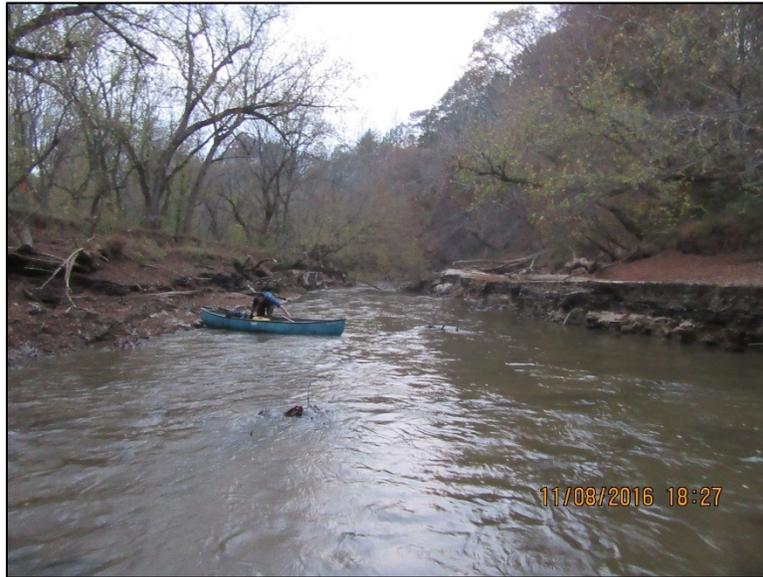
Photo 4-6

Description: View looking upstream at Cross Section 4 from a downstream position

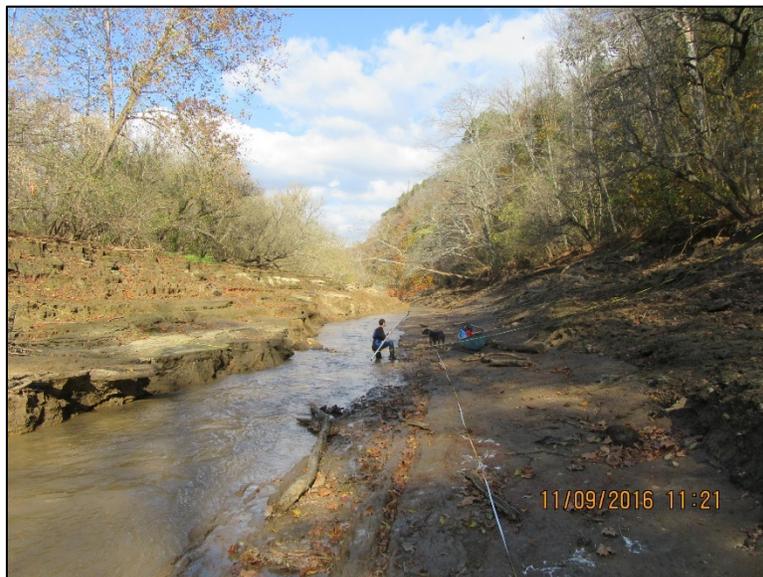
Photo 5-5

Description: View looking downstream at Cross Section 5 from an upstream position

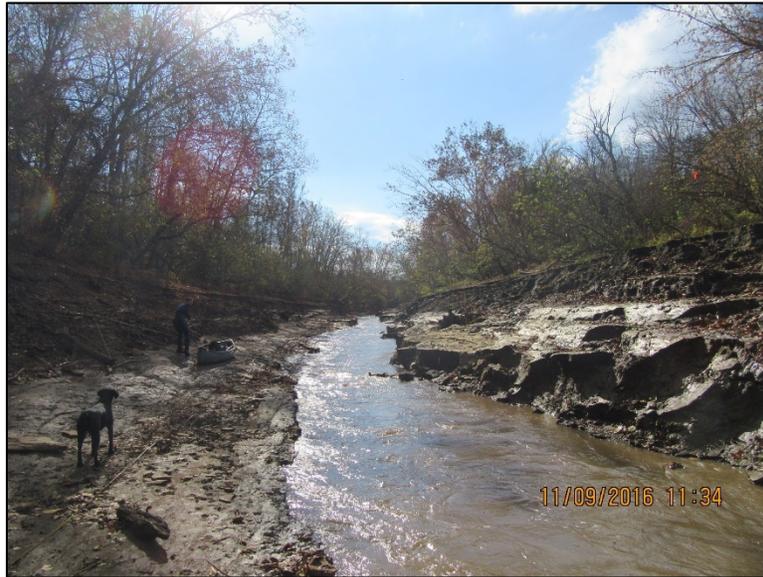
Photo 5-6

Description: View looking upstream at Cross Section 5 from a downstream position

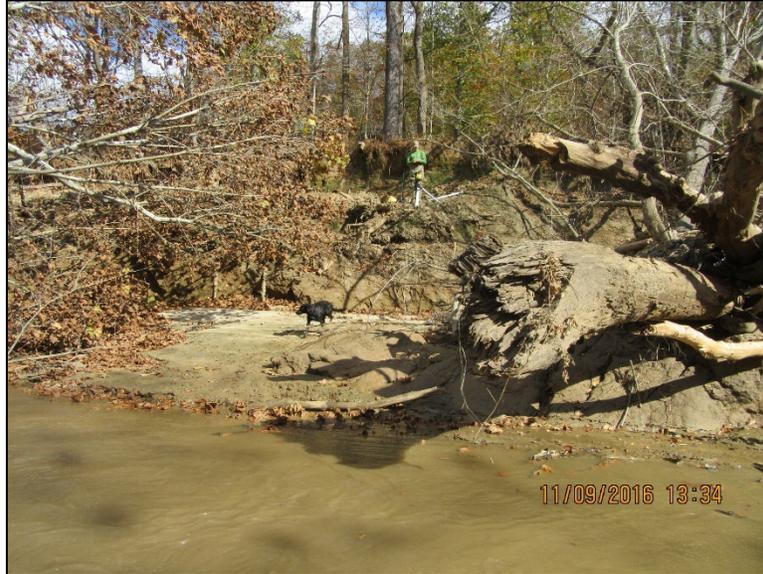
Photo 6-4

Description: View looking right from the middle of Cross Section 6

Vegetation: 10% herbaceous cover, large trees and shrubs at top of bank

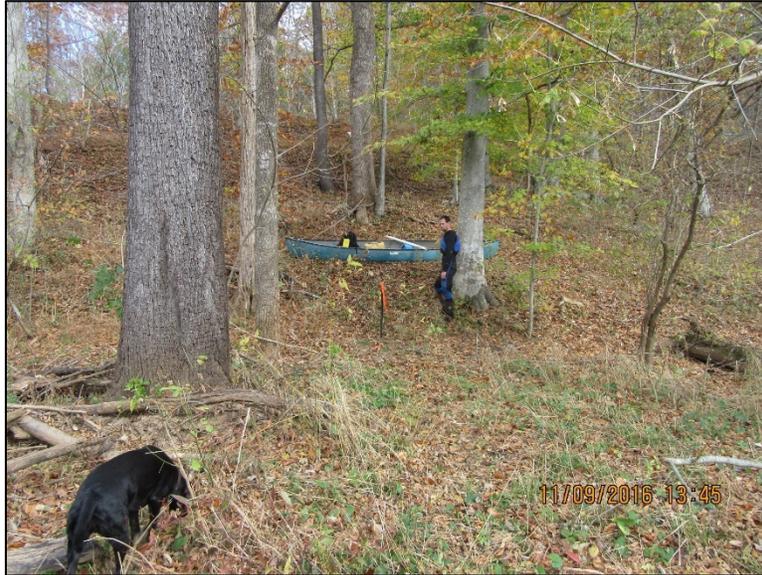
Photo 6-6

Description: View looking at the right bank pin from the top of bank.

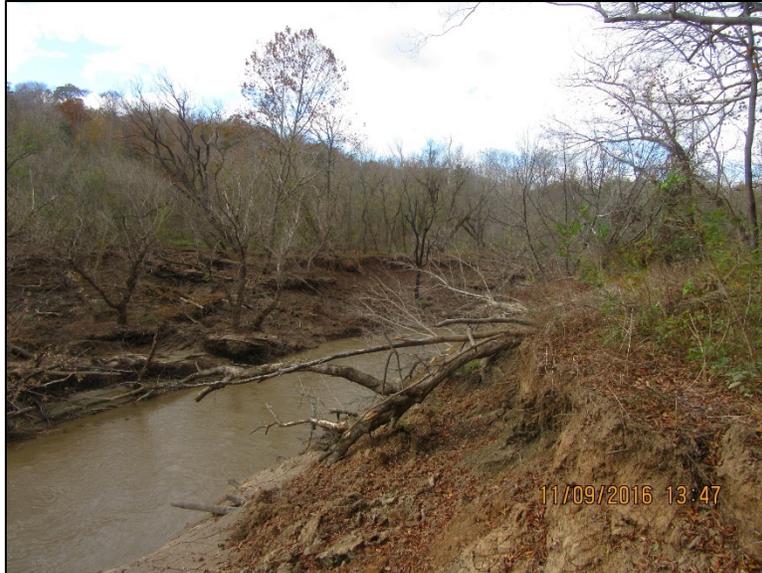
Photo 6-7

Description: View looking downstream at Cross Section 6 from an upstream position

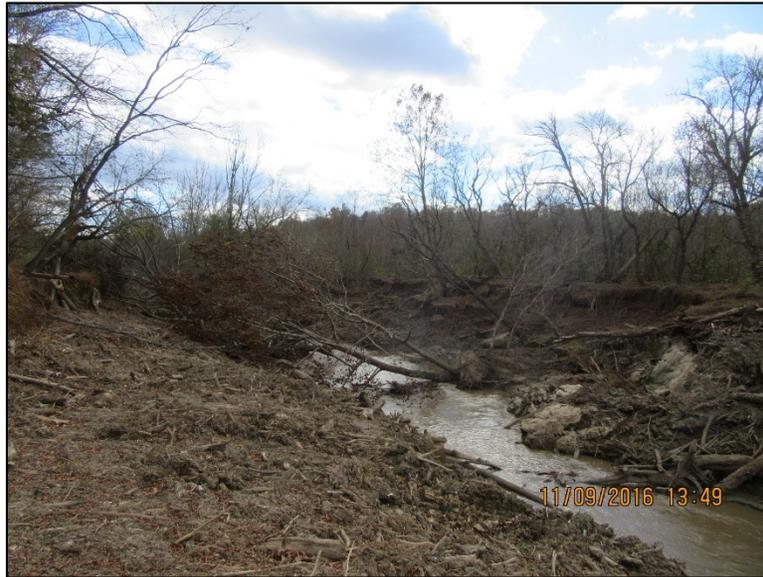
Photo 6-8

Description: View looking upstream at Cross Section 6 from a downstream position

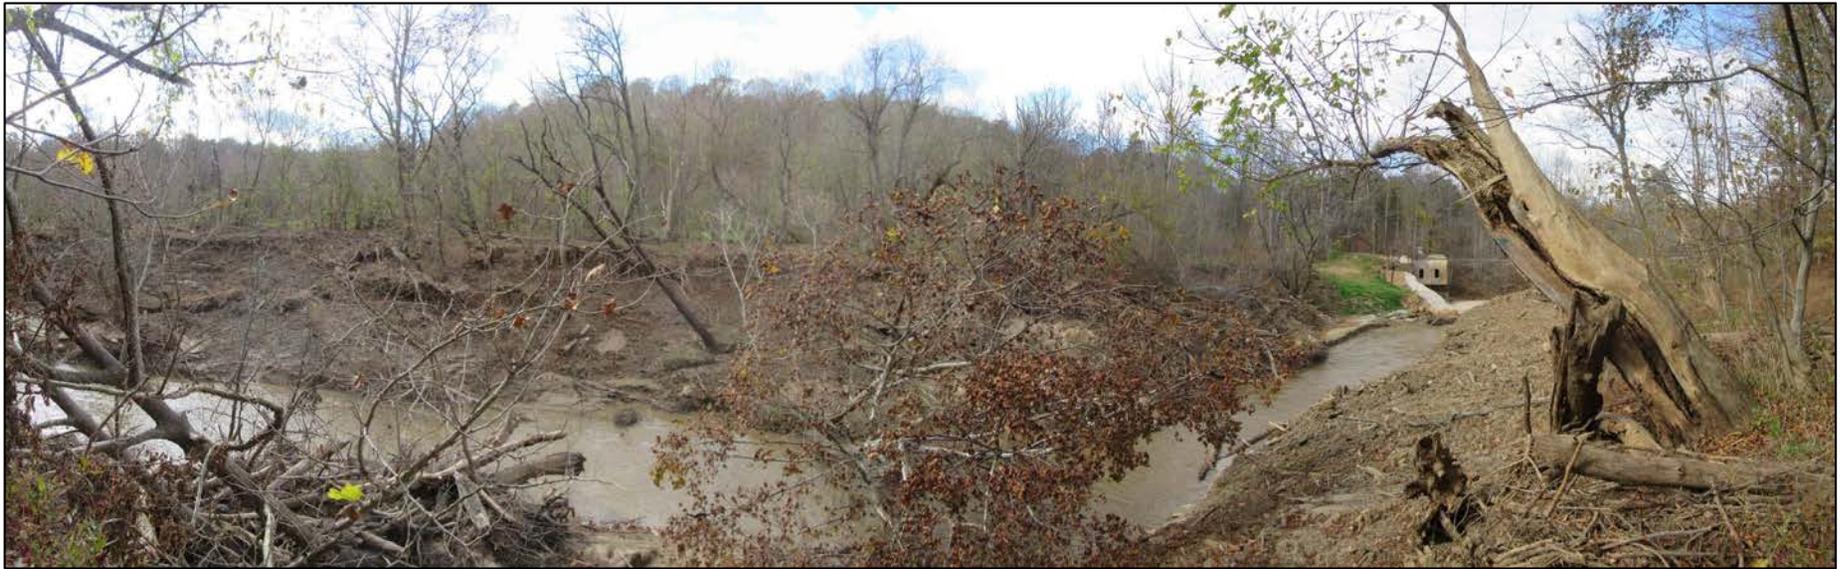
Photo 6-9 (combined image)
Location, Orientation: XS 6, Right Bank Panorama
Permit Number: JPA #15-1551
Wetland Data Sheet Reference: n/a
11/9/16, 12:50 PM
Description: Panoramic view of channel from right bank position.

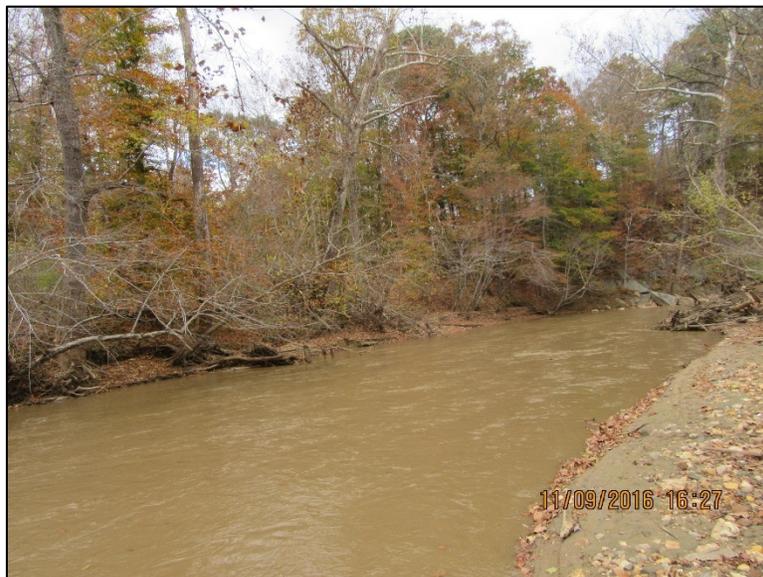
Photo 7-5

Description: View looking downstream at Cross Section 7 from an upstream position

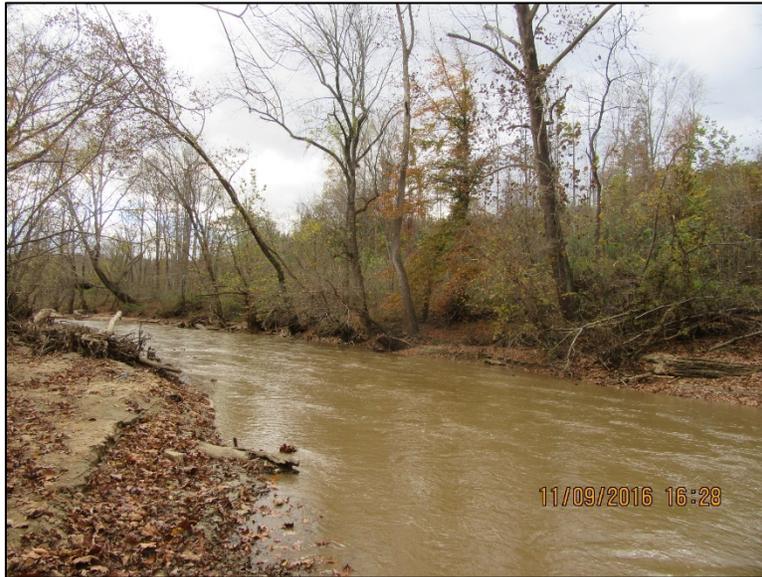
Photo 7-6

Description: View looking upstream at Cross Section 7 from a downstream position

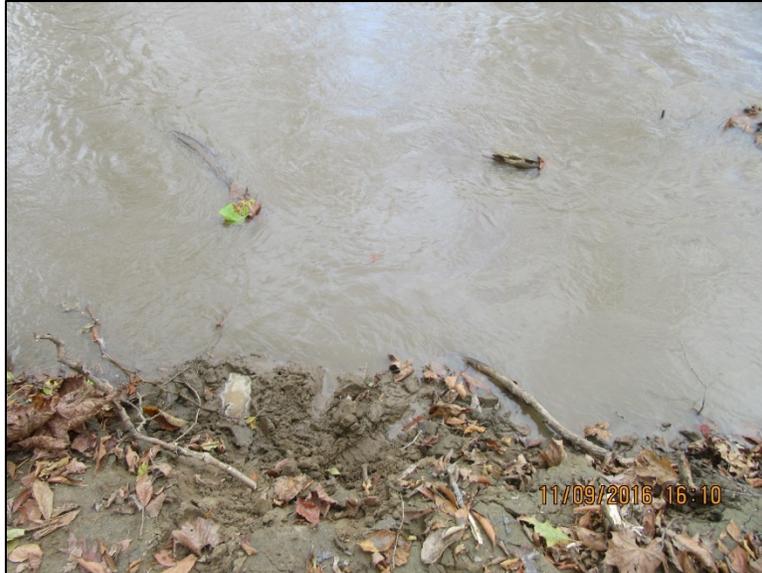
Photo 7-7

Description: Bed material at Cross Section 7 was almost entirely **silt**

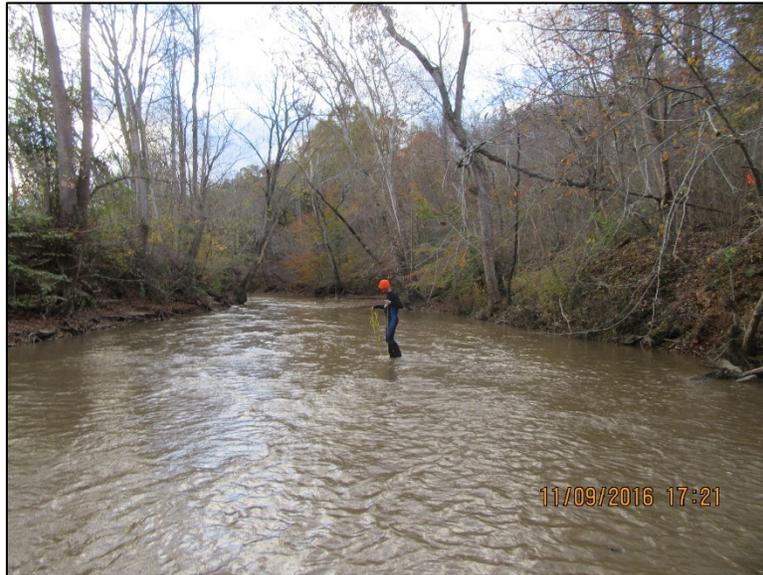
Photo 8-6

Description: View looking upstream at Cross Section 8 from a downstream position

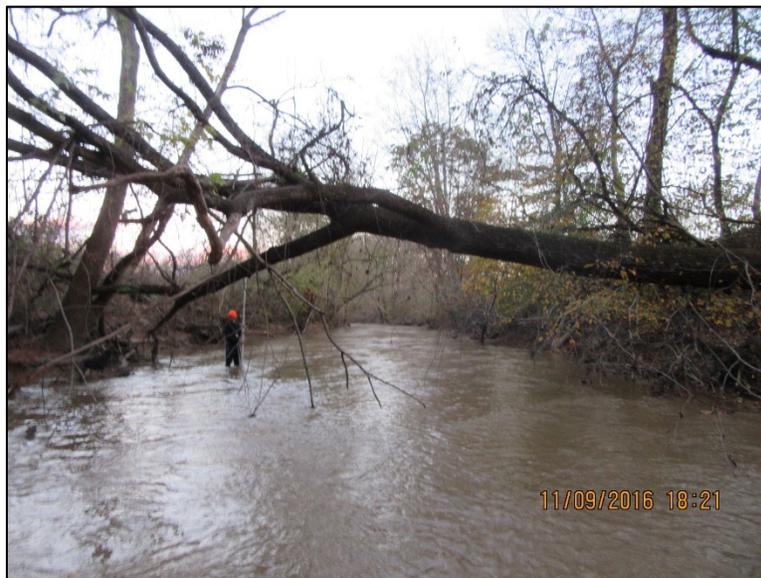
Photo 9-1

Description: View looking upstream from the middle of Cross Section 9
Woody Debris: 10-15

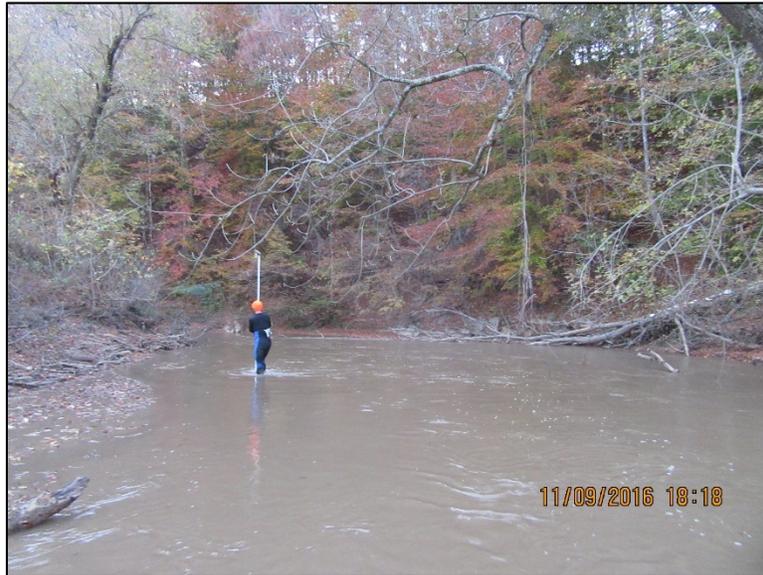
Photo 9-2

Description: View looking downstream from the middle of Cross Section 9

Woody Debris: 10-15

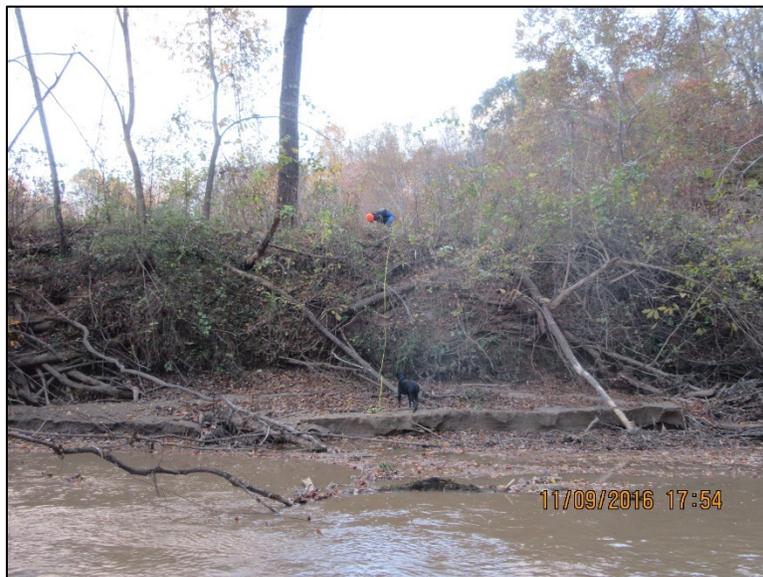
Photo 9-3

Description: View looking left from the middle of Cross Section 9

Vegetation: 60% herbaceous cover with small trees on top of bank

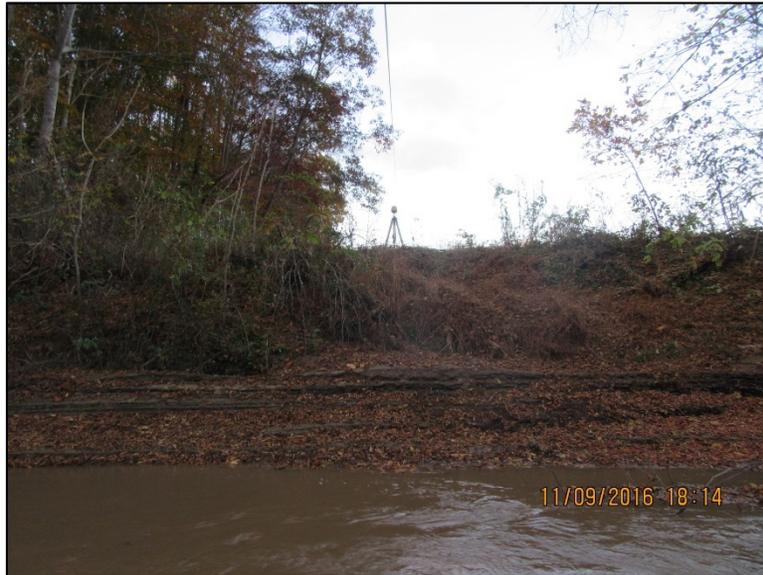
Photo 9-4

Description: View looking right from the middle of Cross Section 9

Vegetation: 50% herbaceous cover on bank (mainly upper portion)

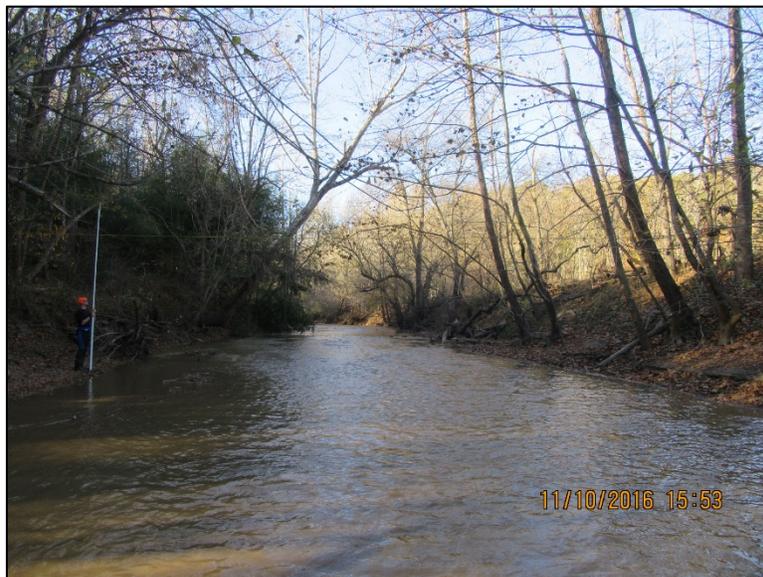
Photo 11-5

Description: View looking downstream at Cross Section 11 from an upstream position
