San Juan and Animas rivers Diversion Study

Final Report

Dale Lyons, Michael A. Farrington, Steven P. Platania, and Dave Gori

31 August 2016
Revised 12 December 2016

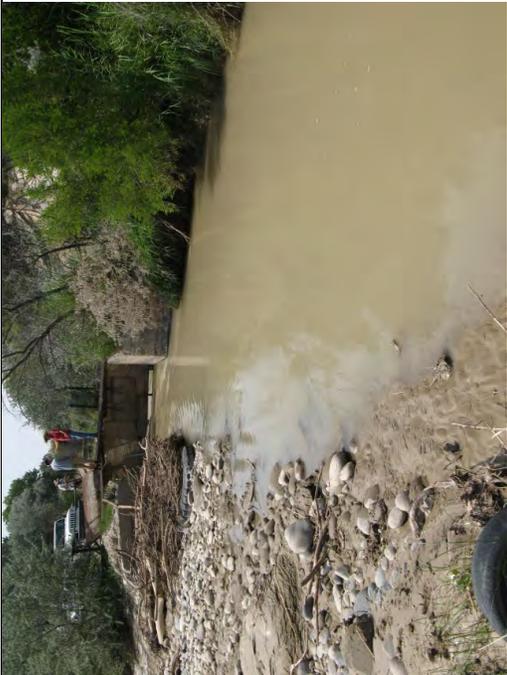
<p>RM 166.3 Jewett Valley Ditch (1 of 2)</p>

<p>View downstream at headgate.</p>

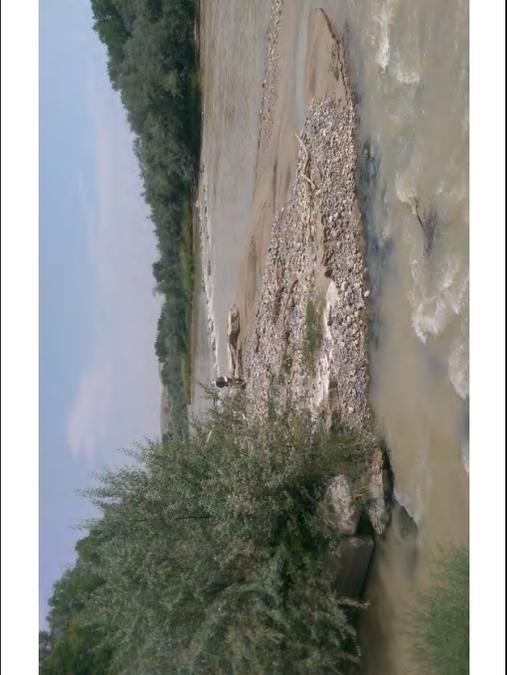
<p>View upstream from headgate of head/grade control structure stretching across main channel.</p>

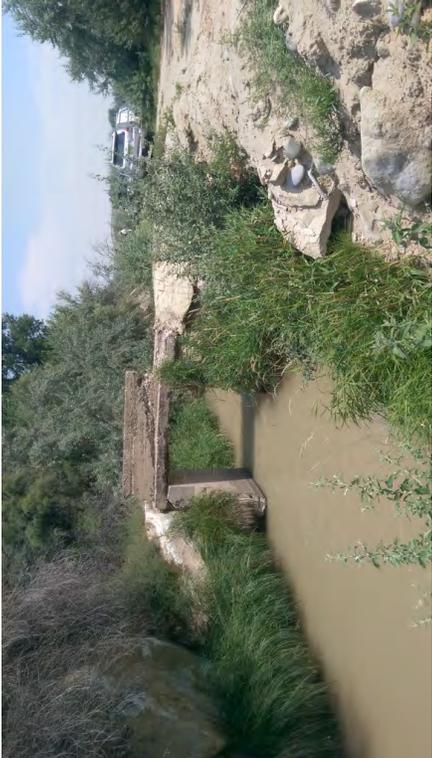
<p>RM 166.3 Jewett Valley Ditch (2 of 2)</p>

<p>A photograph showing a concrete structure with a small opening, likely a headgate, situated in a river. The water is brown and turbulent. The surrounding area is rocky and has some green vegetation.</p>	<p>View upstream of old headgate structure</p>

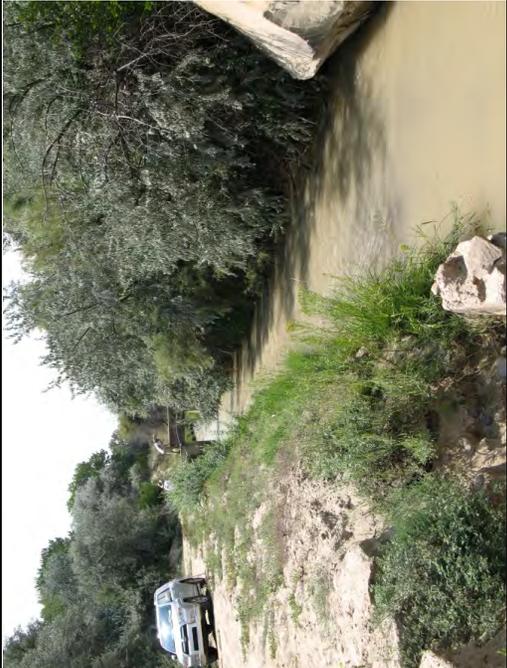
<p>A photograph showing a river with a concrete structure in the foreground. The water is brown and turbulent. The surrounding area is rocky and has some green vegetation.</p>	<p>View downstream from current headgate of old headgate</p>

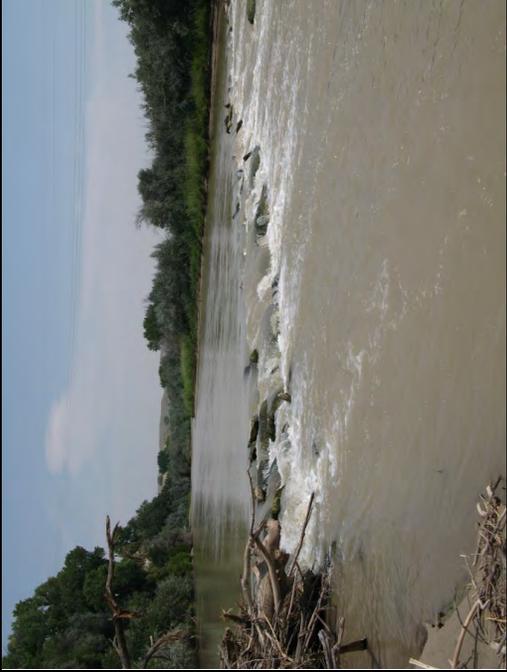
<p>A photograph showing a river with a concrete structure in the foreground. The water is brown and turbulent. The surrounding area is rocky and has some green vegetation.</p>	<p>Head/grade control structure</p>

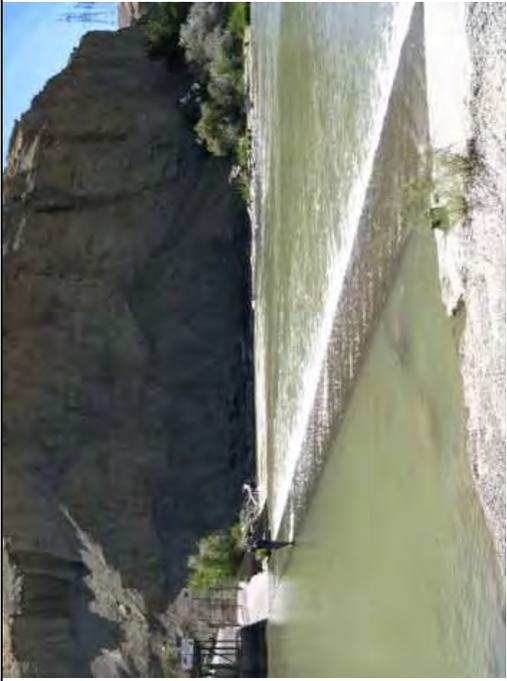
<p>RM 163.7 APS Four Corners Units 4 & 5 (1 of 2)</p>

<p>A wide-angle photograph showing a large concrete diversion structure in the middle of a river. The water is turbulent and white with foam. In the background, there are steep, rocky hills under a clear blue sky.</p>	<p>View upstream of diversion structure.</p>

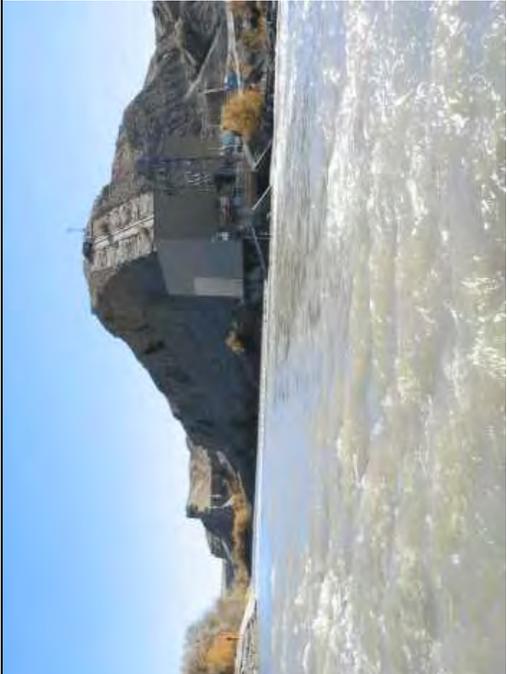
<p>A close-up view of a concrete structure with a grid-like metal mesh in the foreground. The structure appears to be part of a diversion system, with water visible behind it. The background shows a rocky hillside.</p>	<p>Concrete head/grade control structure.</p>

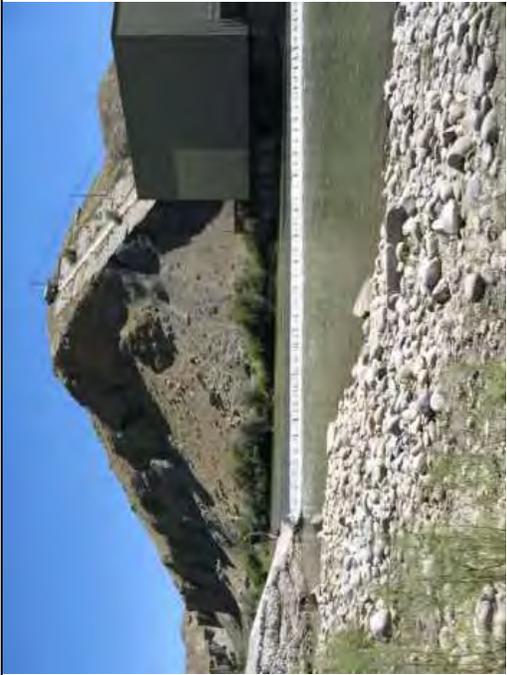
<p>RM 163.7 APS Four Corners Units 4 & 5 (2 of 2)</p>

<p>A wide-angle photograph showing a concrete head/grade control structure on the left, a rocky riverbed in the center, and a steep, rocky hillside on the right under a clear blue sky.</p>	<p>View upstream of head/grade control structure</p>

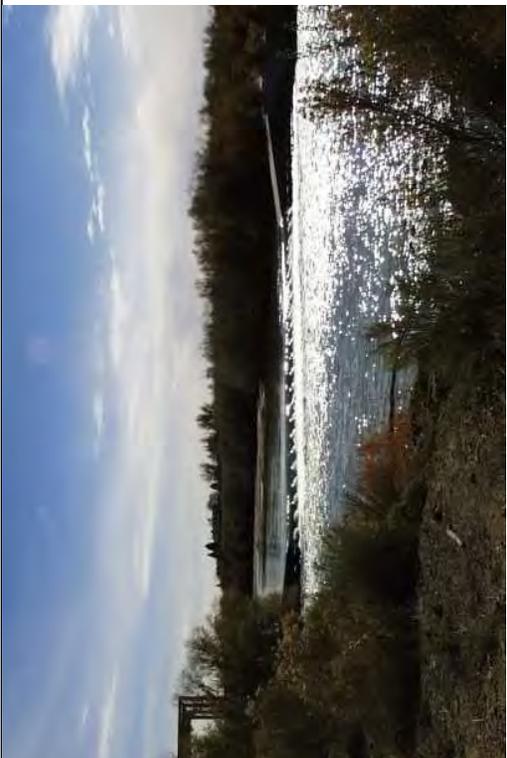
<p>RM 166.7 PNM San Juan Generating Station</p>

<p>View upstream of concrete head/grade control structure, diversion headgate at left.</p>

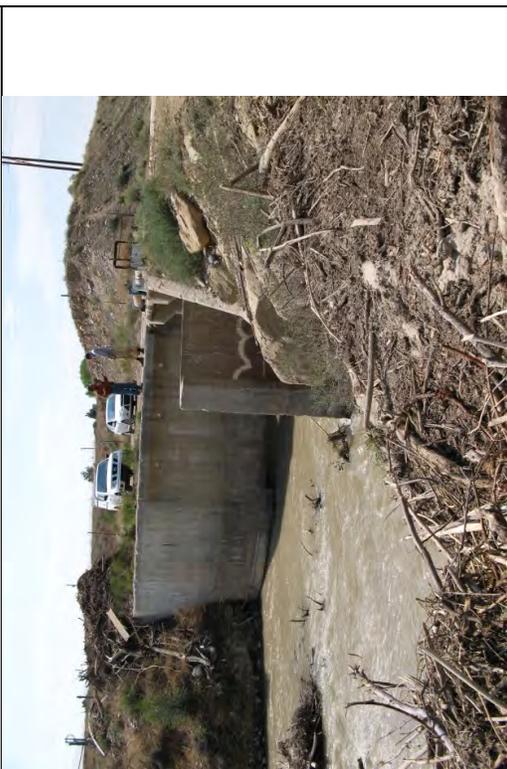
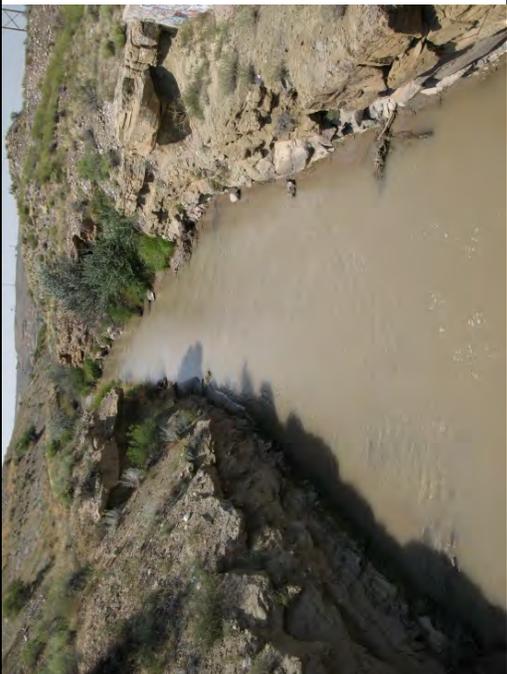
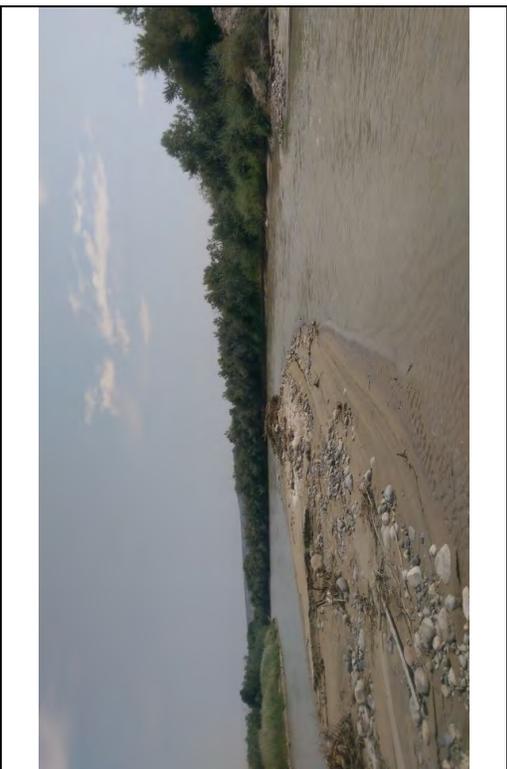
<p>RM 178.4 Fruitland Irrigation Canal/Shiprock Irrigation (1 of 2)</p>

<p>View downstream of headgate structure with gate operators removed.</p>	<p>Headgate structure.</p>

<p>View downstream of canal from headgate.</p>	<p>Headgate structure.</p>

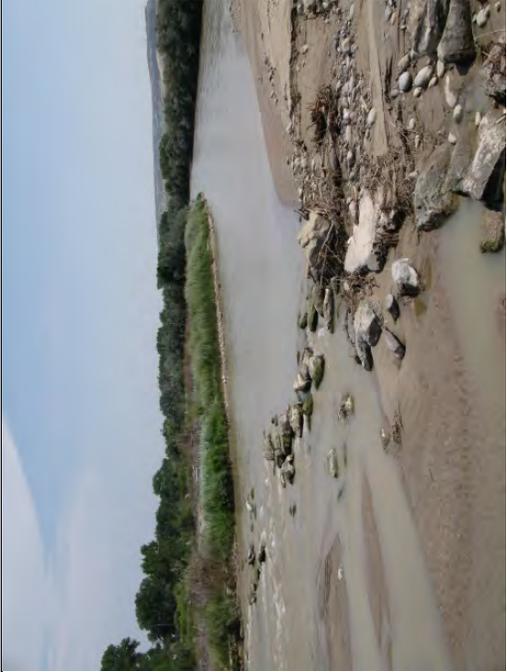
<p>RM 178.4 Fruitland Irrigation Canal/Shiprock Irrigation (2 of 2)</p>

<p>Head/grade control structure.</p>

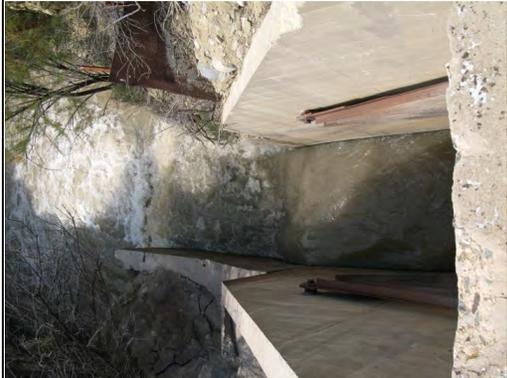
<p>Spillway with diverted water.</p>

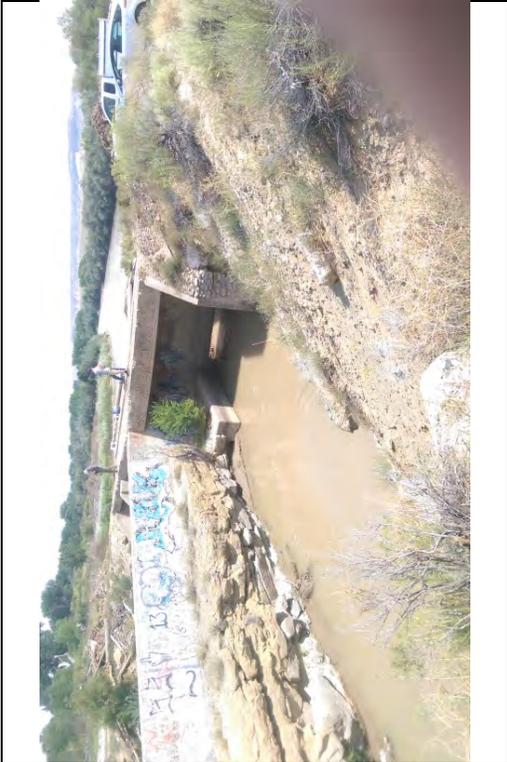
<p>View upstream of headgate structure.</p>

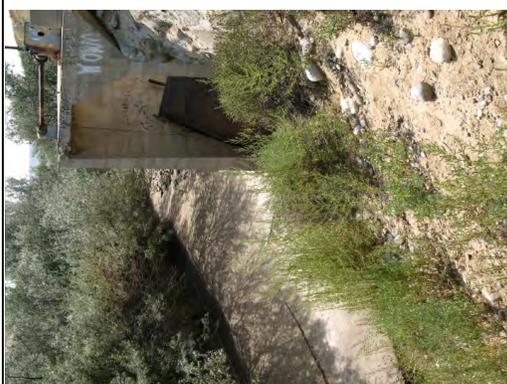
<p>Spillway gate.</p>

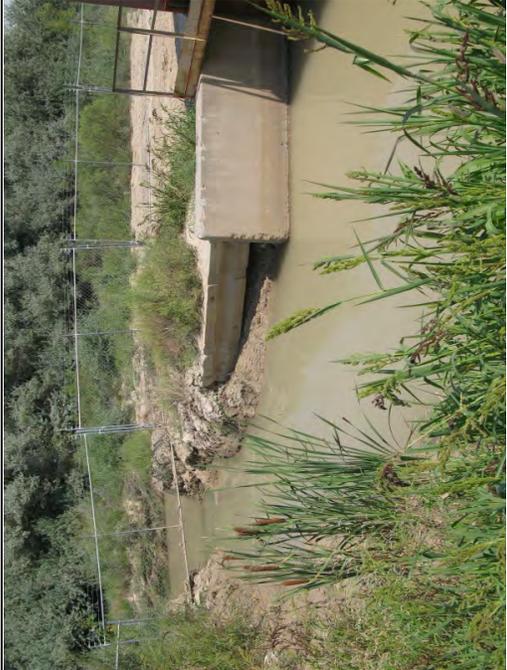
<p>RM 195.6 Williams Field Services Kutz Plant</p>

<p>Inlet channel with "Gilligan's Island" in background.</p>

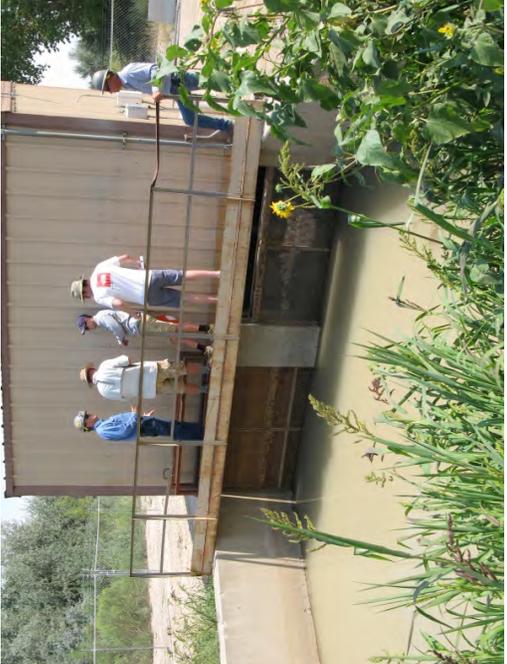
<p>Pumphouse with debris/fish screens across pump inlet.</p>

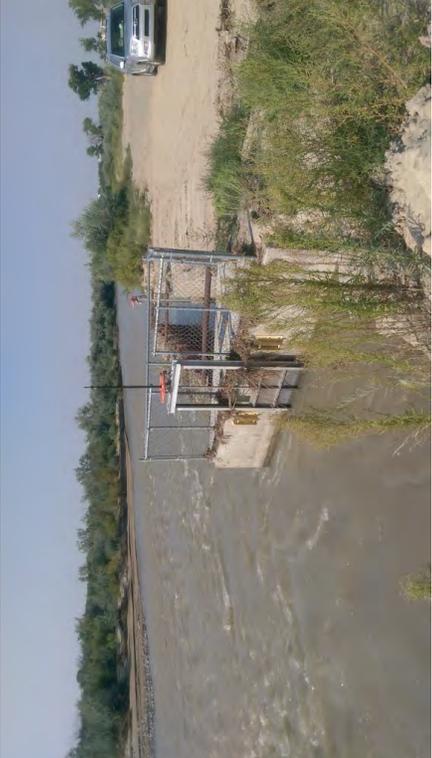
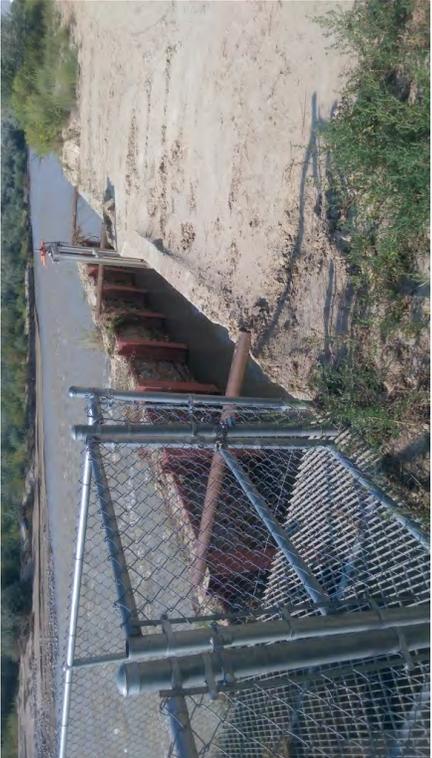
<p>RM 197.9 City of Bloomfield Second Source</p>

<p>View downstream of diversion inlet gate.</p>	<p>View downstream of diversion channel and headgate (right).</p>

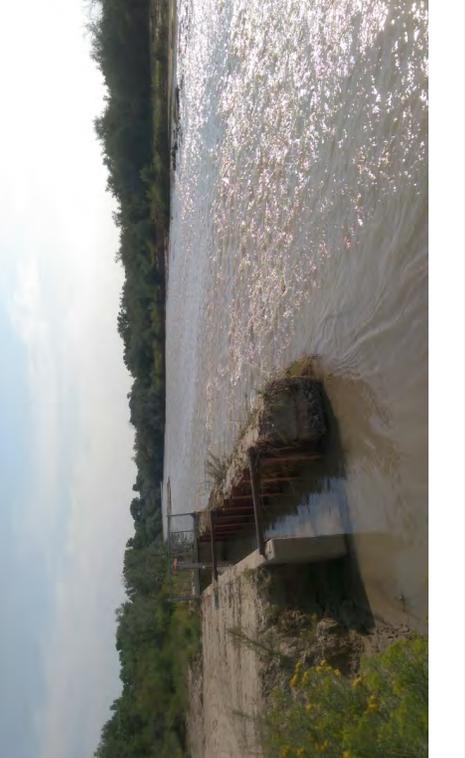
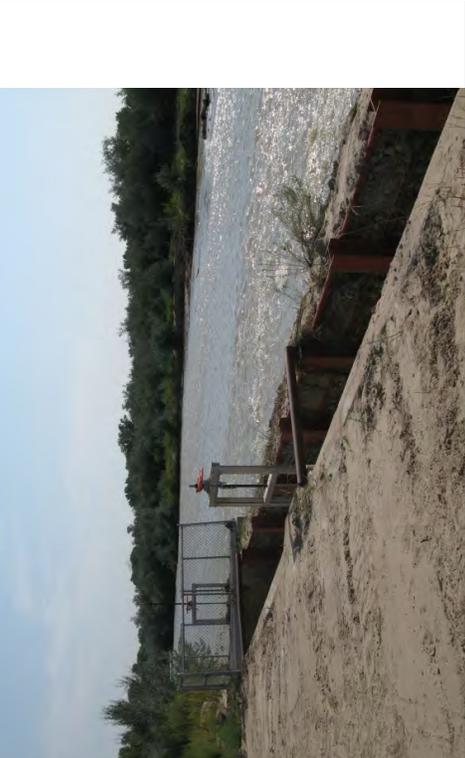
<p>View upstream of diversion channel.</p>	<p>View upstream of headgate and across river.</p>

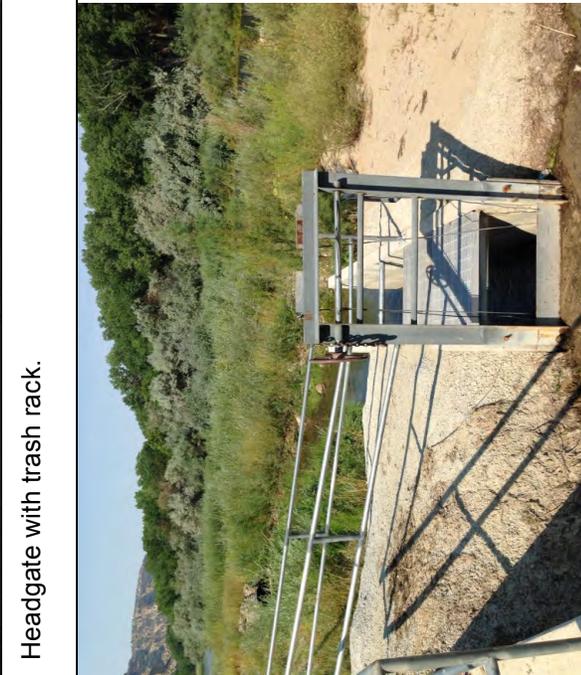
<p>A close-up view of the headgate structure, showing a metal trash rack installed across the opening. The concrete structure is situated on a dirt bank with sparse vegetation.</p>	<p>Spillway gate and return channel in background.</p>
<p>Primary and secondary headgates (secondary seldom used).</p>

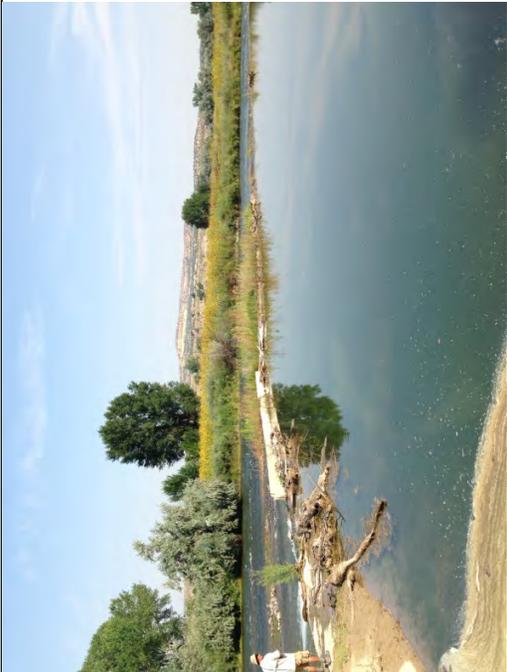
<p>RM 214.4 Turley-Manzanares Ditch (2 of 2)</p>

<p>Head/grade control structure.</p>

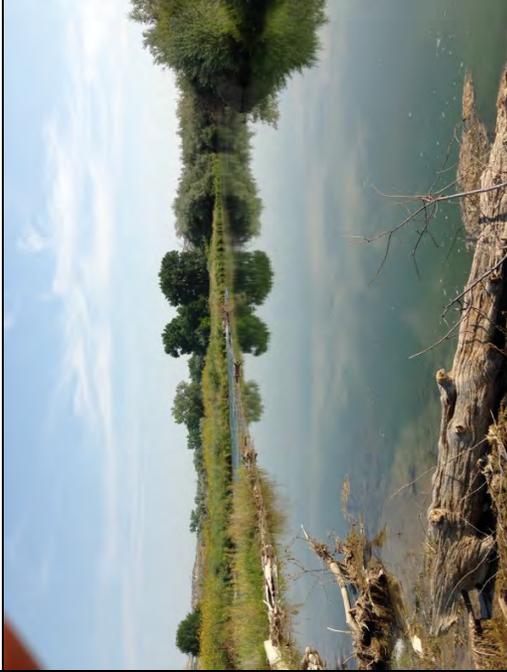
<p>View upstream of ponded area upstream of diversion.</p>

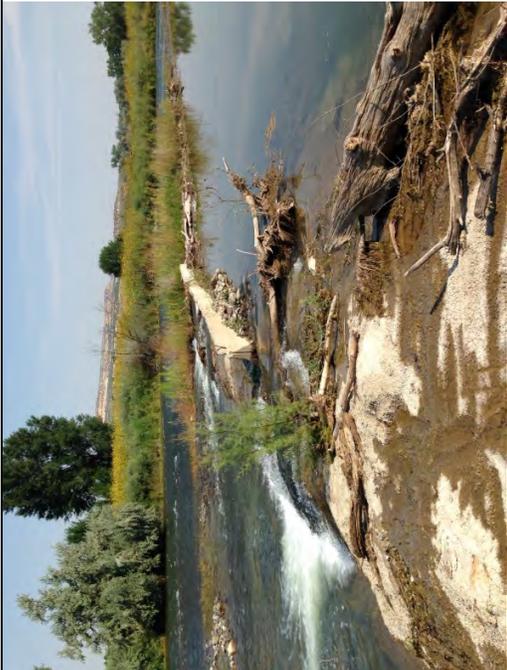
<p>Head/grade control structure.</p>

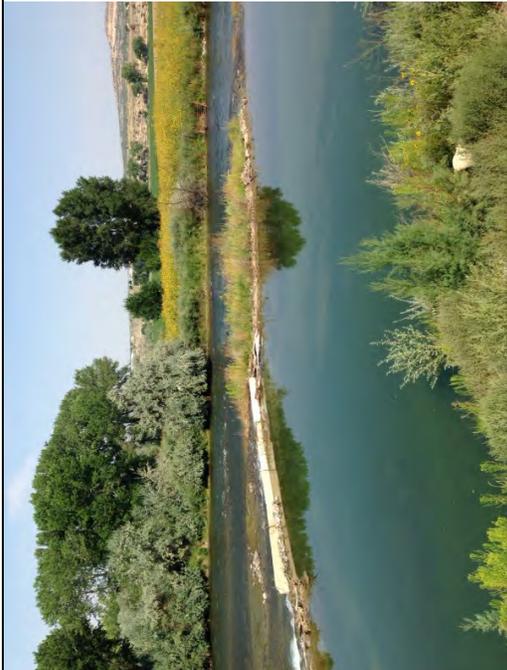
<p>Head/grade control structure with main channel in background.</p>

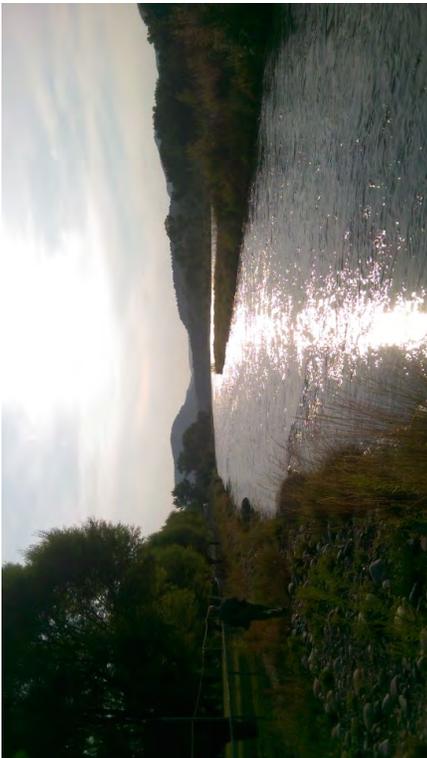
<p>RM 217.8 Bloomfield Irrigation District (1 of 2)</p>

<p>A wide-angle photograph showing a river channel flowing through a valley. The water is clear and reflects the sky. The banks are lined with green trees and shrubs. In the distance, mountains are visible under a clear sky.</p>	<p>View upstream of diversion channel inlet.</p>

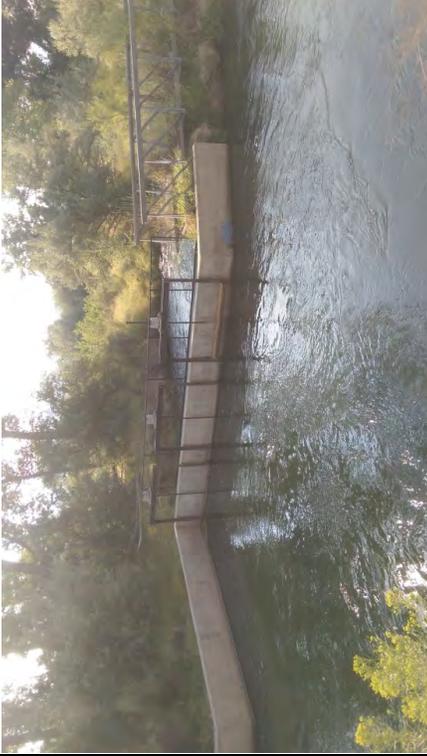
<p>A photograph of a concrete spillway structure with several gates. Water is flowing over the spillway. In the background, a return channel is visible, surrounded by dense green trees.</p>	<p>Spillway gates and return channel in background.</p>

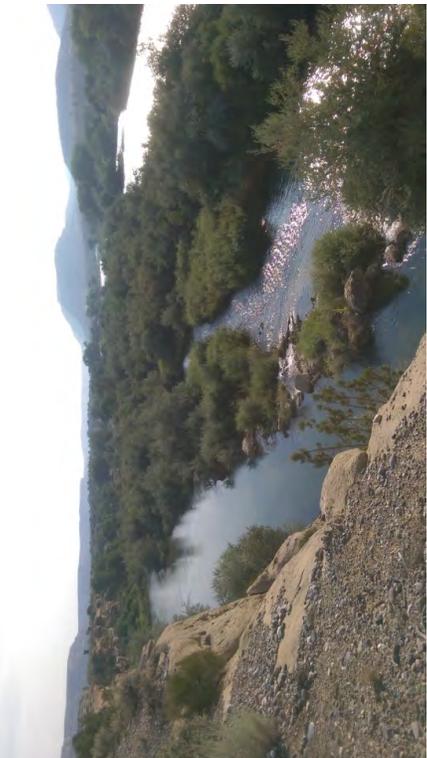
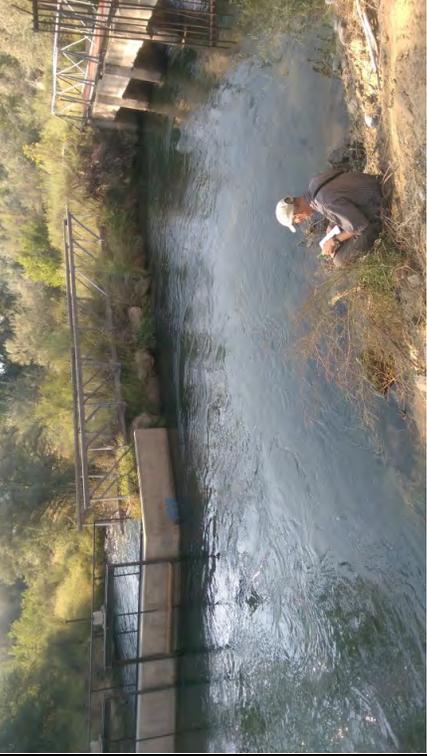
<p>A photograph of a spillway and headgate structure. A person is sitting on the bank, looking at the water. The structure is made of concrete and metal. The water is flowing over the spillway.</p>	<p>Spillway and headgate structure.</p>	<p>Diversion channel, with loss back to main river channel.</p>

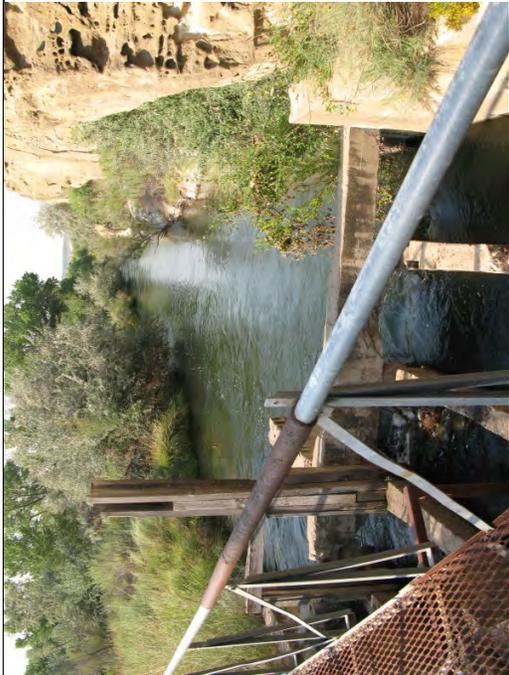
<p>A photograph showing a view downstream from a headgate structure. The structure consists of a concrete wall with a metal grate. A large metal pipe runs diagonally across the foreground. The river flows through a rocky channel with some vegetation on the banks.</p>	<p>View downstream of headgate structure.</p>

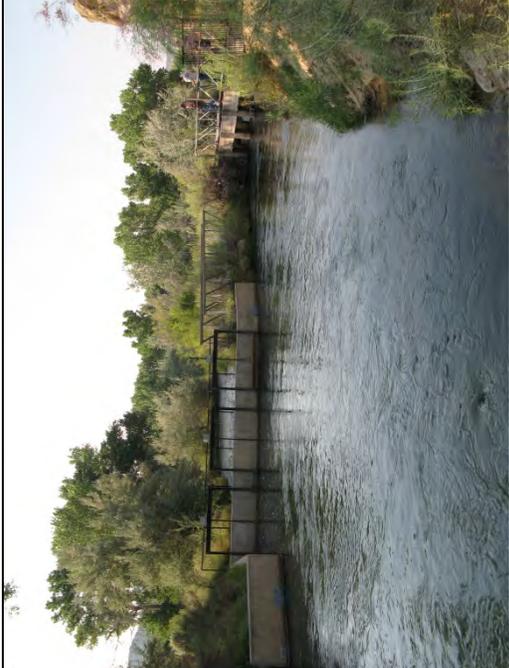
<p>A photograph showing a spillway and headgate structure. The spillway is a concrete wall with a metal grate. The headgate structure is a concrete wall with a metal grate. The river flows through the opening. The background shows a rocky hillside with some vegetation.</p>	<p>Spillway and headgate structure.</p>

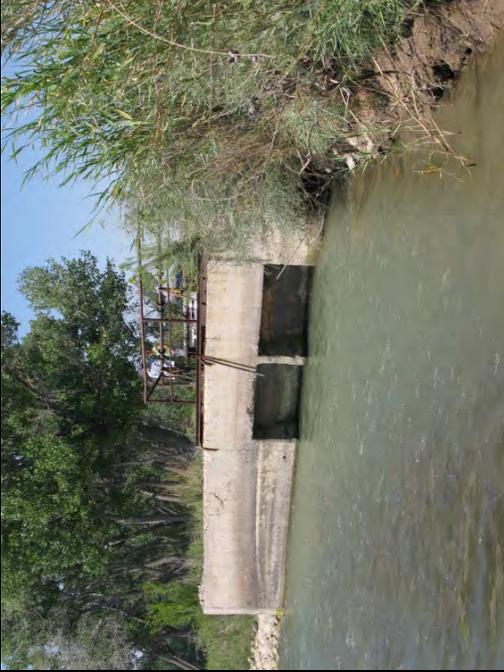
<p>Concrete headgate structure.</p>

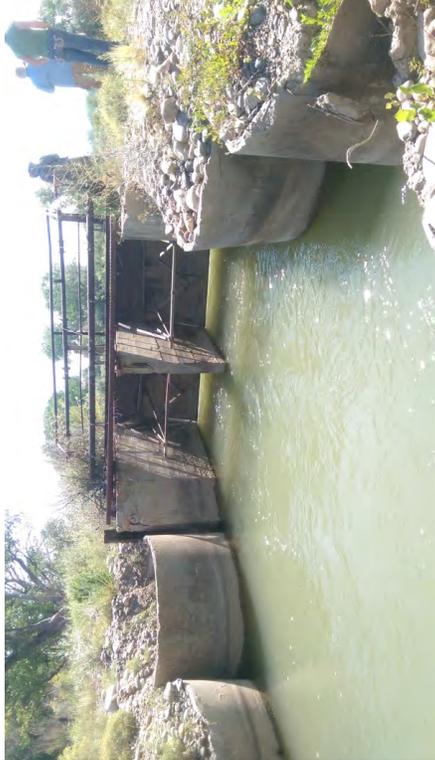
<p>Back of headgate structure, with radial gates.</p>

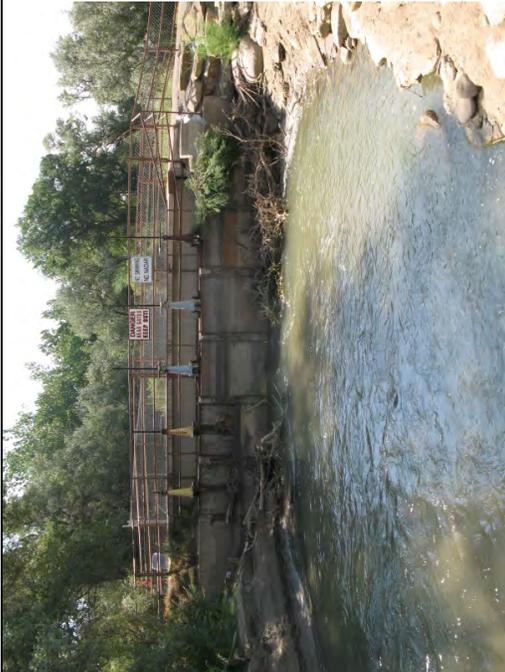
<p>Headgate structure with concrete/boulder head/grade control structure at right.</p>	<p>View downstream of headgate structure at left and concrete/boulder head/grade control structure at right.</p>

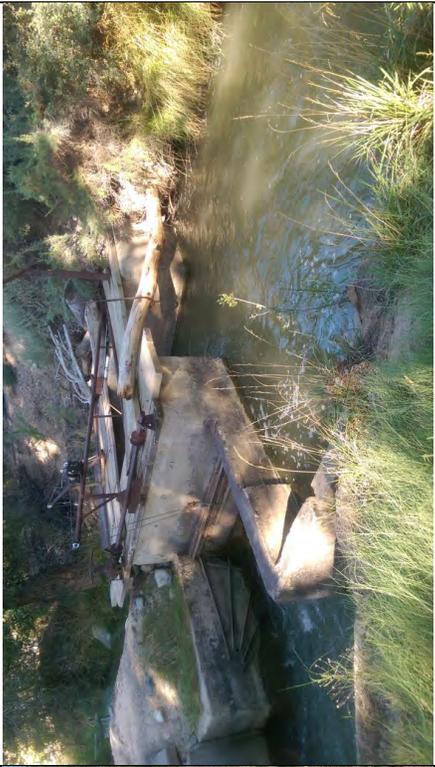
<p>View downstream of diversion channel, below inlet at main channel.</p>	<p>Concrete headgate and spillway structure with radial gates.</p>

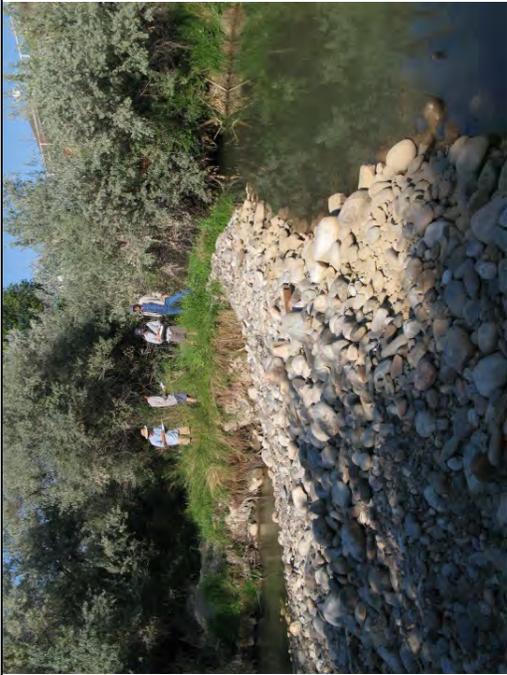
<p>Secondary head/grade control structure across diversion channel; headgate behind field crew.</p>

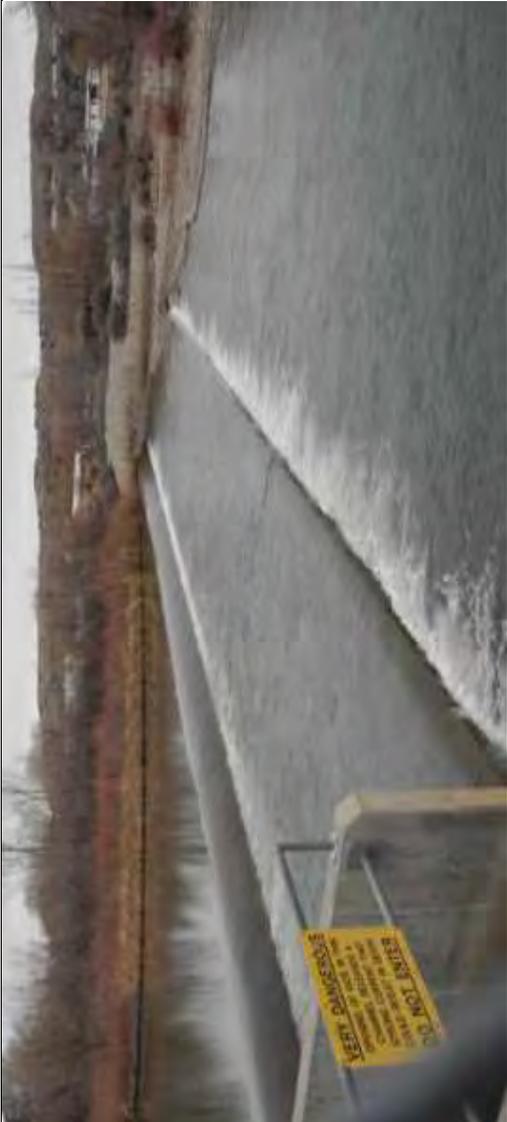
<p>Head/grade control structure, with diversion inlet in foreground.</p>

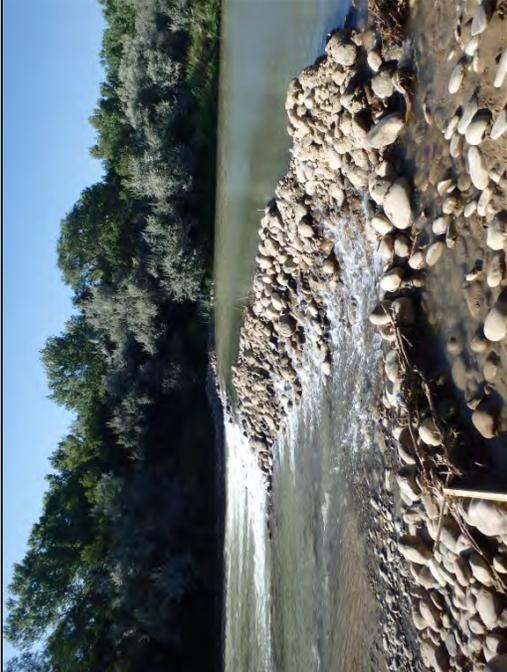
<p>Head/grade control structure in main channel 40 meters downstream of headgate.</p>

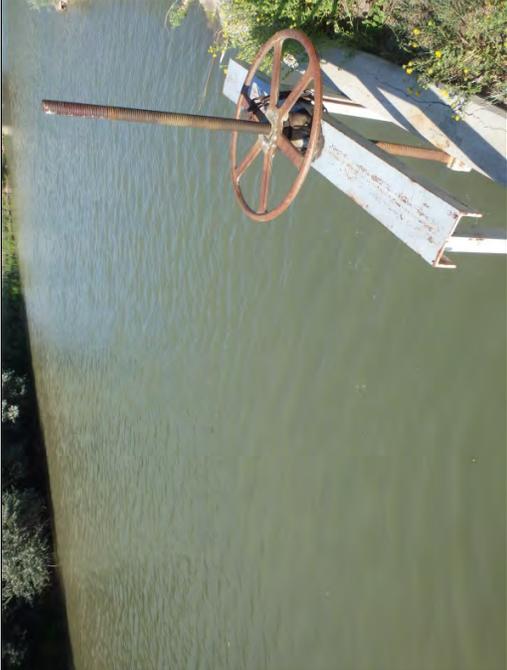
<p>Concrete headgate structure along main river channel.</p>

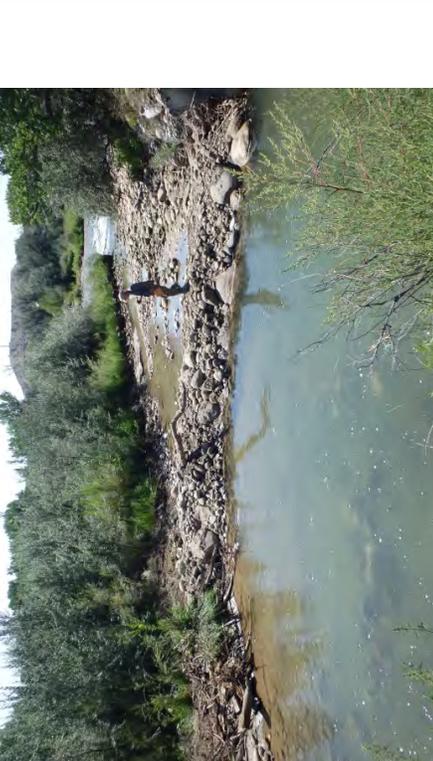
<p>A photograph of a secondary head/grade control structure. It features a concrete structure with a metal gate, situated in a rocky stream bed. A person is visible in the background for scale.</p>	<p>Secondary head/grade control structure, headgate at right.</p>

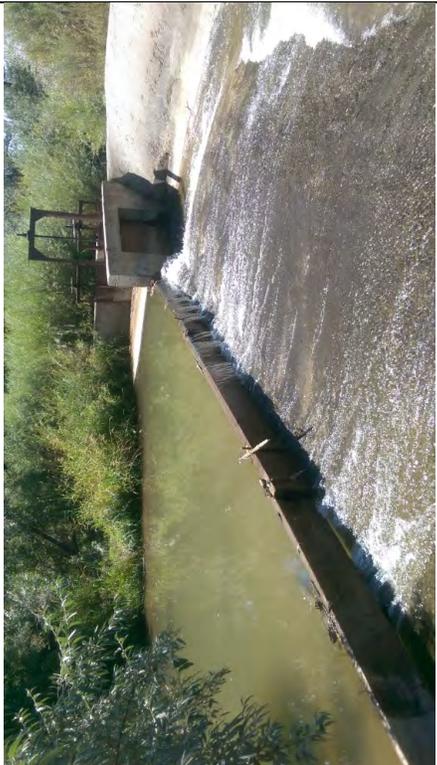
<p>Headgate, spillway gate, and secondary head/grade control structure.</p>

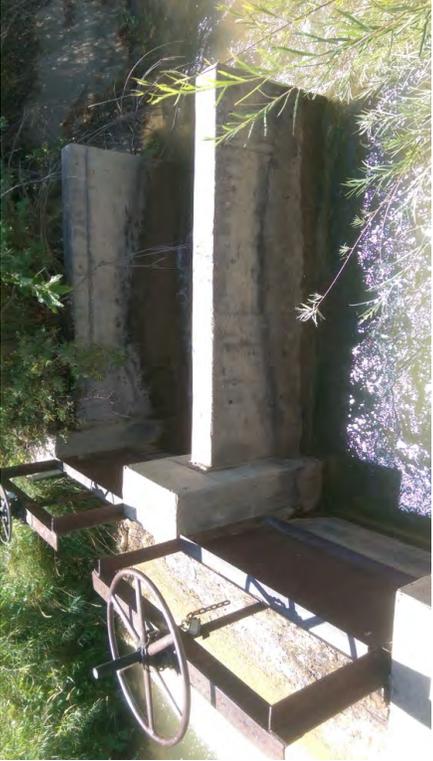
<p>RM 16.8 Kello-Blancett Ditch (2 of 2)</p>

<p>Headgate structure.</p>

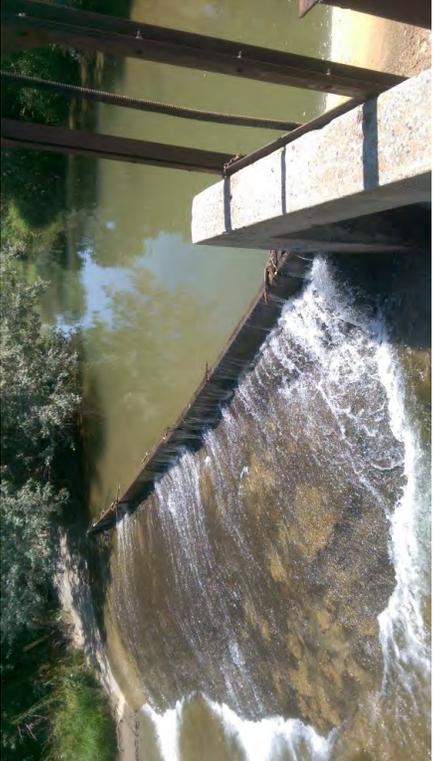
<p>Secondary concrete head/grade control structure.</p>

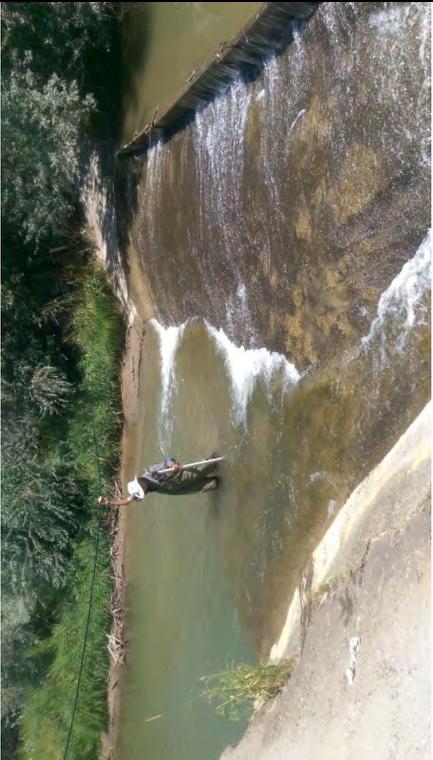
<p>View of secondary concrete head/grade control structure, from headgate.</p>

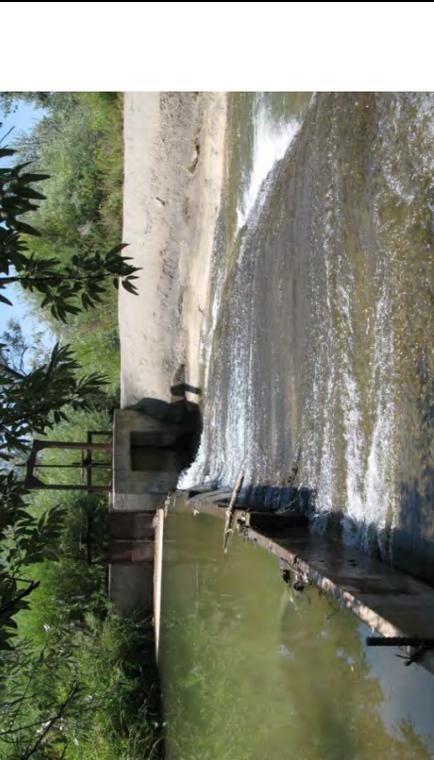
<p>Secondary concrete head/grade control structure.</p>

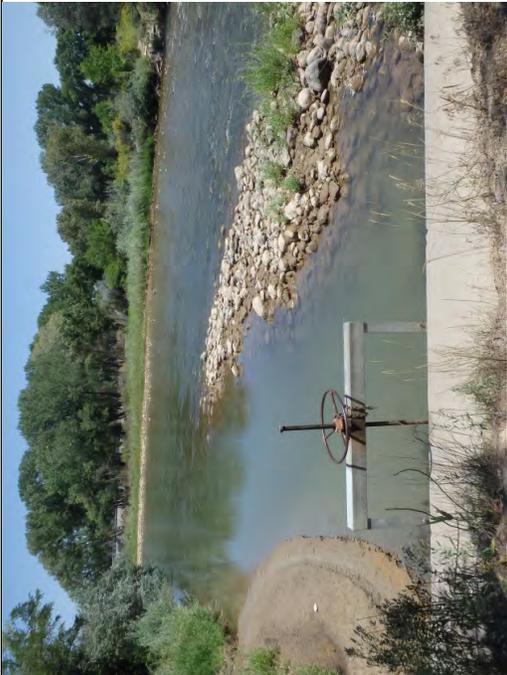
<p>RM 19.8 Eledge Mill Ditch</p>

<p>View upstream from headgate.</p>

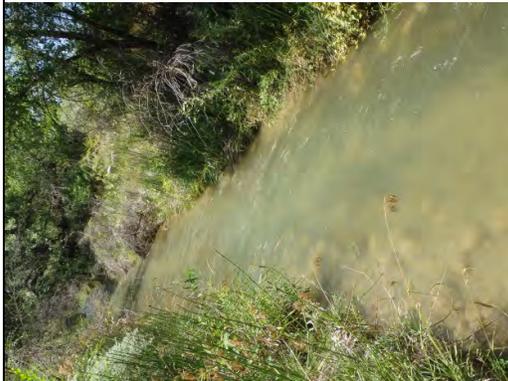
<p>View downstream of ditch, from headgate.</p>

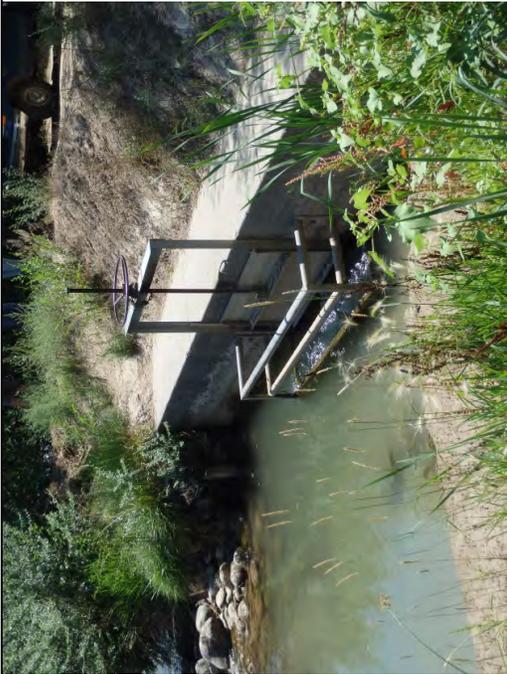
<p>Headgate structure with trash rack.</p>

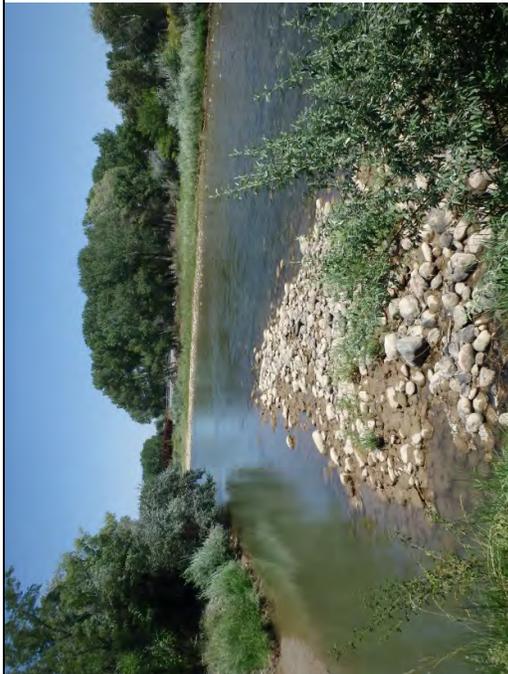
<p>View upstream from headgate.</p>

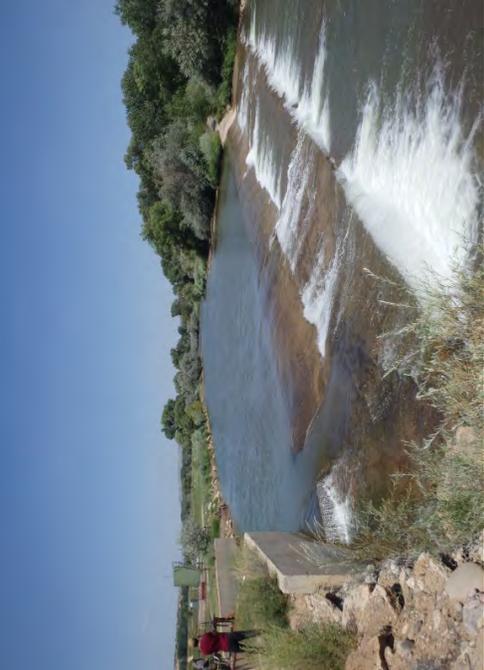
<p>RM 21.4 Farmers Irrigation District (1 of 2)</p>

<p>Concrete head/grade control structure.</p>

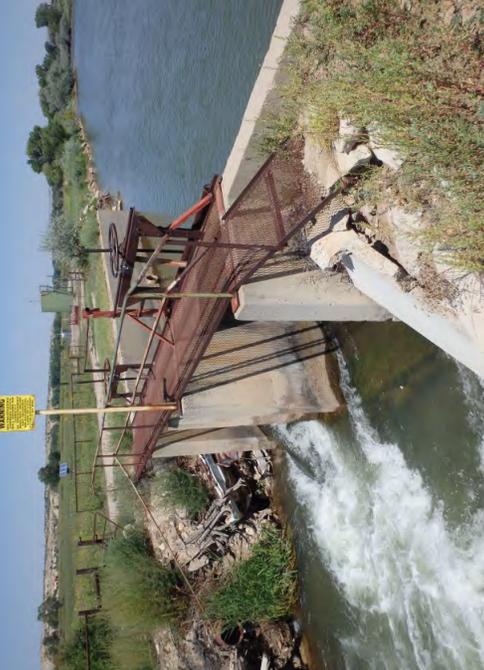
<p>View upstream of headgate structure.</p>

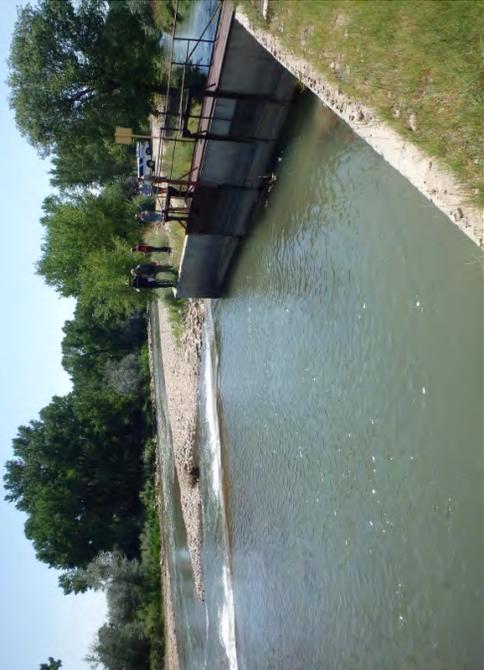
<p>Headgate structure and head/grade control structure at left.</p>

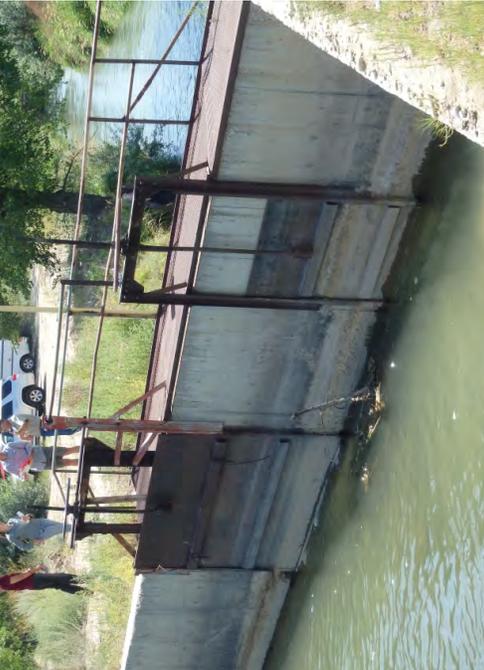
<p>Headgates.</p>

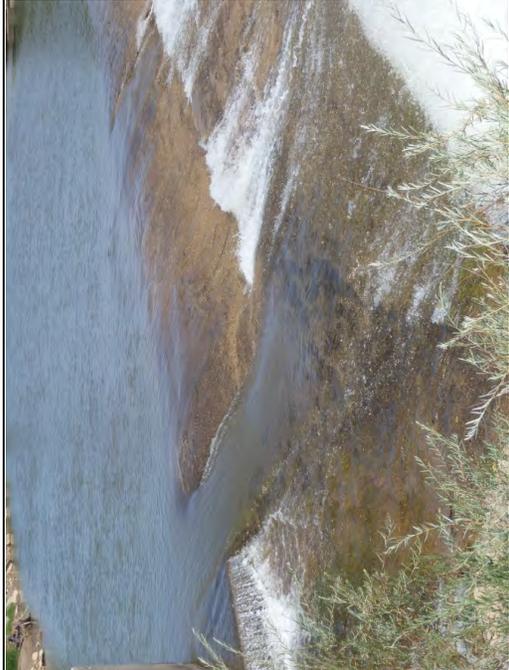
<p>RM 21.4 Farmers Irrigation District (2 of 2)</p>

A close-up photograph of a head/grade control structure. The structure is a concrete barrier across a river channel, with water flowing over it and creating white foam. The surrounding area is grassy and appears to be a natural or semi-natural environment.	<p>Close-up of head/grade control structure.</p>

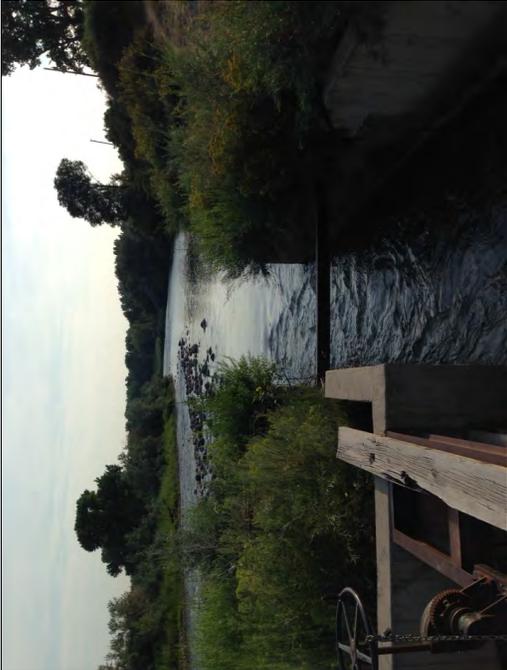
<p>RM 21.8 Lower Animas Ditch</p>

<p>View upstream of head/grade control structure, from headgate.</p>

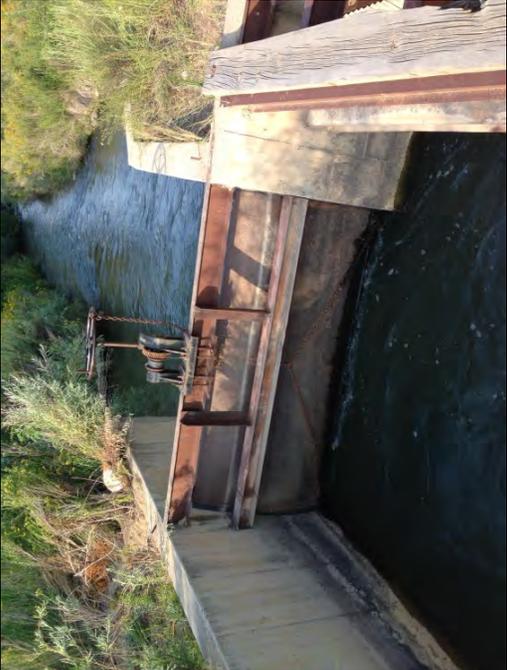
<p>Radial headgate.</p>

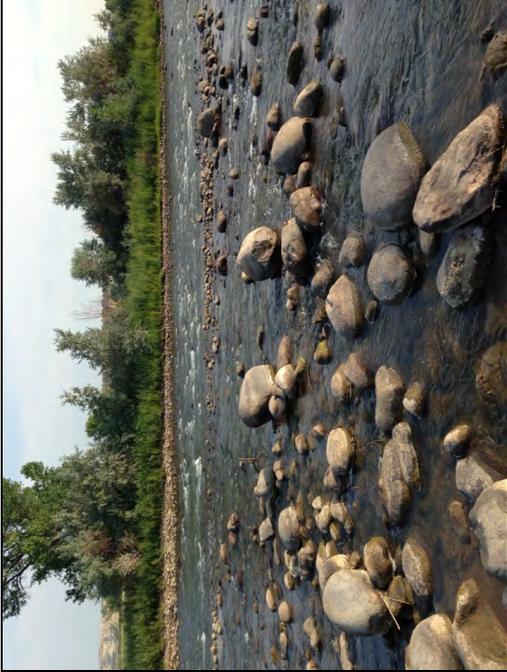
<p>Head/grade control structure, extending partially across channel.</p>

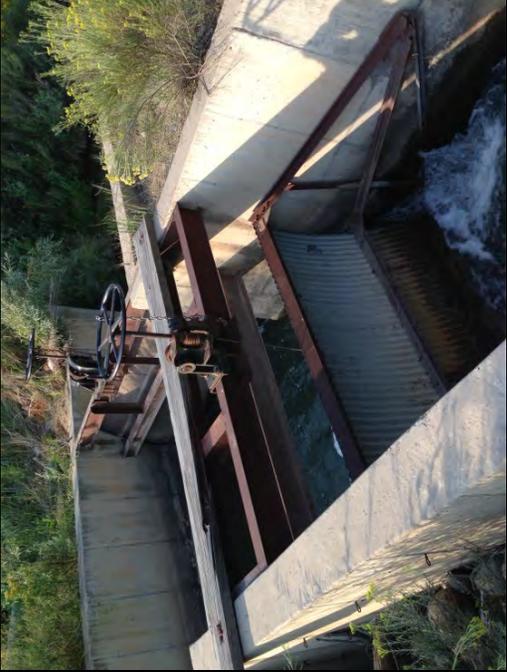
<p>Radial spillway gate.</p>

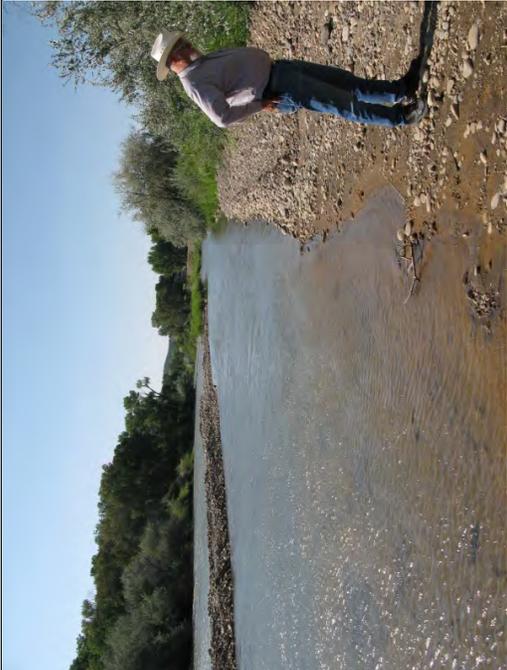
<p>RM 29.6 Stacey Ditch</p>

<p>View downstream of diversion channel inlet.</p>

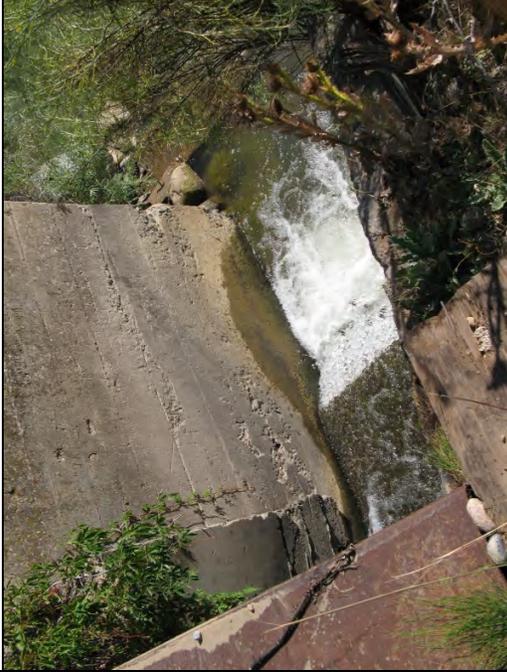
<p>Headgate structure, with spillway to left.</p>

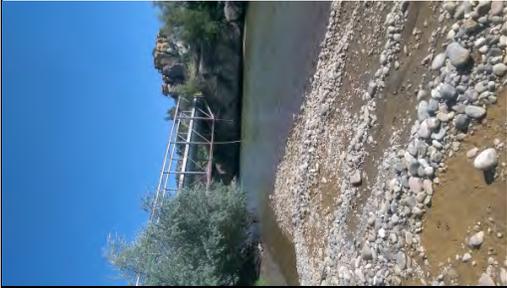
<p>Spillway with return to main river channel.</p>
