San Juan and Animas rivers Diversion Study

Final Report

Dale Lyons, Michael A. Farrington, Steven P. Platania, and Dave Gori

31 August 2016
Revised 12 December 2016

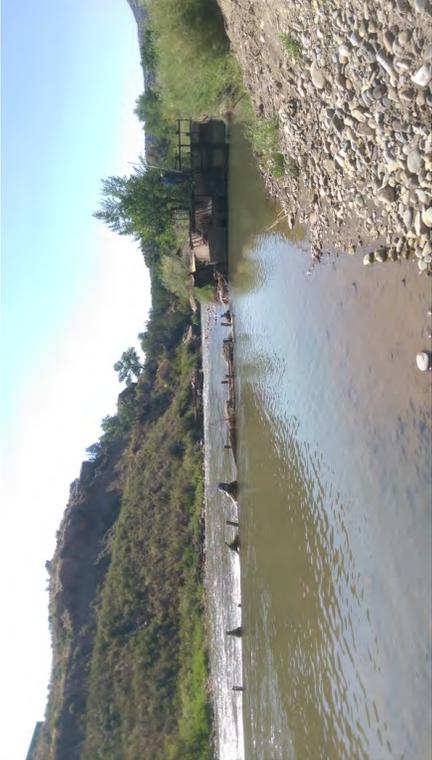
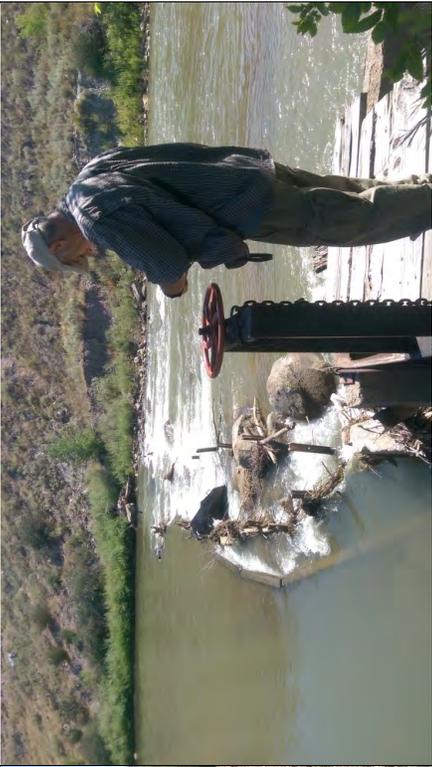
<p>RM 33.8 Cedar Ditch</p>

<p>View of head/grade control structure, from headgate.</p>

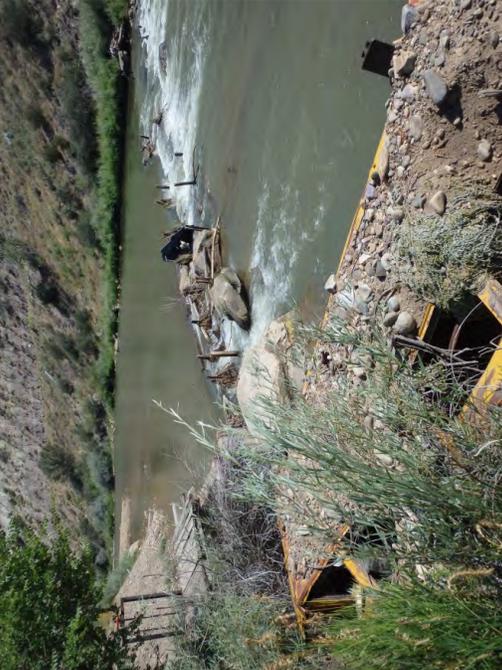
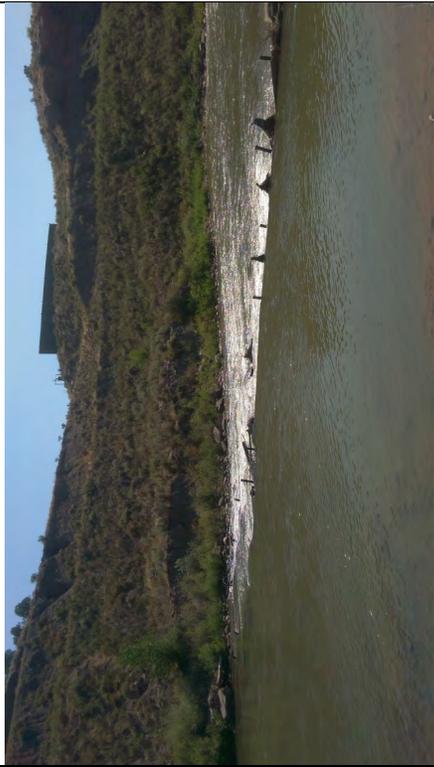
<p>View downstream of head/grade control structure.</p>	<p>View upstream of head/grade control structure.</p>
----------------------------	---	--	---	--	---	---	---

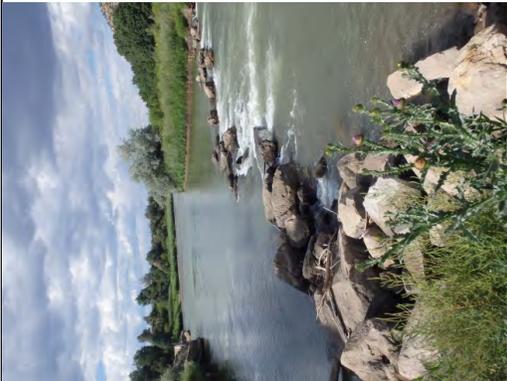
<p>RM 39.7 Twin Rock Ditch</p>

<p>View upstream of head/grade control structure.</p>

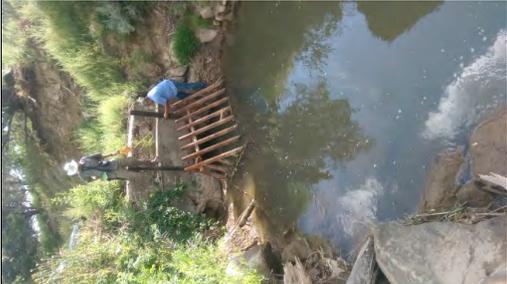
<p>Diversion structure with trash rack.</p>

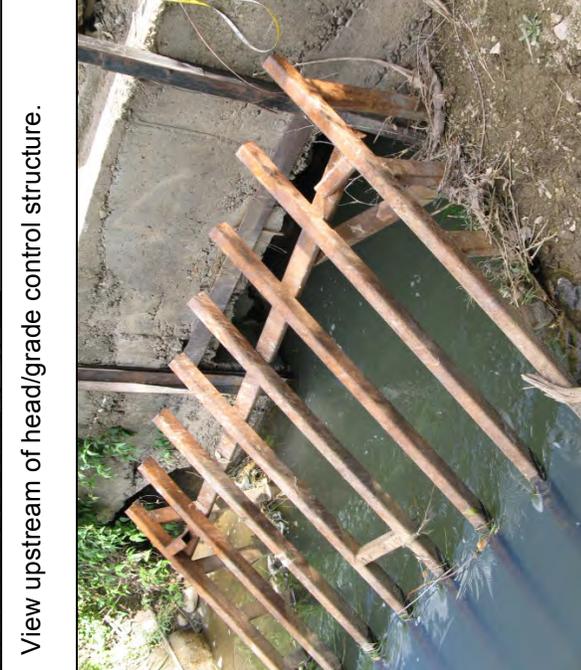
<p>Trash rack.</p>

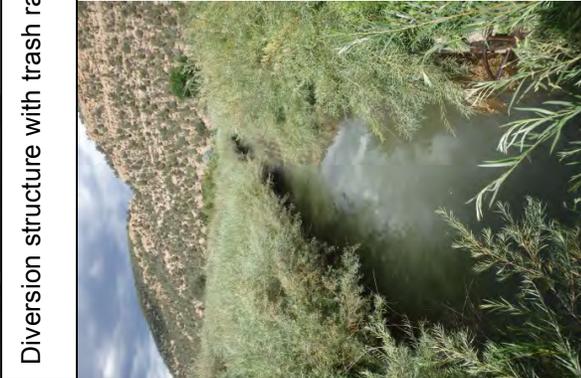
<p>View downstream of ditch, from diversion structure.</p>
--------------------------------	--	---	--	---

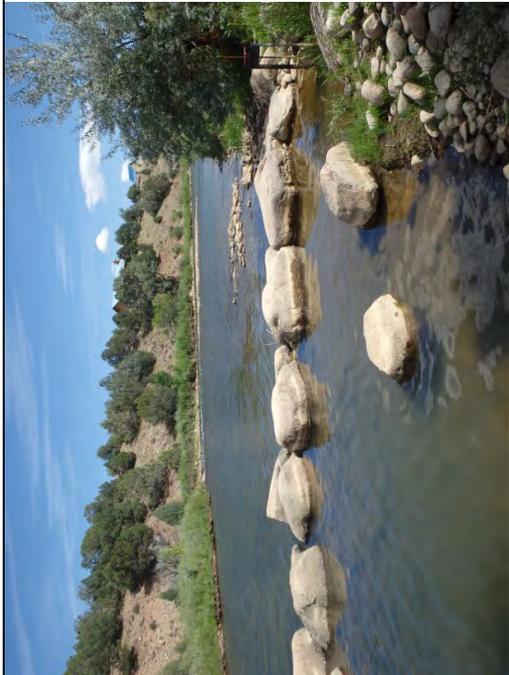
<p>RM 48.9 Dena Ditch/Little Fishes Wildlife Habitat Enhancement Project</p>

<p>View downstream of head/grade control comprised of large boulders.</p>

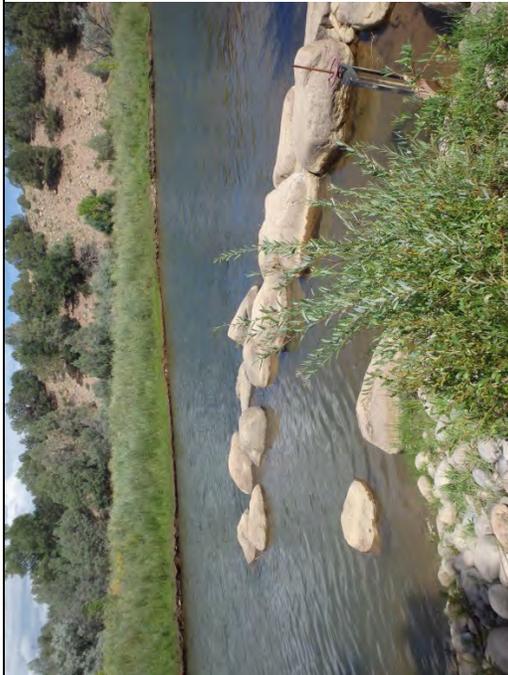
<p>Boulders extending partially across channel.</p>

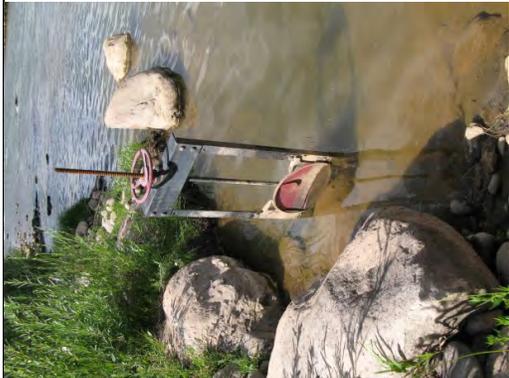
<p>Headgate at pipe inlet.</p>

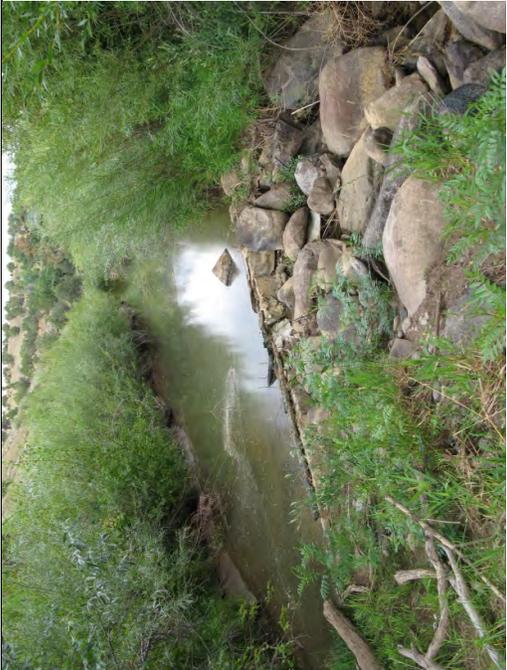
<p>RM 53.5 Cason Ditch</p>

<p>Uncontrolled spillway adjacent to headgate structure.</p>

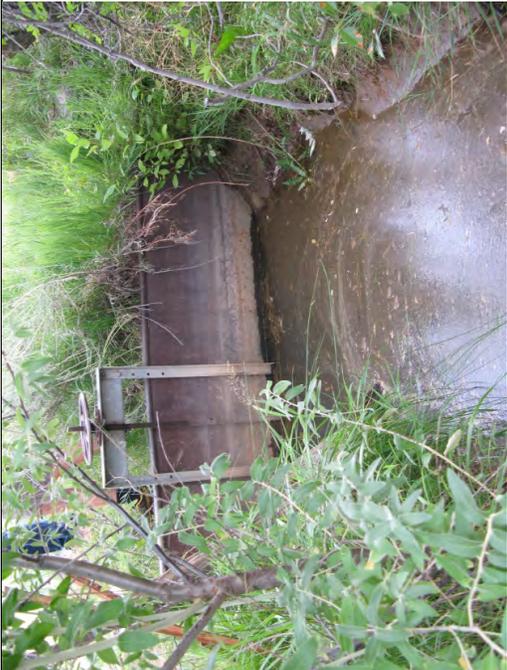
<p>Headgate structure.</p>

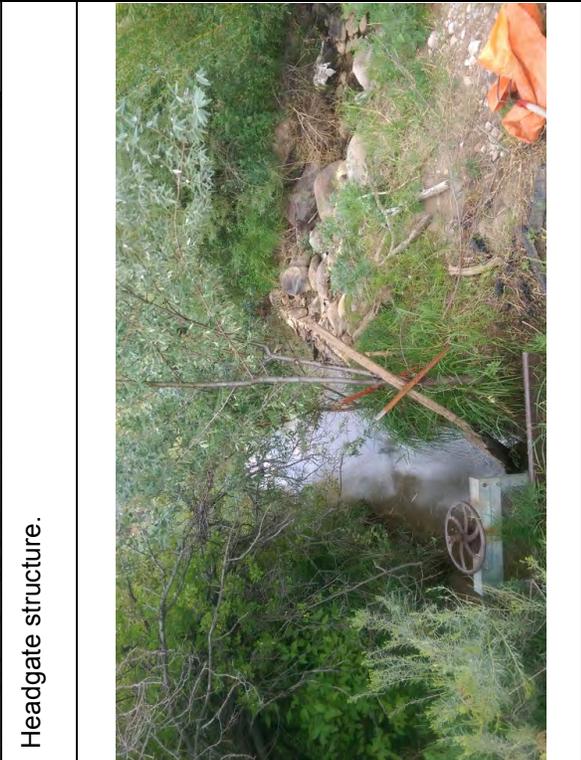
<p>View upstream of headgate and spillway.</p>
----------------------------	---	--	--	---

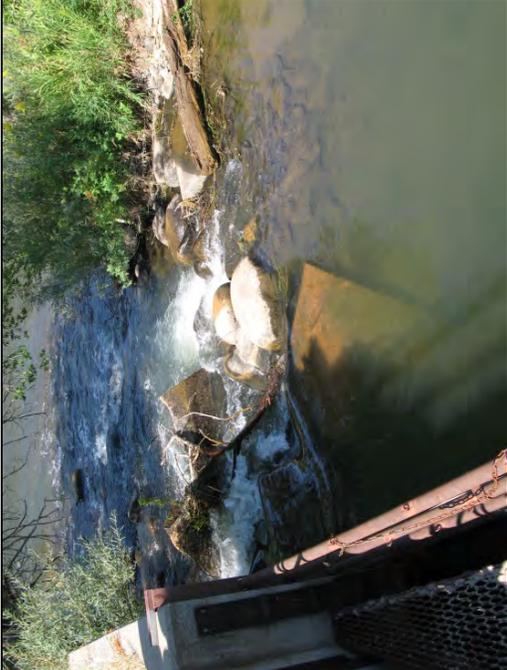
<p>RM 55.1 East Mesa Ditch</p>

<p>Uncontrolled spillway return to main channel.</p>

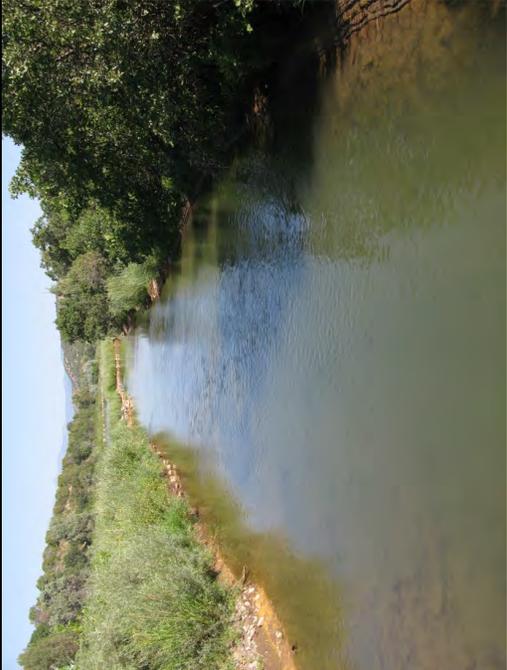
<p>View upstream along diversion channel.</p>

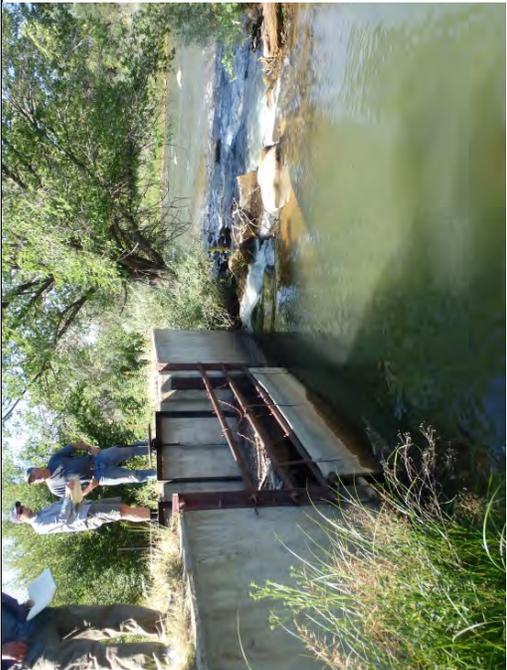
<p>Headgate structure and uncontrolled spillway return to main channel.</p>

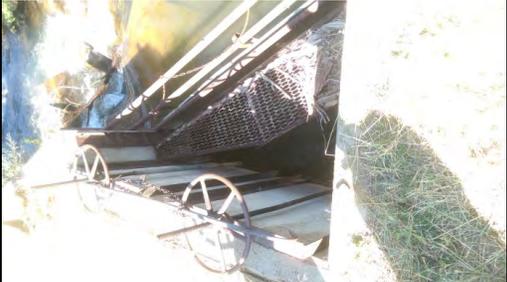
<p>Headgates and trash rack.</p>

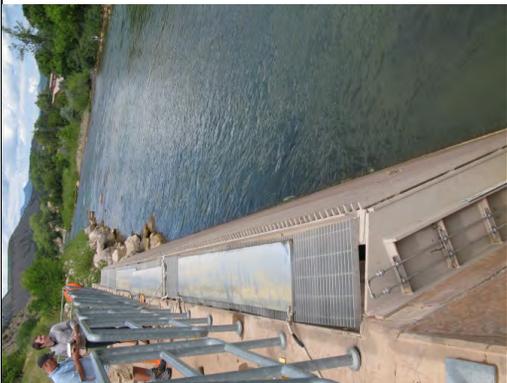
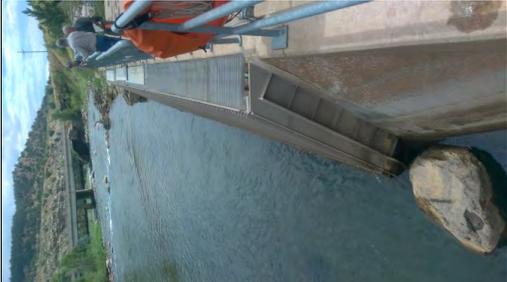
<p>RM 59.8 USBR Animas-La Plata Project/Lake Nighthorse Diversion (1 of 2)</p>

<p>View upstream of diversion.</p>	<p>View downstream of diversion structure.</p>

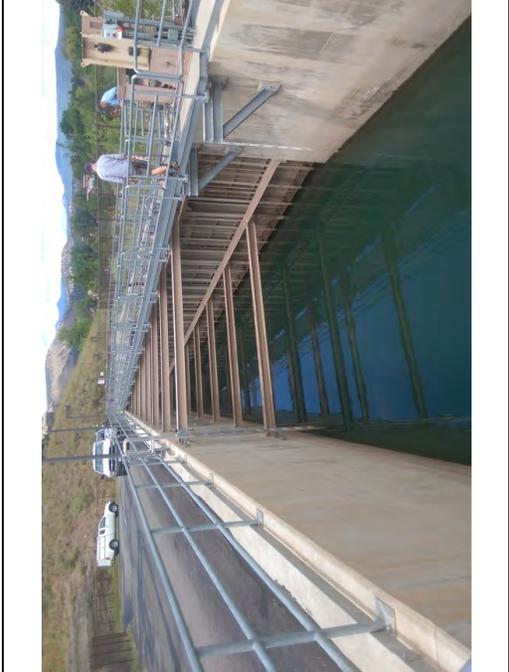
<p>A closer view of the fish screen structure, showing the metal railings and the concrete walkway above the water. The water is dark and still, reflecting the sky.</p>	<p>View of settling pond, fish screen sluice structure.</p>

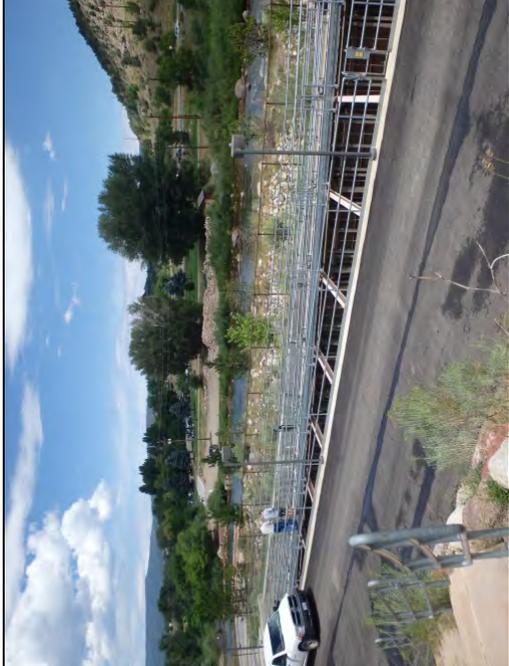
<p>A view of the settling pond and fish screen structure from a different angle, showing a paved road and a white car in the foreground. The background features green trees and a clear blue sky.</p>	<p>View of settling pond, fish screen sluice structure.</p>

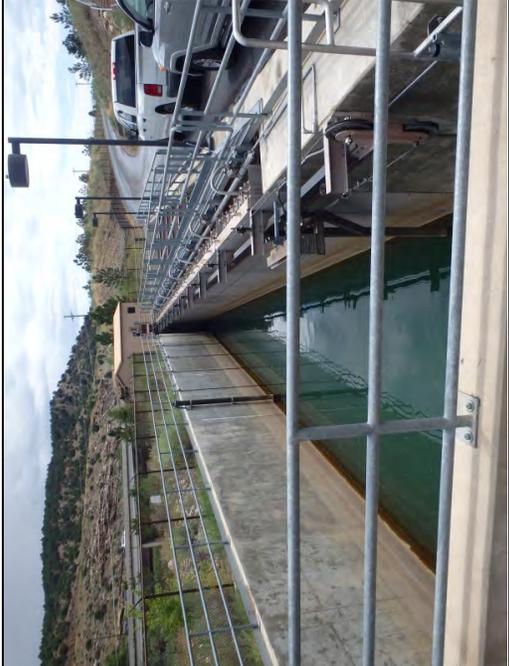
<p>A view from the concrete walkway looking down at the fish screen structure and the water below. The metal railings are prominent in the foreground.</p>	<p>View of settling pond, fish screen sluice structure.</p>

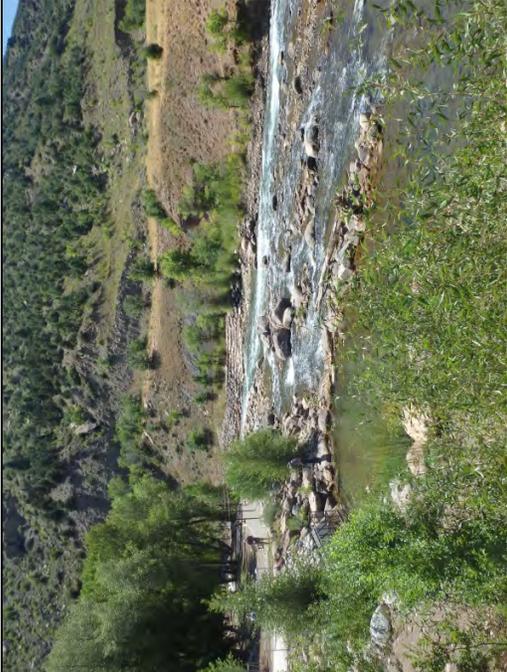
<p>RM 60.2 City of Durango Santa Rita Diversion</p>

<p>View downstream of diversion structure and short head/grade control structure.</p>

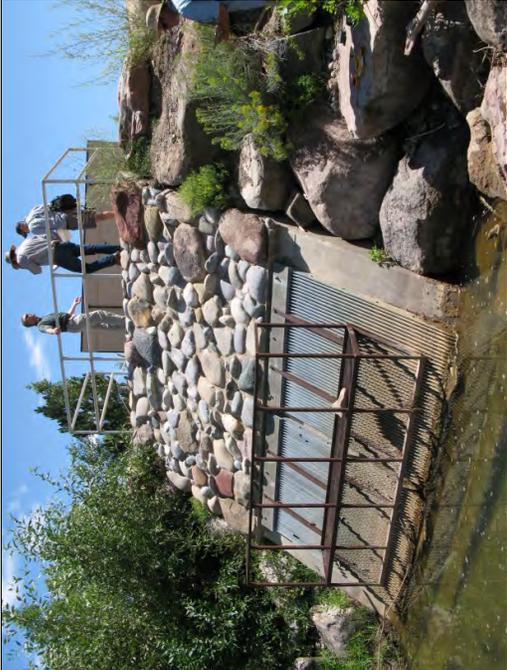
<p>Diversion intake structure</p>

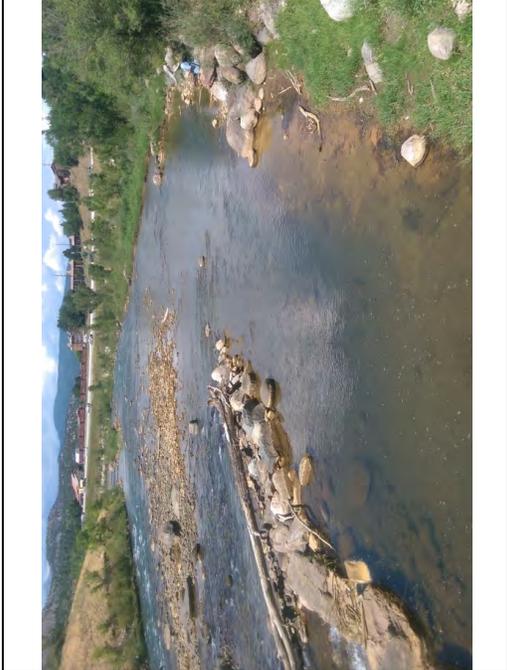
<p>View upstream of head/grade control structure (boulders), from diversion structure.</p>
