**2011 ANNUAL REPORT**  
**CERCLA Non-time Critical Removal Action**  
**MIDWAY ATOLL NATIONAL WILDLIFE REFUGE**  
**MIDWAY ISLAND**  
**Contract No. F11PC00327**

29 February 2012

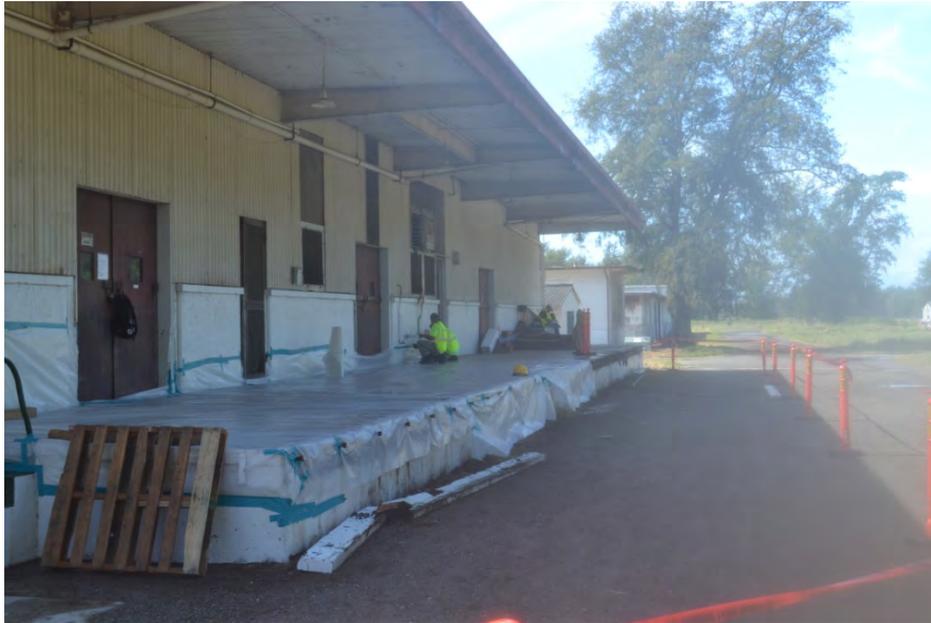
Photo 01 – Iniki preparing for abatement of the eaves or overhang of the loading dock

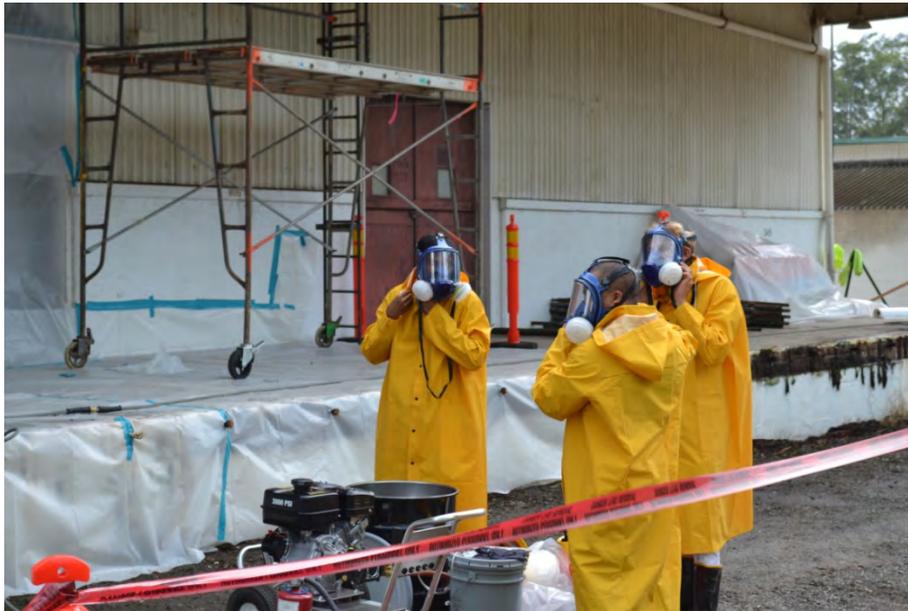
Photo 03: Preparing for Maectite / water solution application to overhang eaves of Bldg 349

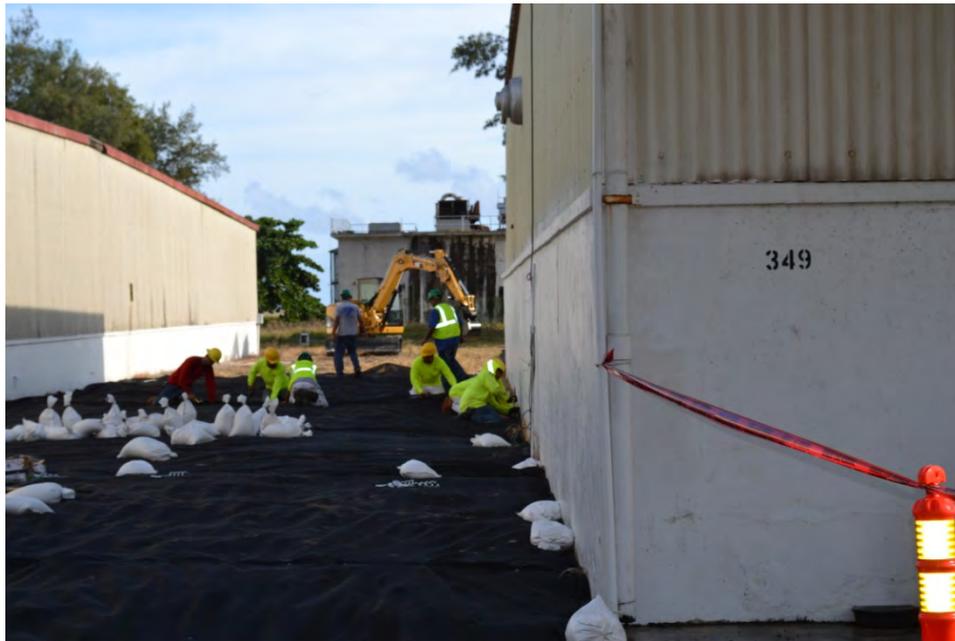
Photo 04: Shadecloth deployment between Bldgs. 356 and 349

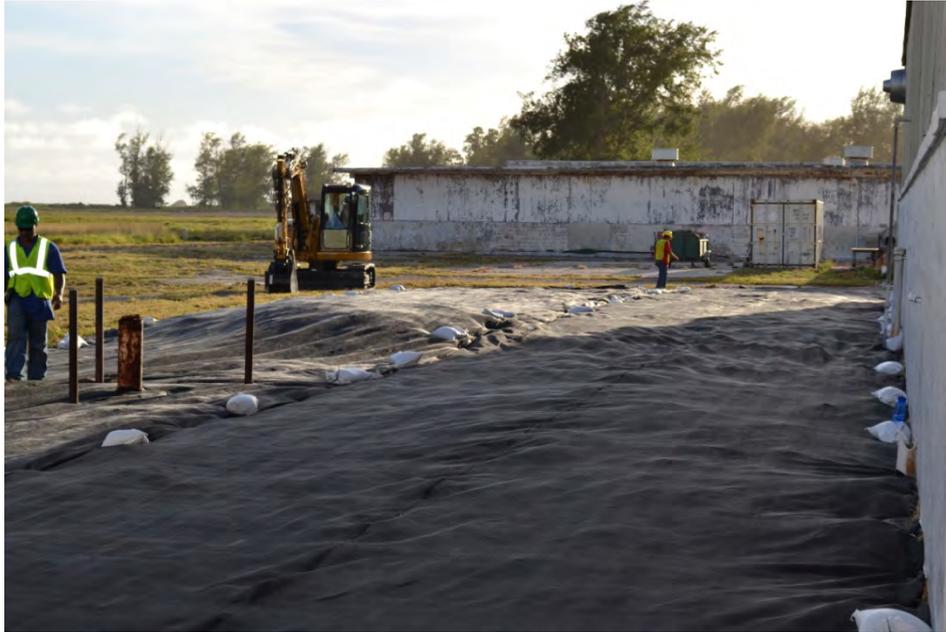
Photo 05: Shadecloth deployment along south wall of Bldg 349

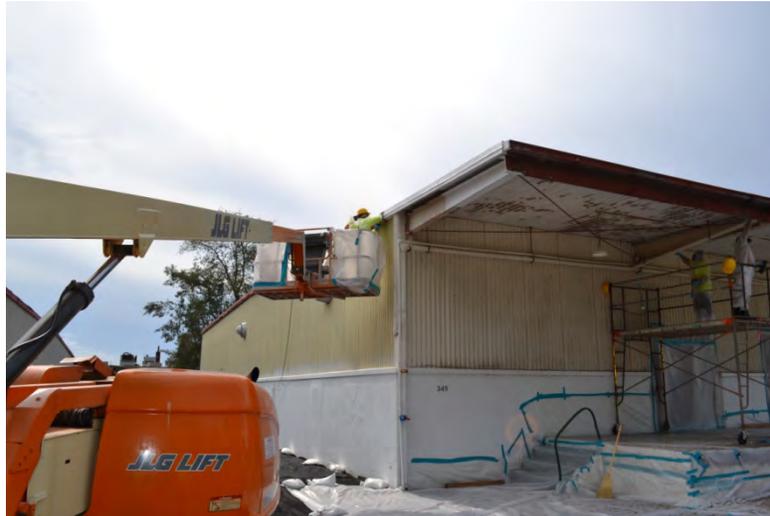
Photo 01 – Iniki abatement along north and east walls of Bldg 349

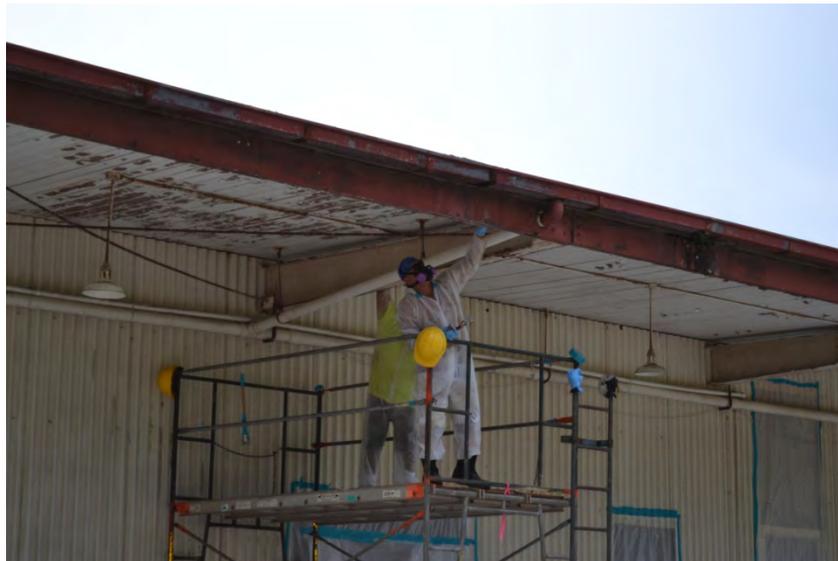
Photo 02 – Iniki scraping loose paint from eaves / overhang of Bldg 349

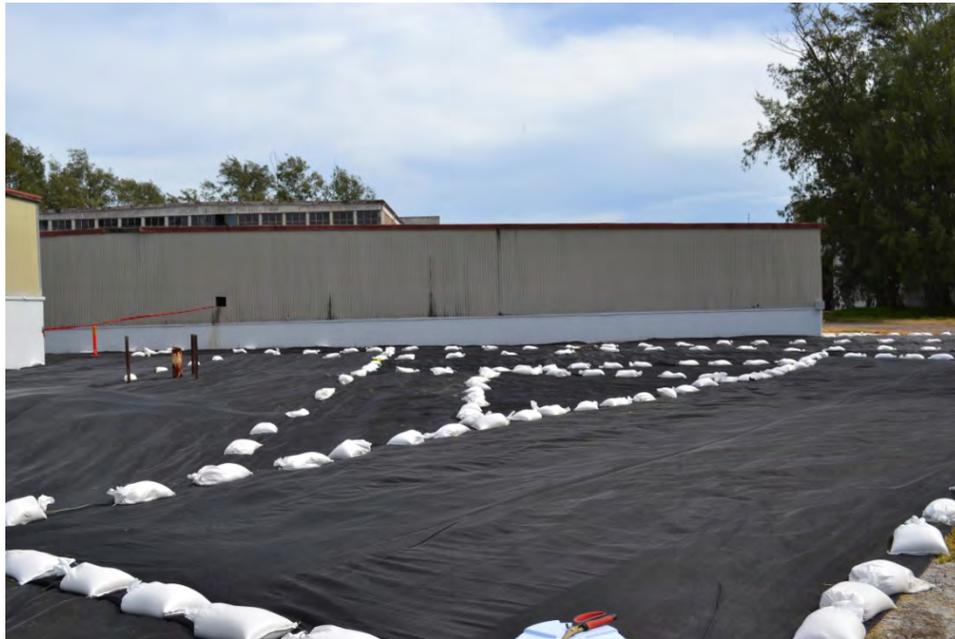
Photo 03: Shade cloth deployment along south wall of Bldg 349

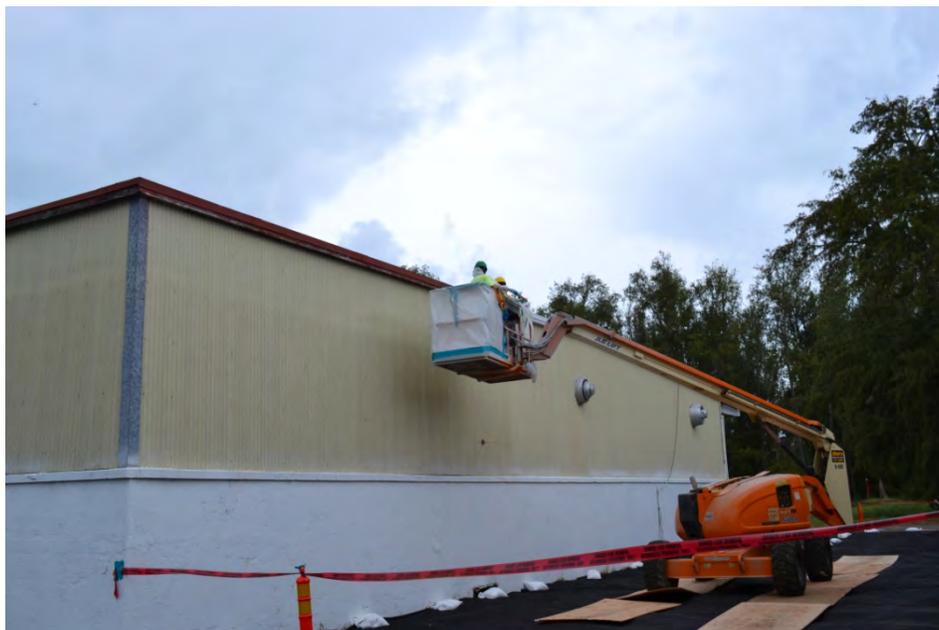
Photo 04: Iniki abatement followed immediately by painting along east wall of bldg 349

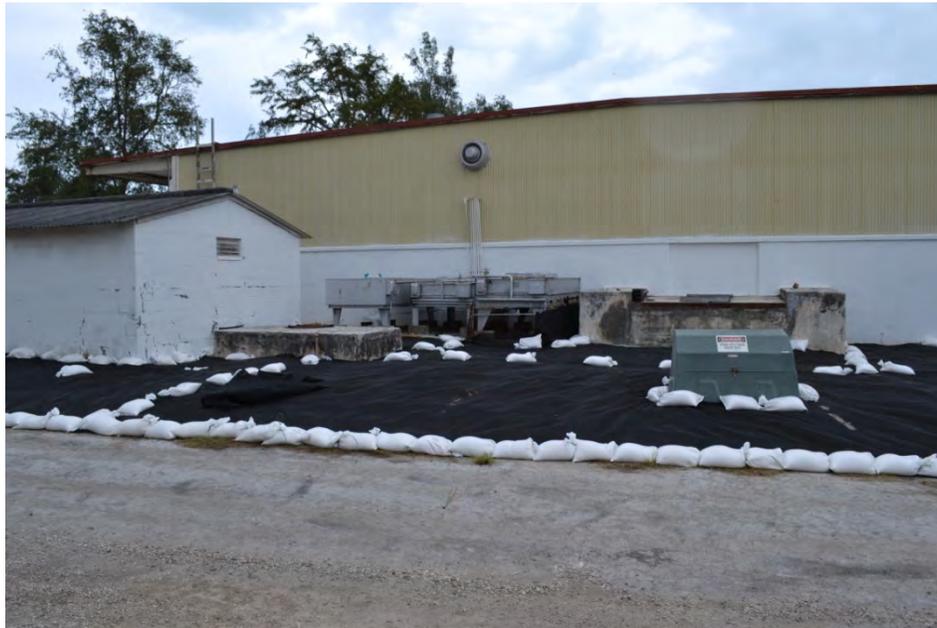
Photo 05: Shadecloth deployment along west wall of Bldg 349

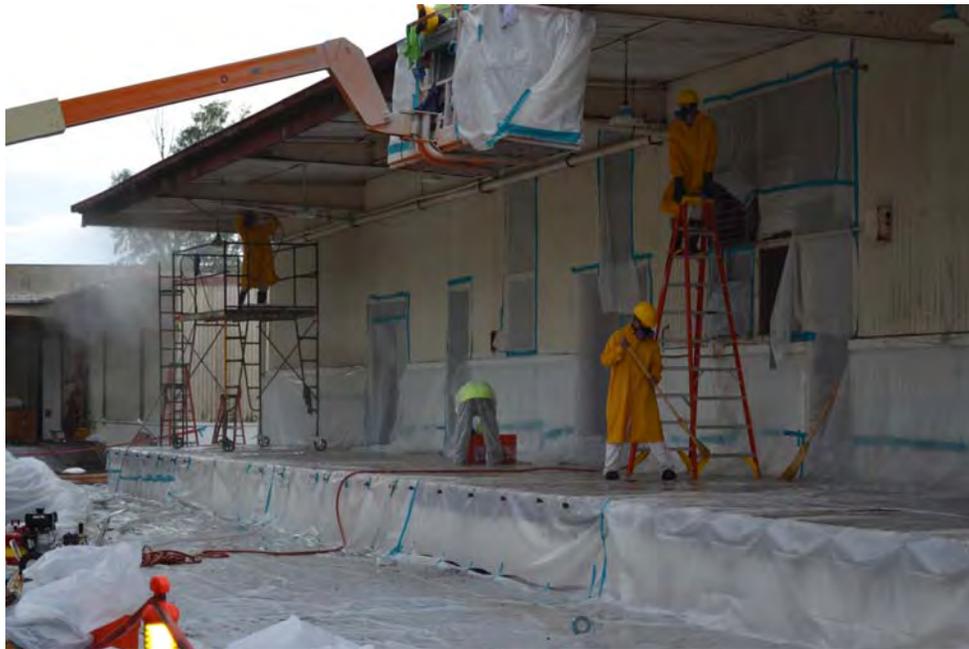
Photo 01 – Iniki abatement along north wall of Bldg 349

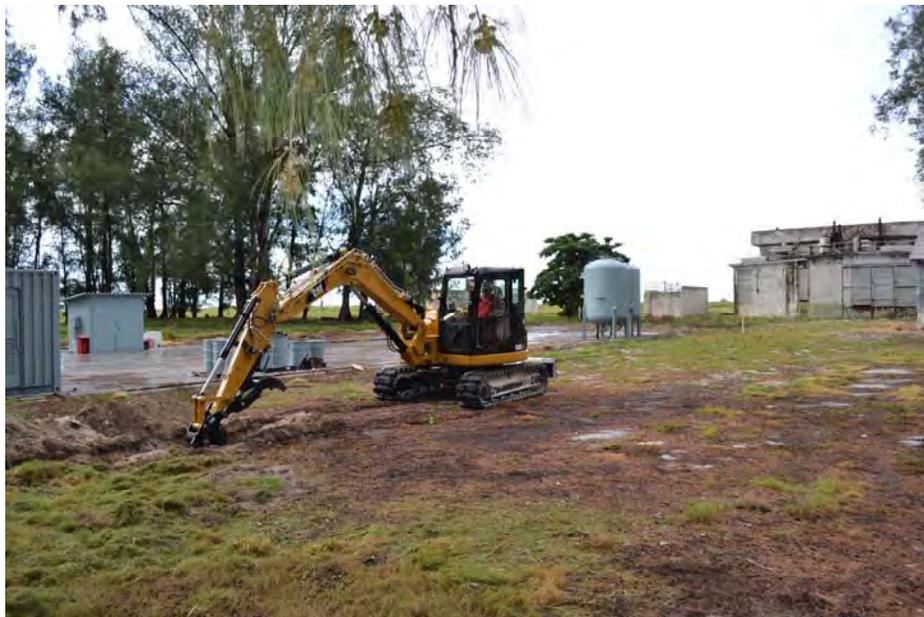
Photo 02 – NWDE trenching along south wall (50' offset) of Bldg. 363

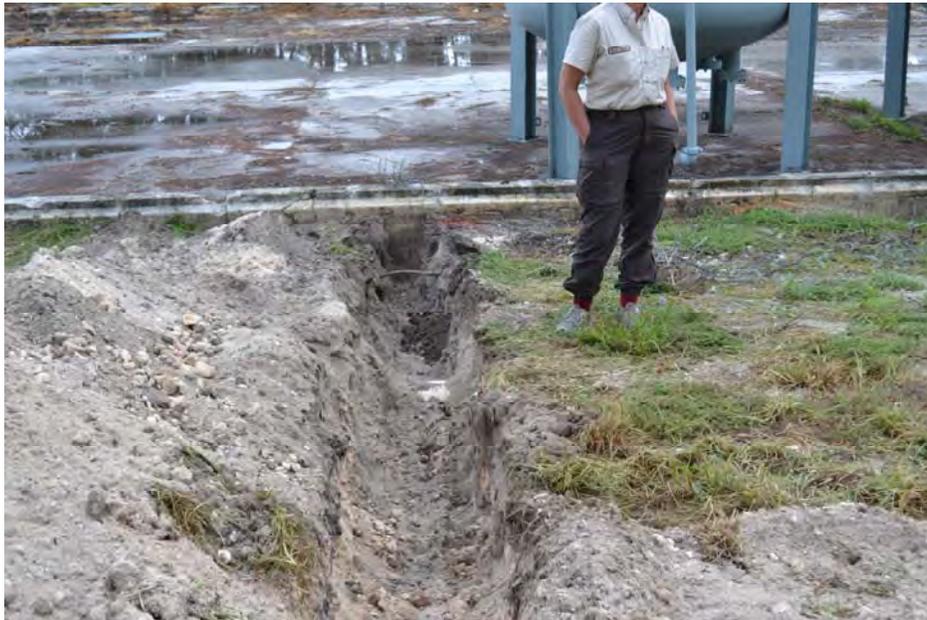
Photo 03: 6" PVC encountered during trenching

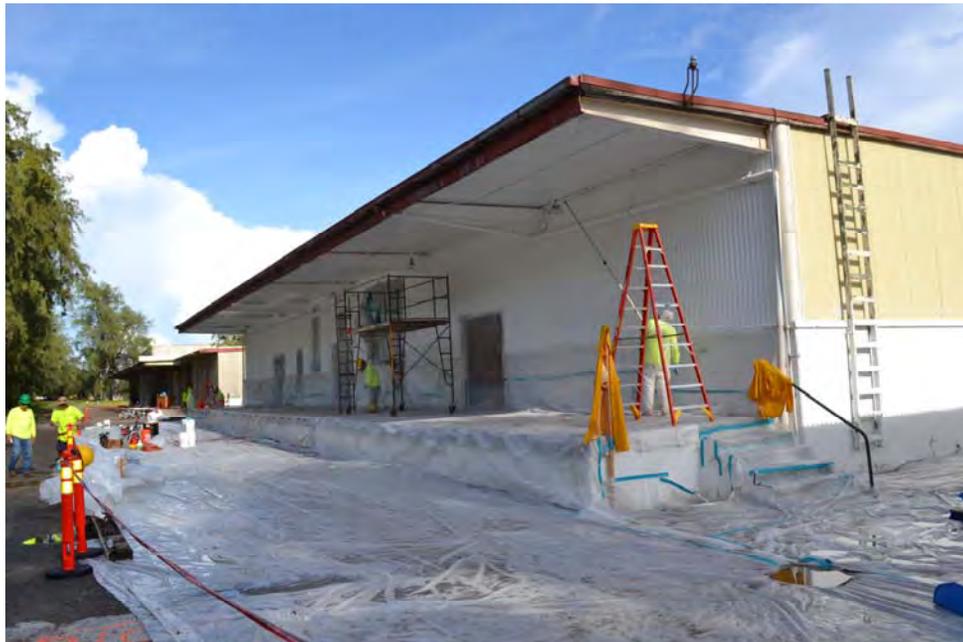
Photo 04: Iniki painting first coat on north wall of Bldg 349

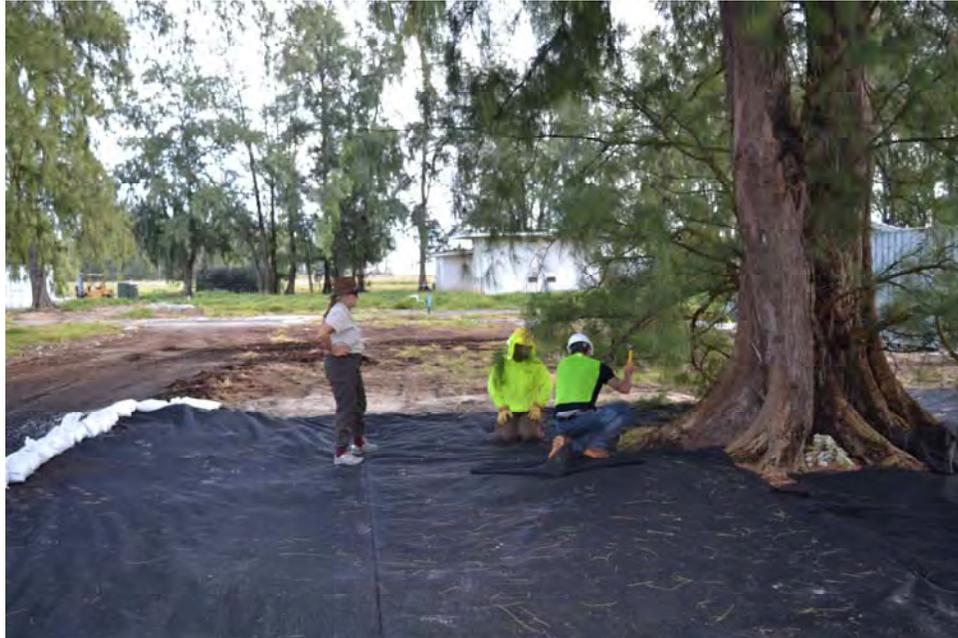
Photo 05: Shadecloth deployment along east wall of Bldg 363

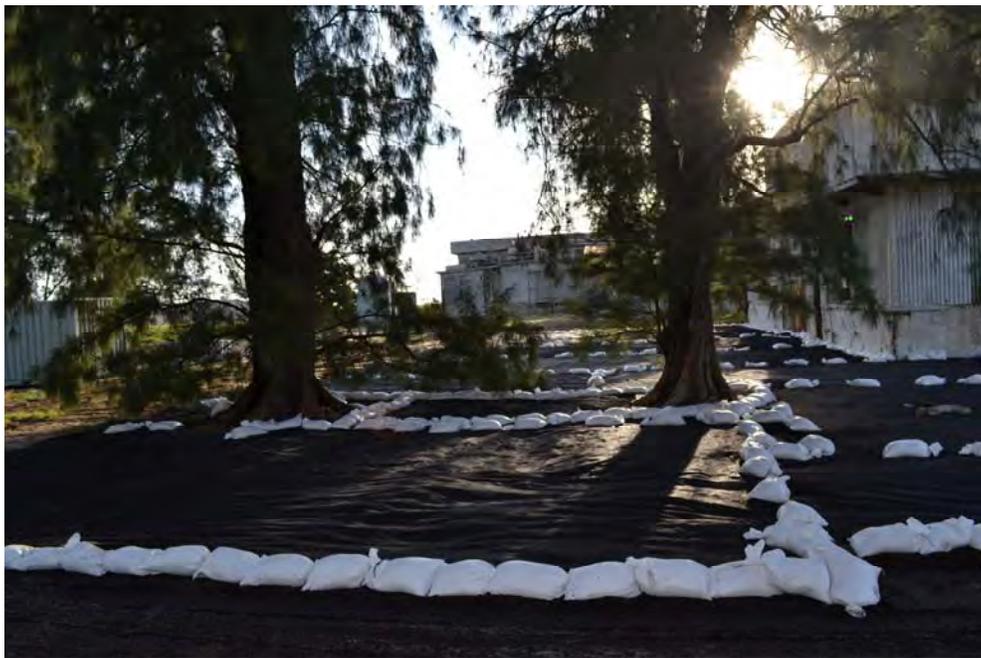
Photo 06 : Completd shadecloth deployment on east and south wall of Bldg 363.

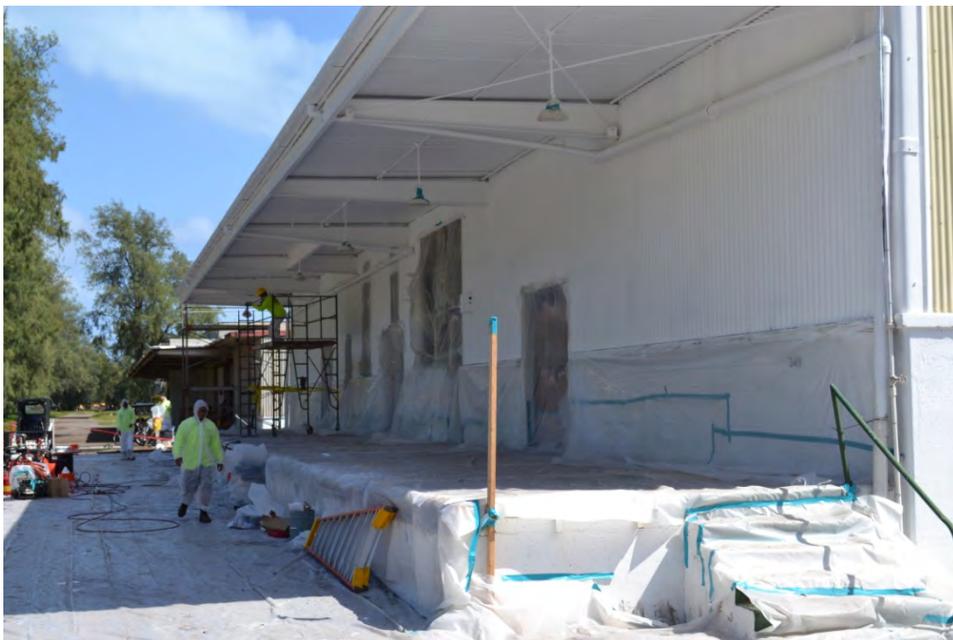
Photo 02 – Iniki working on final coat, north wall Bldg. 349

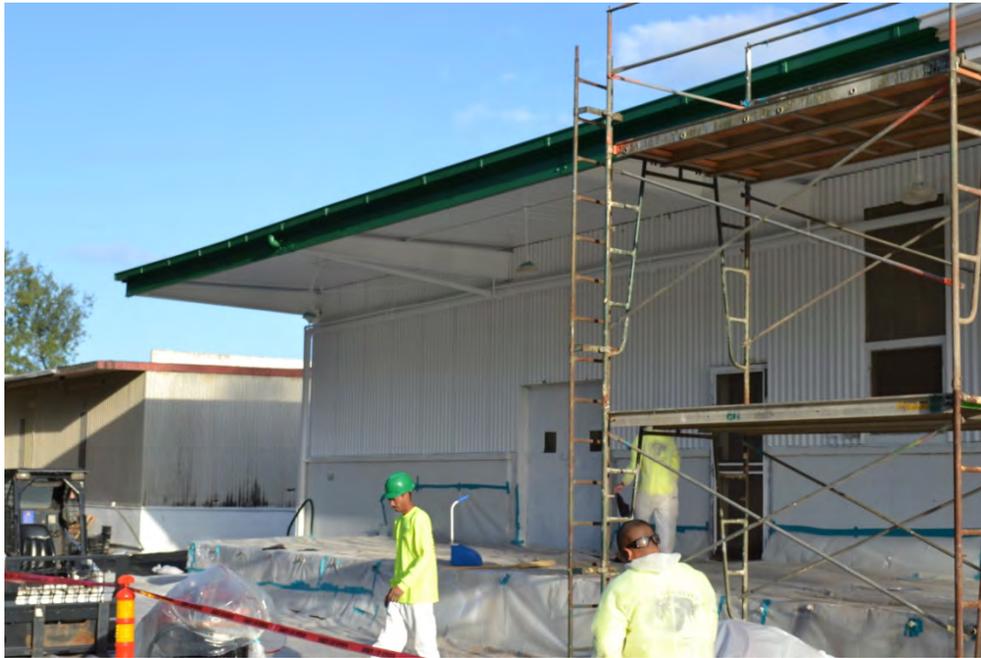
Photo 03: Iniki working on final coat on trim (green color), north wall Bldg 349

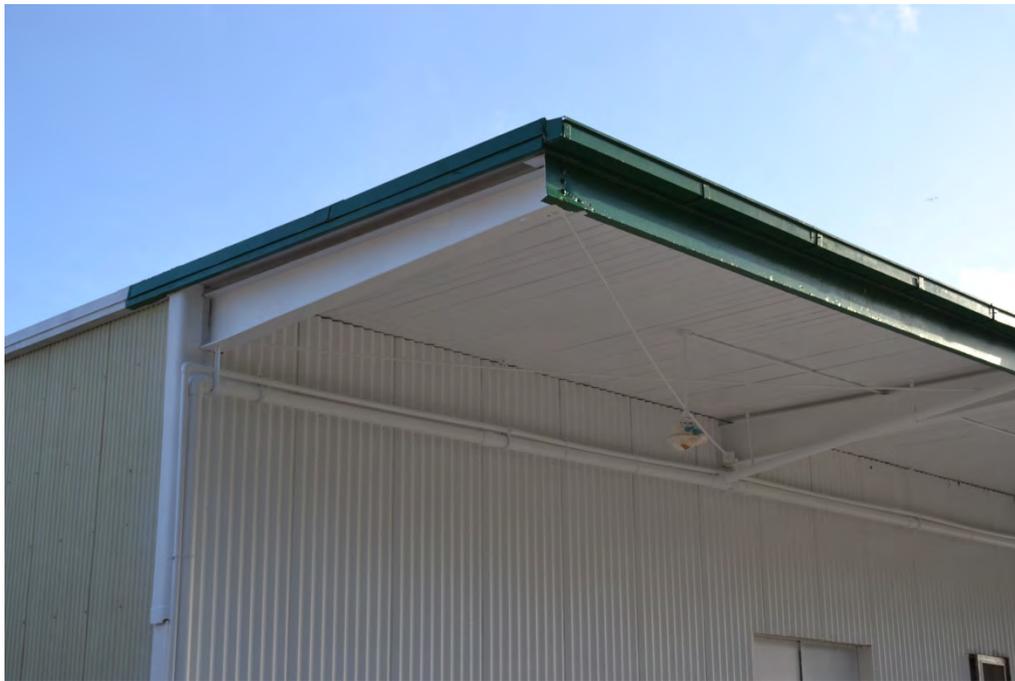
Photo 04: Iniki working on final coat of trim (green color) on north and east wall of Bldg 349

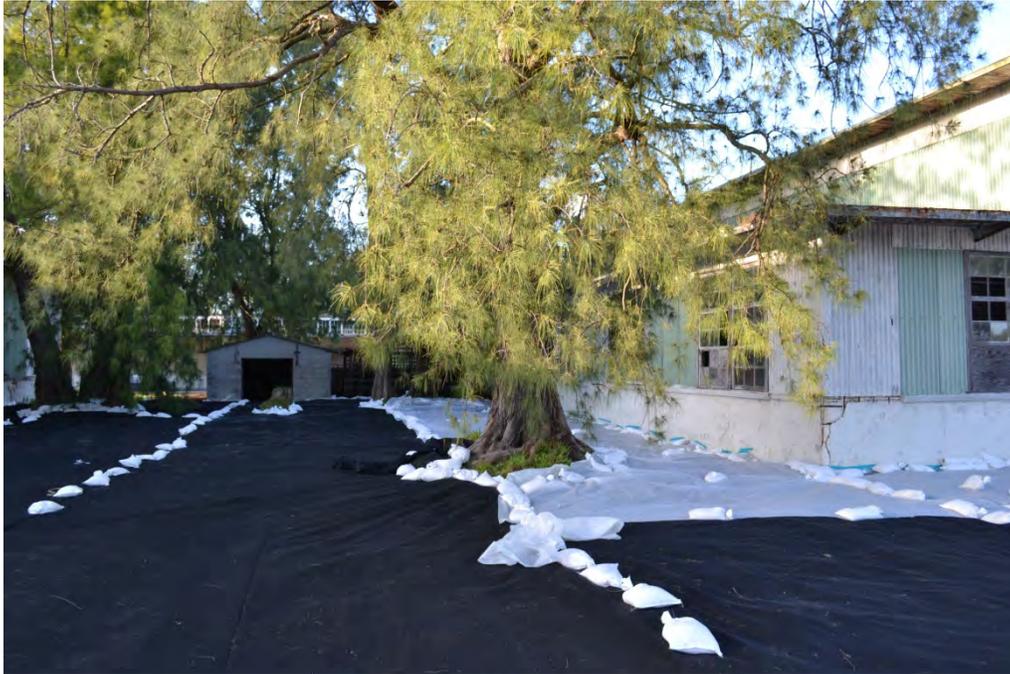
Photo 05: Shadecloth deployment along west wall of Bldg 363, plastic sheeting is in preparation for Iniki's work on Bldg 363

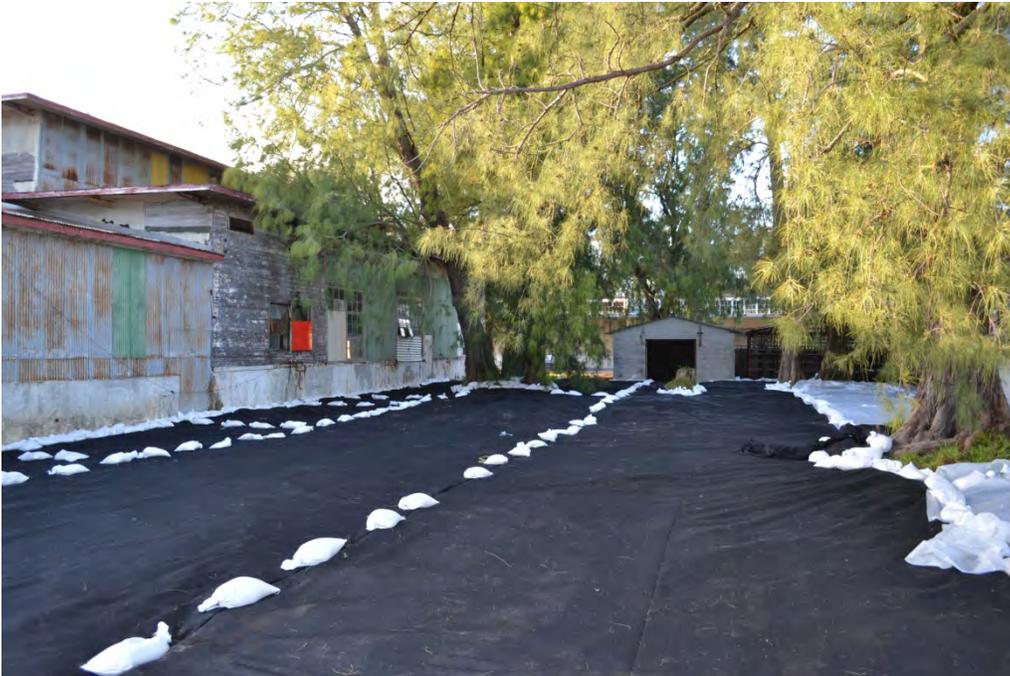
Photo 06 : Shadecloth deployment between Bldg 363 and 357.

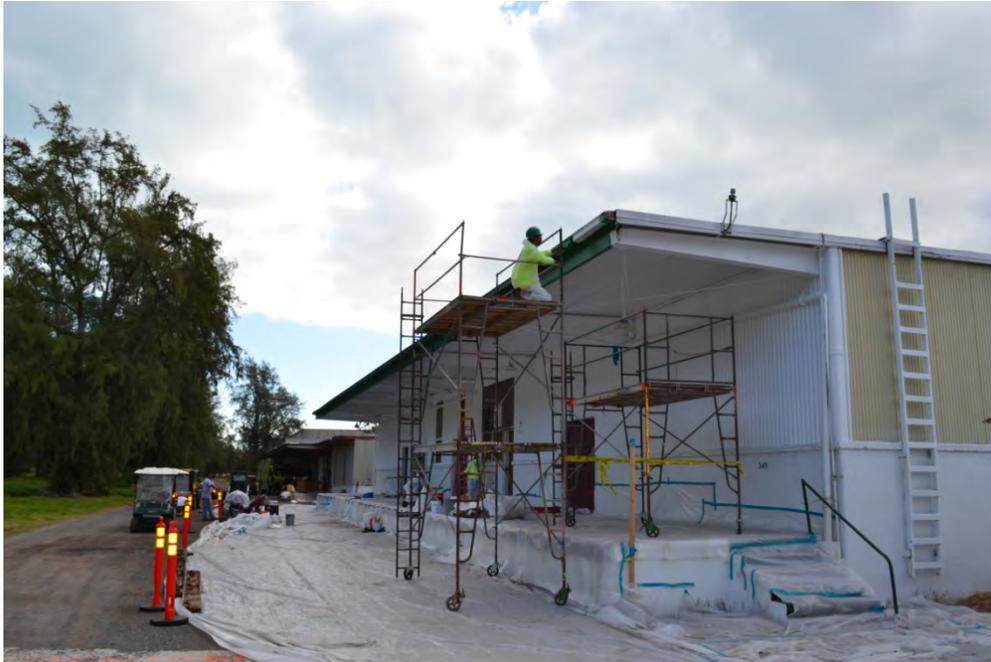
Photo 01 – Iniki continues with Final coat (green color) on trim, north wall Bldg 349

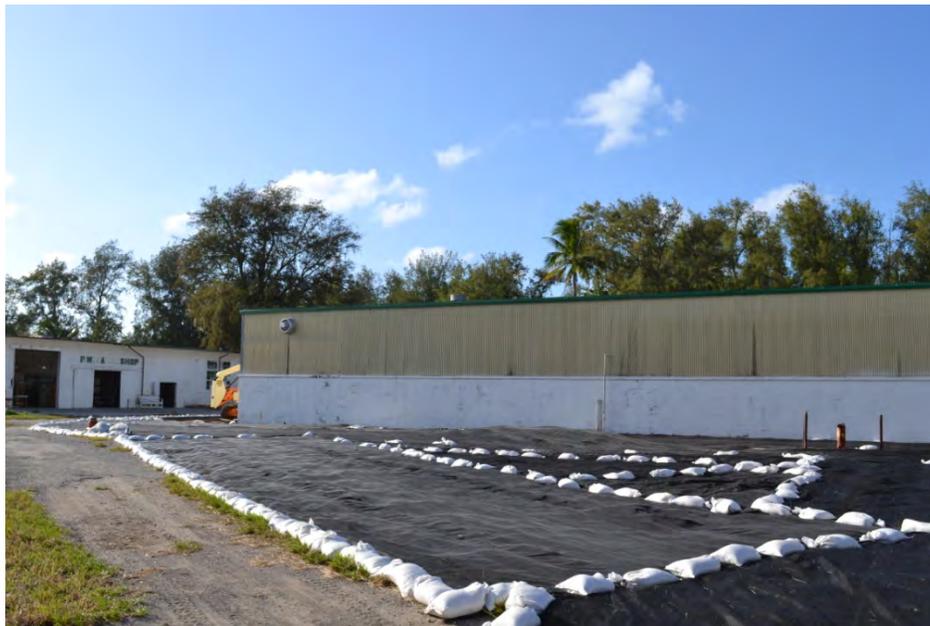
Photo 02 – Final coat (green color) on fascia board only, south wall Bldg 349

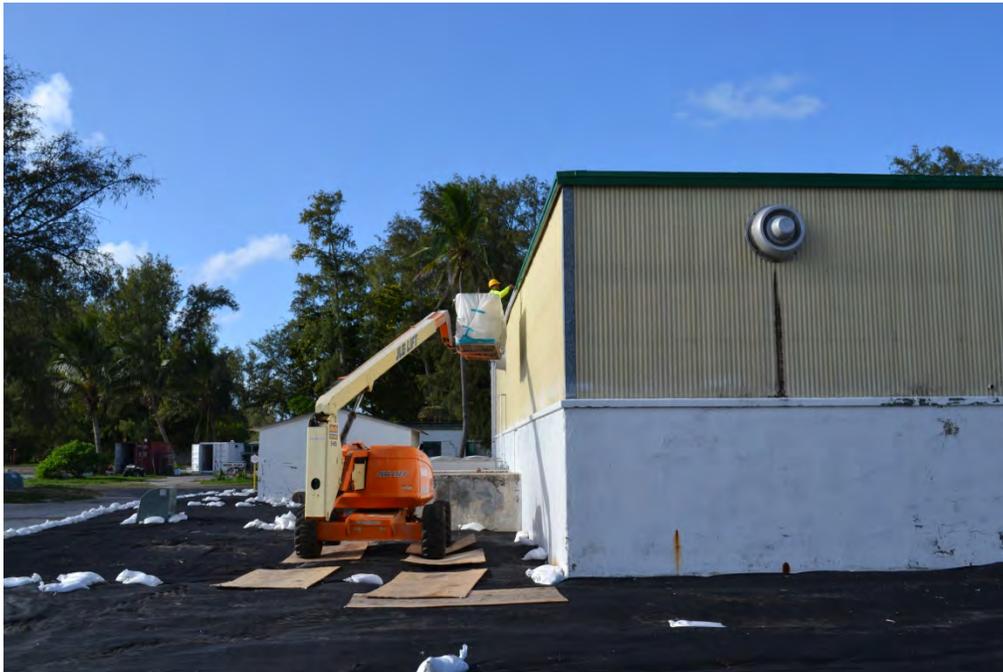
Photo 03: Iniki working on final coat on fascia board only (green color), east wall Bldg 349

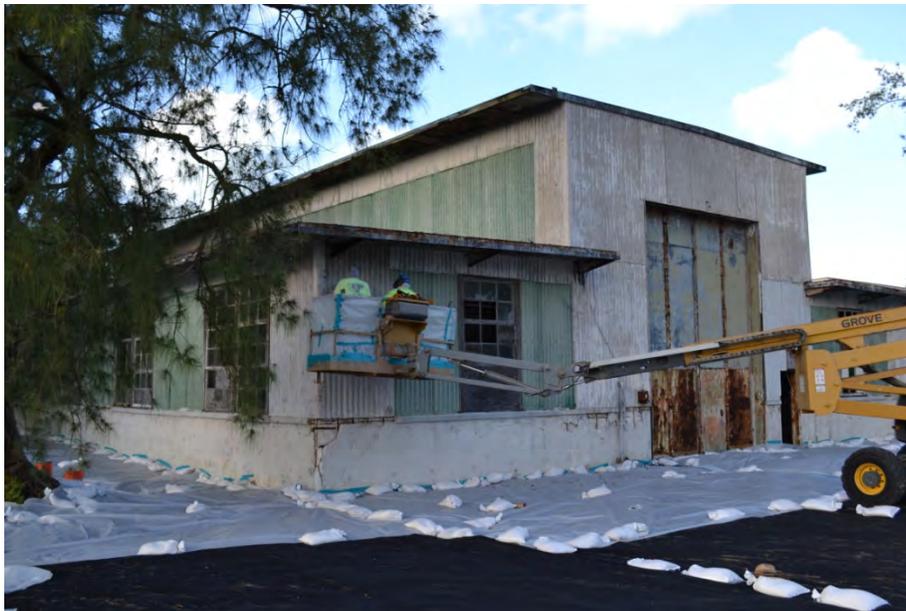
Photo 04: Iniki working on abatement on south wall of Bldg 363

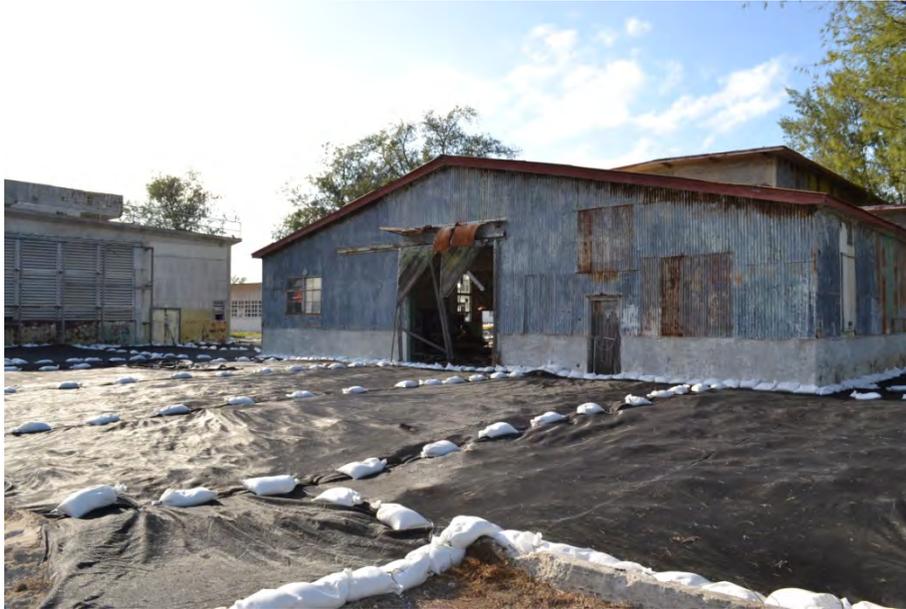
Photo 05: Shadecloth deployment along south wall of Bldg 357

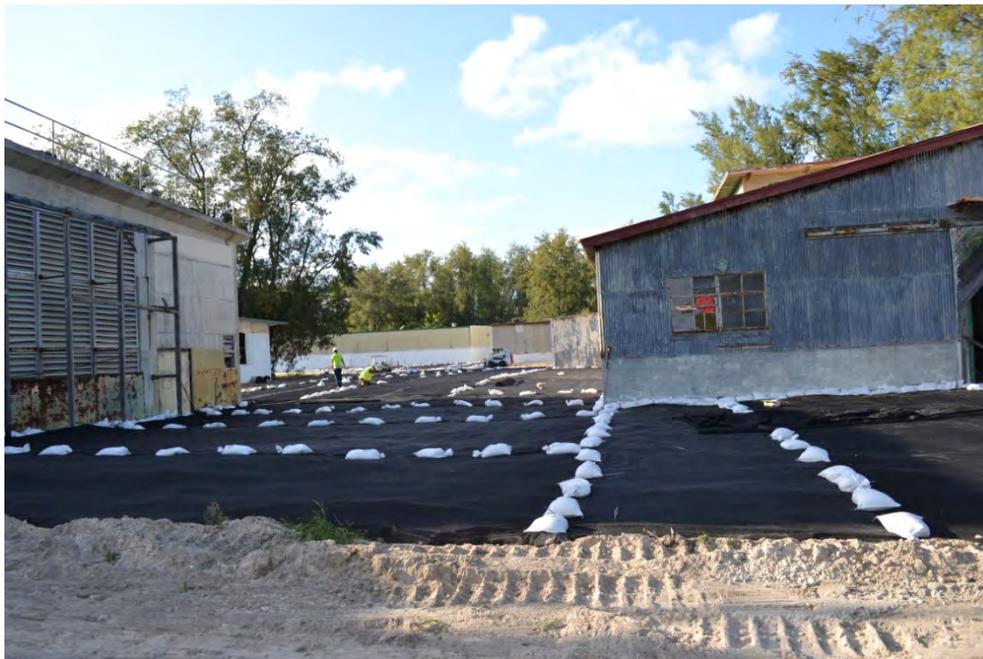
Photo 06 : Shadecloth deployment between Bldg 357 and 354.

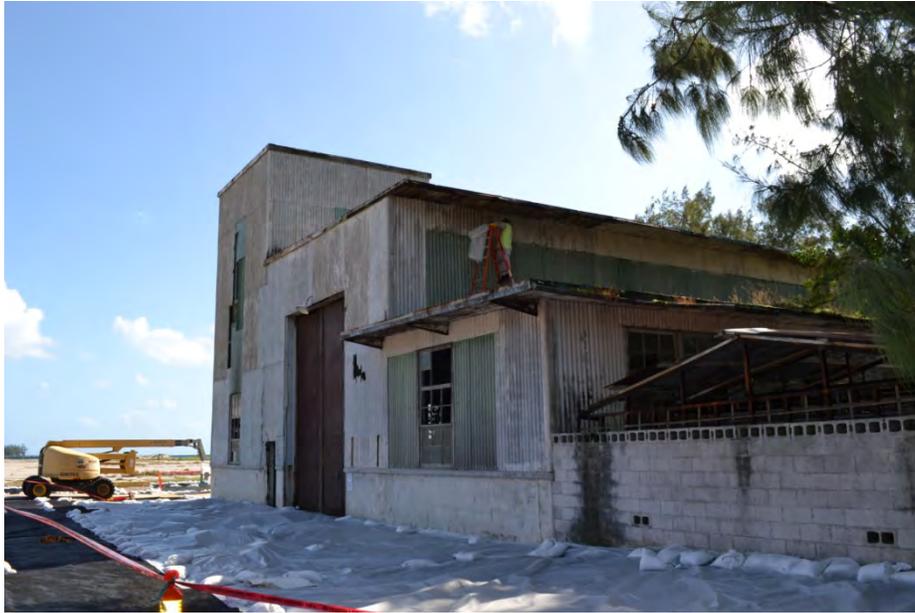
Photo 01 – Iniki abatement of second story overhang (roof access) on west wall Bldg 363

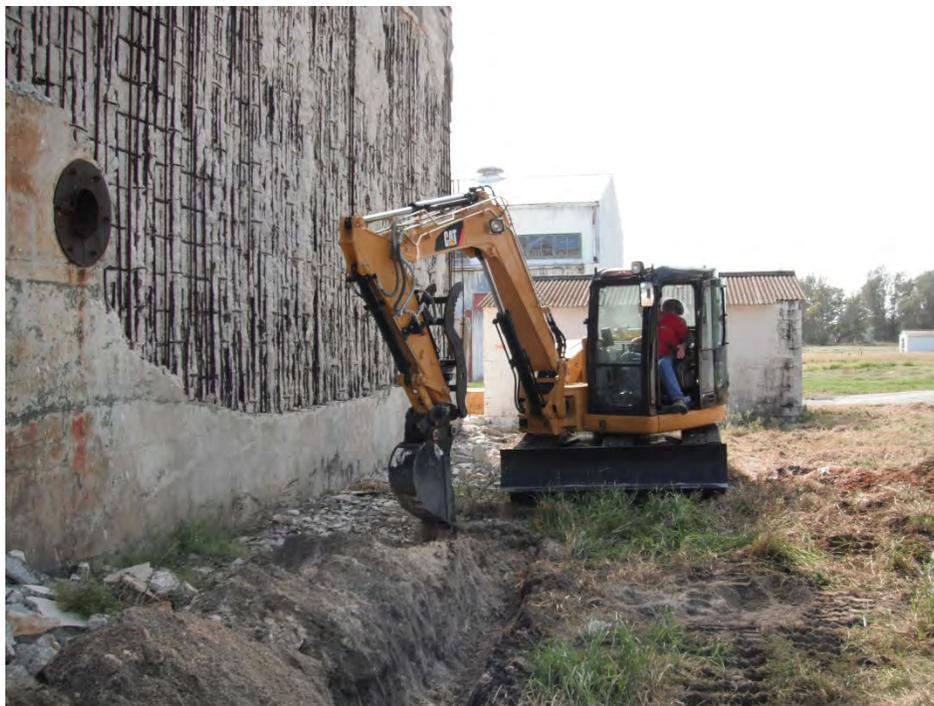
Photo 04: NWDE trenching in advance of shadecloth deployment along south wall Bldg.353 (Photo was taken on 10/18/11)

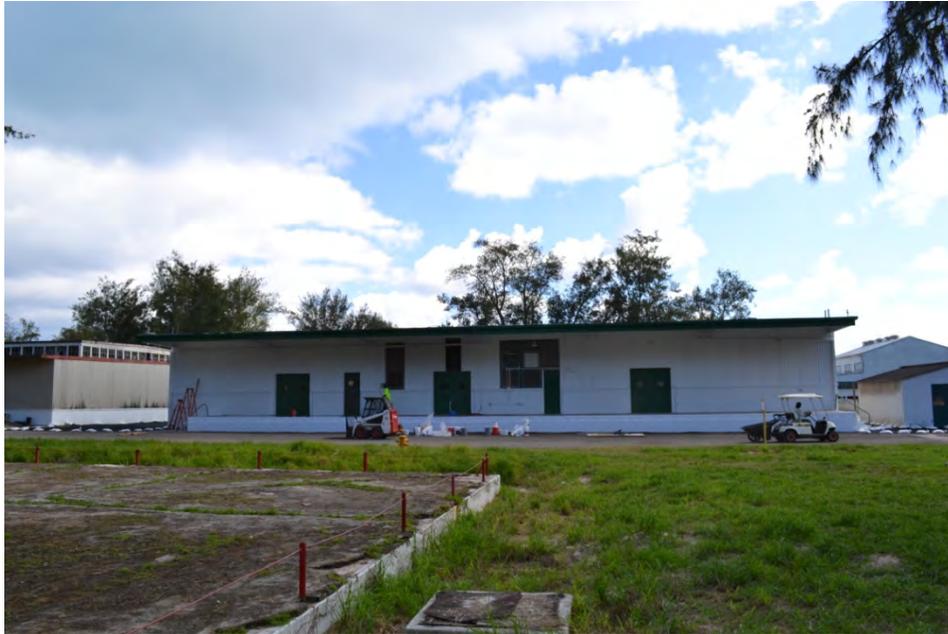
Photo 01 – North wall Bldg 349 completed.

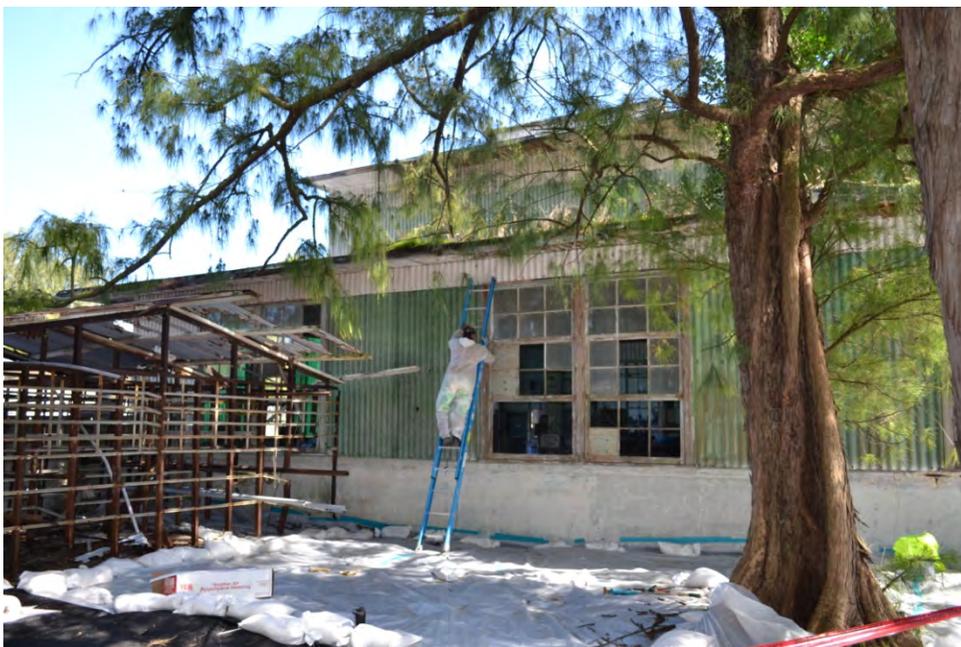
Photo 02 – Abatement of West Wall Bldg 363.

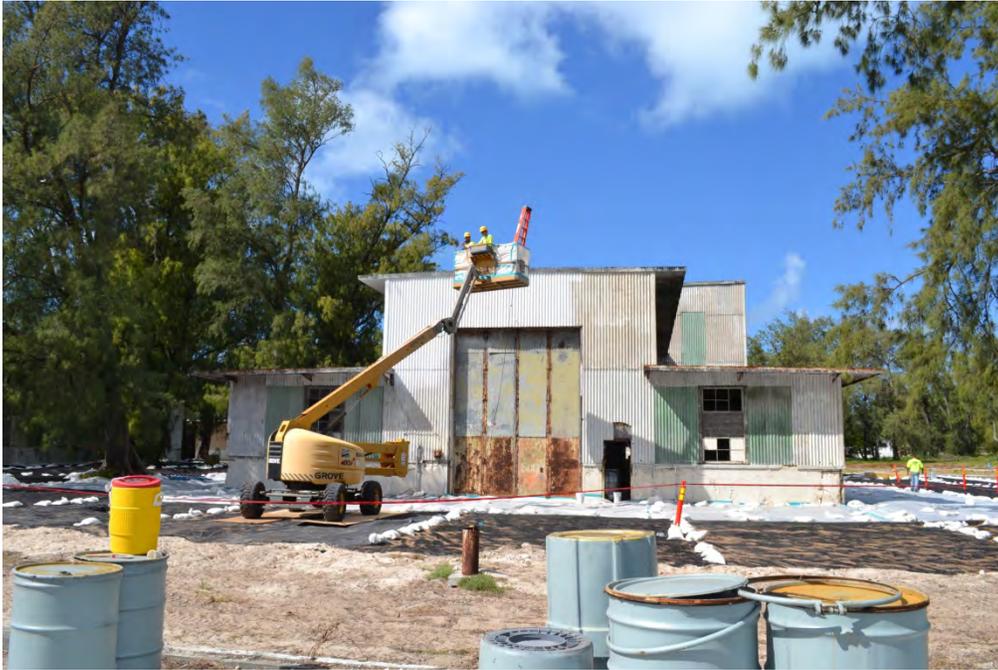
Photo 03: Painting (priming) south wall Bldg 363.

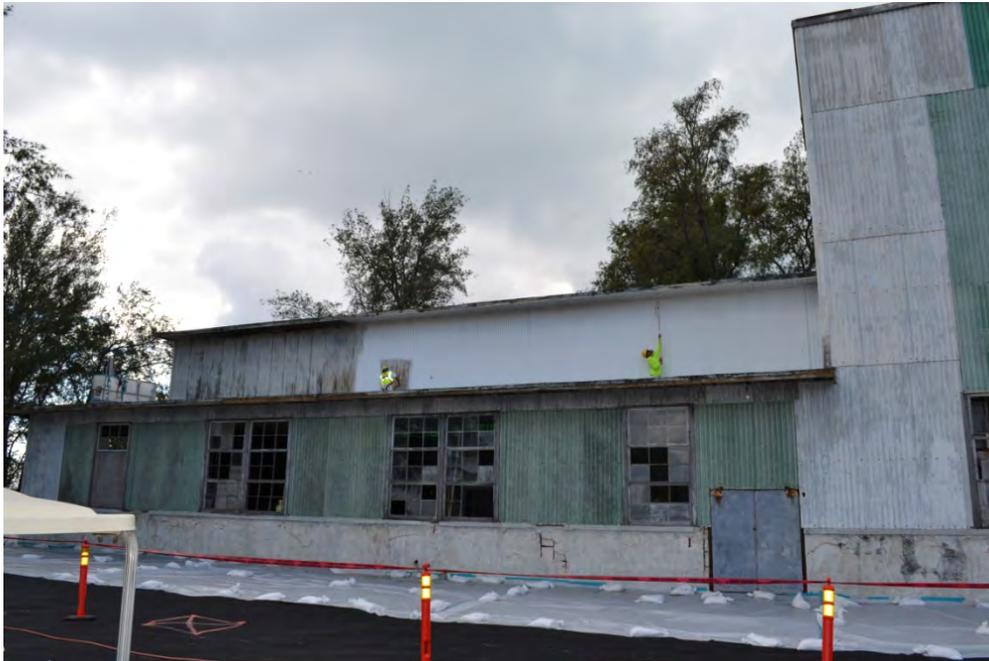
Photo 04: Painting (priming) east wall (second story) Bldg 363

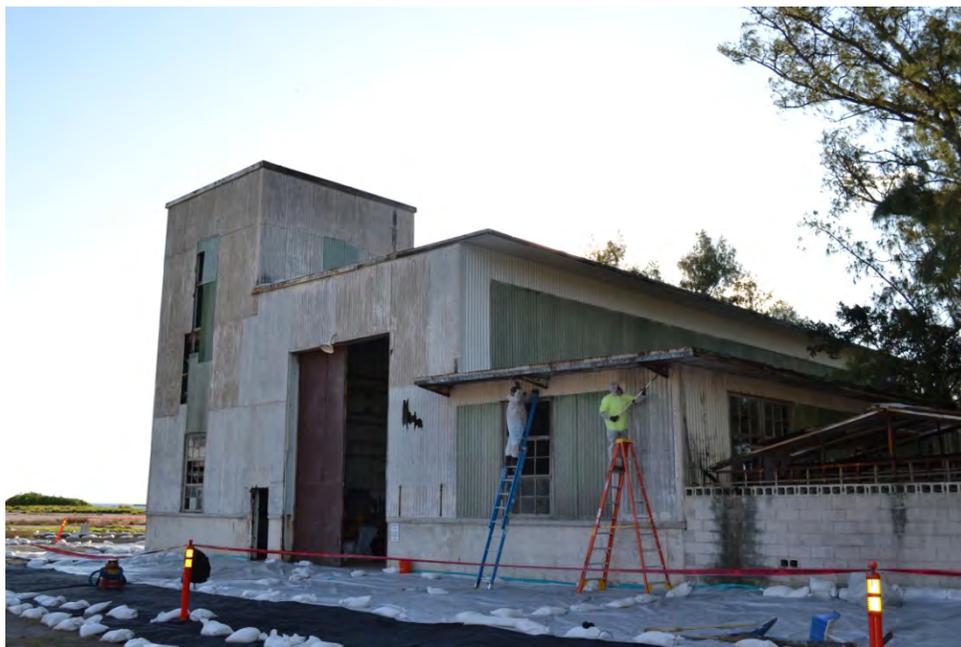
Photo 02 – Abatement of North Wall Bldg 363.

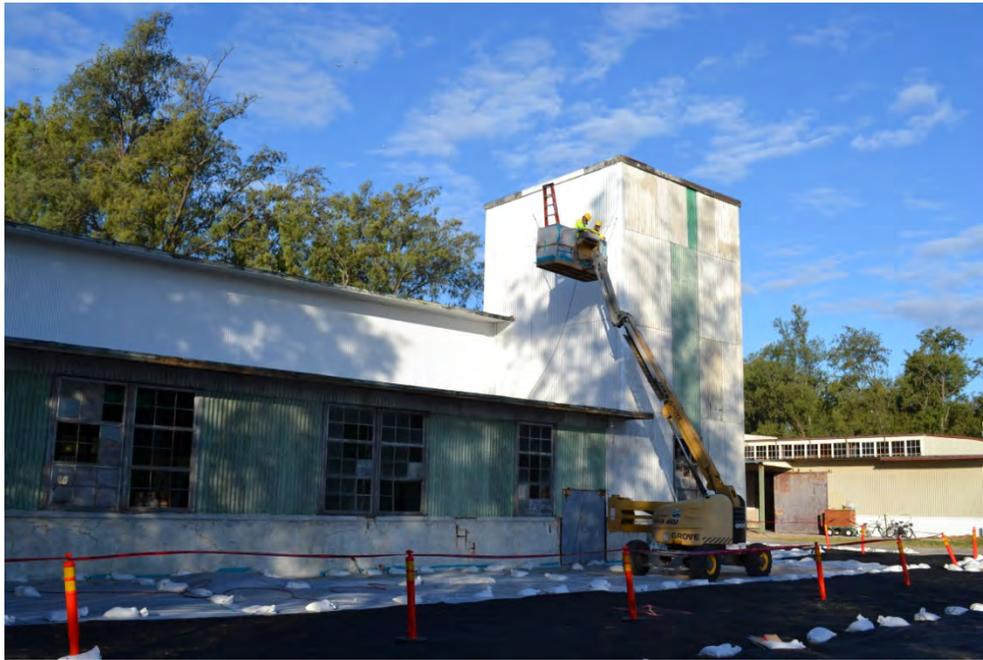
Photo 03: Painting (priming) tower and east wall Bldg 363.

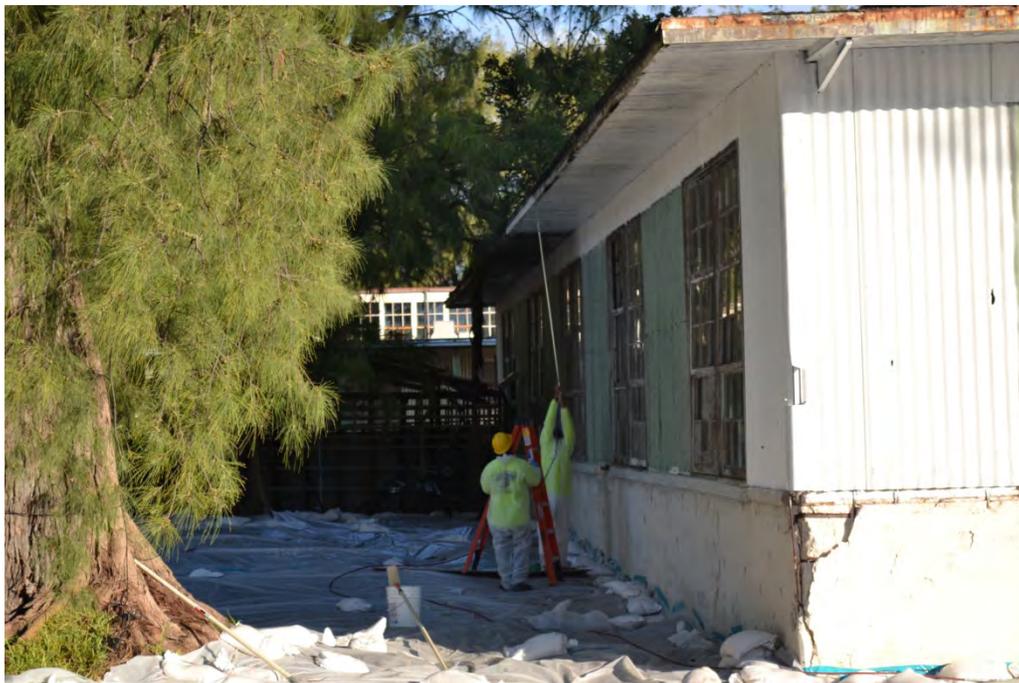
Photo 04: Painting (priming) west wall Bldg 363

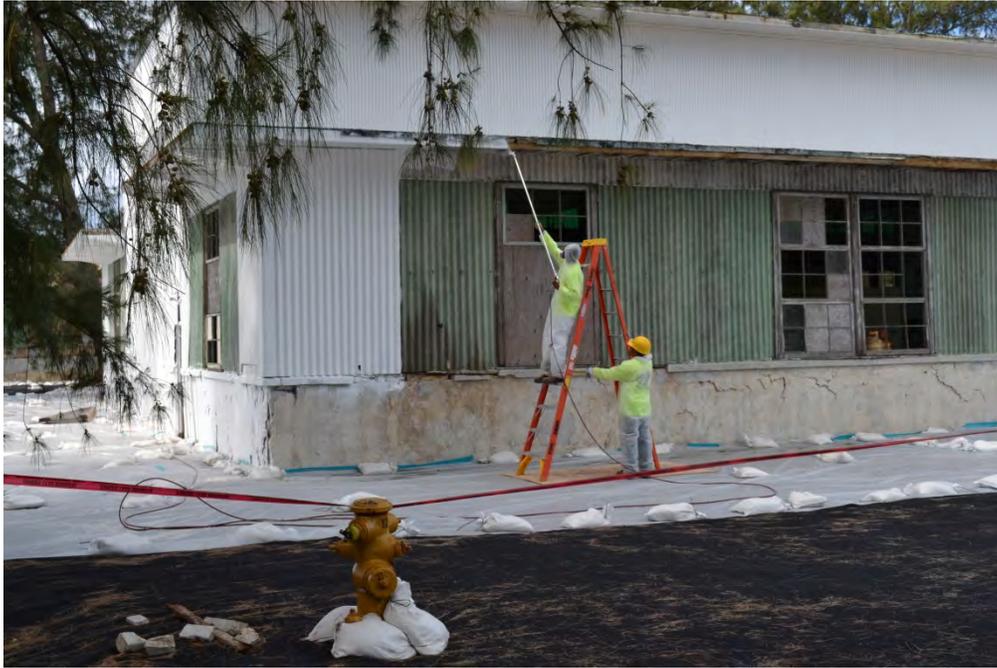
Photo 5: Painting (priming) east wall (1<sup>st</sup> story) of Bldg 363
