**2011 ANNUAL REPORT**  
**CERCLA Non-time Critical Removal Action**  
**MIDWAY ATOLL NATIONAL WILDLIFE REFUGE**  
**MIDWAY ISLAND**  
**Contract No. F11PC00327**

29 February 2012

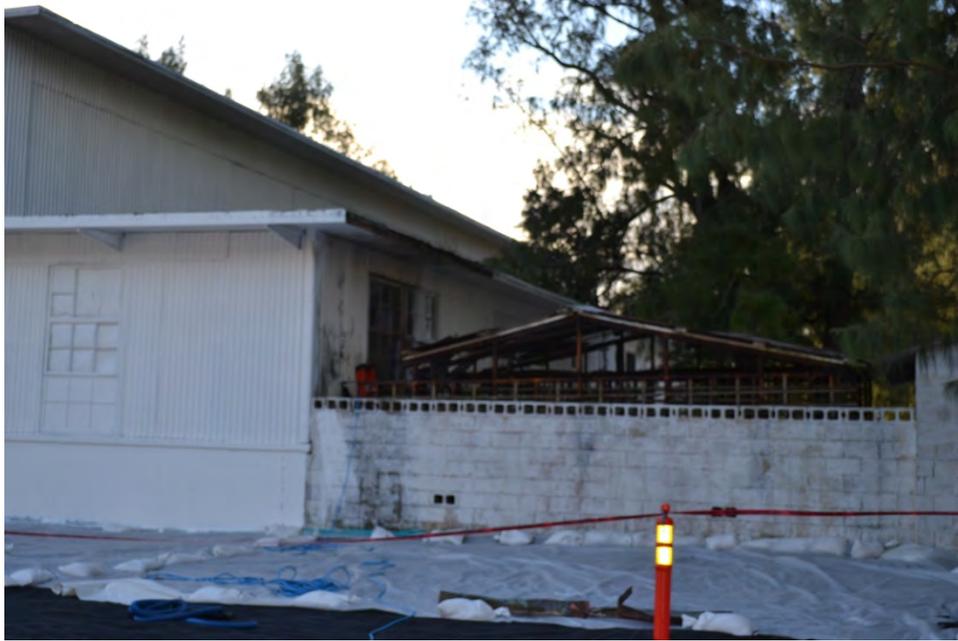
Photo 01 – Block wall associated with Bldg 393. Note pipe rack behind the block wall.

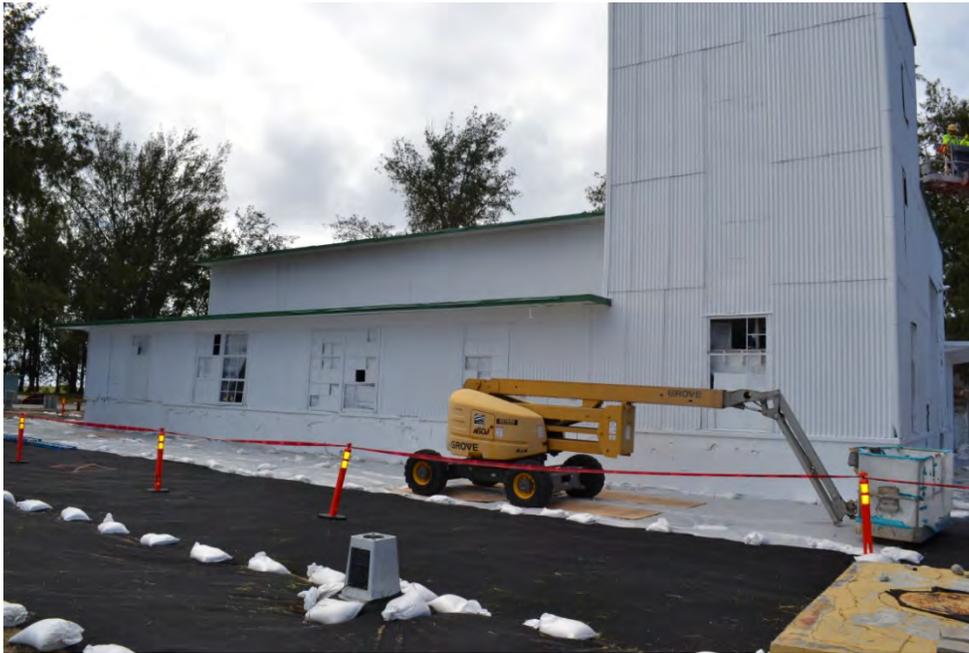
Photo 5: Iniki painting trim (green) east wall of Bldg 363

US FWS PM requests that the trim on Bldg 363 be painted green and concrete foundation walls (from ground surface to approximately 4 foot above grade be painted grey. US FWS PM will try to find grey paint to use.

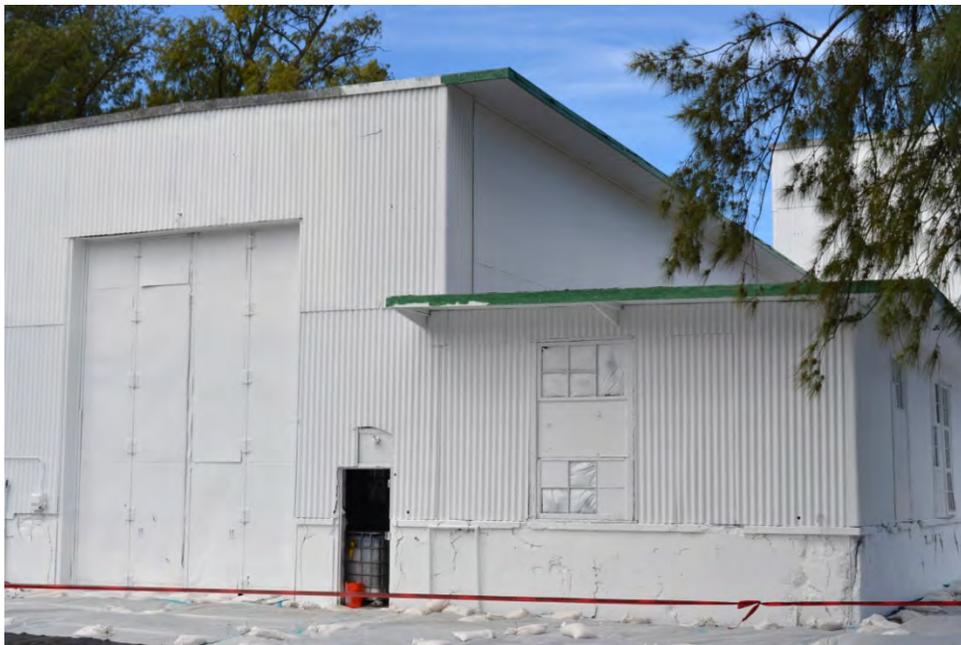
Photo 6: Iniki painting trim (green) south wall of Bldg 363.

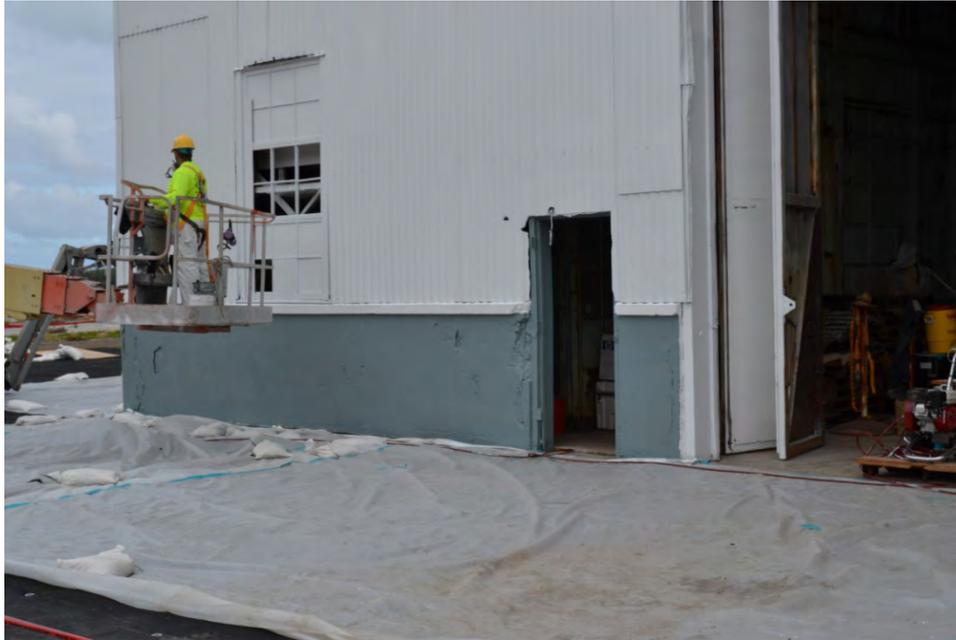
Photo 7: Foundation wall (concrete) is painted grey, north wall Bldg 363.

Iniki receives paint (grey, about 20 gallons) from US FWS PM for top coat for the foundation wall, north side Bldg 363.

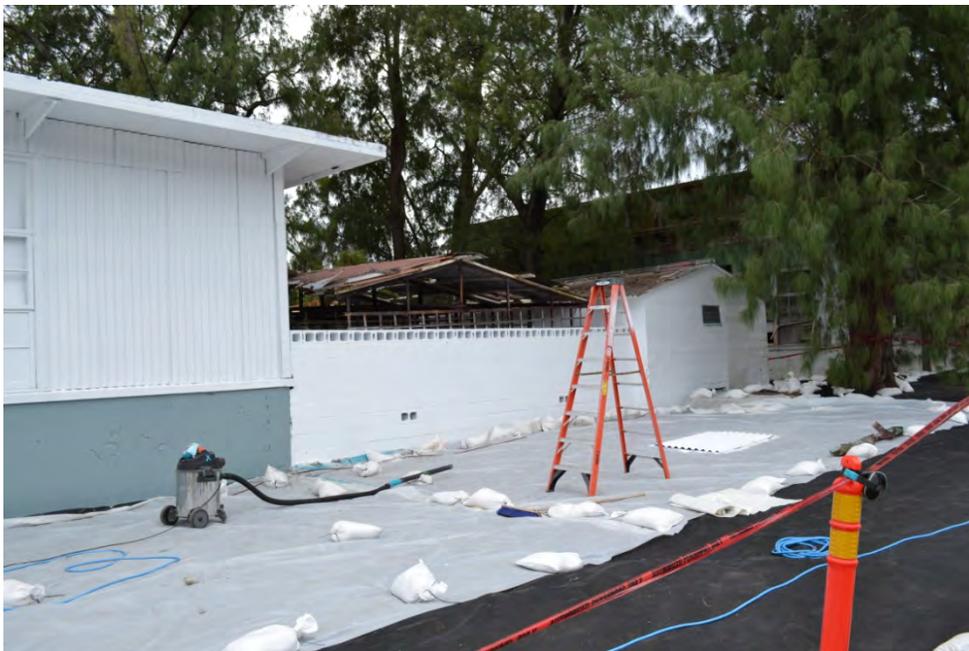
Photo 8: Painting (priming) block wall associated with Bldg 363.

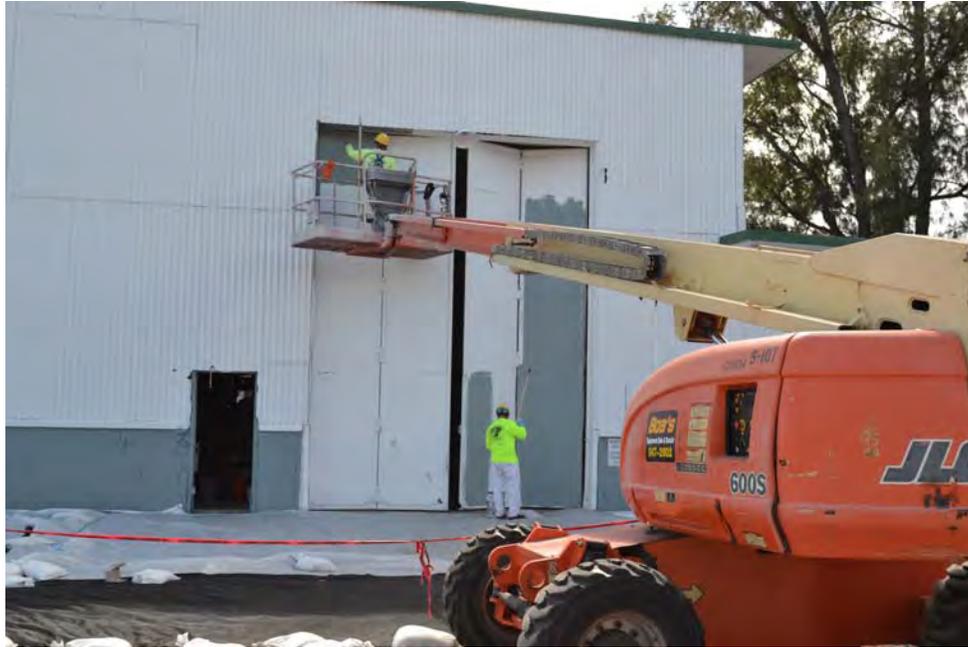
Photo 01 – Iniki applying final coat (grey) to doors on north side, Bldg 363.

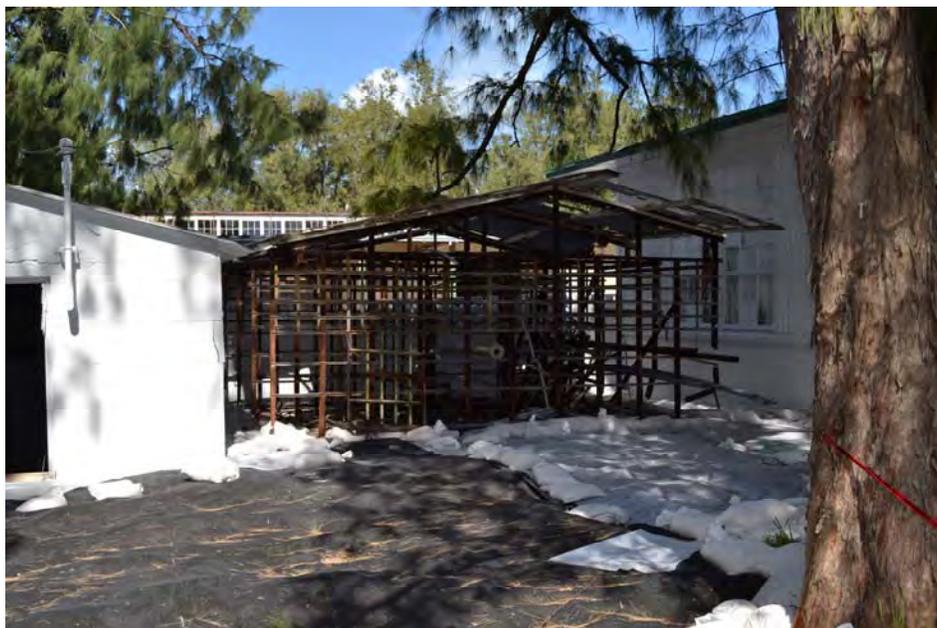
Photo 02 – Iniki painting front and back side of block wall and out building associated with Bldg 363..

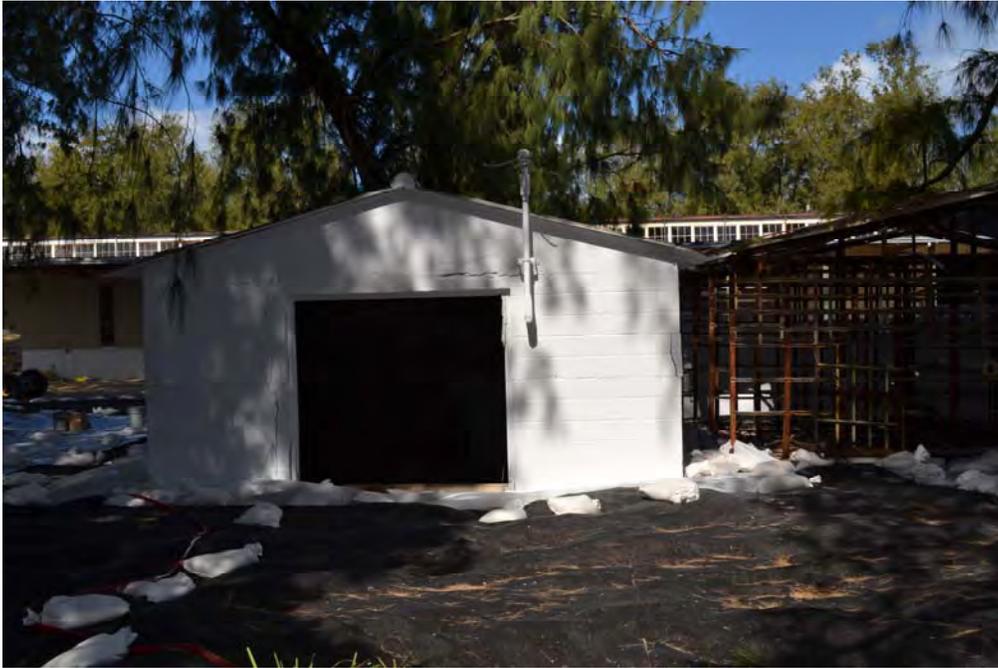
Photo 03: Iniki painting out building associated with Bldg 363.

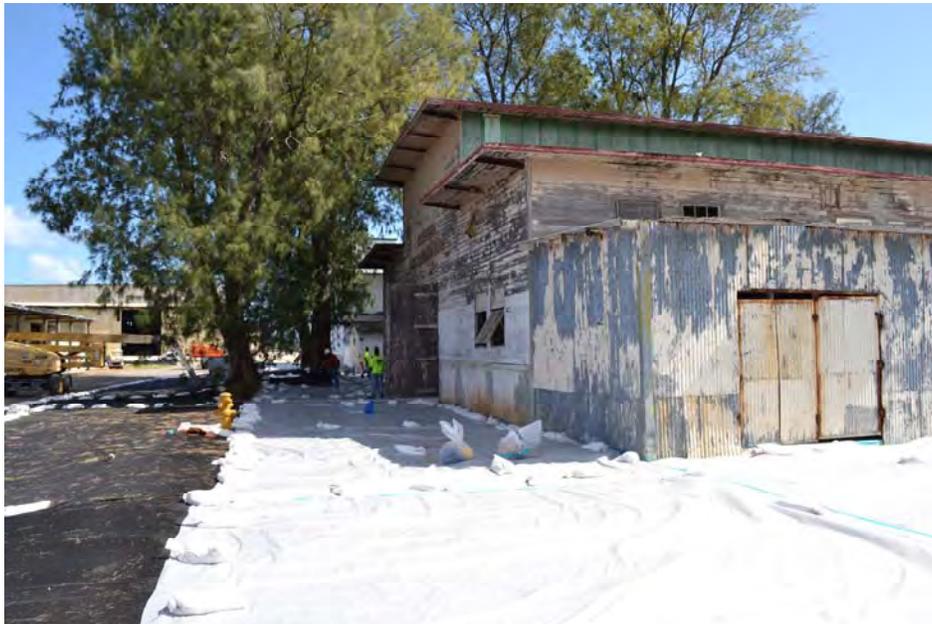
Photo 04: Iniki laying down poly (plastic) along north side Bldg 357 in advance of abatement activities.

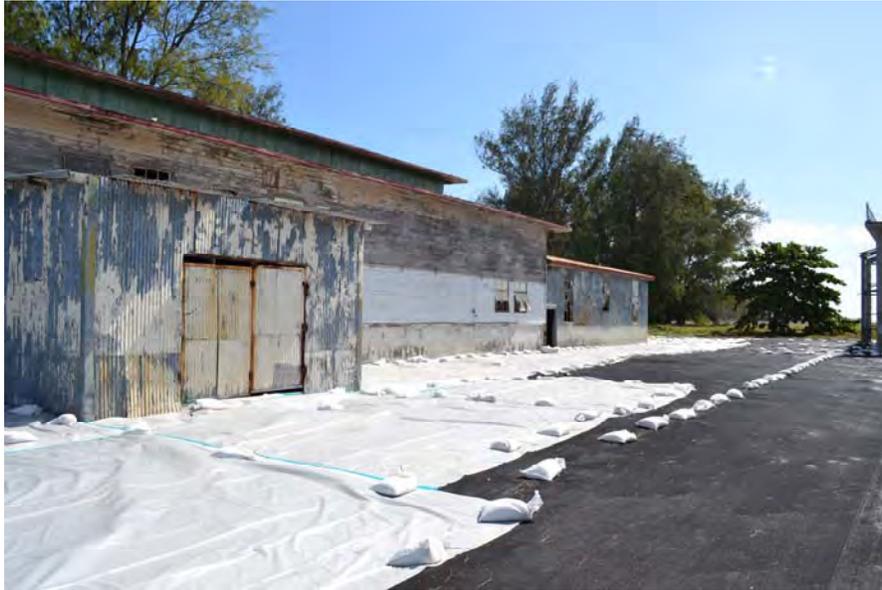
Photo 5: Iniki laying down plastic in advance of abatement activities along west wall Bldg 357.

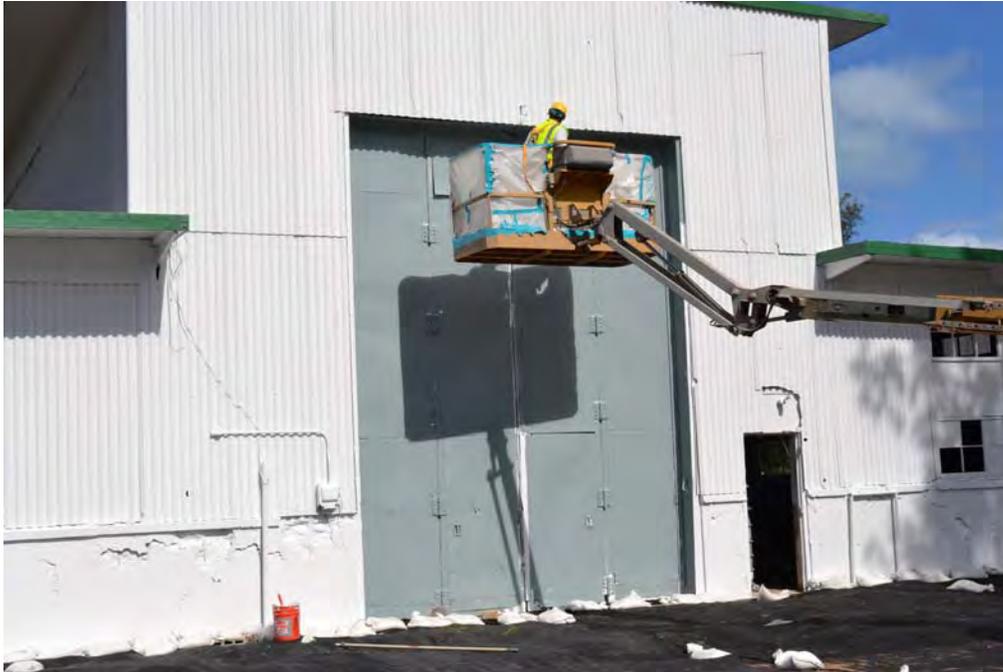
Photo 01 – Iniki is painting large doors (grey) on south wall, Bldg 363.

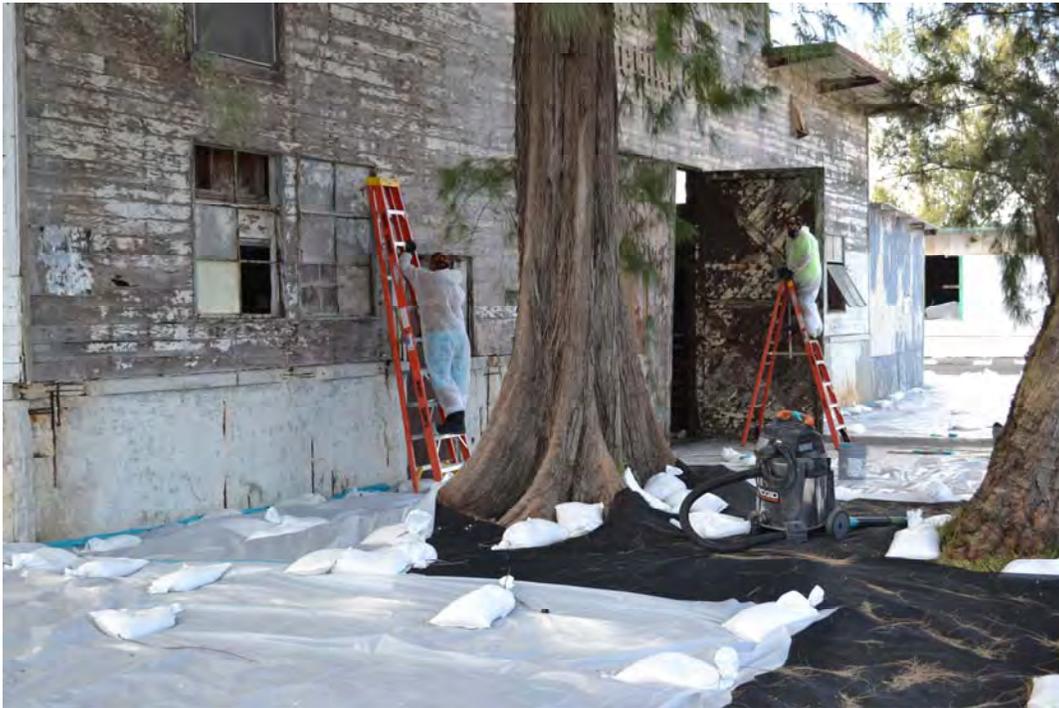
Photo 03: Iniki initiating abatement along north wall Bldg 357.

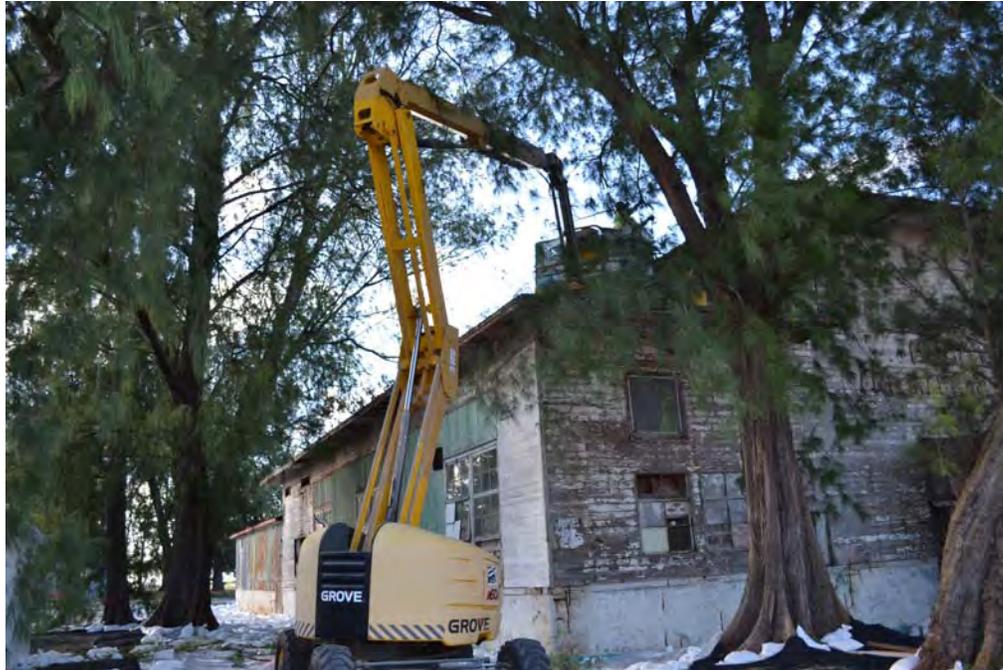
Photo 01 – Iniki is abating on east wall (second story), Bldg 363.

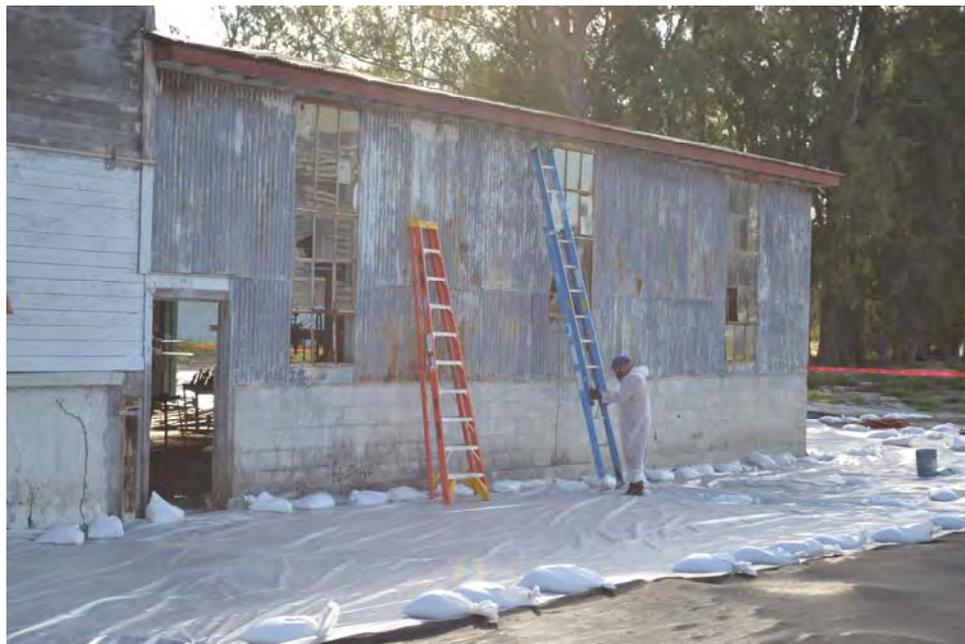
Photo 02 – Iniki is abating on west wall, Bldg 357.

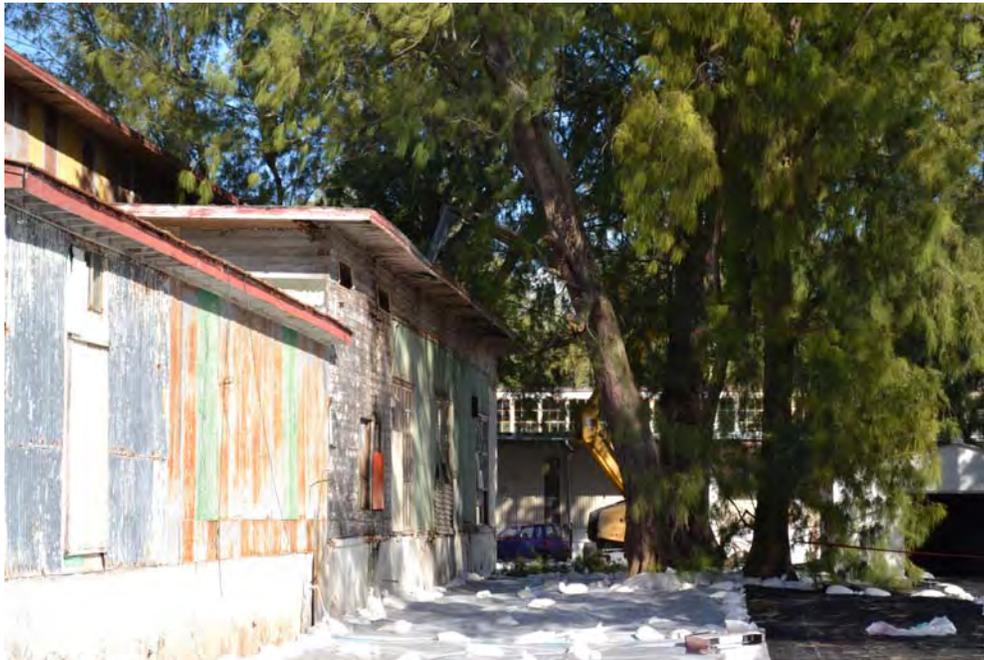
Photo 03: Iniki is abating the east wall second story, Bldg 357.

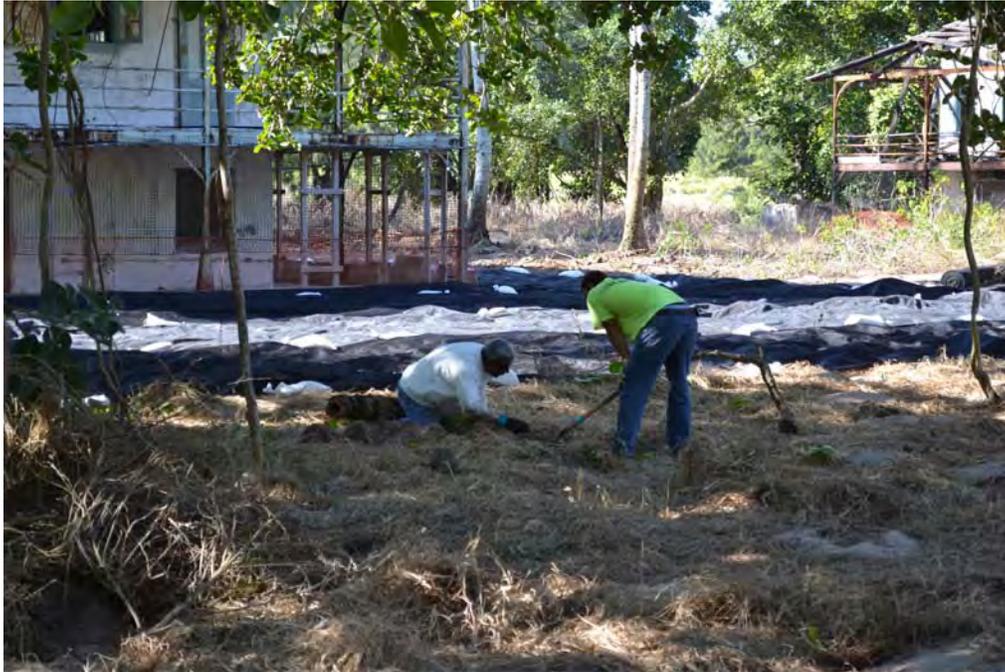
Photo 5: NWDE is inspecting bird burrows surrounding Bldg 628.

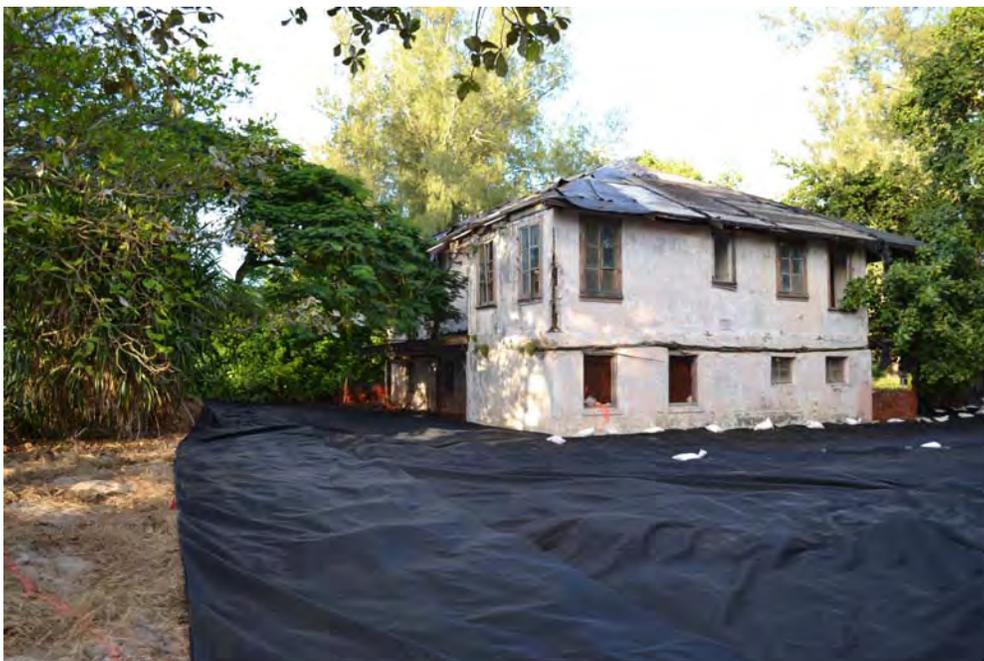
Photo 6: NWDE lays shade cloth temporarily along west and south wall of Bldg 628.

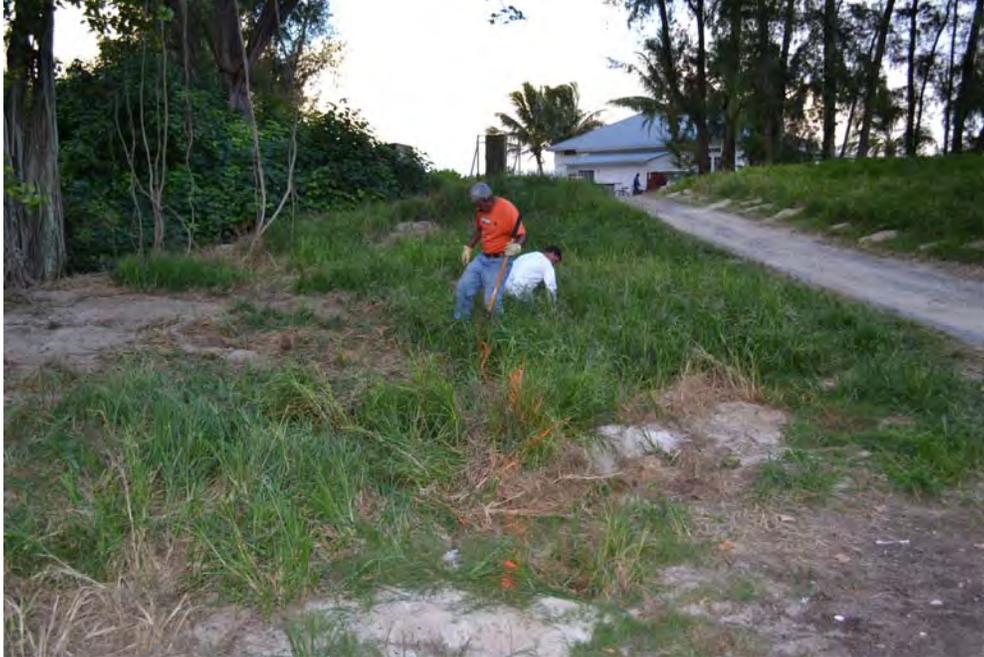
Photo 01 – NWDE is inspecting bird burrows north of Bldg 628. Note the orange markings area an electric line.

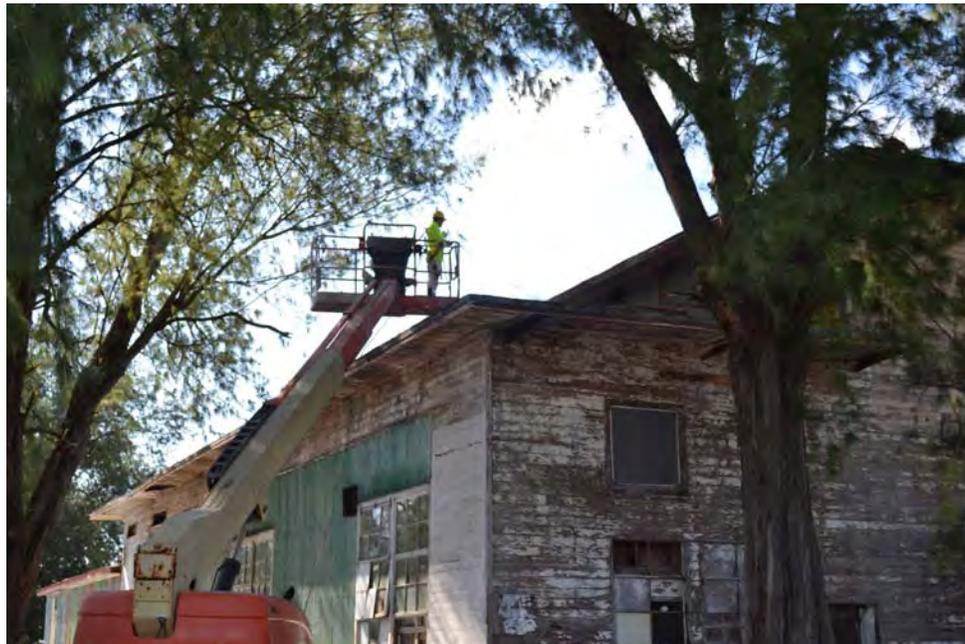
Photo 02 – Iniki is rinsing the west wall (second story), Bldg 357.

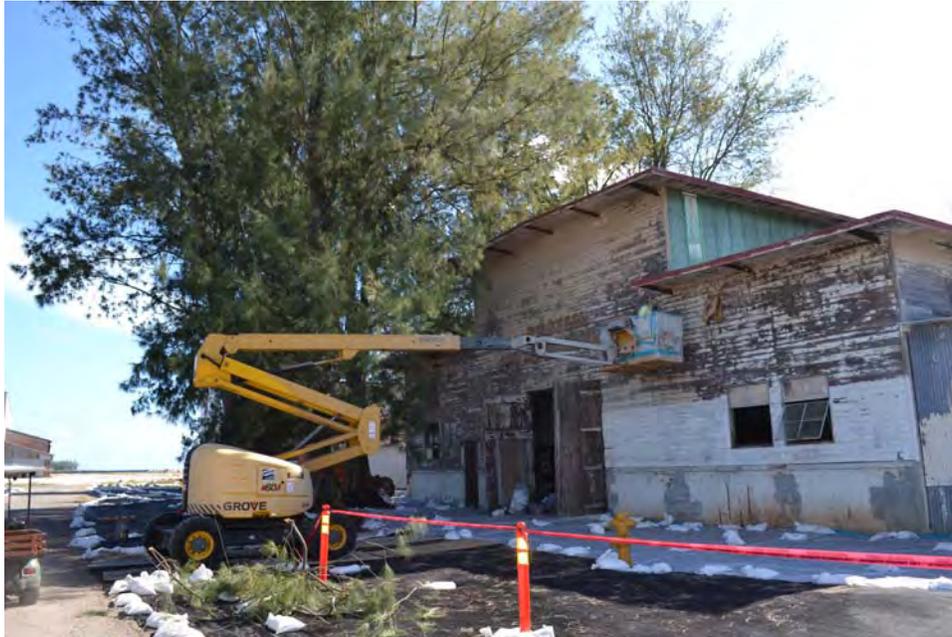
Photo 03: Iniki is abating the north wall, Bldg 357.

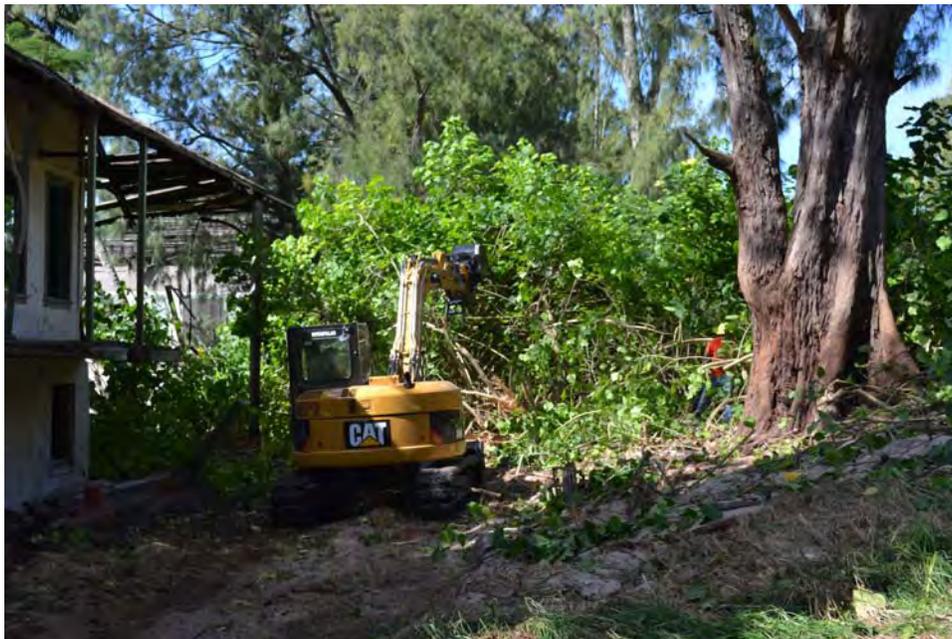
Photo 04: NWDE is removing brush along the north wall of Bldg 628.

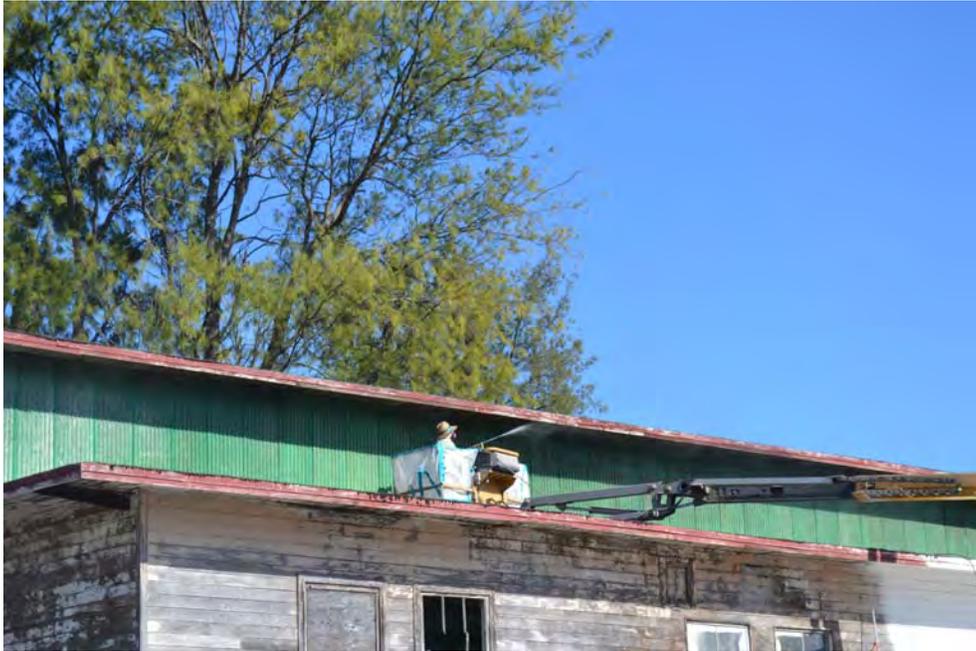
Photo 5: Iniki is rinsing the west wall (second story), Bldg 357.

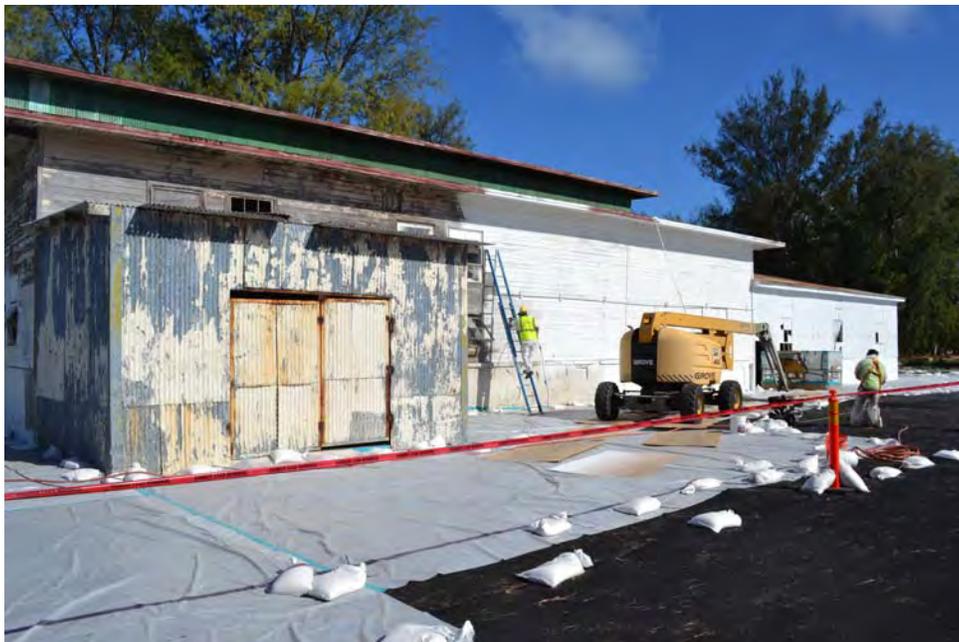
Photo 6: Iniki is painting (priming) the west wall of Bldg 357..

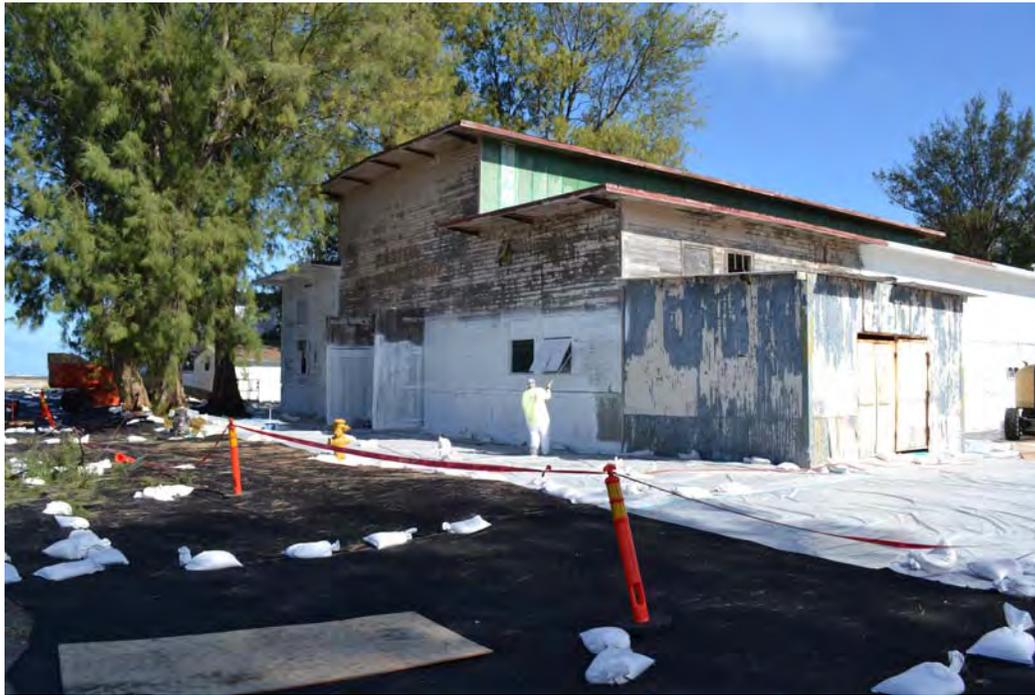
Photo 7: Iniki is painting (priming) the north wall of Bldg 357.

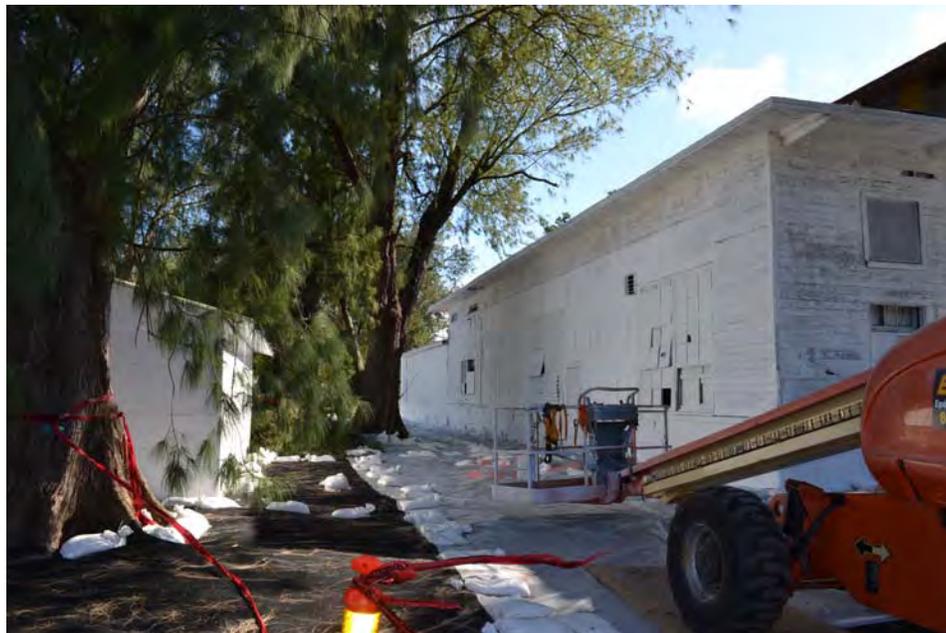
Photo 8: Iniki is painting (priming) the east wall of Bldg 357.

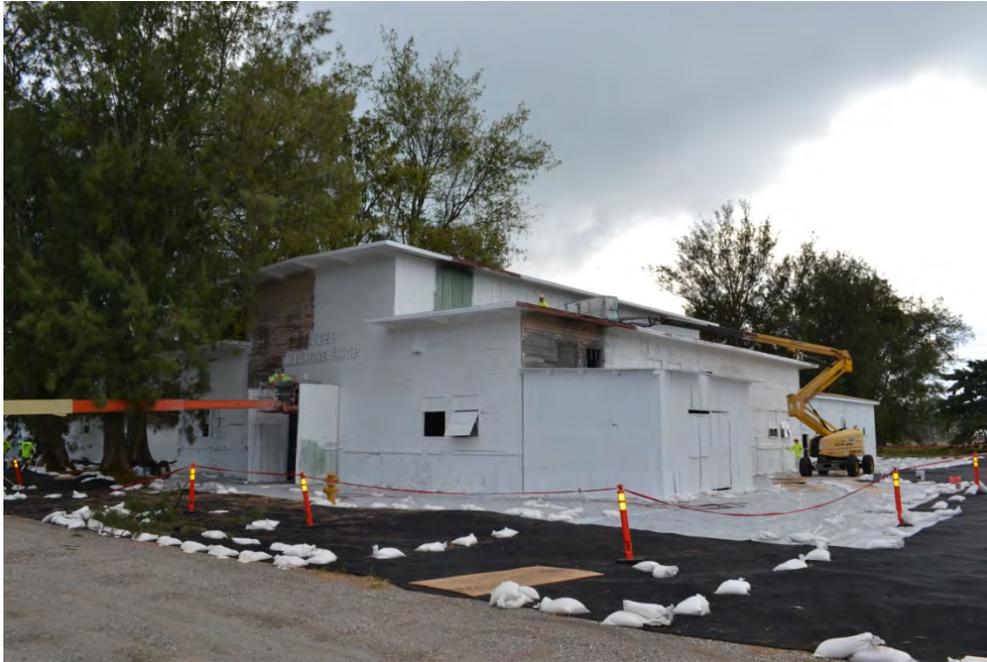
Photo 01 – Iniki is priming the west wall, Bldg 357..

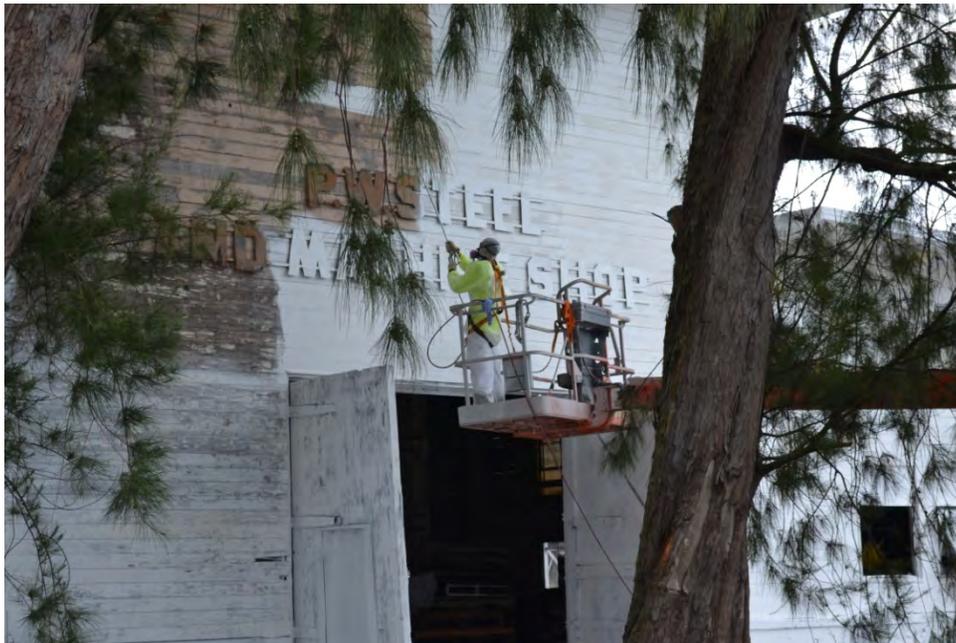
Photo 02 – Iniki is priming the north wall, Bldg 357.

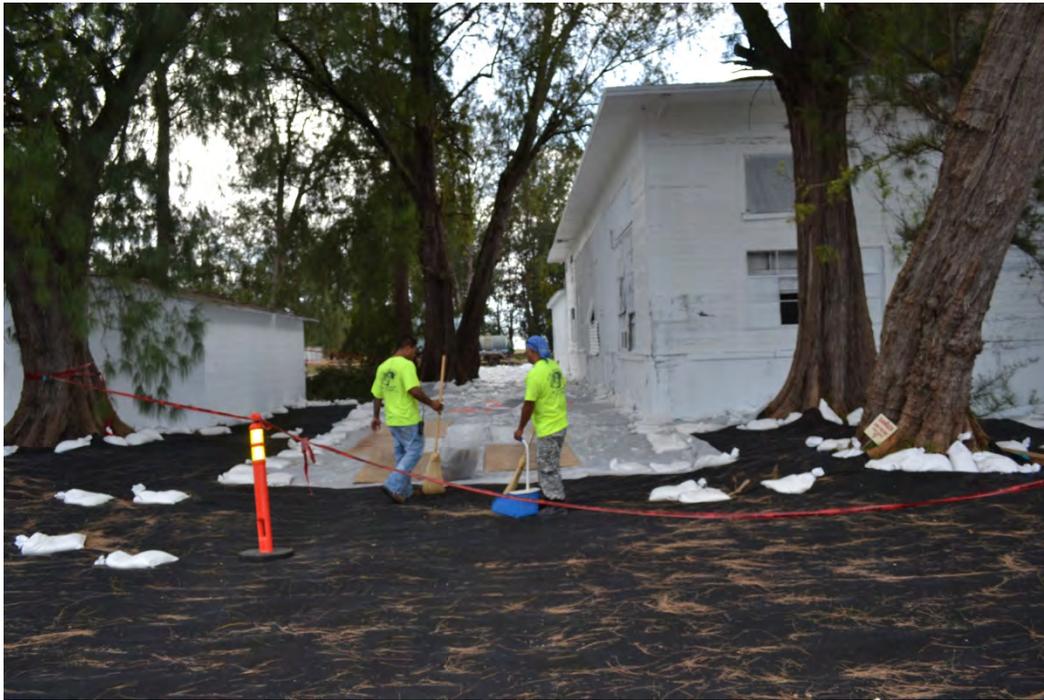
Photo 03: Iniki is cleaning up around Bldg 357.

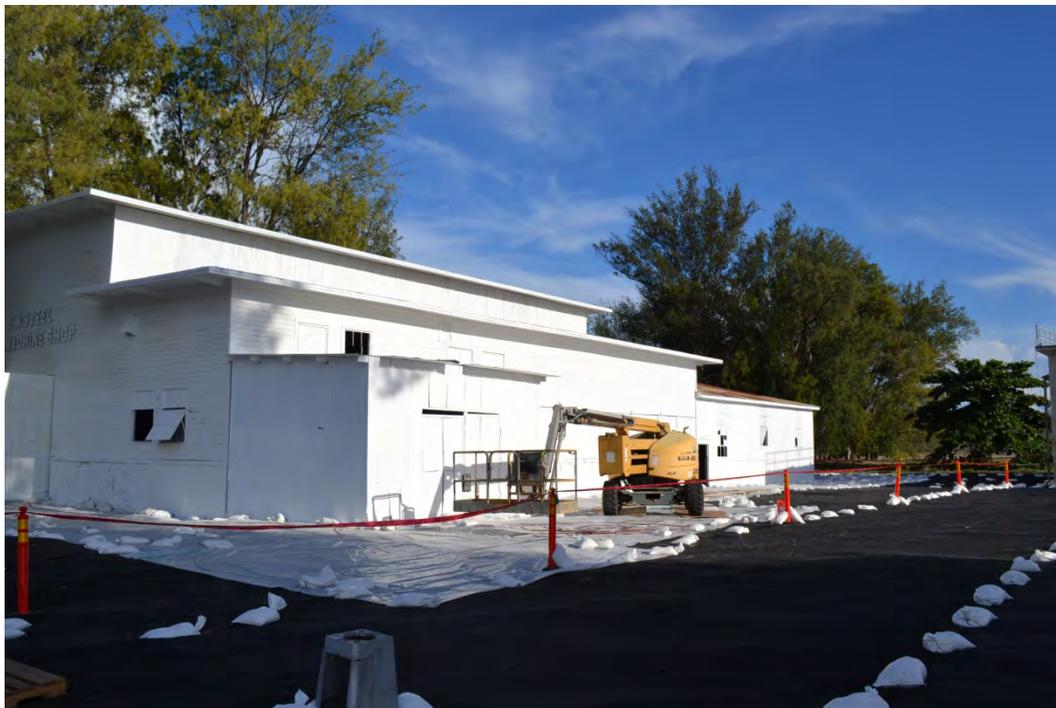
Photo 04: Primed west wall Bldg 357.

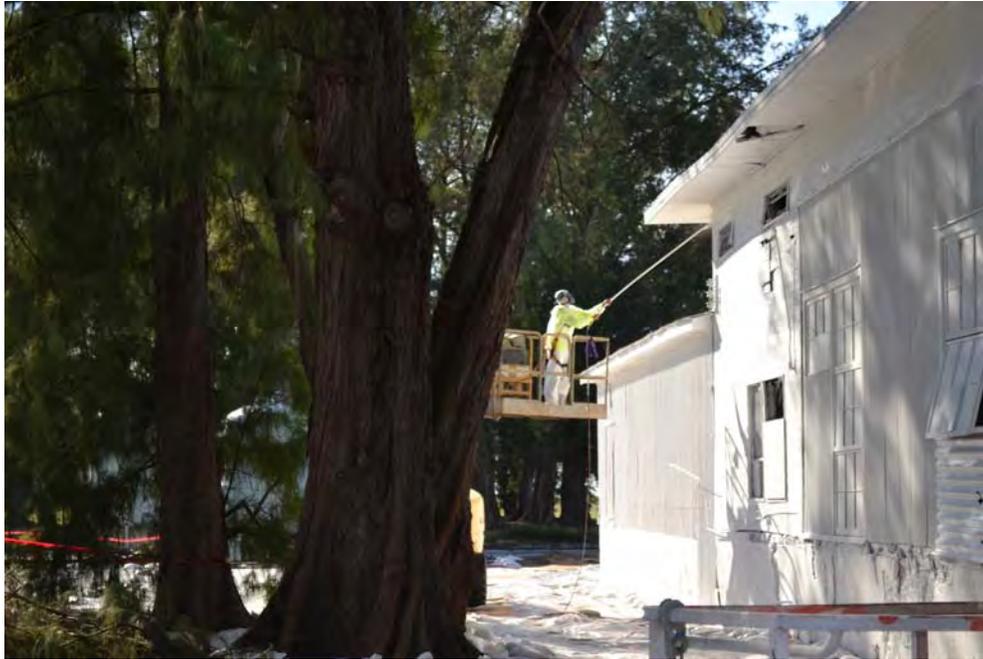
Photo 01 – Iniki is priming the south wall (second story), Bldg 357..

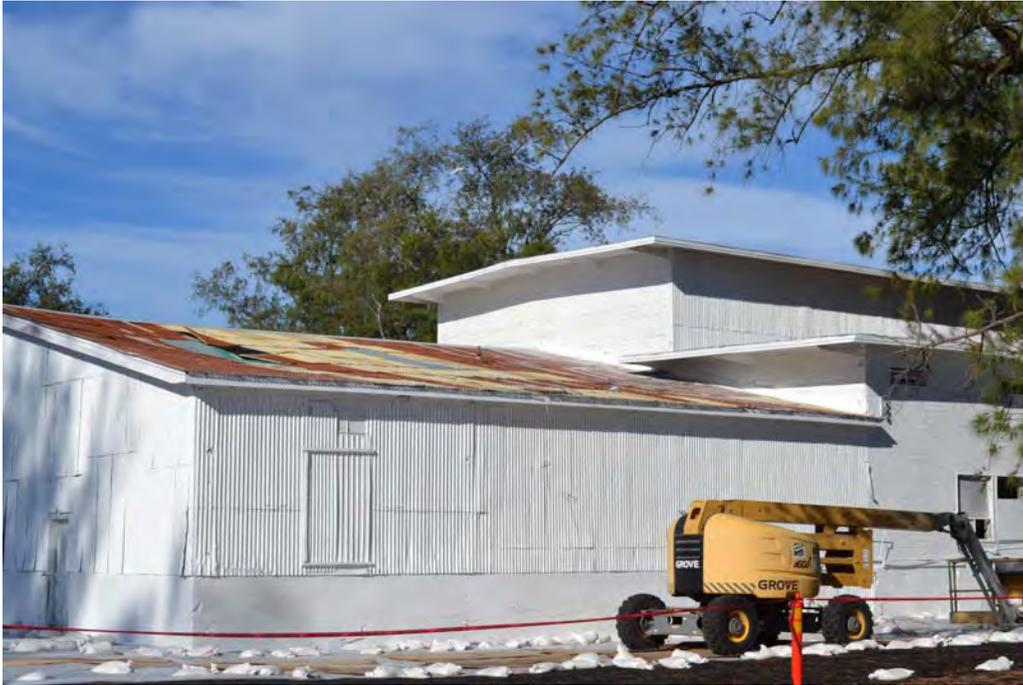
Photo 03: Priming is complete (Bldg 357).

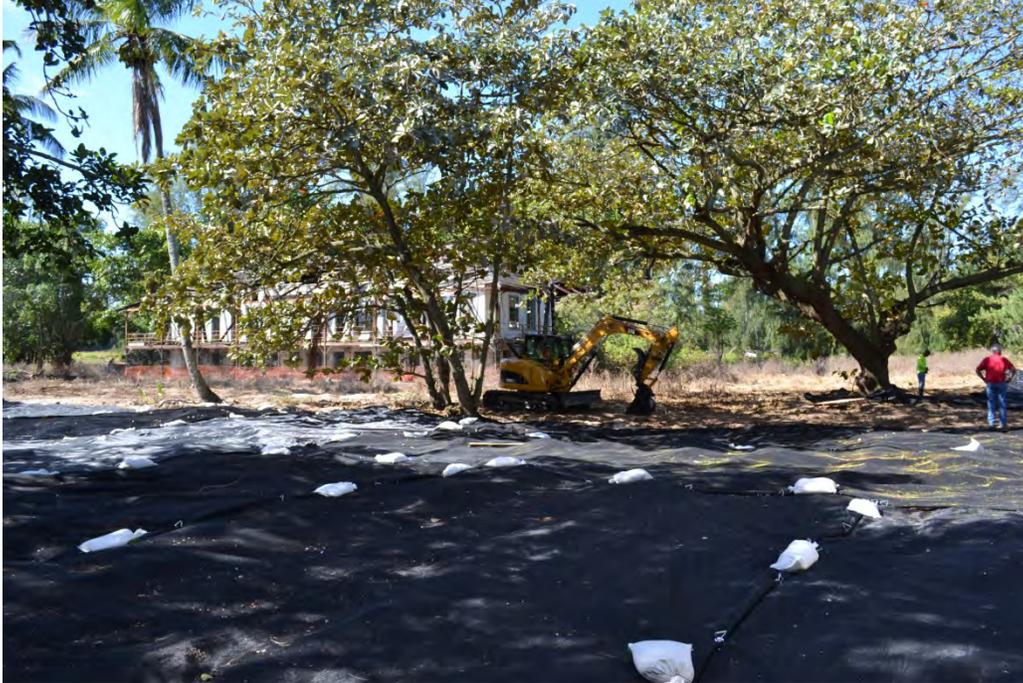
Photo 01 – NWDE is smoothing areas in advance of shadecloth deployment.

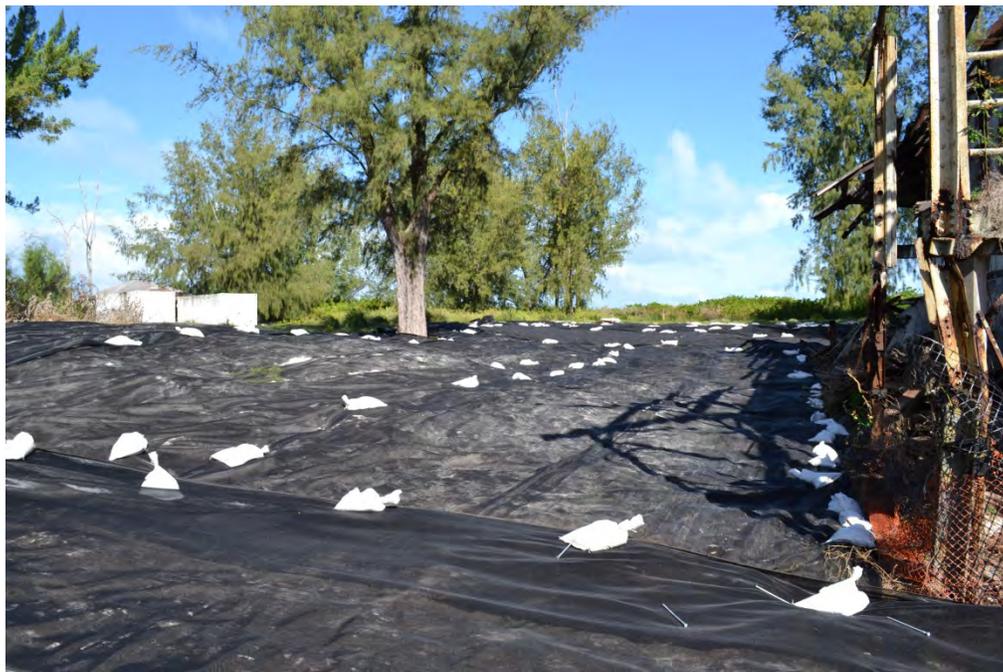
Photo 02 – NWDE is anchoring shadecloth west of Bldg 619.

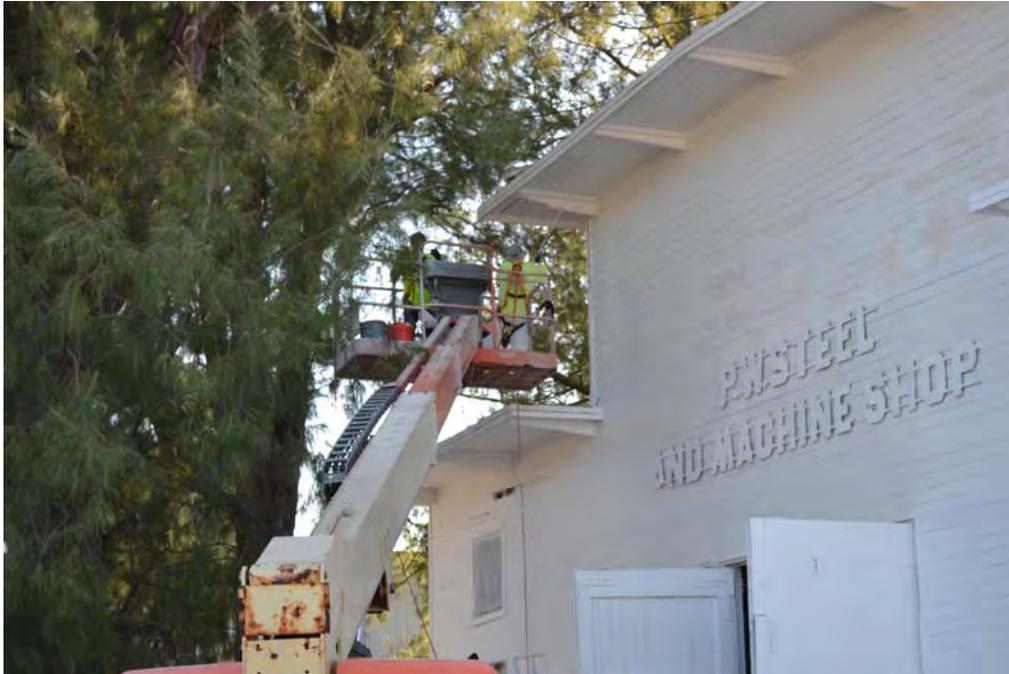
Photo 01 – Iniki is painting the final coat on the north wall of Bldg 357.
