**2011 ANNUAL REPORT**  
**CERCLA Non-time Critical Removal Action**  
**MIDWAY ATOLL NATIONAL WILDLIFE REFUGE**  
**MIDWAY ISLAND**  
**Contract No. F11PC00327**

29 February 2012

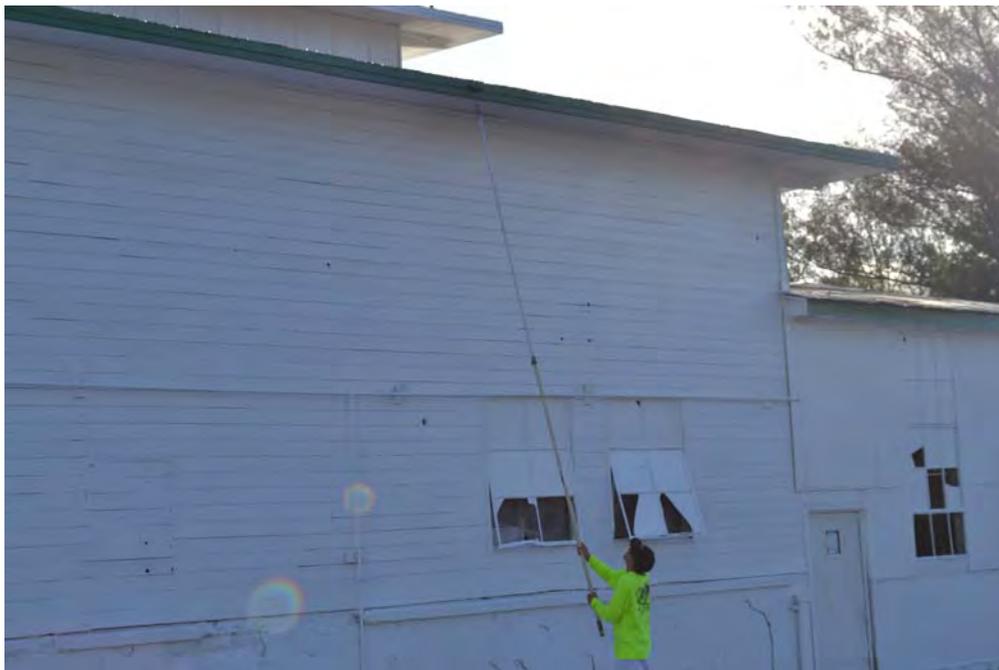
Photo 02 – Iniki is painting the trim (green) on the west wall of Bldg 357.

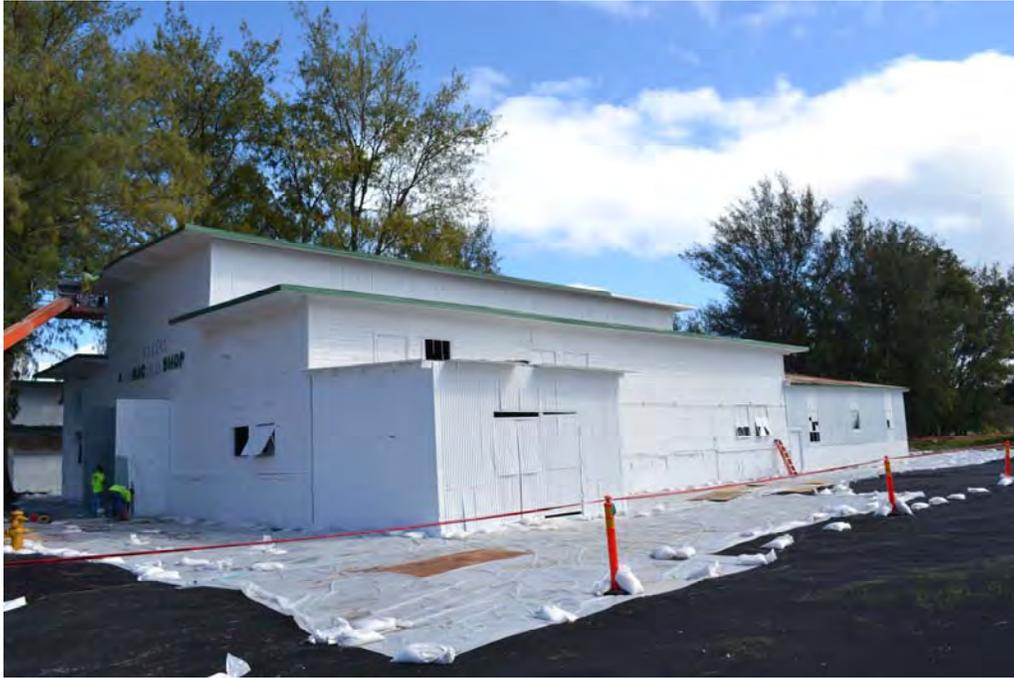
Photo 3: North and West walls in progress (Bldg 357).

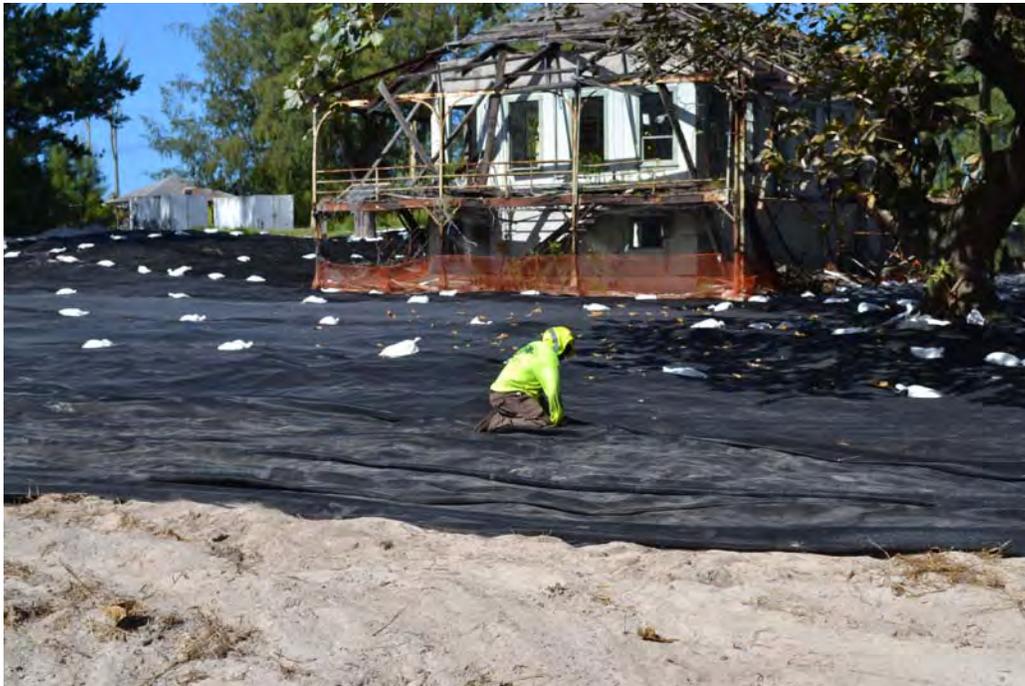
Photo 4: NWDE anchoring shade cloth north of BLDG 623.

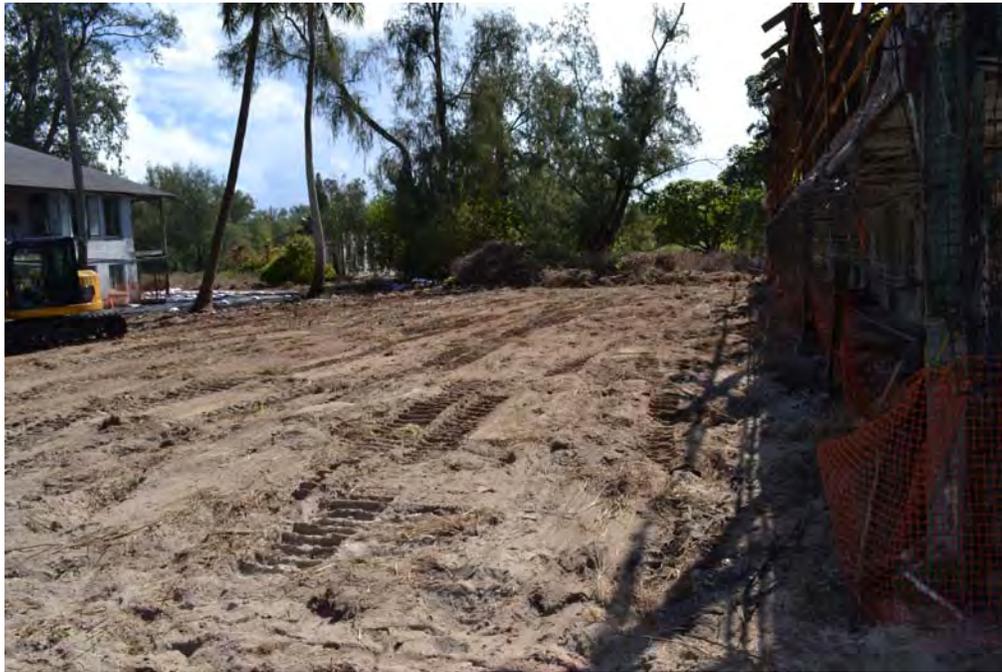
Photo 5: Smoothed out area immediately east of Bldg 623 in advance of shade cloth deployment.

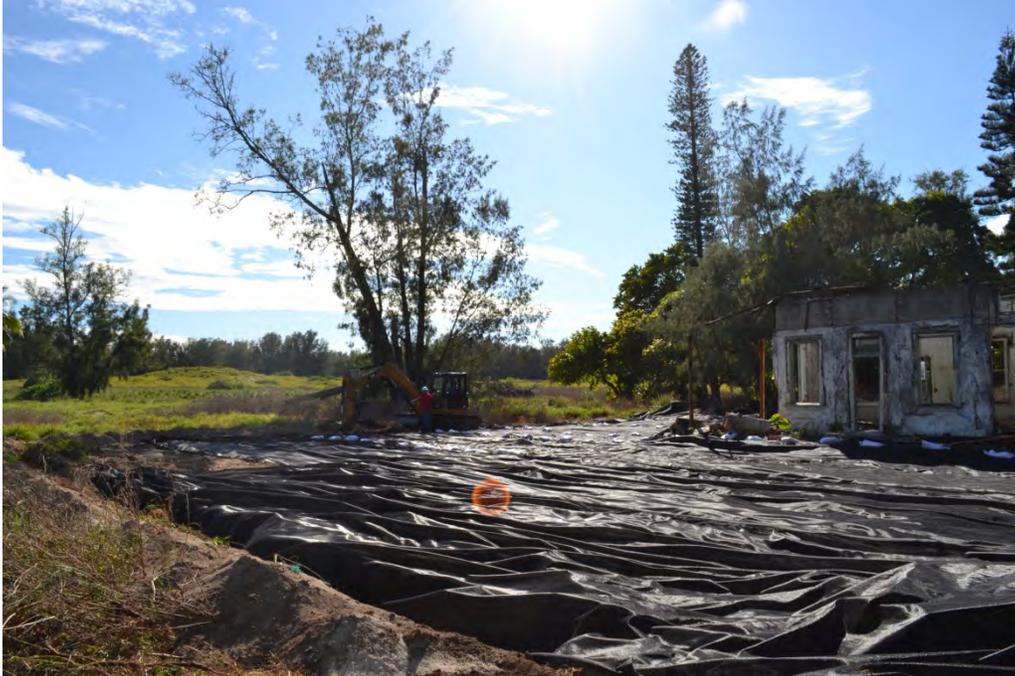
Photo 01 – NWDE is deploying shadecloth along the east and south walls of Bldg 626.

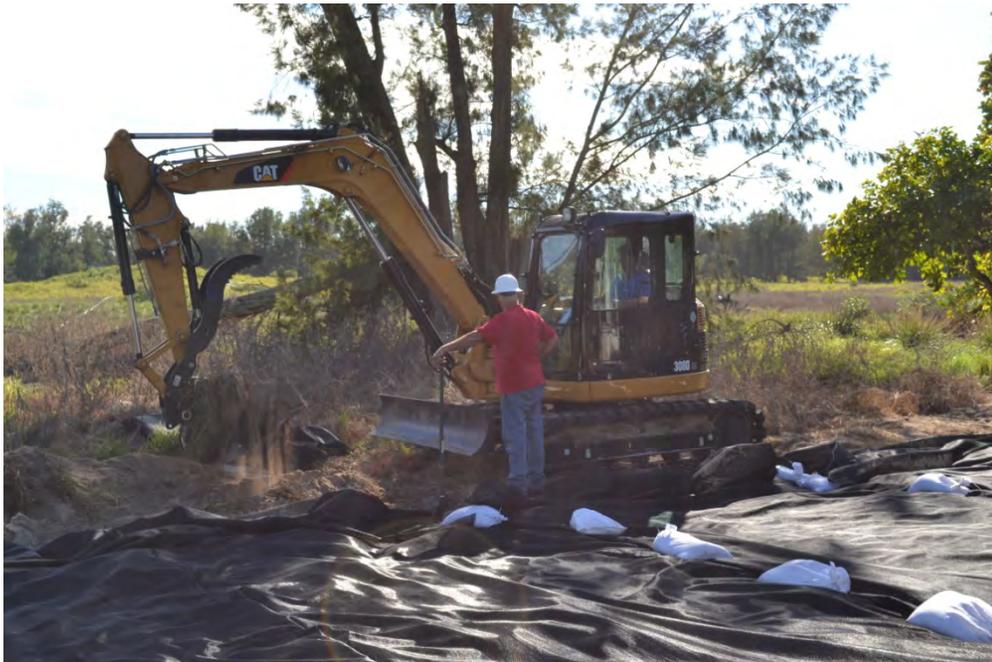
Photo 02 – NWDE is trenching to anchor / secure the shadecloth along the south wall (50' offset) of Bldg 626.

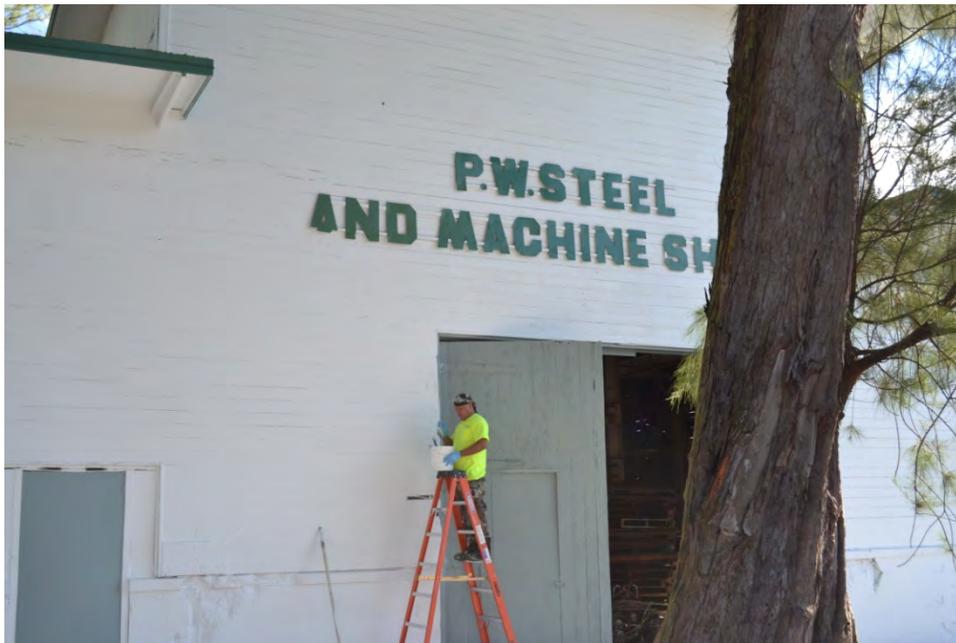
Photo 3: Iniki is painting the large doors on the north wall of Bldg 357.

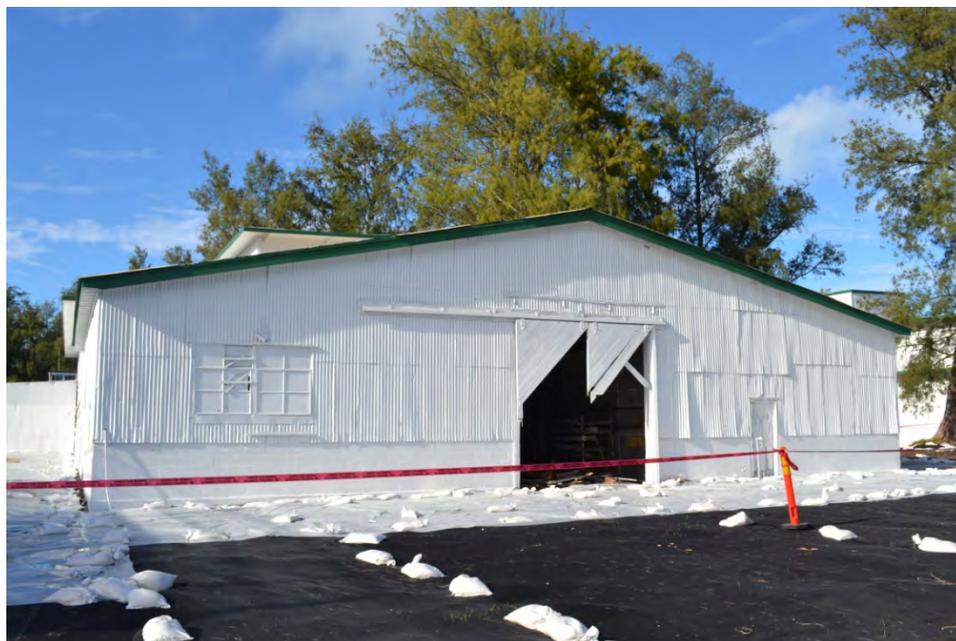
Photo 4: Iniki is continuing painting the trim on all sides of Bldg 357.

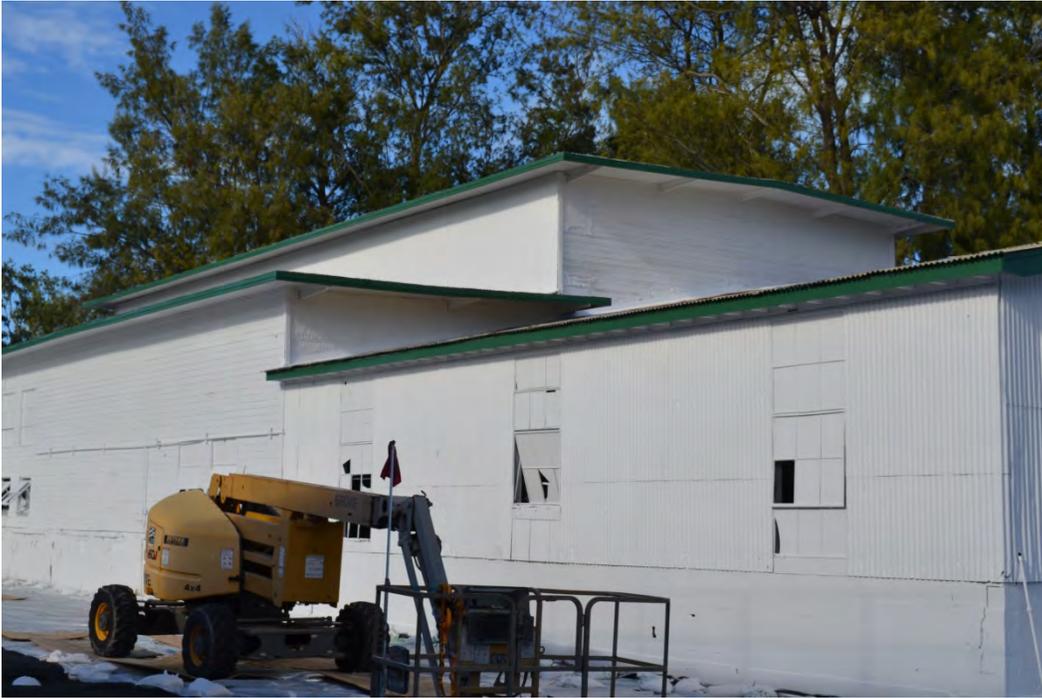
Photo 5: Iniki is continuing to paint the trim on all sides of Bldg 357.

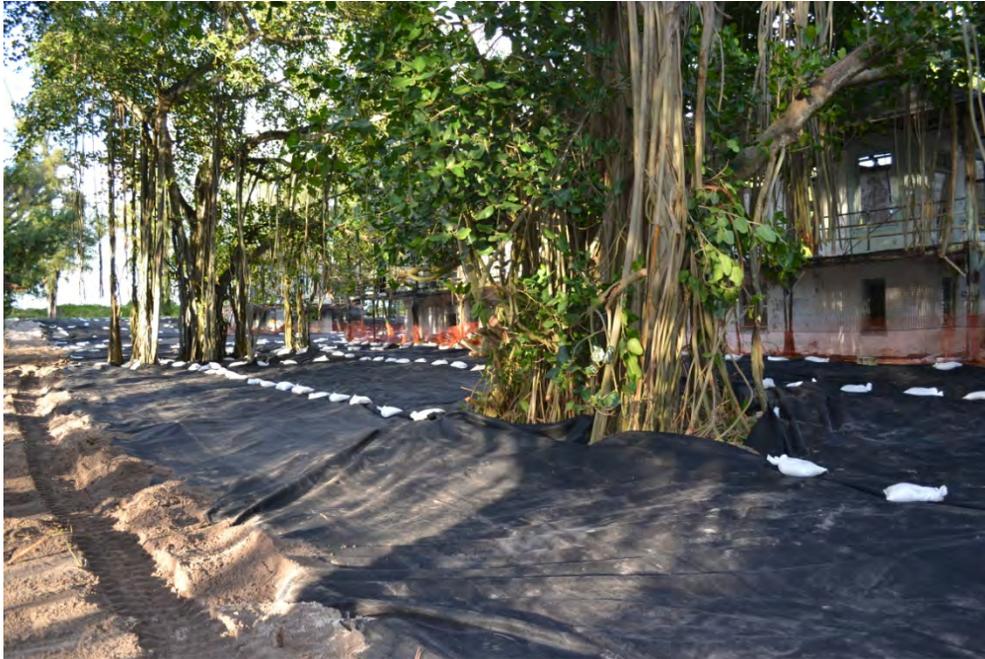
Photo 01 – Deployed shade cloth along the west wall of Bldg 623.

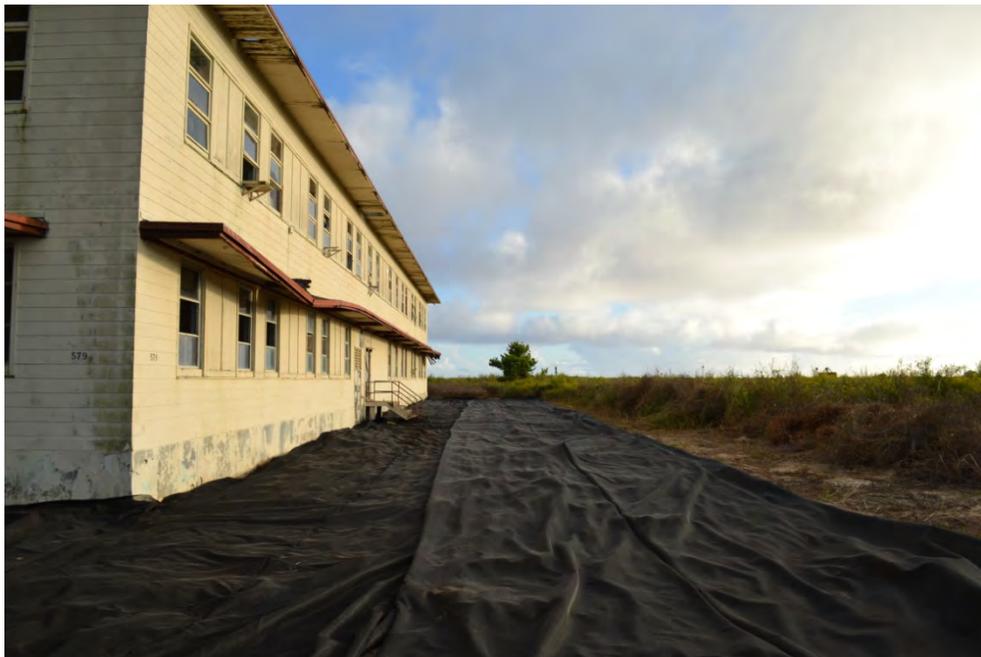
Photo 02 – NWDE is temporarily laying shade cloth along west wall (30' offset) of Bldg 579 (DU2).

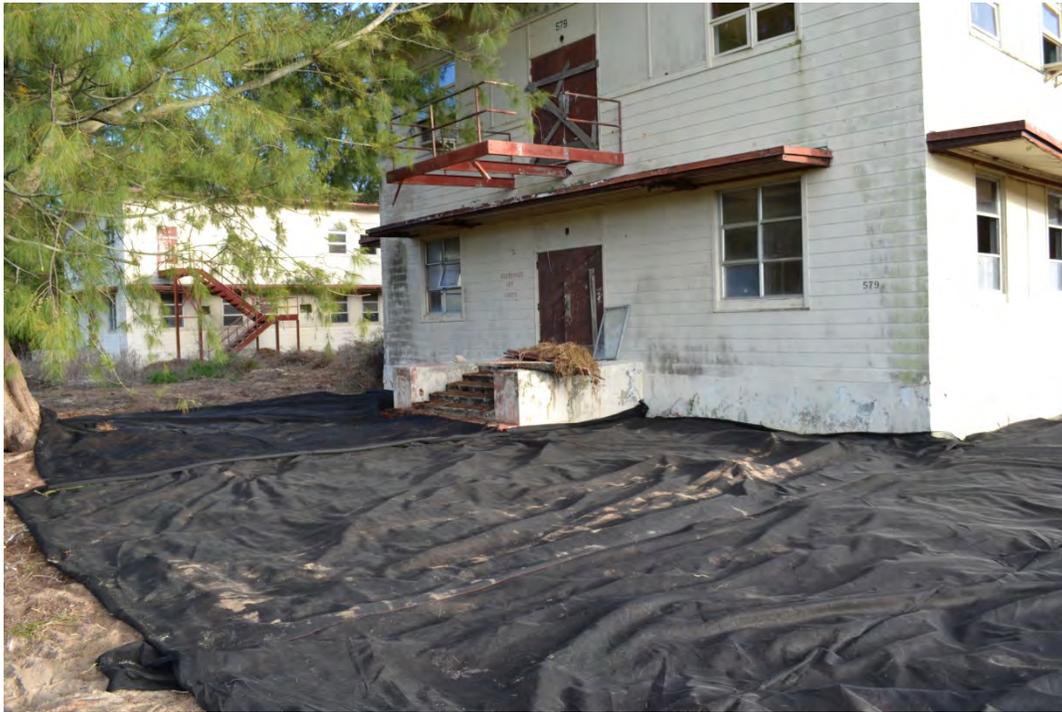
Photo 3: NWDEis temporarily laying shade cloth along north wall (30' offset) of Bldg 579 (DU2).

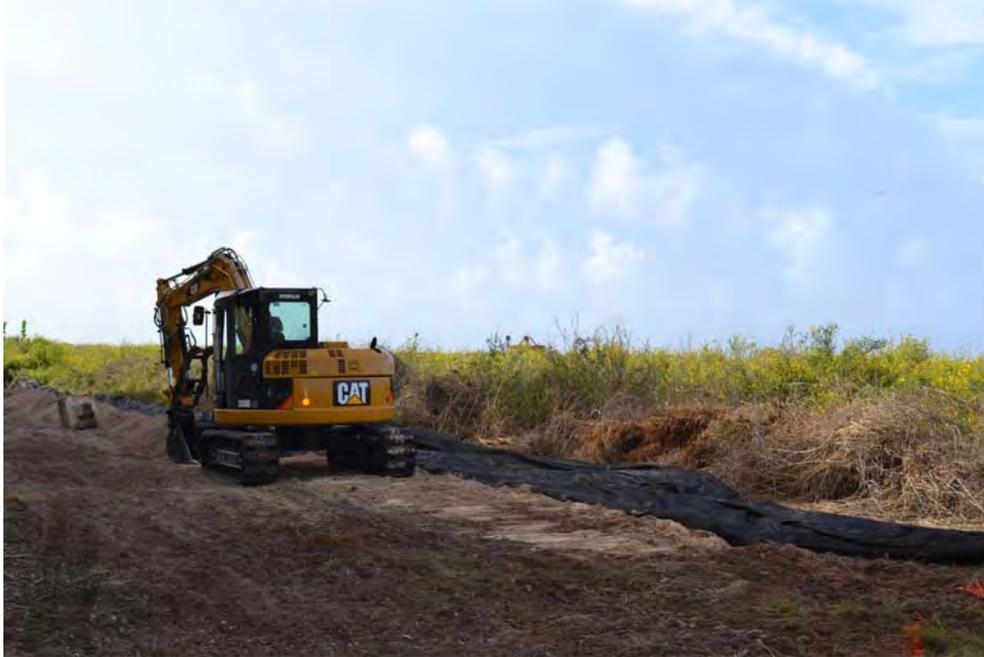
Photo 01 – Anchoring shade cloth by backfilling the trench along the west wall (30' offset) of Bldg 579.

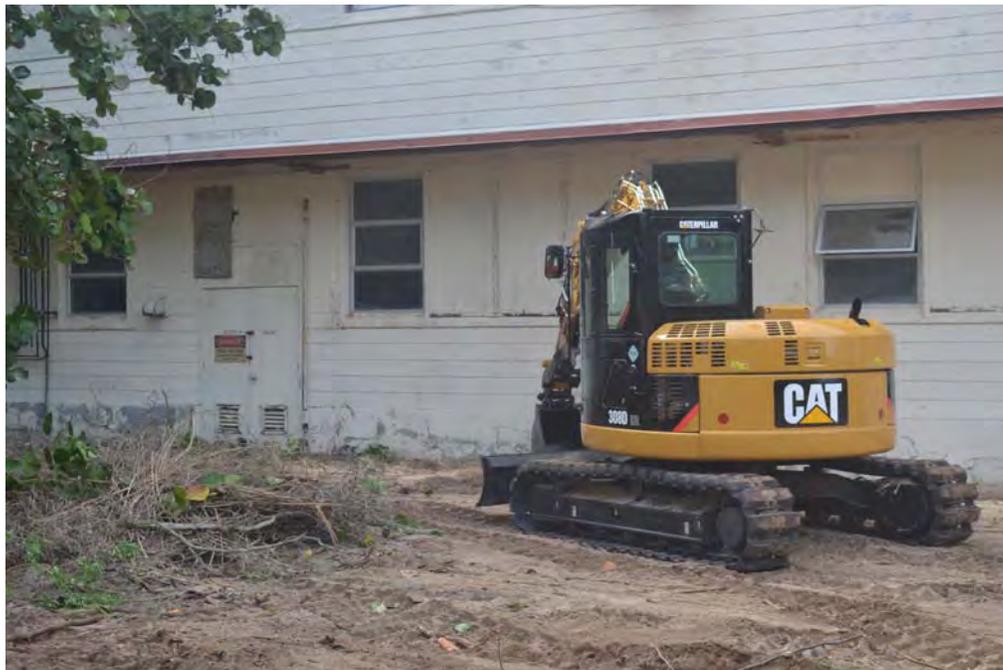
Photo 02 – NWDE is clearing brush and smoothing over the area in between Bldgs 578 and 579.

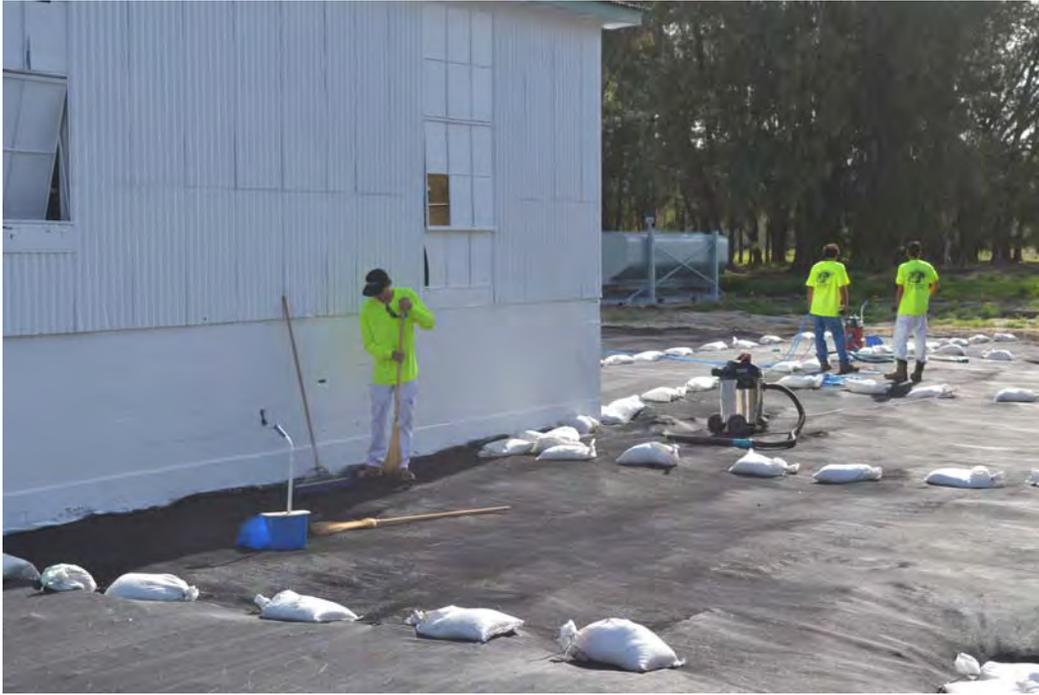
Photo 3: Iniki is cleaning up surrounding Bldg 357.

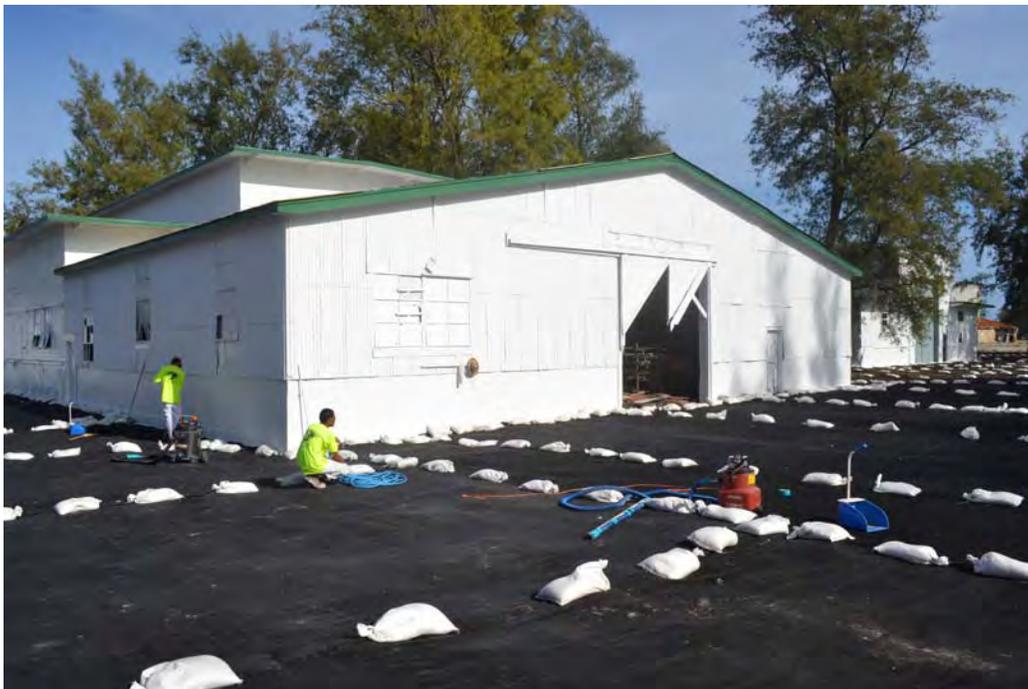
Photo 4: Iniki is cleaning up surrounding Bldg 357.

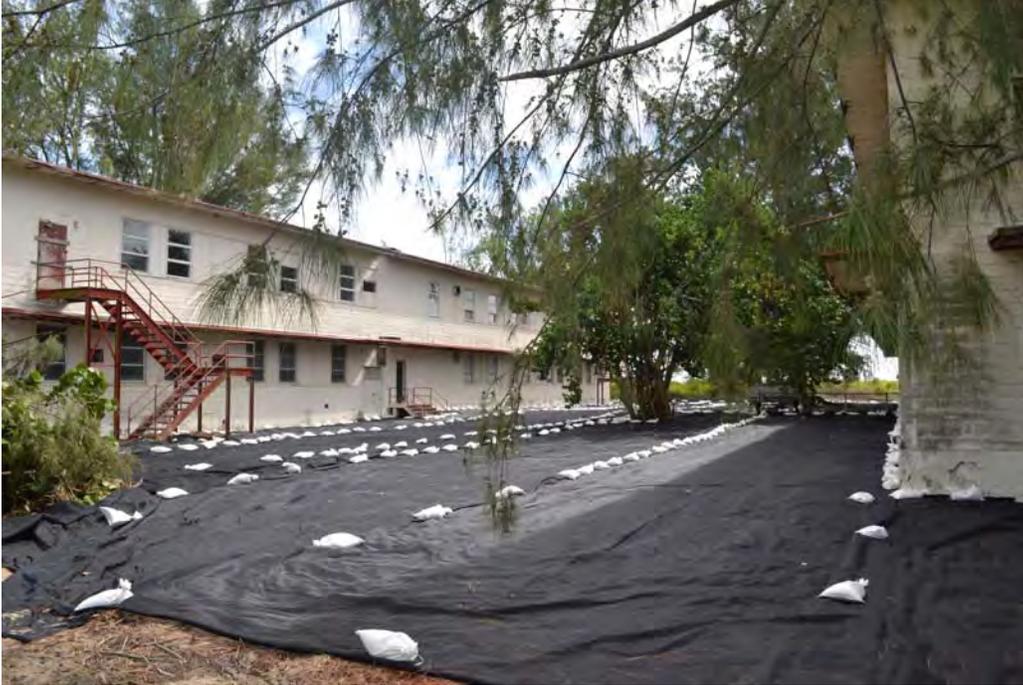
Photo 01 – Shadecloth deployed in between Bldgs 578 and 579.

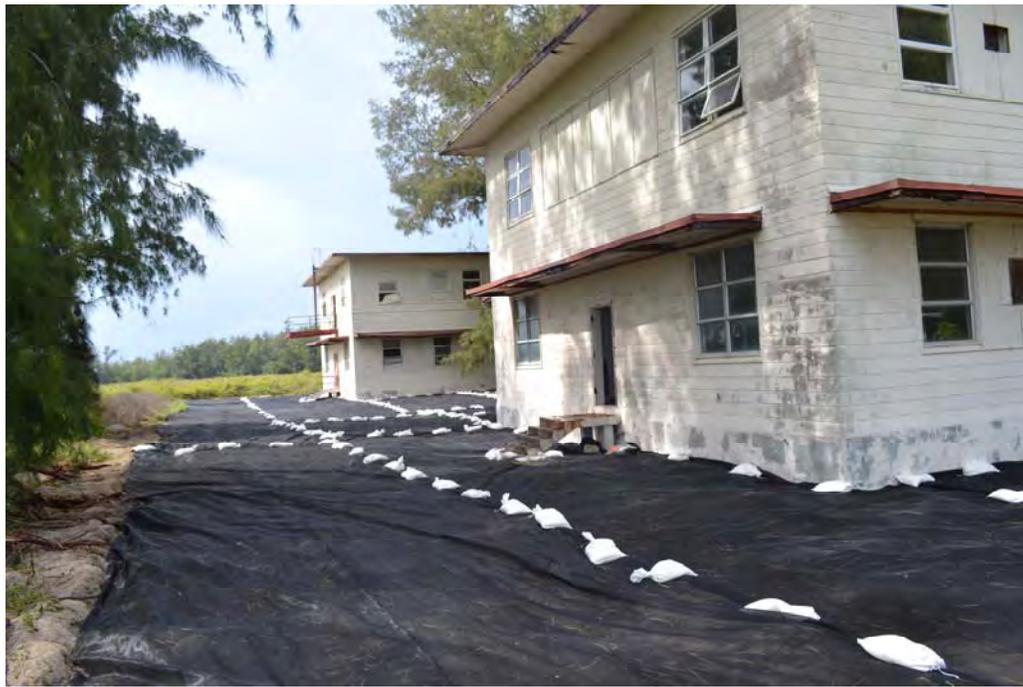
Photo 02 – Shadecloth deployed along the south walls of Bldgs 578 and 579.

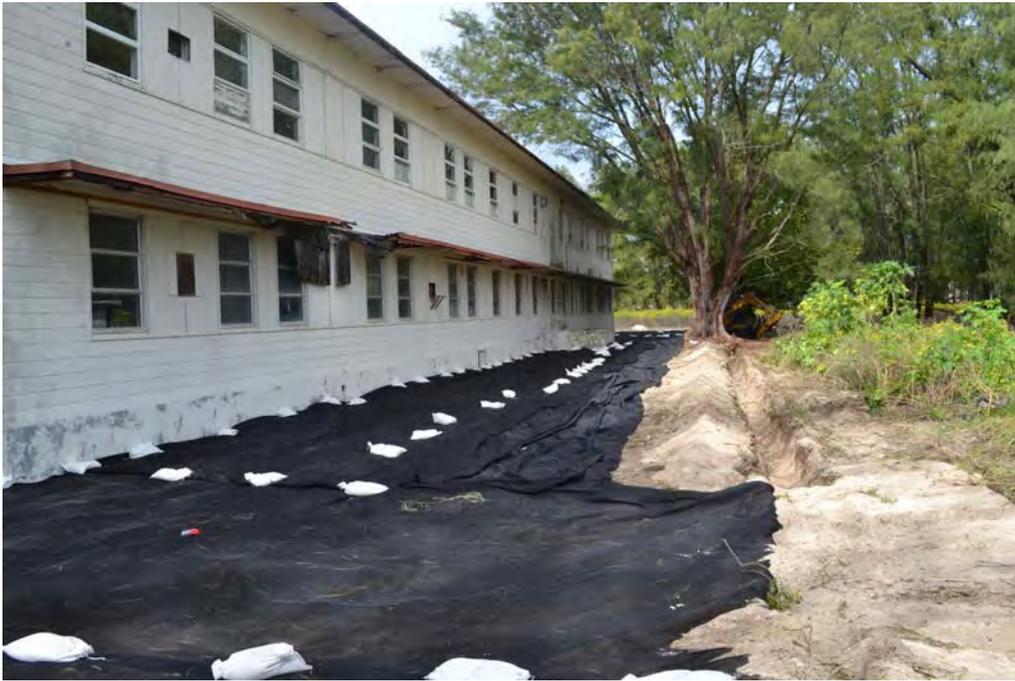
Photo 3: Temporarily deployed shade cloth along the east wall of Bldg 578.

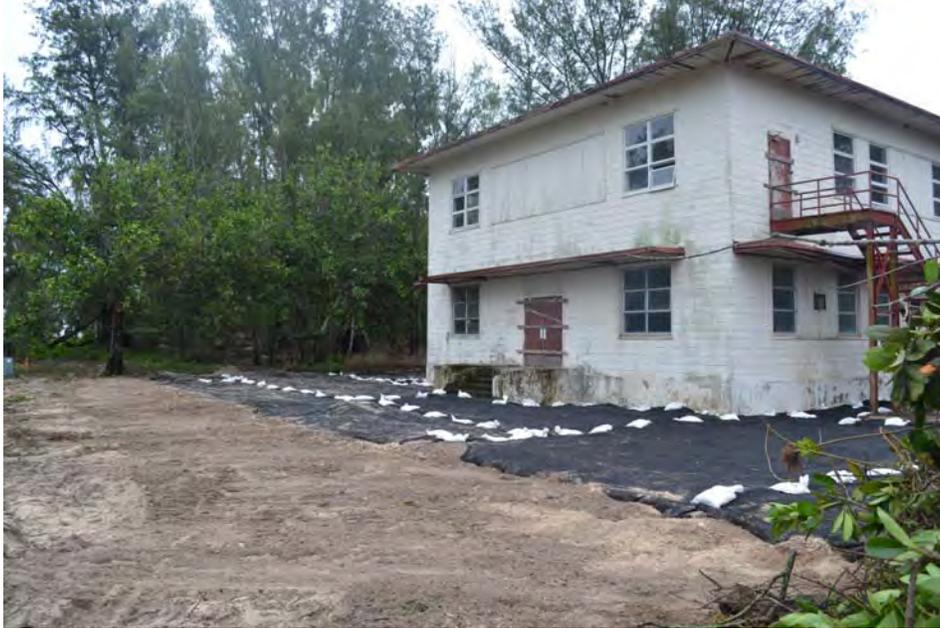
Photo 01 – Shadecloth deployed along north wall Bldg 578.

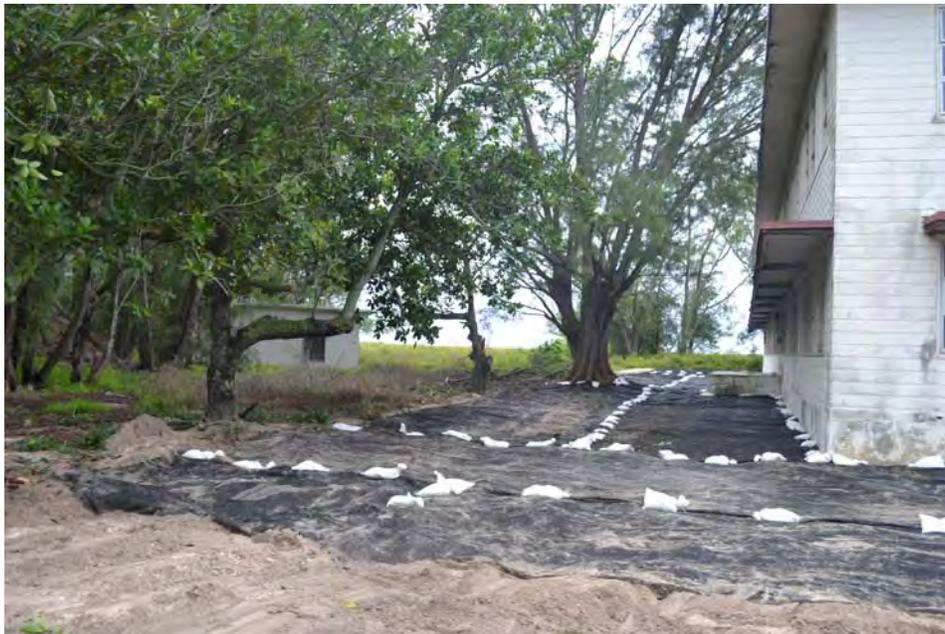
Photo 02 – Shadecloth deployed along the east wall of Bldg 578.

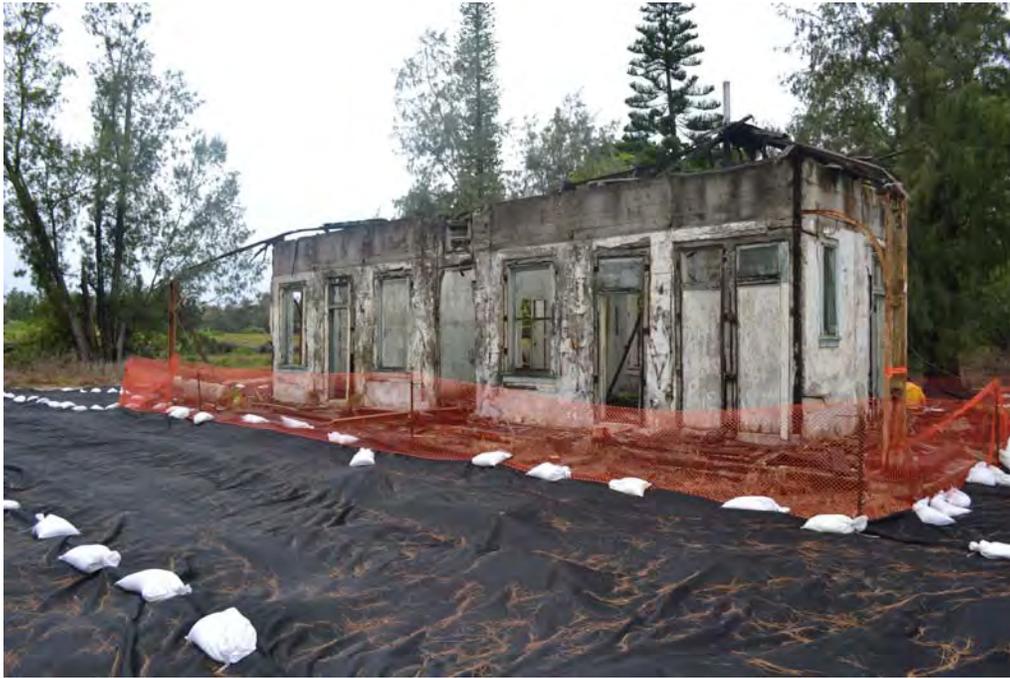
Photo 3: NWDE placed construction fence surrounding the foundation of Bldg 626.

1230 – NWDE continues moving the 3 brush piles at DU1. NWDE continues finishing with shadecloth deployment. NWDE puts up orange construction fencing surround the foundation of Bldg 626 to prevent birds from entering the building.

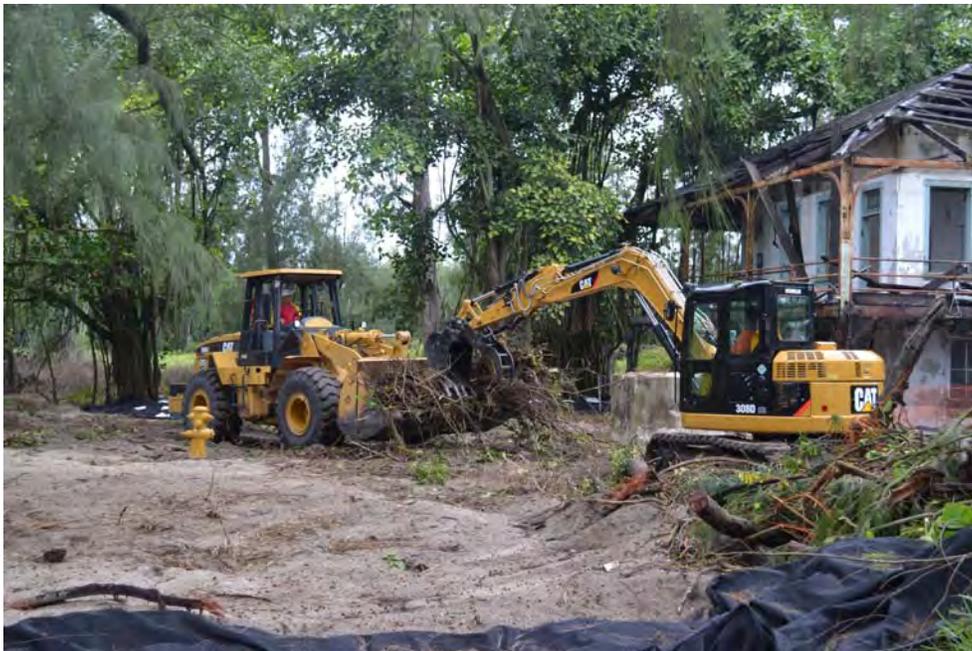
Photo 4: NWDE moving brush piles at DU1.

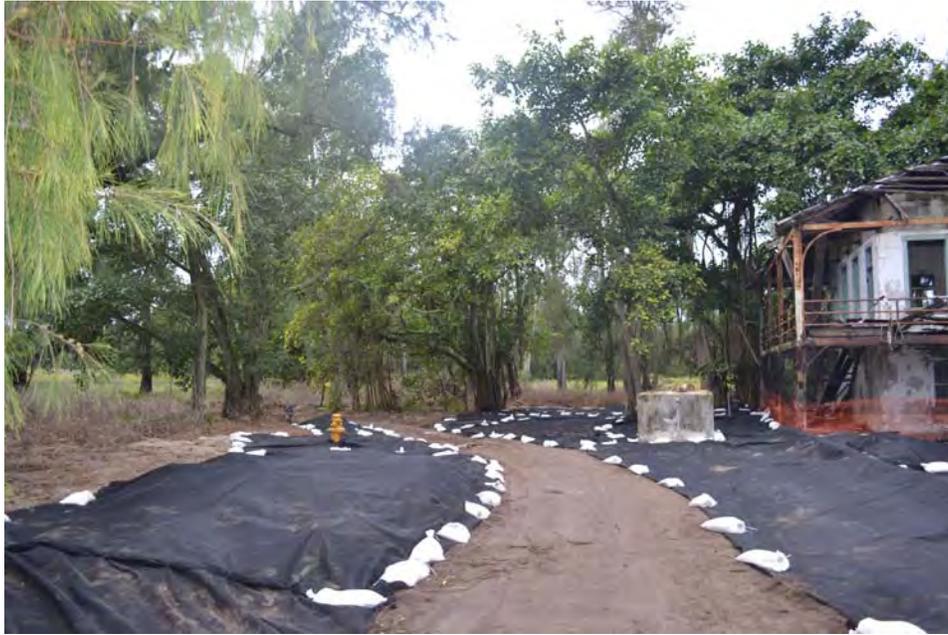
Photo 5: Completed Shadecloth deployment south of Bldg 623.

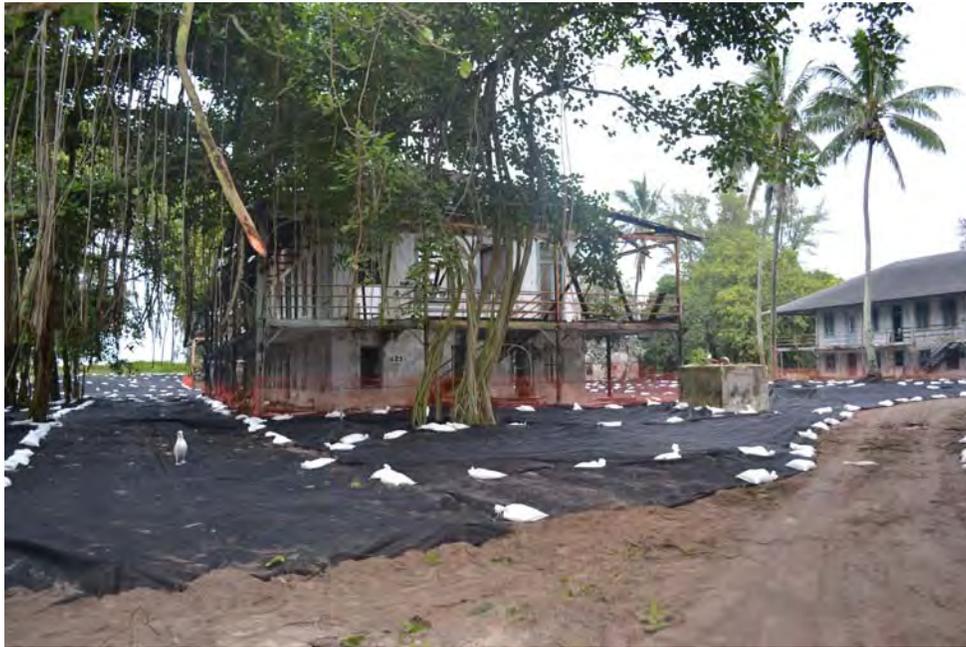
Photo 6: Completed Shadecloth deployment south of Bldg 623.

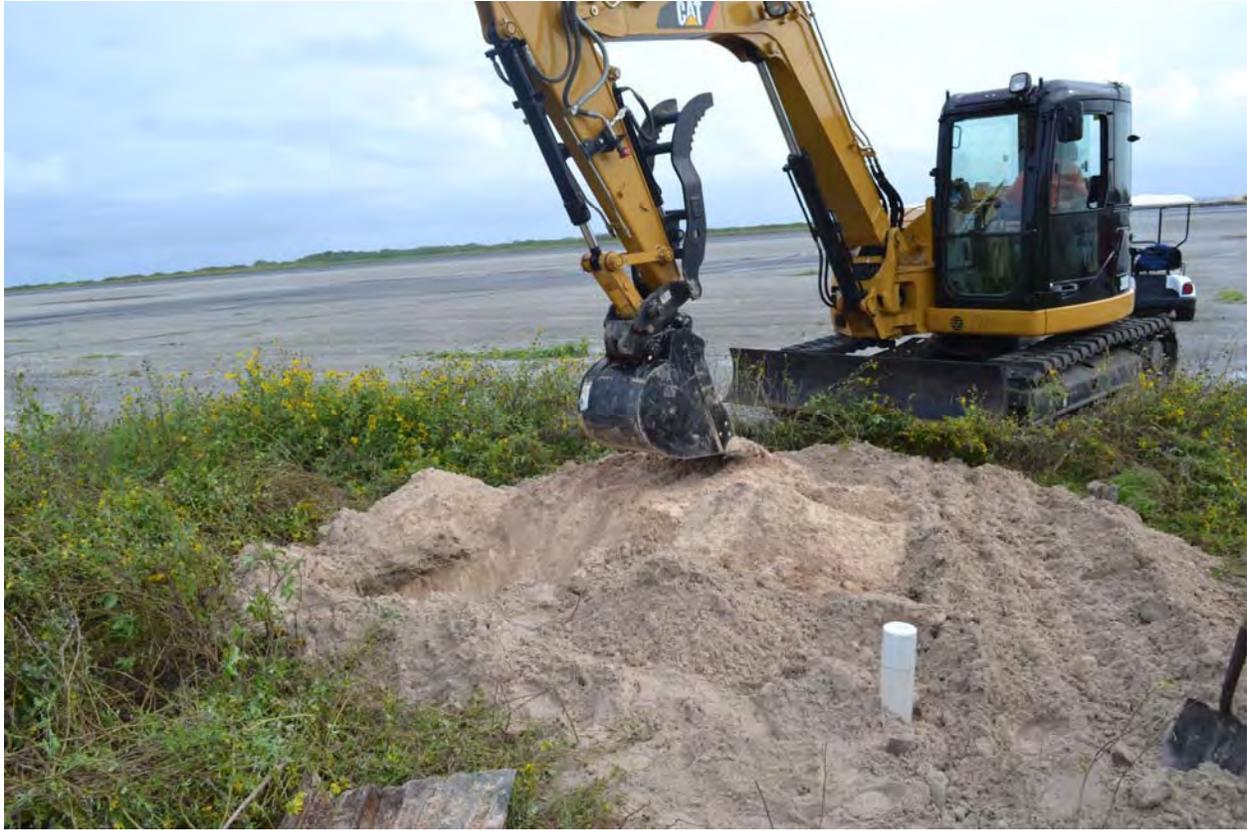
Photo 01 – NWDE excavating test pits to determine water table elevation and install peizometers.

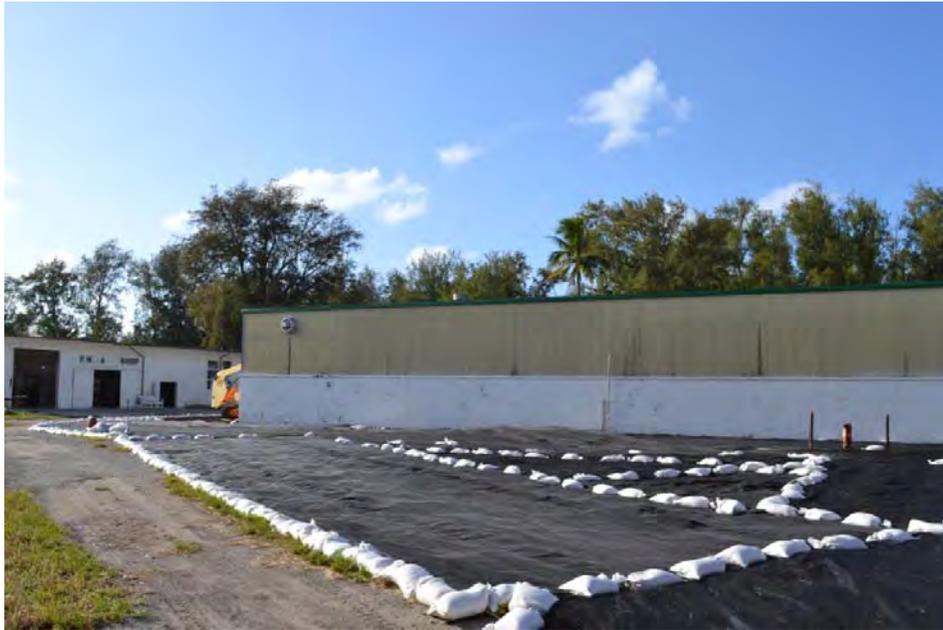
Photo 1: 10/20/11 – Looking North west @ South facing Wall of Bldg 349; Abatement / Re-Paint complete.

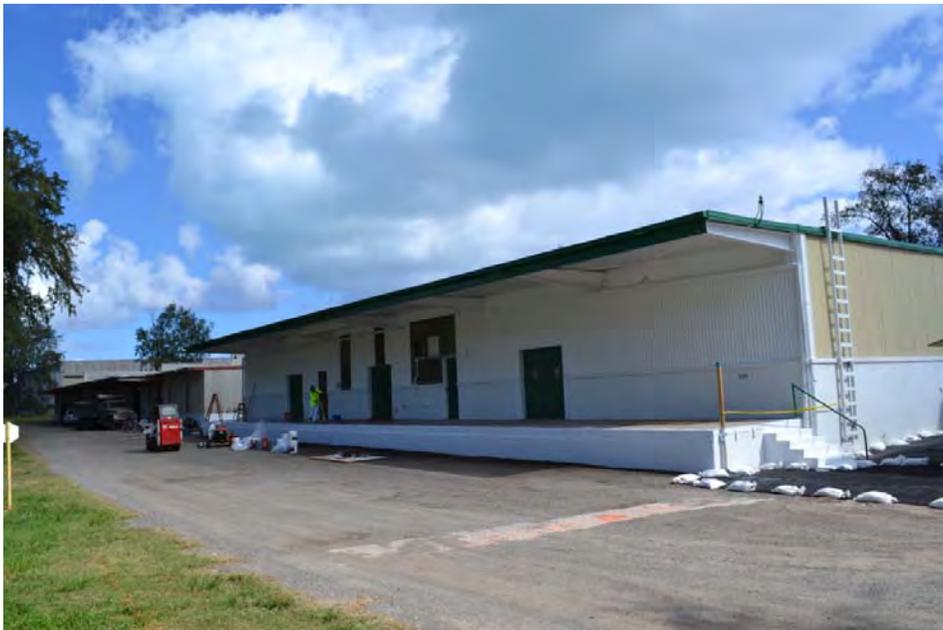
Photo 2: 10/20/11 – Looking South east @ North facing Wall of Bldg 349; Abatement / Re-Paint complete

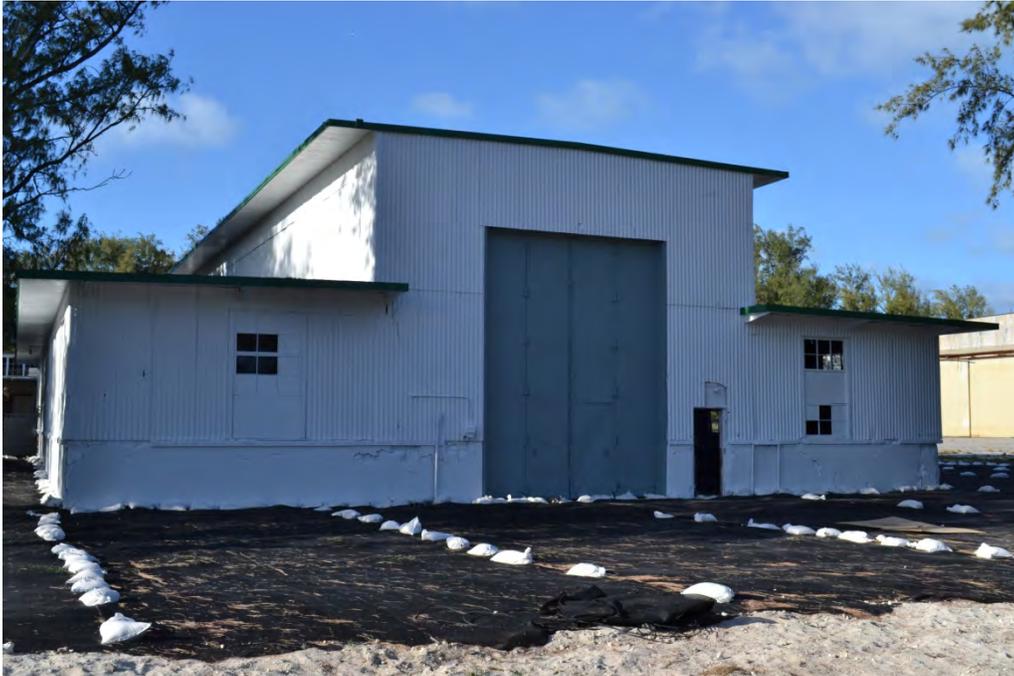
Photo 3: 10/26/11 – Looking North @ South facing Wall of Bldg 363; Abatement / Re-Paint complete

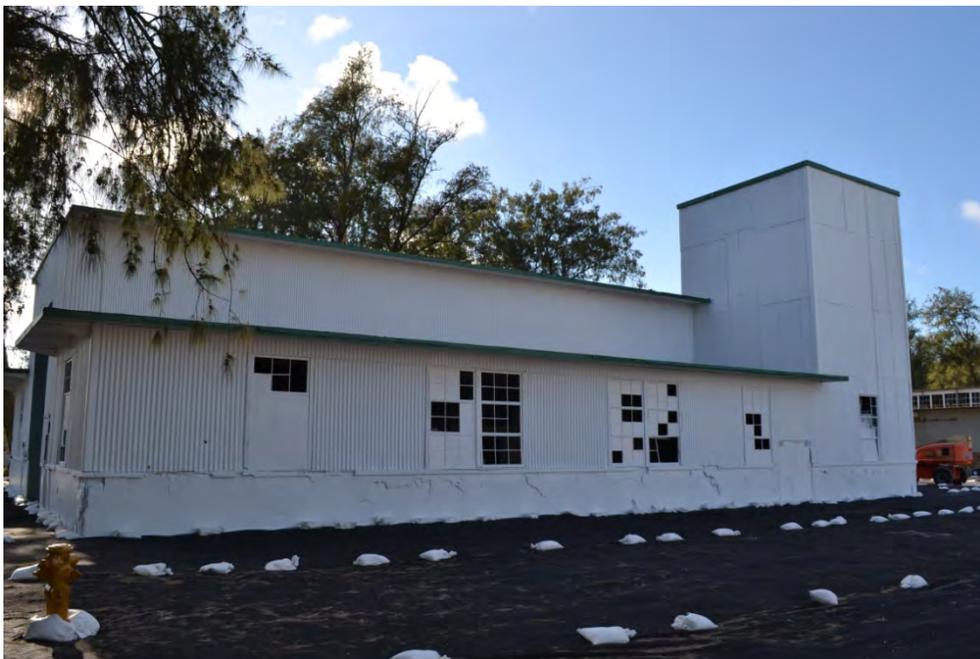
Photo 4: 10/26/11 – Looking West @ East facing Wall of Bldg 363; Abatement / Re-Paint complete

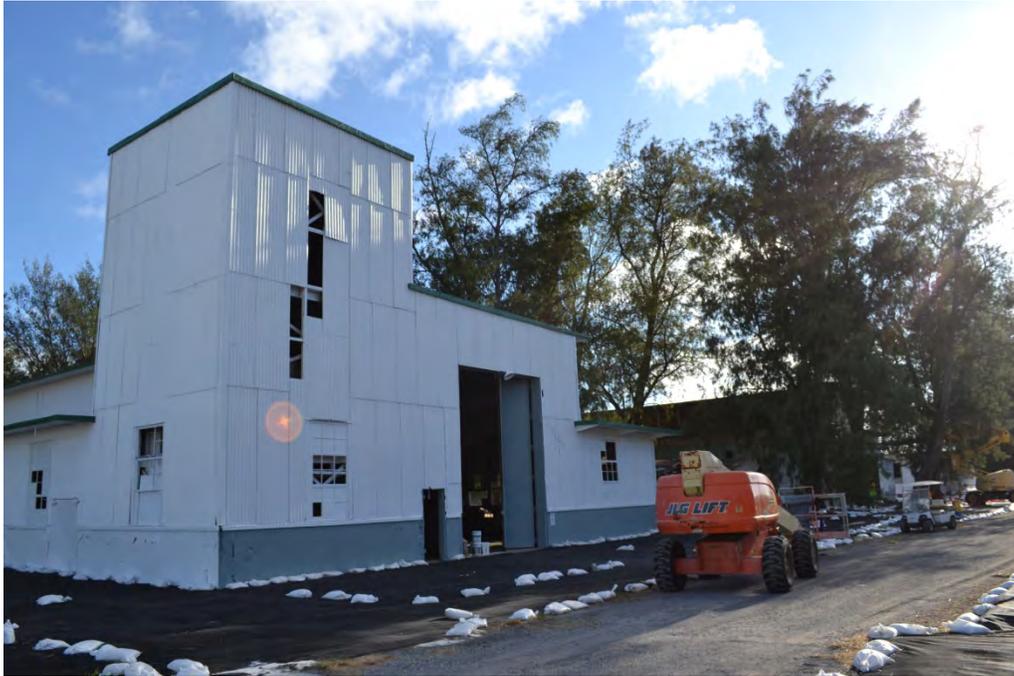
Photo 5: 10/26/11 – Looking South @ North facing Wall of Bldg 363; Abatement / Re-Paint complete

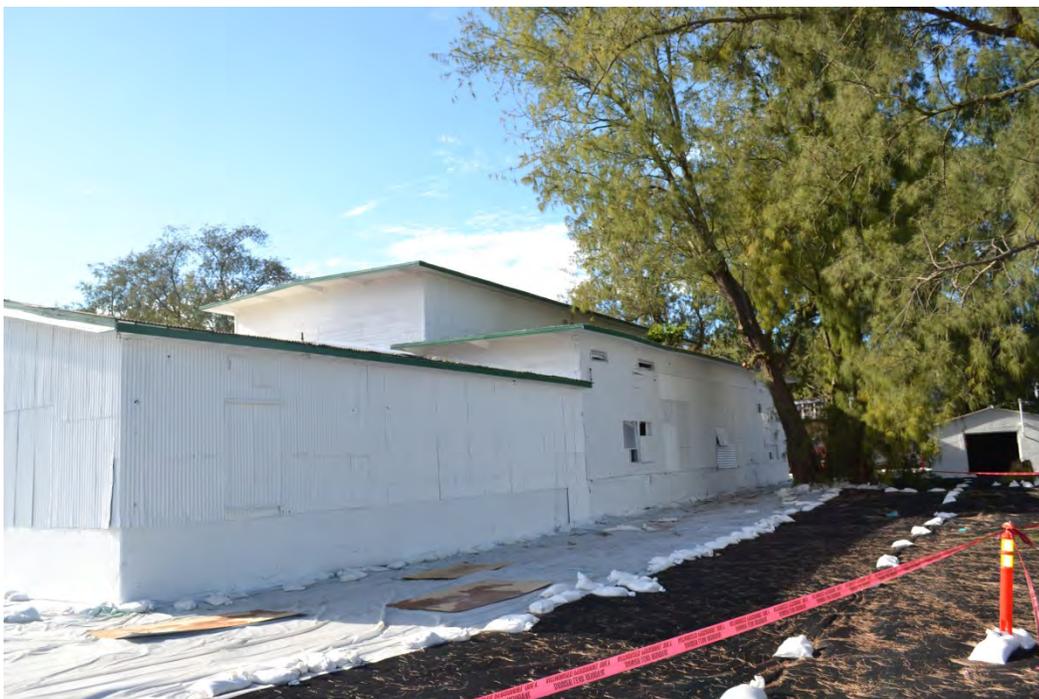
Photo 6: 11/2/11 – Looking North west @ East facing Wall of Bldg 357; Abatement / Re-Paint complete

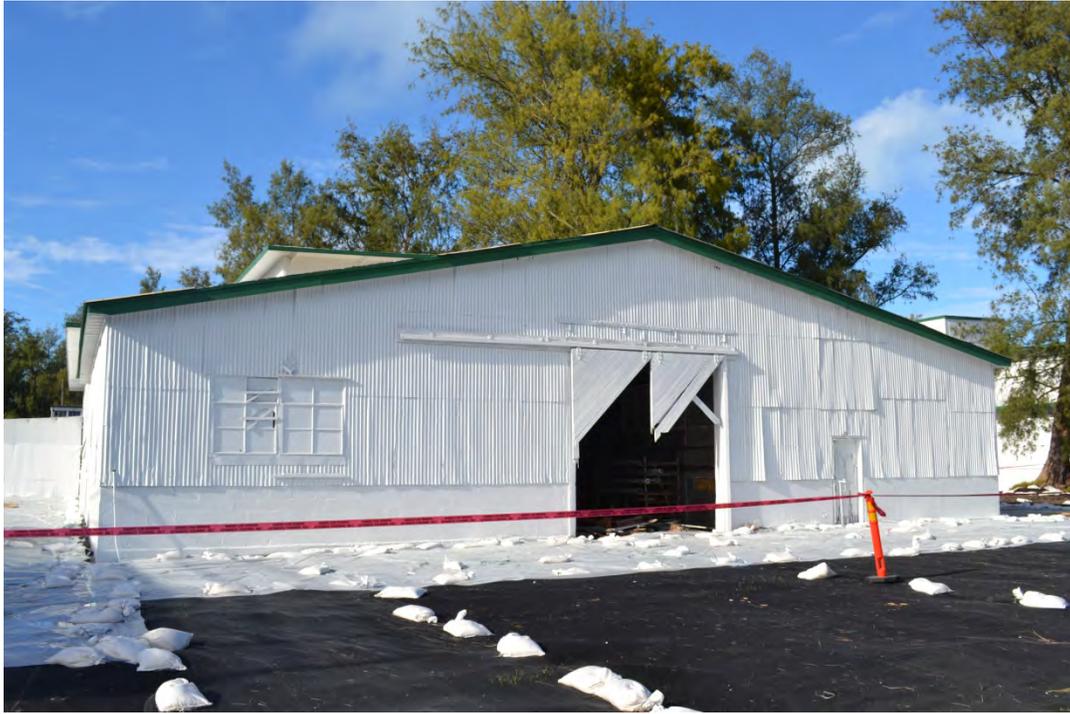
Photo 7: 11/2/11 Looking North west @ South facing Wall of Bldg 357; Abatement / Re-Paint complete
