**2011 ANNUAL REPORT**  
**CERCLA Non-time Critical Removal Action**  
**MIDWAY ATOLL NATIONAL WILDLIFE REFUGE**  
**MIDWAY ISLAND**  
**Contract No. F11PC00327**

29 February 2012

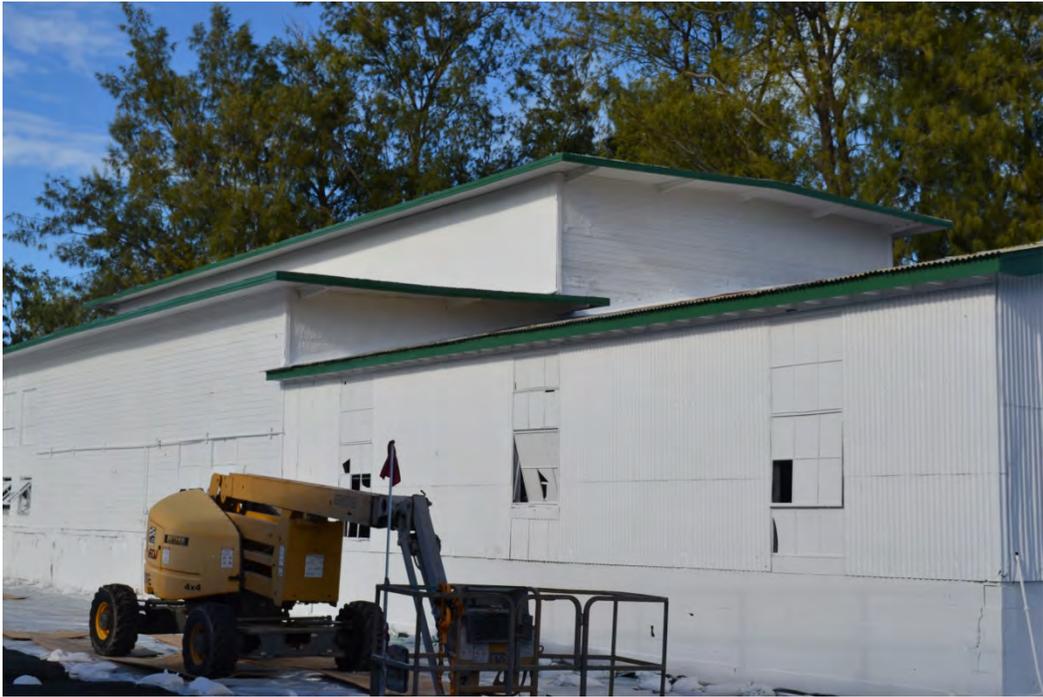
Photo 8: 11/2/11 – Looking North @ West facing Wall of Bldg 357; Abatement / Re-Paint complete

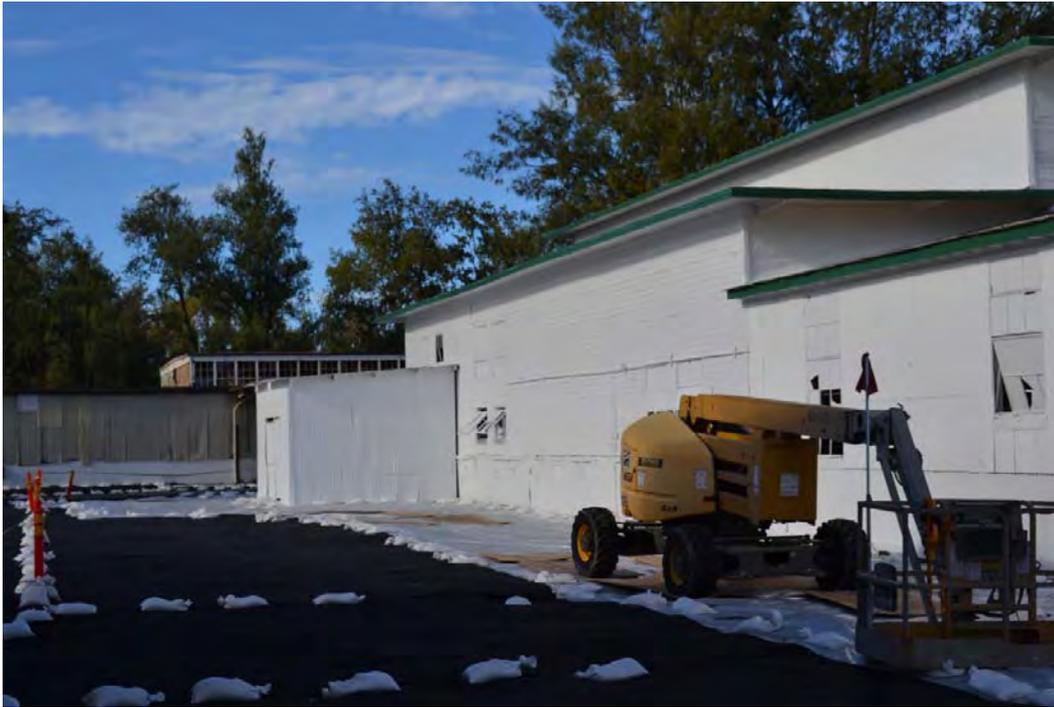
Photo 9: 11/2/11 - Looking North west @ West facing Wall of Bldg 357; Abatement / Re-Paint complete

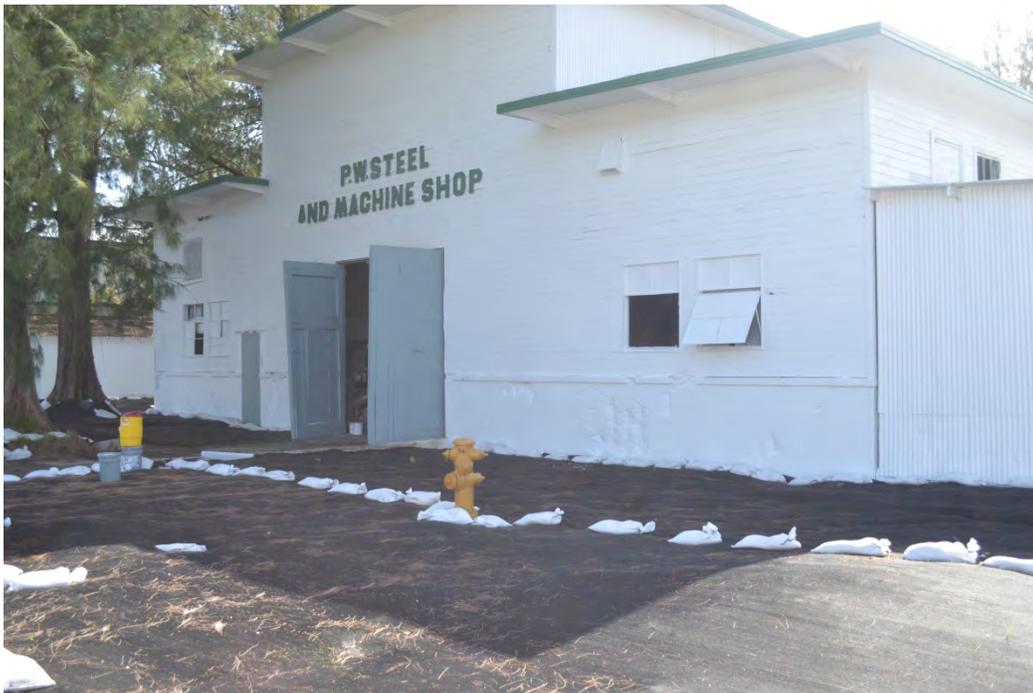
Photo 10: 11/4/11 - Looking East @ North facing Wall of Bldg 357; Abatement / Re-Paint complete

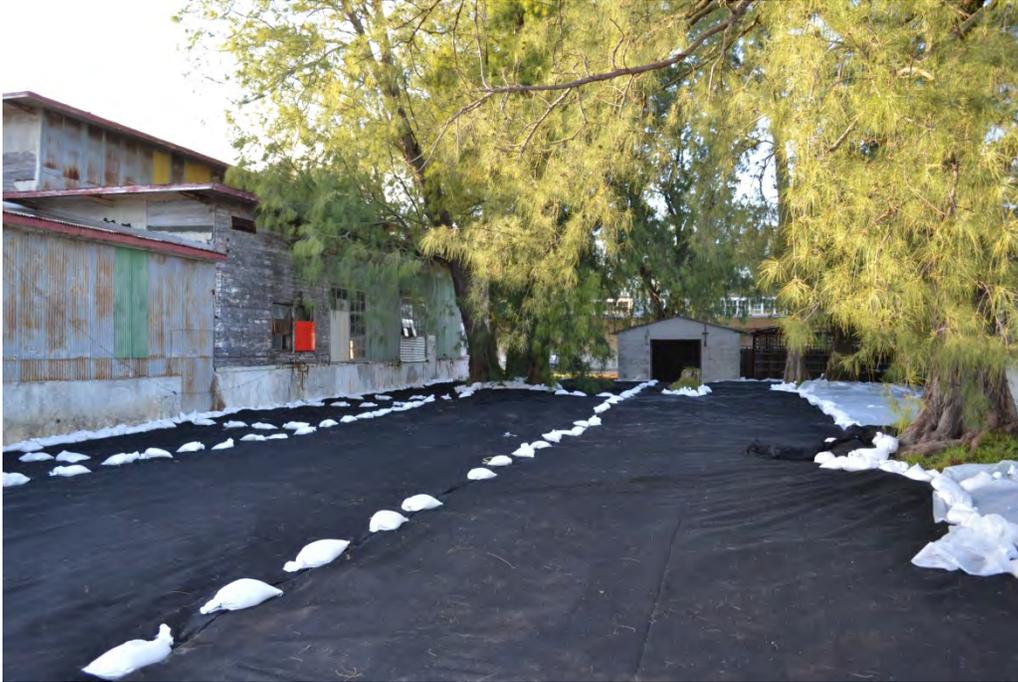
Photo 11: 10/17/11 - Looking North west @ Shadecloth deployed between Bldgs 357 and 363

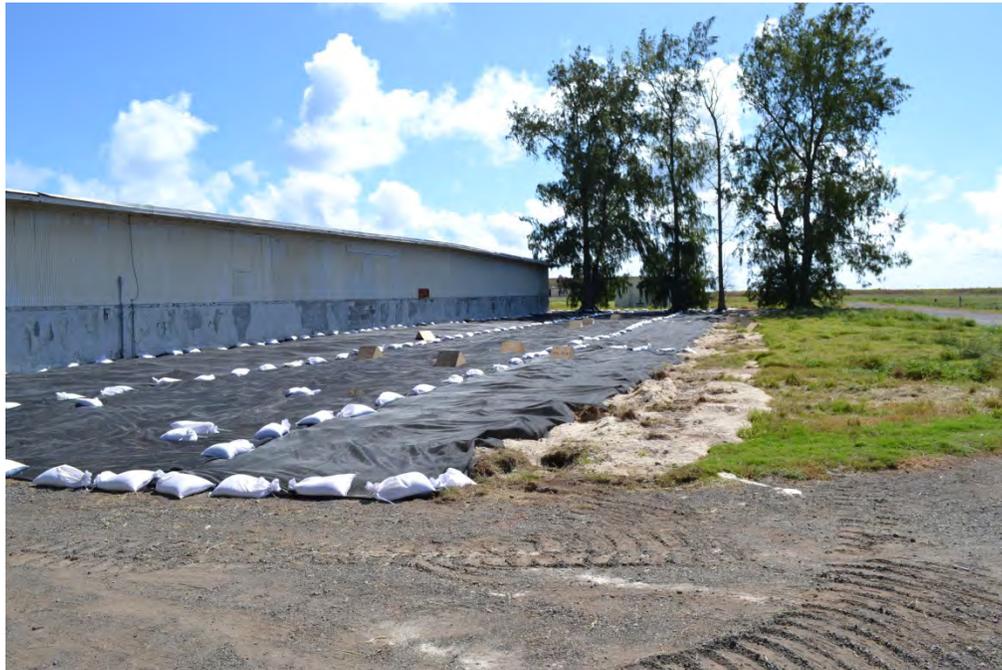
Photo 13: 10/23/11 - Looking South east @ Shadecloth deployed along the west facing wall of Bldg 393

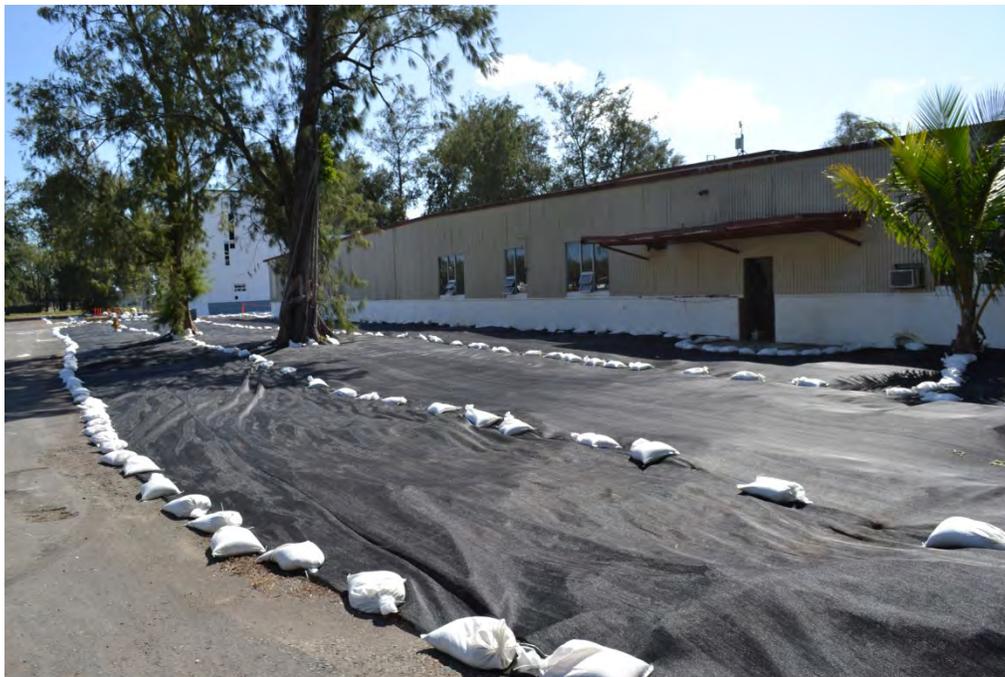
Photo 14: 10/24/11 – Looking South @ Shadecloth deployed along the east facing wall of Bldg 356

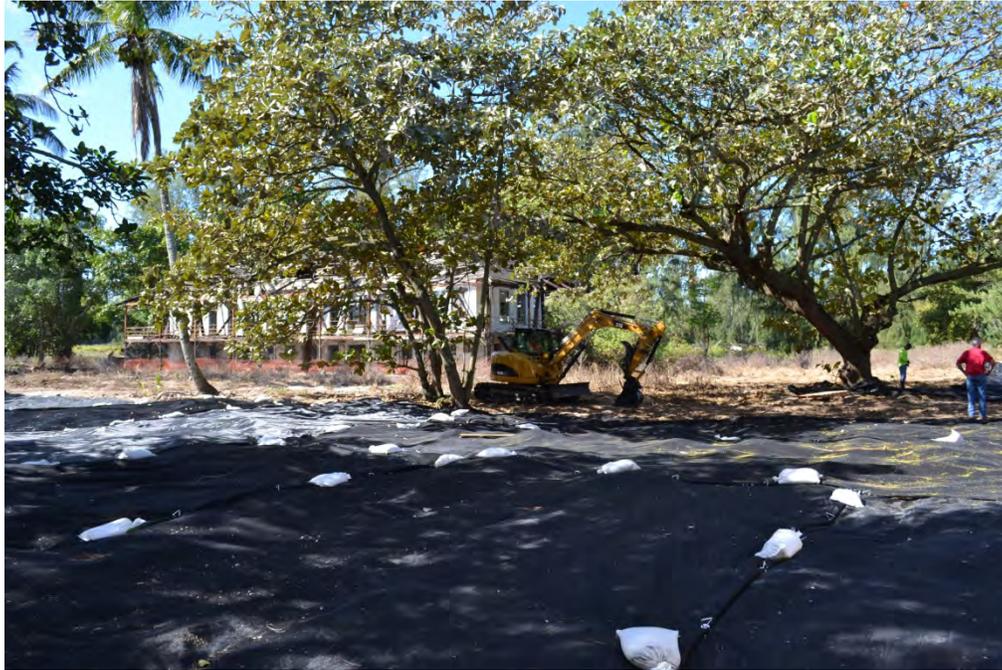
Photo 15: 10/31/11 – Looking West @ Shade cloth deployed along the south facing wall of Bldg 628

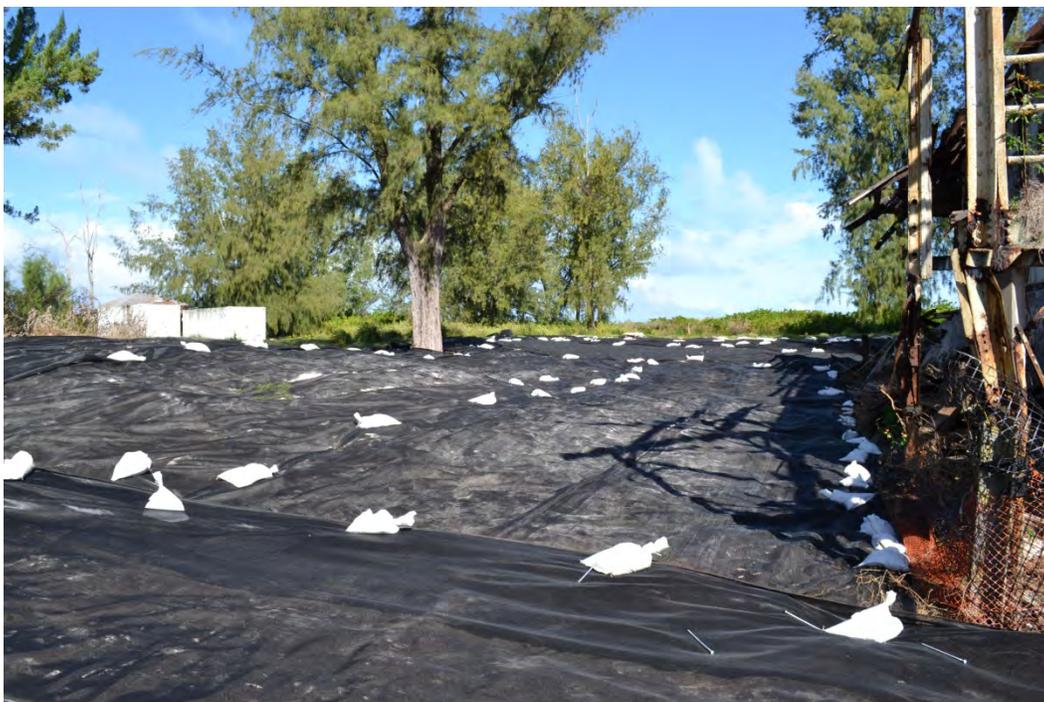
Photo 16: 10/31/11 – Looking North west @ Shade cloth deployed along the west facing wall of Bldg 619

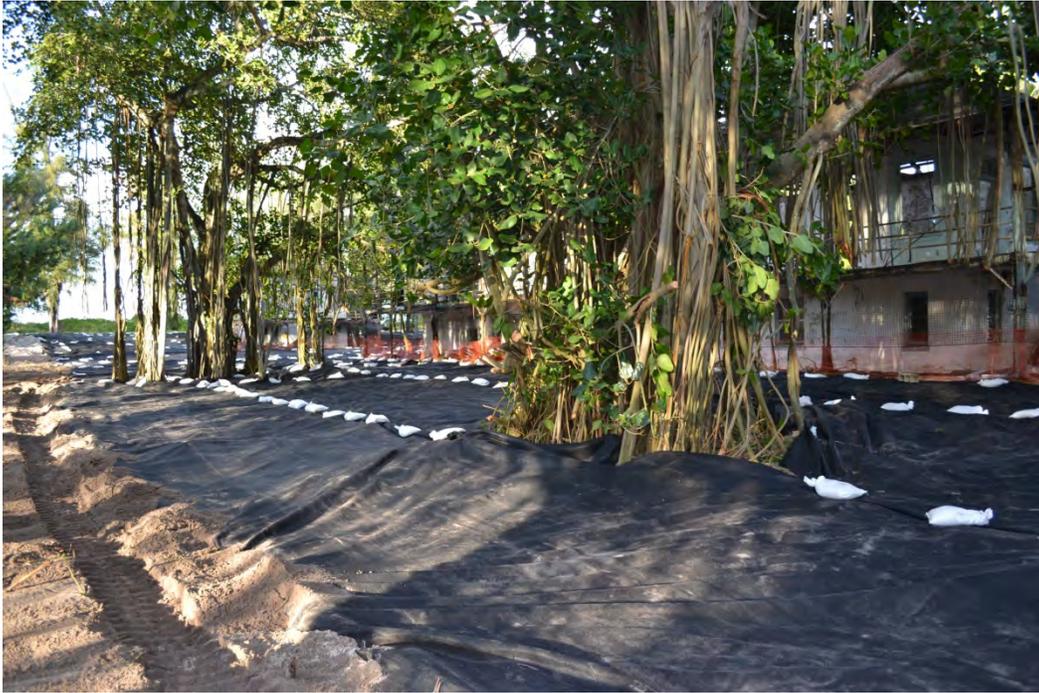
Photo 17: 11/3/11 – Looking North east @ Shadecloth deployed along the west facing wall of Bldg 623

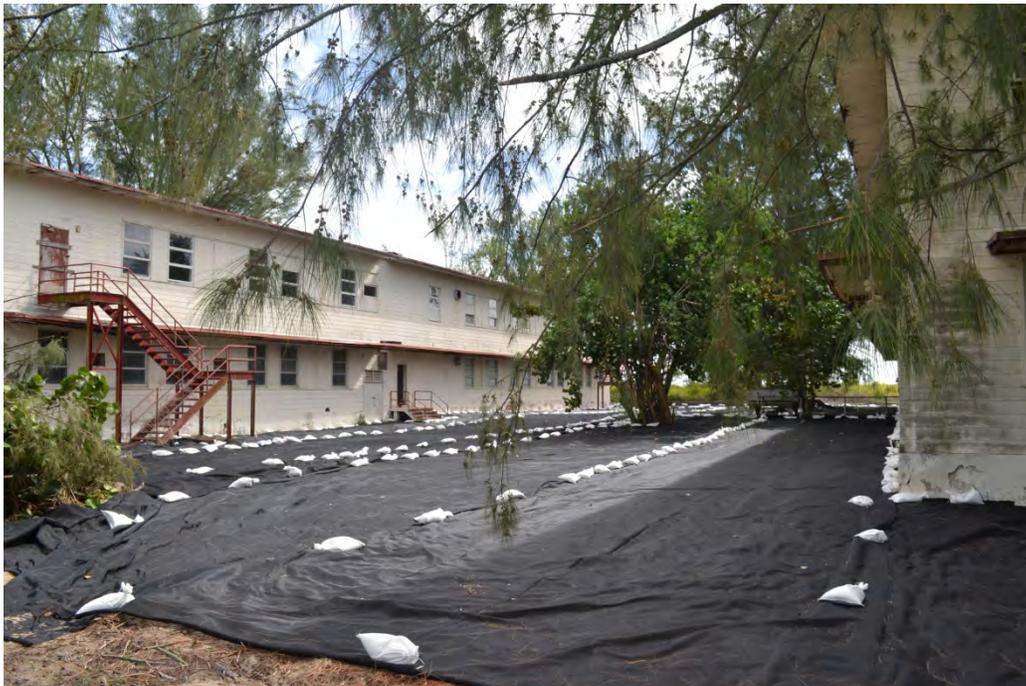
Photo 18: 11/7/11 – Looking South east @ Shadecloth deployed between Bldgs 578 and 579

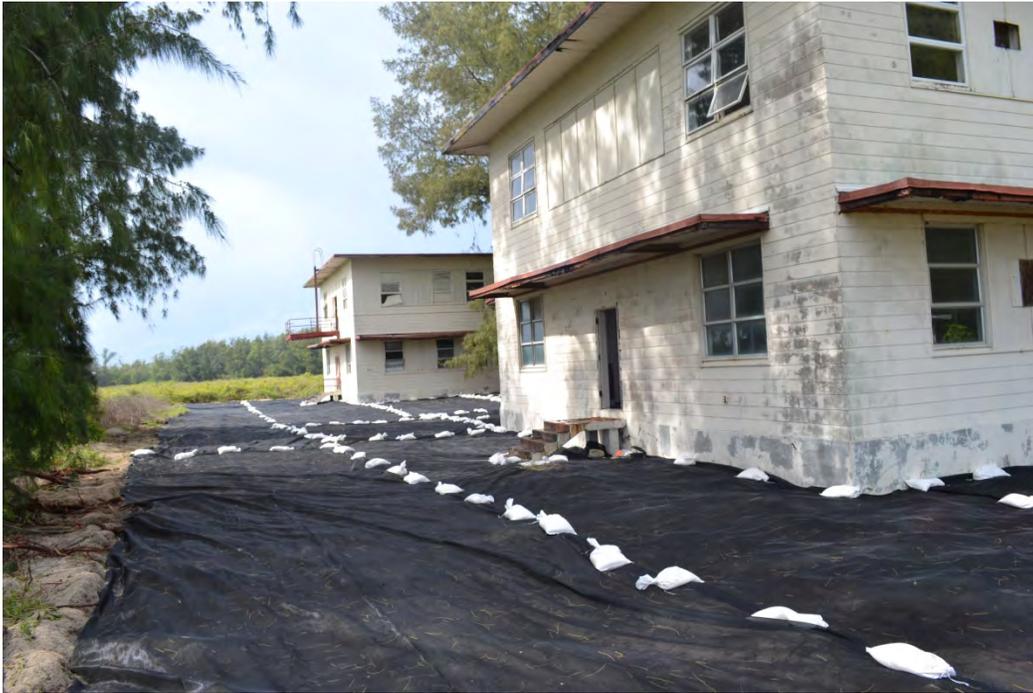
Photo 19: 11/6/11 – Looking West @ Shadecloth deployed along the south facing walls of Bldgs 578 and 579
